IMG_1704
Taken by: TBM - HNTB @ 11:17 AM on 1/08/19
Design #1617 - Ramp D over Mississippi Blvd.
Location: first splice from south end on west side
Looking SW

NOTE: throughout this document, suggested issues to be addressed / repaired are book ended with *'s as such *xxx xxx xxx*

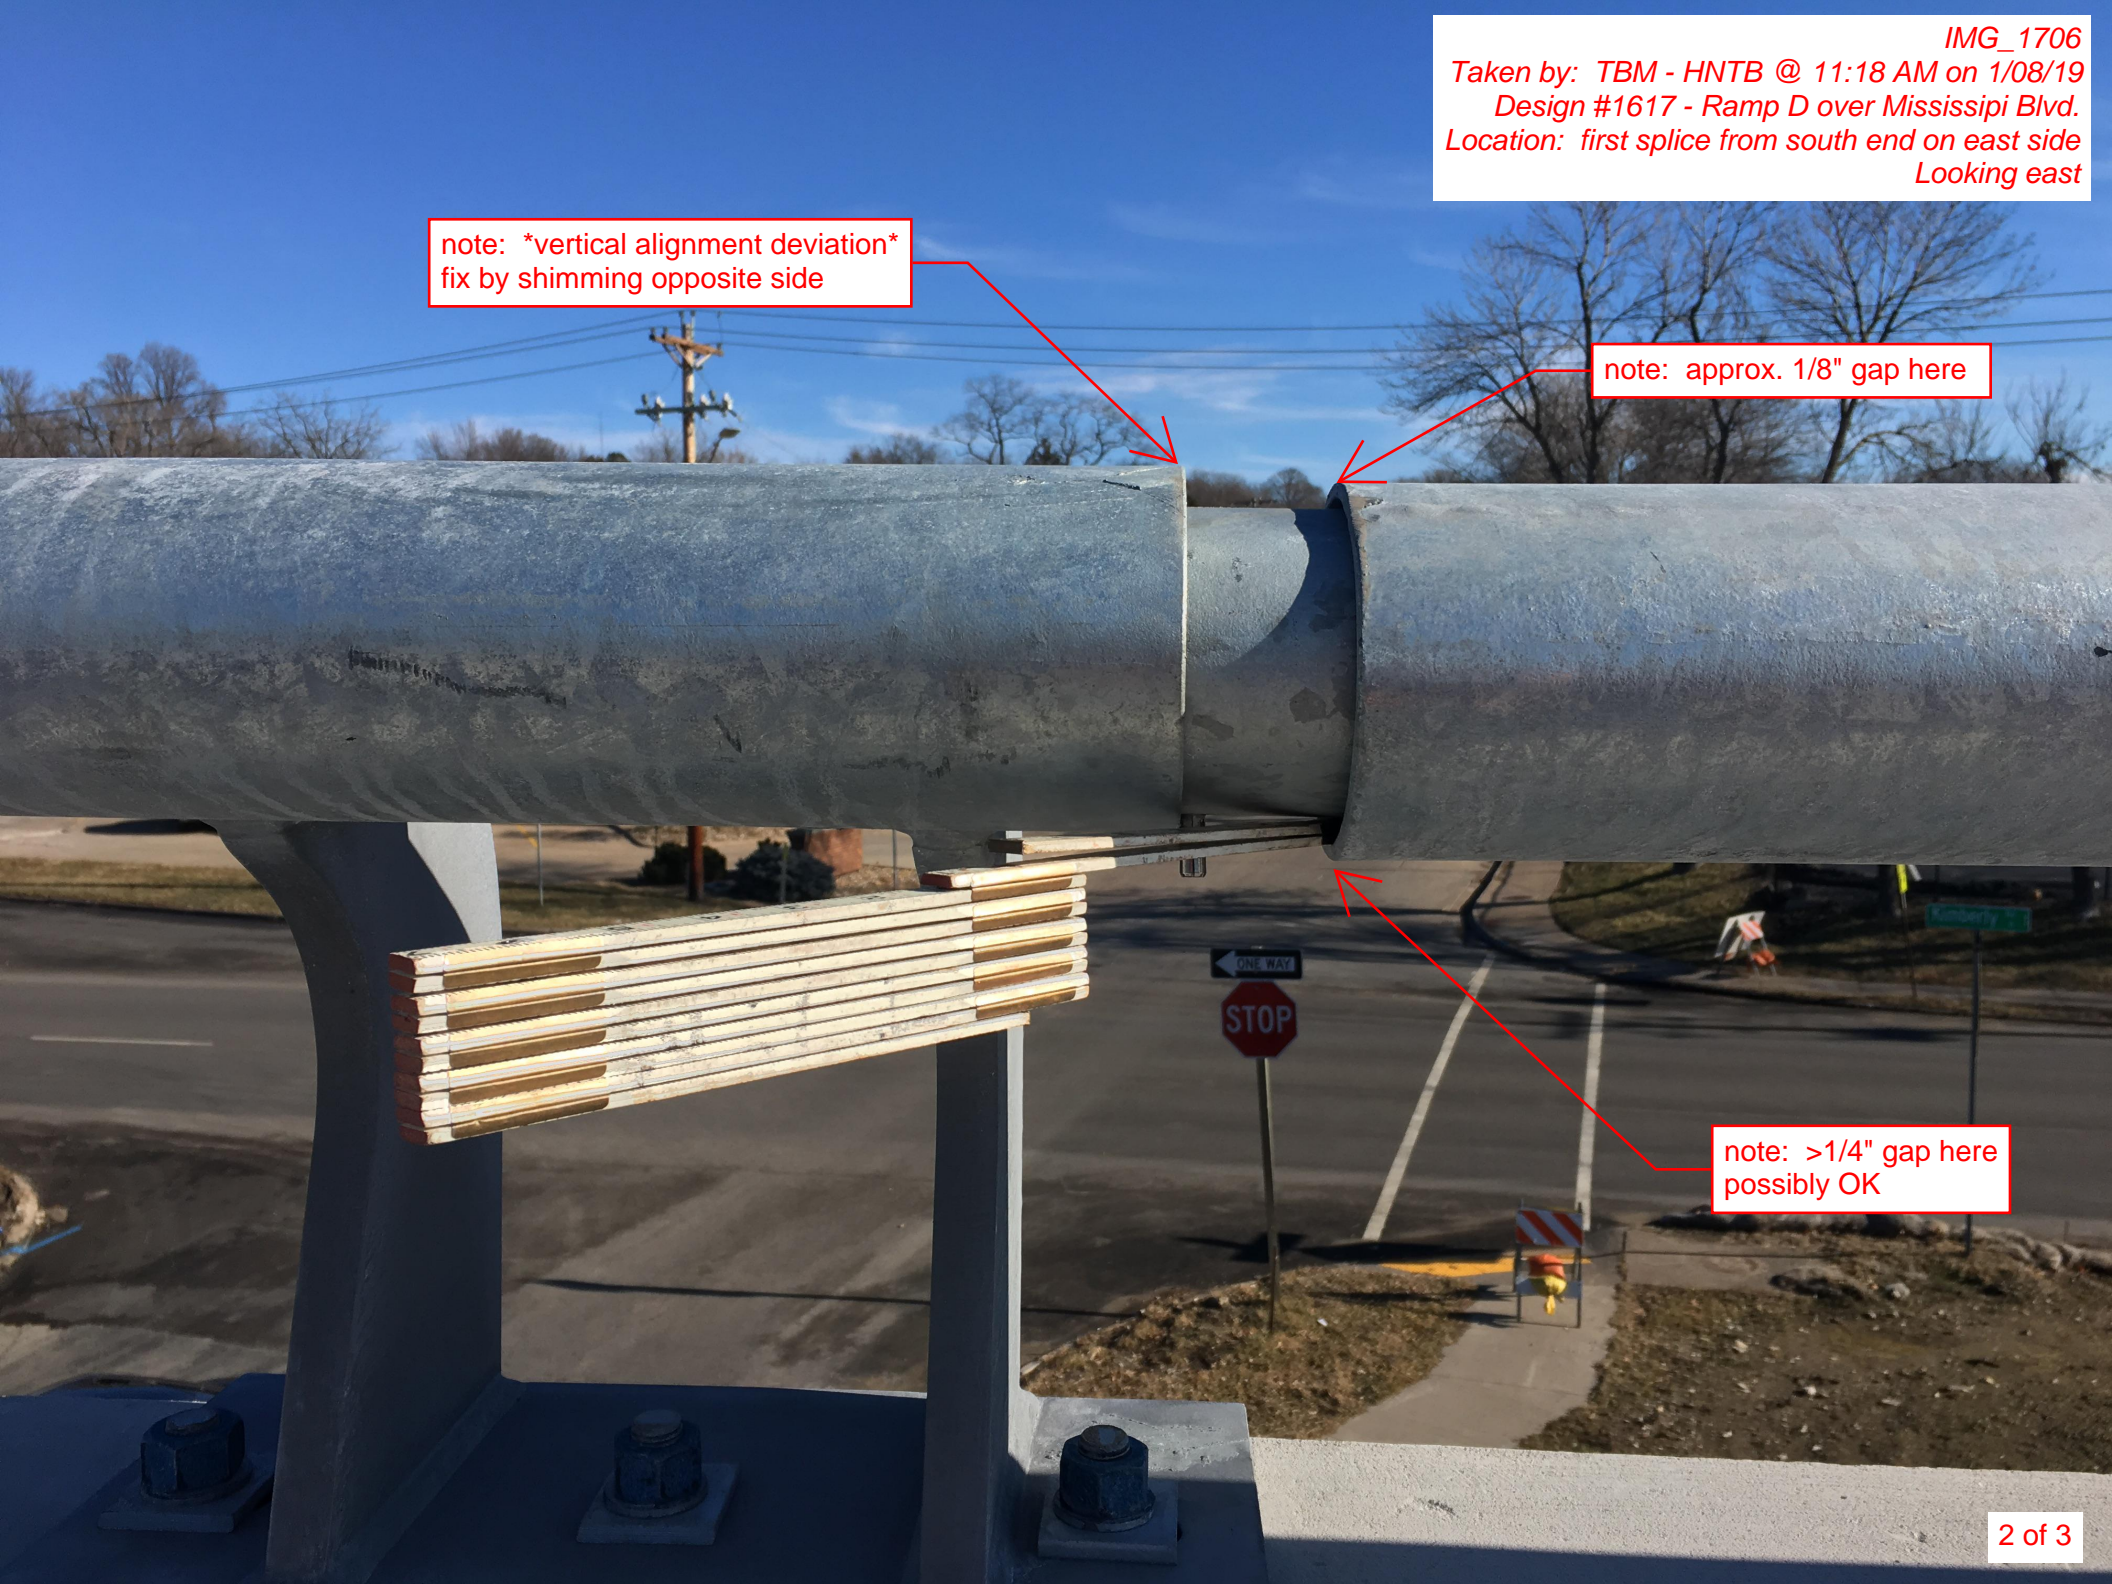
Taken by: TBM - HNTB @ 11:18 AM on 1/08/19
Design #1617 - Ramp D over Mississippi Blvd.
Location: first splice from south end on east side
Looking east

note: *vertical alignment deviation*
fix by shimming opposite side

note: approx. 1/8" gap here

note: >1/4" gap here
possibly OK

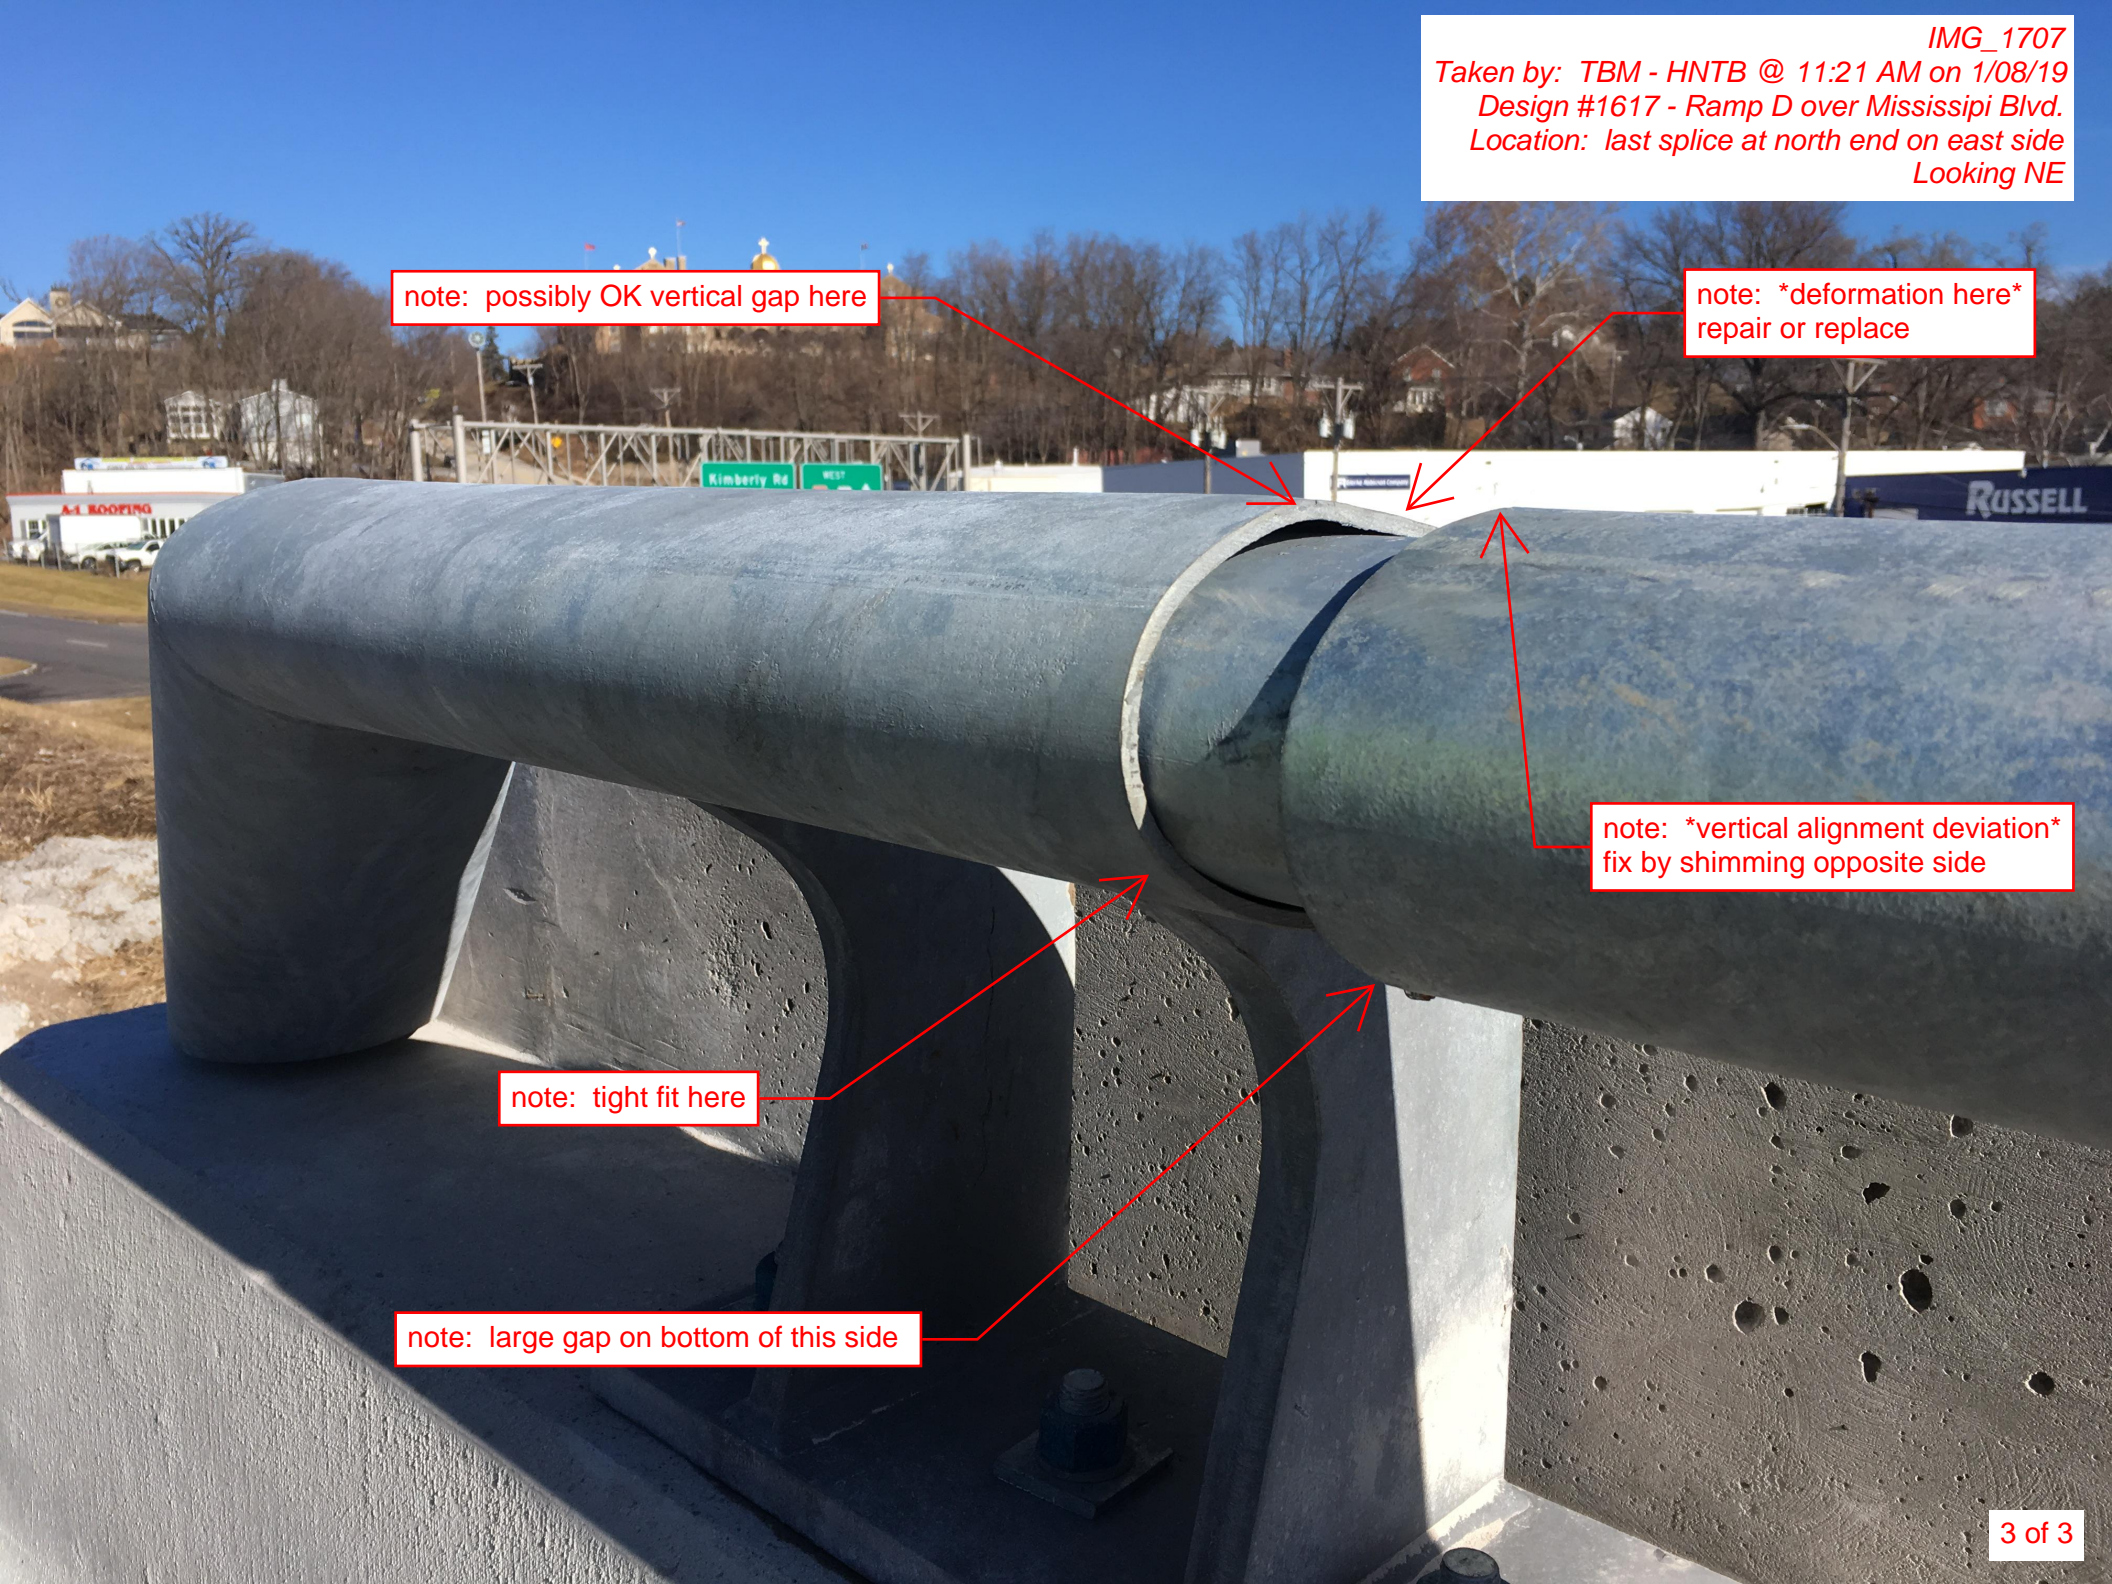
Taken by: TBM - HNTB @ 11:21 AM on 1/08/19
Design #1617 - Ramp D over Mississippi Blvd.
Location: last splice at north end on east side
Looking NE

note: possibly OK vertical gap here

note: *deformation here*
repair or replace

note: *vertical alignment deviation*
fix by shimming opposite side

note: tight fit here

note: large gap on bottom of this side
