U.S. Department
of Transportation
**Federal Highway
Administration**

Publication No. FHWA-RD-96-032
January 1997

Crash Testing and Evaluation of Retrofit Bridge Railings and Transition

VANDAL PROTECTION FENCE ON NEW JERSEY SAFETY SHAPE BRIDGE RAILING

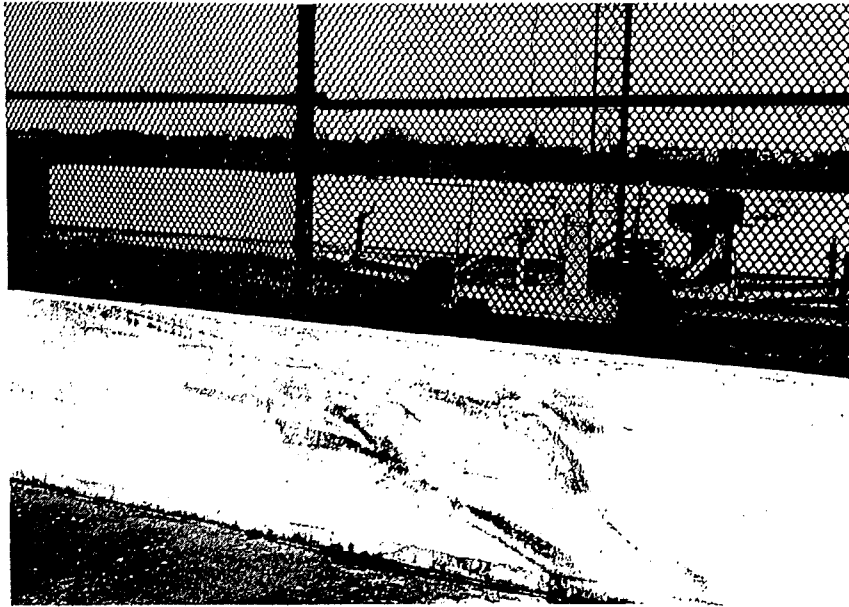
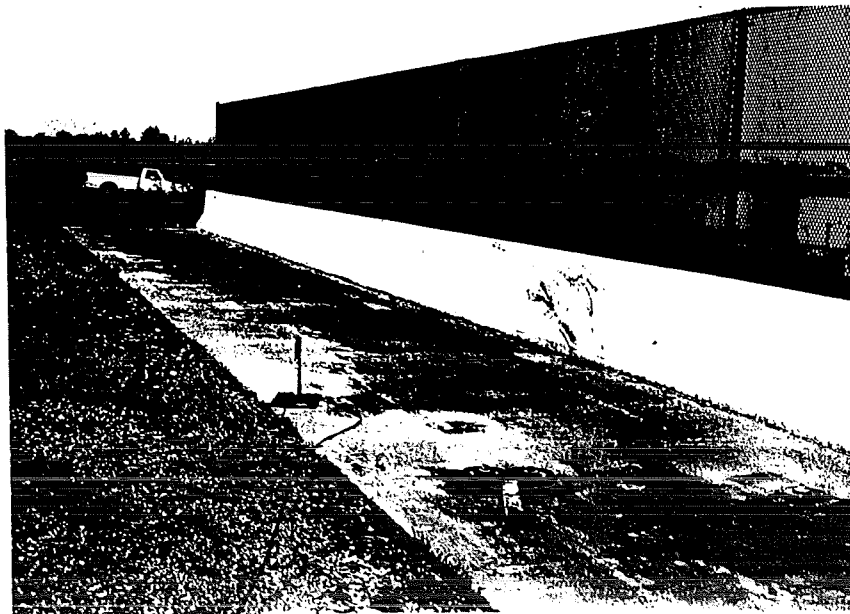
Figure 45. Vandal protection fence on New Jersey safety shape after test 472070-6.

As seen in figure 45, the installation received minimal damage. There were tire marks on the face of the safety shape and the lower edge of the wire fabric was pushed behind the lower horizontal line rail between post 5 and 6. The middle horizontal line rail was disconnected on the upstream side at the post 5 location and the post 5 anchor was pushed back 13 mm (0.5 in) as shown in figure 46. Maximum dynamic deflection of the fence was 142 mm (5.6 in) (measured at the top of the rail) and maximum residual deformation was 76 mm (3.0 in). Total length of contact with the installation was 5.2 m (17.0 ft).

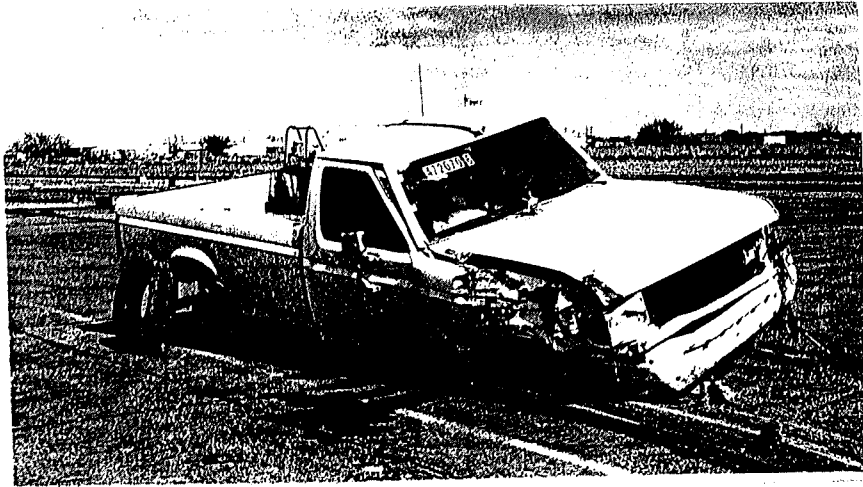
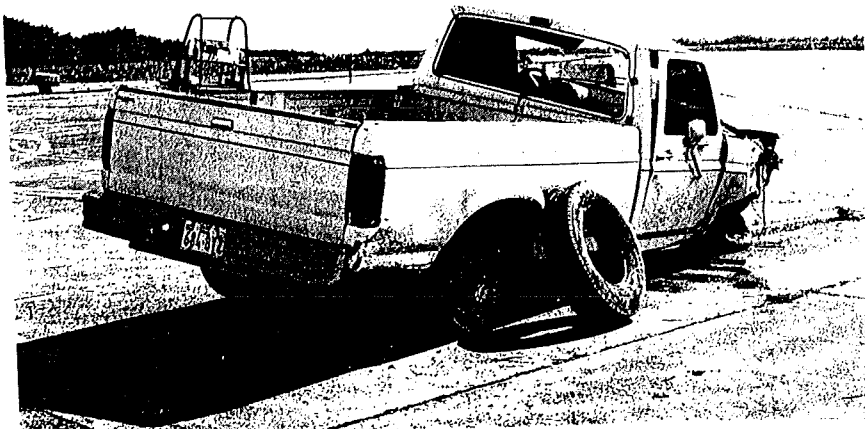
Figure 47. Vehicle after test 472070-6.

The vehicle sustained moderate damage as shown in figure 47. The stabilizer bar, floorpan, frame and front axle on the right side were bent and the windshield was cracked. The front bumper, hood, grill, right front quarter panel, both doors, and rear quarter panel were damaged. There was a small fold running diagonally in the floorpan of the occupant compartment. Maximum exterior crush at the right front corner of the vehicle was 170 mm (6.7 in). There was 70 mm (2.8 in) deformation into the occupant compartment of the firewall on the passenger side of the vehicle.

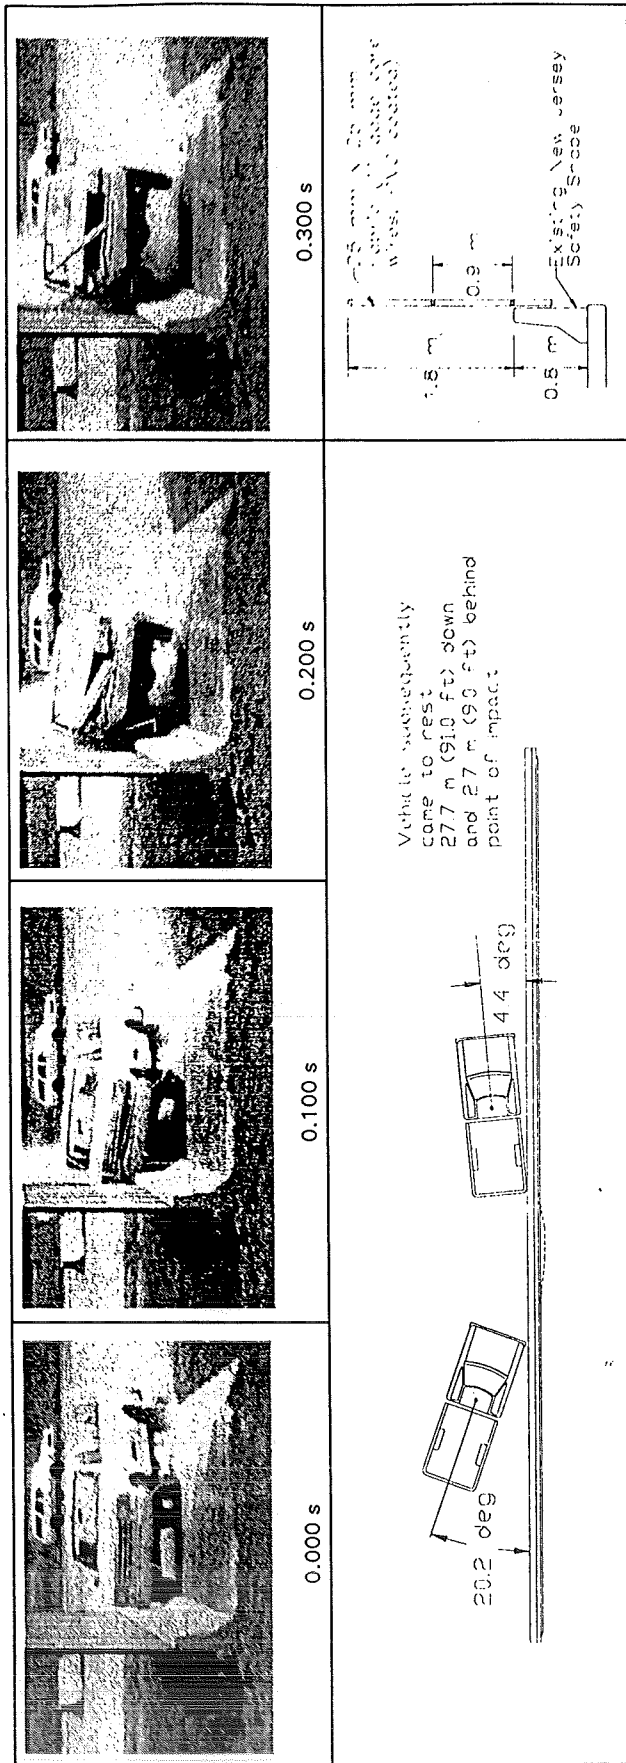
Figure 48. Summary of results for test 472070-6.

The vandal protection fence mounted on the New Jersey safety shape bridge railing successfully contained and redirected the vehicle and met all evaluation criteria set forth in the AASHTO *Guide Specifications for Bridge Railings* PL2 conditions for the pickup test. The vehicle did not penetrate or go over the installation. There was no measurable deformation to the safety shape and maximum deflection of the fence was 142 mm (5.6 in) measured at the top of the fence. Presence of the fence itself did not result in adverse performance. There were no detached elements or debris to exhibit undue hazard to adjacent traffic. The vehicle sustained moderate damage with minimal deformation (70 mm (2.8 in)) into the passenger compartment. The vehicle remained upright and stable during and after the impact sequence. The trajectory of the vehicle was judged to have posed minimal potential hazard to adjacent traffic as the vehicle exited the installation with a trajectory of 4.4 degrees. The coefficient of friction was calculated at 0.32. The occupant risk factors were well within the desirable limits. In summary, the impact performance of the vandal protection fence on the New Jersey safety shape bridge railing was considered satisfactory according to guidelines set forth by AASHTO, as shown in table 9.
