1. REPORT NUMBER FHWA/CA10-0515	2. GOVERNMENT ASSOCIATION NUMBER	3. RECIPIENT'S CATALOG NUMBER
4. TITLE AND SUBTITLE DEVELOPMENT OF WEED CONTROL BARRIER BENEATH METAL BEAM GUARDRAIL		5. REPORT DATE January 2011

**DEVELOPMENT OF WEED CONTROL BARRIER BENEATH METAL
BEAM GUARDRAIL**

January, 2011

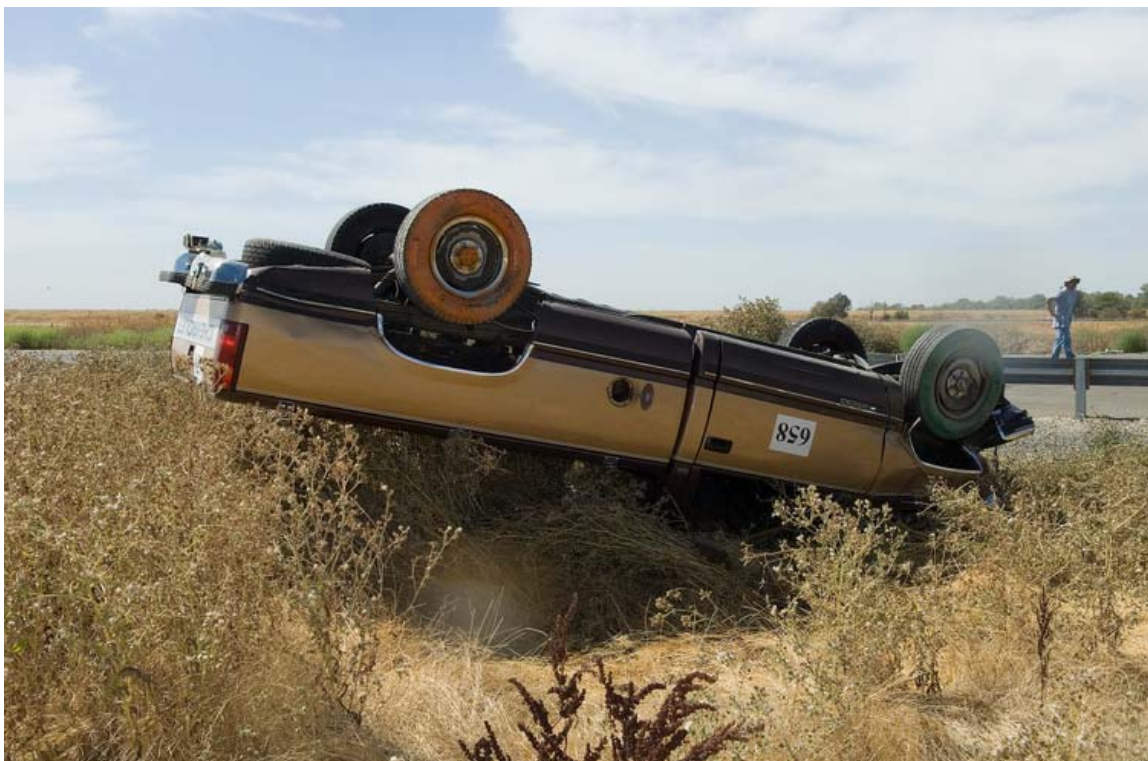
Figure 2-18 – Test vehicle after Test 658

The vehicle was extensively damaged from the w-beam rail rupture and subsequent vehicle rollover. No further analysis of vehicle damage was performed.

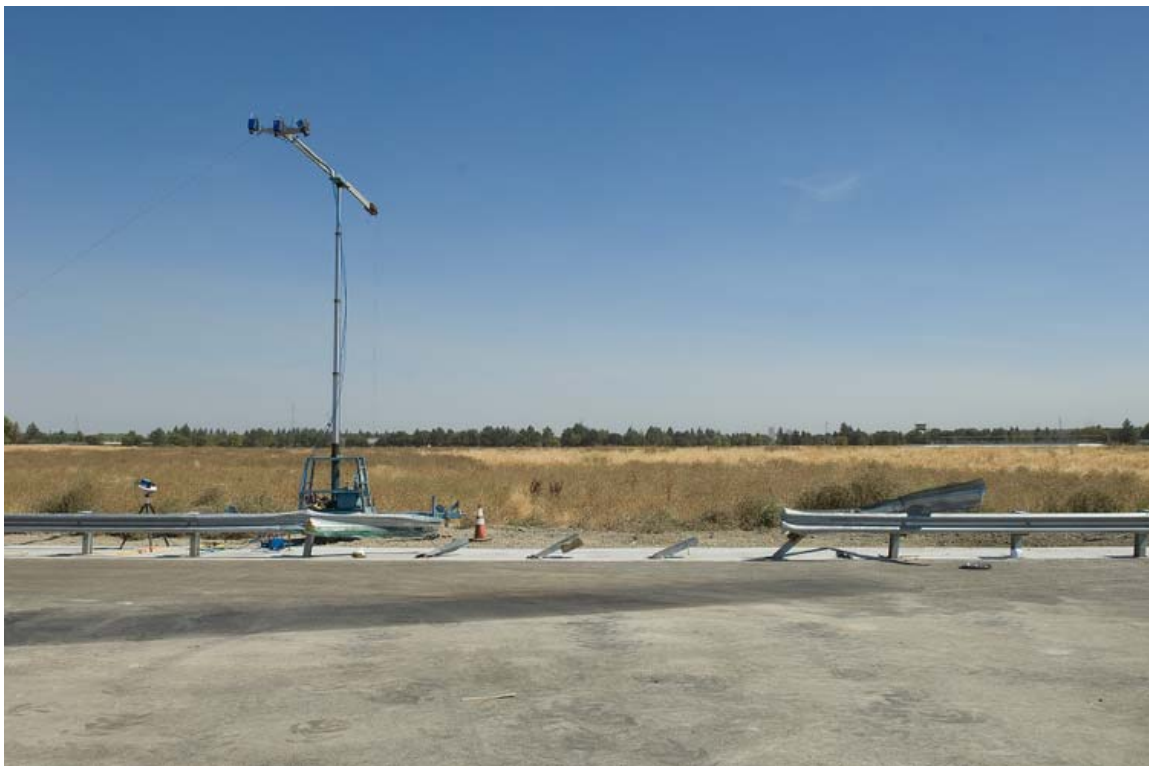
Figure 2-20 – Test 658 Test Article after Impact

The main damage was the rupture of the w-beam rail. Secondly, the upstream SFT deflected toward the impact point, likely because the soil surrounding the metal tube was not adequately compacted. The rail stretched upstream of the impact point and compressed downstream of the impact point, as evidenced by movement of as much as ¼ inch at the lap splices. Every post twisted counterclockwise, possibly also because of the inadequate anchoring of the upstream end treatment. As the rail shifted laterally (in the downstream direction), the wood post at the downstream SFT fractured (see Figure 2-22). Several blockouts also fractured during impact and were thrown from the point of impact toward the field. The blockout nearest the point of impact appeared to fracture upon impact, possibly before the post was able to rotate. Thus the reaction point of the rail would not have been raised, possibly contributing to the system failure. At the rupture point, the bottom of the w-beam element appears to have failed in shear due to contact with the top of the post at that location while the upper portion appears to have failed in tension.

Because of the results of Test 658, several design changes were made to the test article before re-testing. The test article for Test 658 was removed and replaced with a new test article. A 193.25-foot section (including end treatments) of MBGR with W6x9 steel posts was used. Again, all steel posts were driven into place without pilot holes. A 100-ft long x 4 ft-8 in section of CRMCrete was placed around 16 posts in the vicinity of impact (from the fifth post upstream of the impact point to the eleventh post downstream of the impact point). The first change made was to use an SRT end terminal instead of an SFT at the upstream end for additional anchorage. Wood posts at the SRT were driven into undersized pilot holes. An SFT was again used at the downstream end. A second significant change was to install the entire test article in native soil rather than in the AASHTO Grade A Standard Soil Pit. The native material is not as stiff as the AASHTO Standard Soil. A less stiff soil would be less likely to resist post rotation, thus making any effect the CRMCrete had on post rotation more pronounced. Third, the rubber boots used in Test 658 were replaced with expanded polystyrene foam (EPF) covered by ½ in of CRMCrete flash over. The EPF had a flexural strength of 33 psi and a compressive strength of 13 psi at 10% deformation. Last, the amount of crumb rubber in the mix was reduced from 4% to 3%. This mix design had a higher 28-day strength (1863 psi, 12.84 MPa) and created a more durable section to withstand cracking. The increase in compressive strength had only a minimal effect on the strength of the leave-out area with EPF since the leave-out section consisted of only ½ in (13 mm) of flash over.

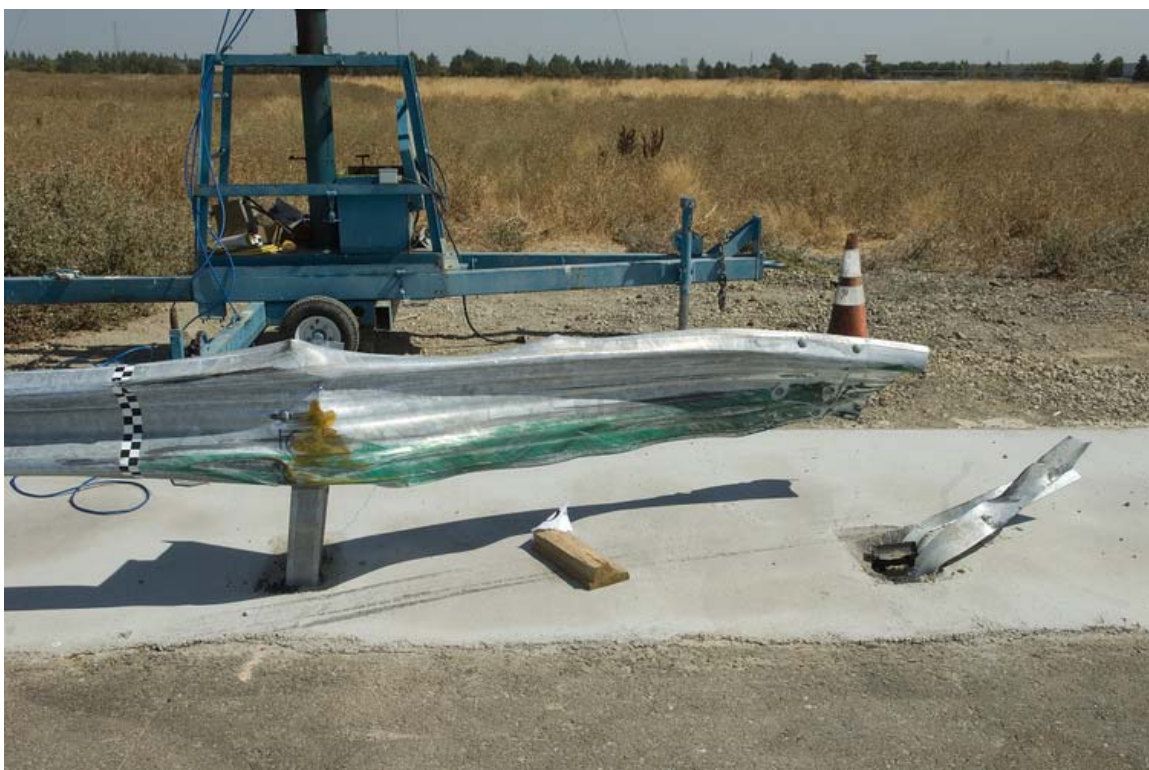
Figure 2-21 – Close-up of Impact Point

The vehicle impacted the w-beam section approximately 18 in (457 mm) upstream of Post 16, a non-splice post, with a speed of 99.8 km/h and impact angle of 25.8°. Post 16 immediately began to deflect backward, toward the field side of the guard rail. Post 16 reached its maximum deflection 0.048 s after impact. Post 17, which was downstream of Post 16, reached its maximum deflection at 0.094 s after impact. At 0.12 s after impact the left-front tire contacted post 17 and at 0.13 s after impact the front tires were redirected toward the field. At about 0.134 s after impact the w-beam completely ruptured, allowing the vehicle to pass through. When the vehicle left the CRMCrete and entered the unpaved field, it rolled over, coming to rest up-side down.

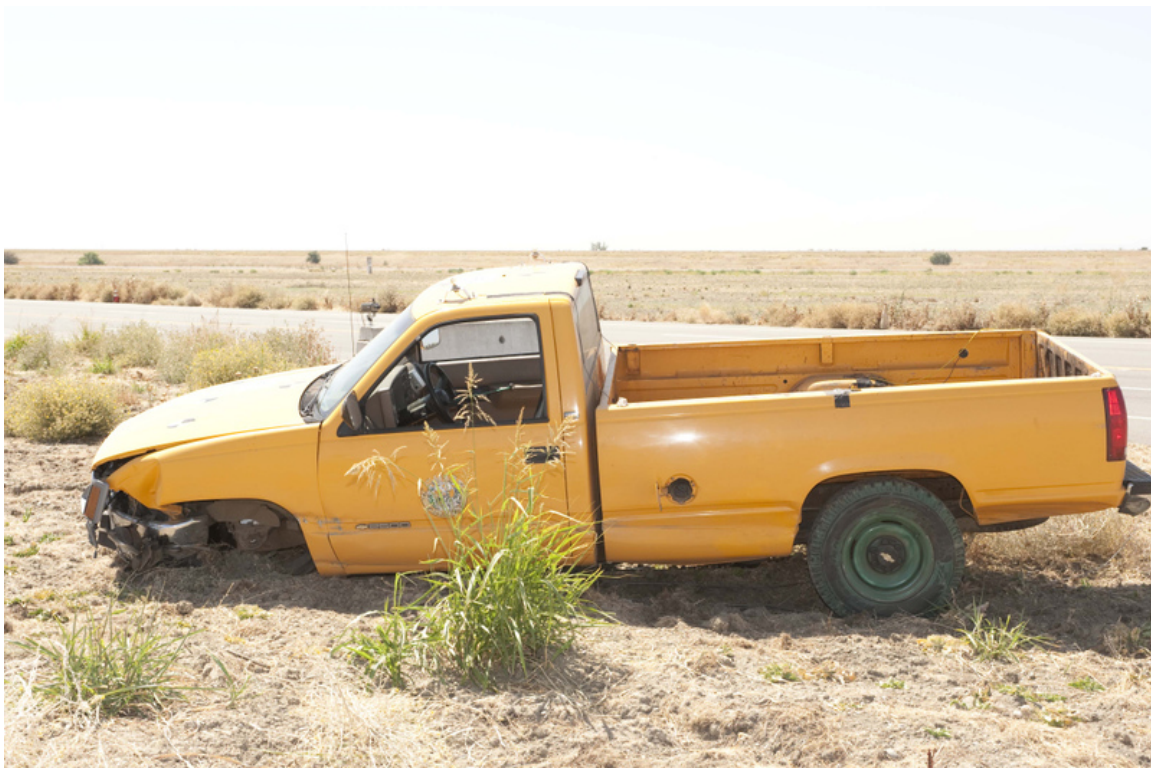
Figure 2-36 – Right Side of Test Vehicle after Test 659

There was mild to moderate damage to the entire left side of the vehicle. The left portion of the front bumper and left front fender were pushed rearward. The left front tire and wheel assembly were detached from the vehicle. There was minor denting of the left door, left side of the bed, and left rear fender. The maximum passenger compartment deformation was one inch, between the motor panel and the rear of the occupant compartment.

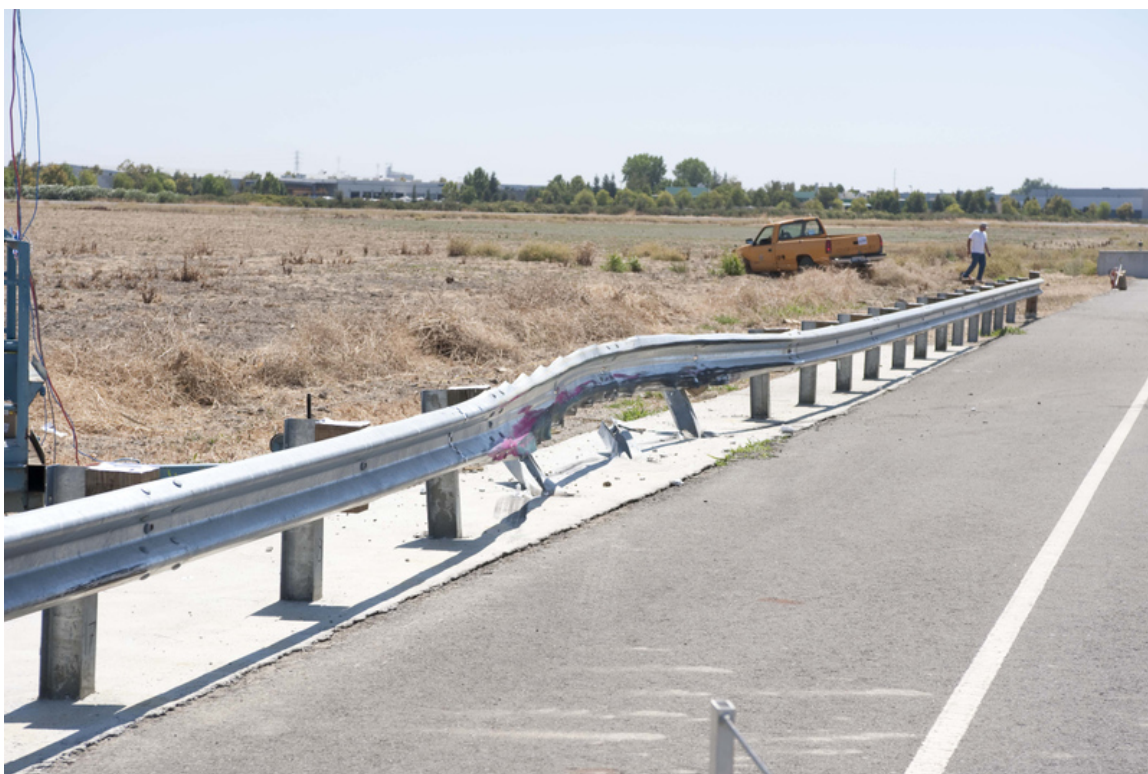
Figure 2-38 – Test Article Overview after Test 659

Posts 19-23 were deflected backward toward the field. Posts 20-22 were pushed over and permanently deformed. The blockouts at posts 20 and 21 were detached from the guardrail and damaged during the impact. The w-beam rail between posts 19-23 was permanently deformed. There was damage to the leave-out areas of posts 19-23 but the damage did not extend into the CRMCrete surrounding the leave-out areas. Blockout debris was found on the field-side as far as 172 feet from the point of impact but this is typical for a metal beam guardrail impact.
