Design Problem No. 1

Dean L. Sicking, Ph.D., P.E.
2004 Roadside Safety Workshop
June 23-24, 2004

Midwest Roadside Safety Facility

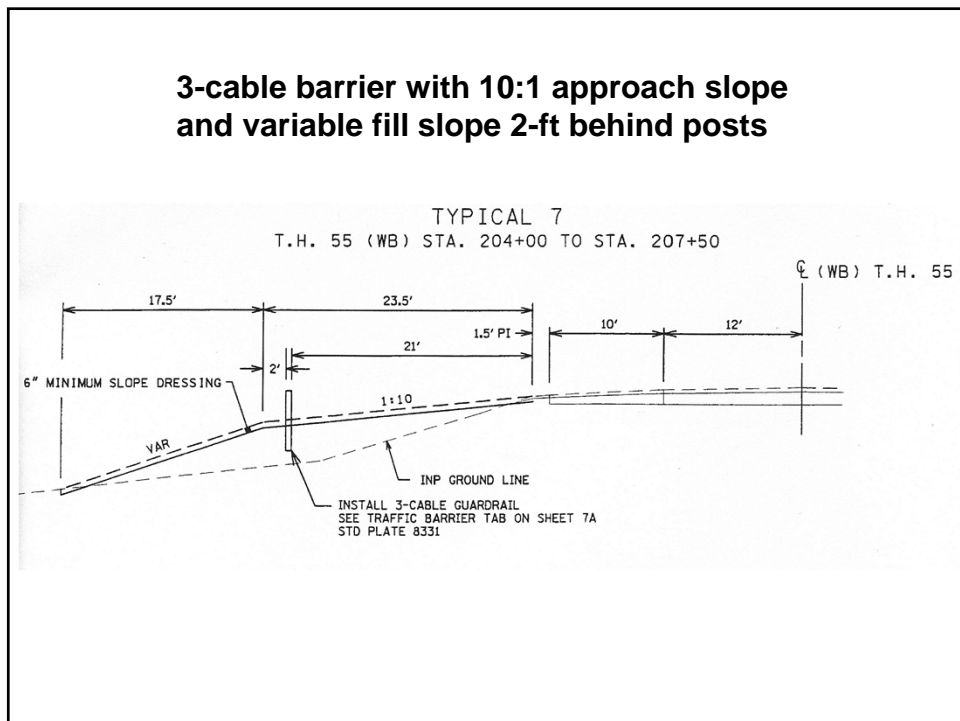
3-cable barrier with 10:1 approach slope and variable fill slope 2-ft behind posts

- three cable barrier incapable of redirecting 2000P vehicle impacting at TL-3 condition of NCHRP 350 when installed adjacent to 1.5:1 slope
- TL-3 approved, strong-post, W-beam design variations exist when placed near or directly on 2:1 fill slope

- Cable guardrail may function in this application, but research not yet complete
- Simulation study indicates cable barrier should provide acceptable performance when placed 3' in front of slope break point and post spacing reduced to 4'
- W-beam guardrail with 7' posts on 3'-1.5" centers placed at the slope break point is an NCHRP Report 350 approved alternative

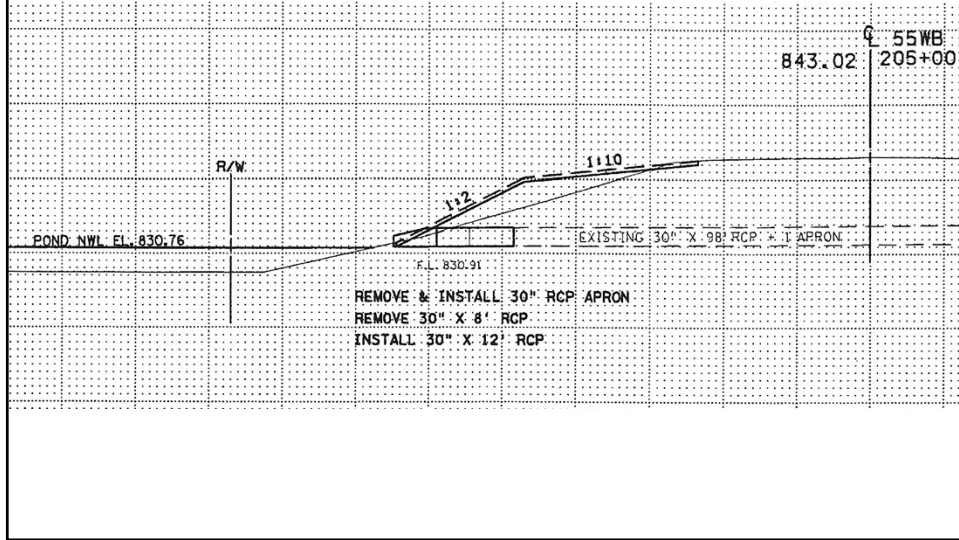
2:1 Fill slope at station 205+00

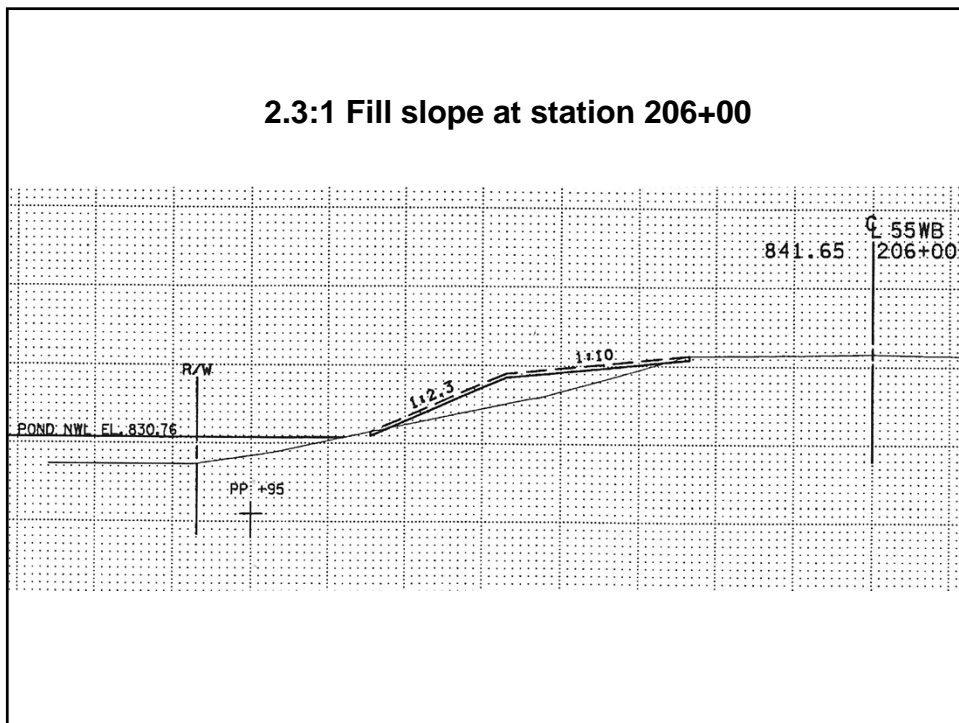
2.3:1 Fill slope at station 206+00

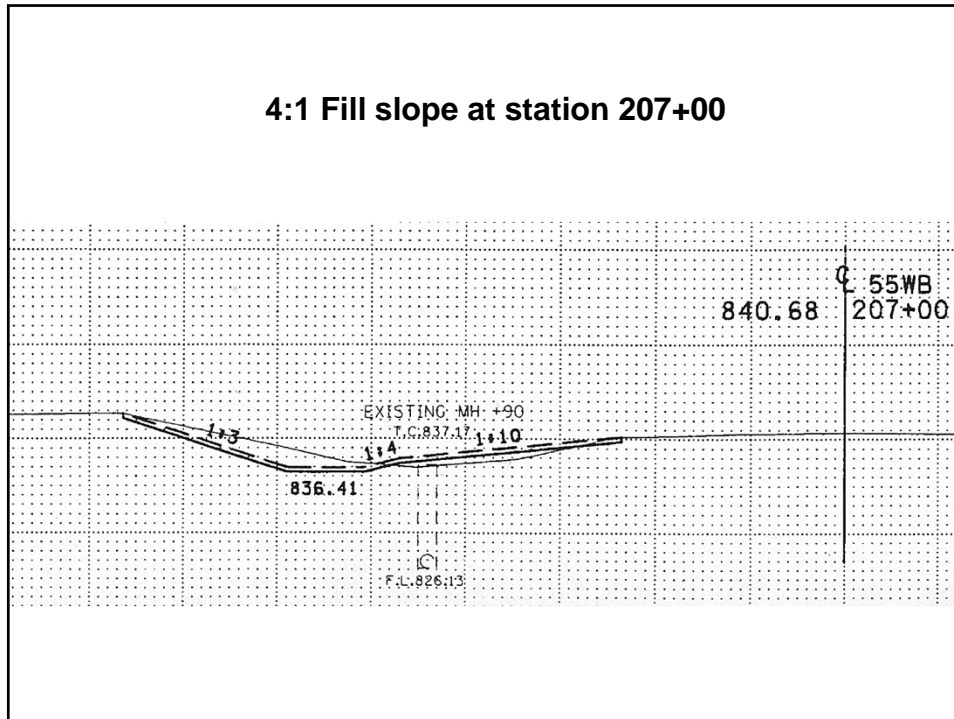
4:1 Fill slope at station 207+00
