DETERMINATION OF THE MAXIMUM MGS MOUNTING HEIGHT – PHASE I CRASH TESTING

MwRSF Research Report No. TRP-03-255-12 Revision-1

November 30, 2015

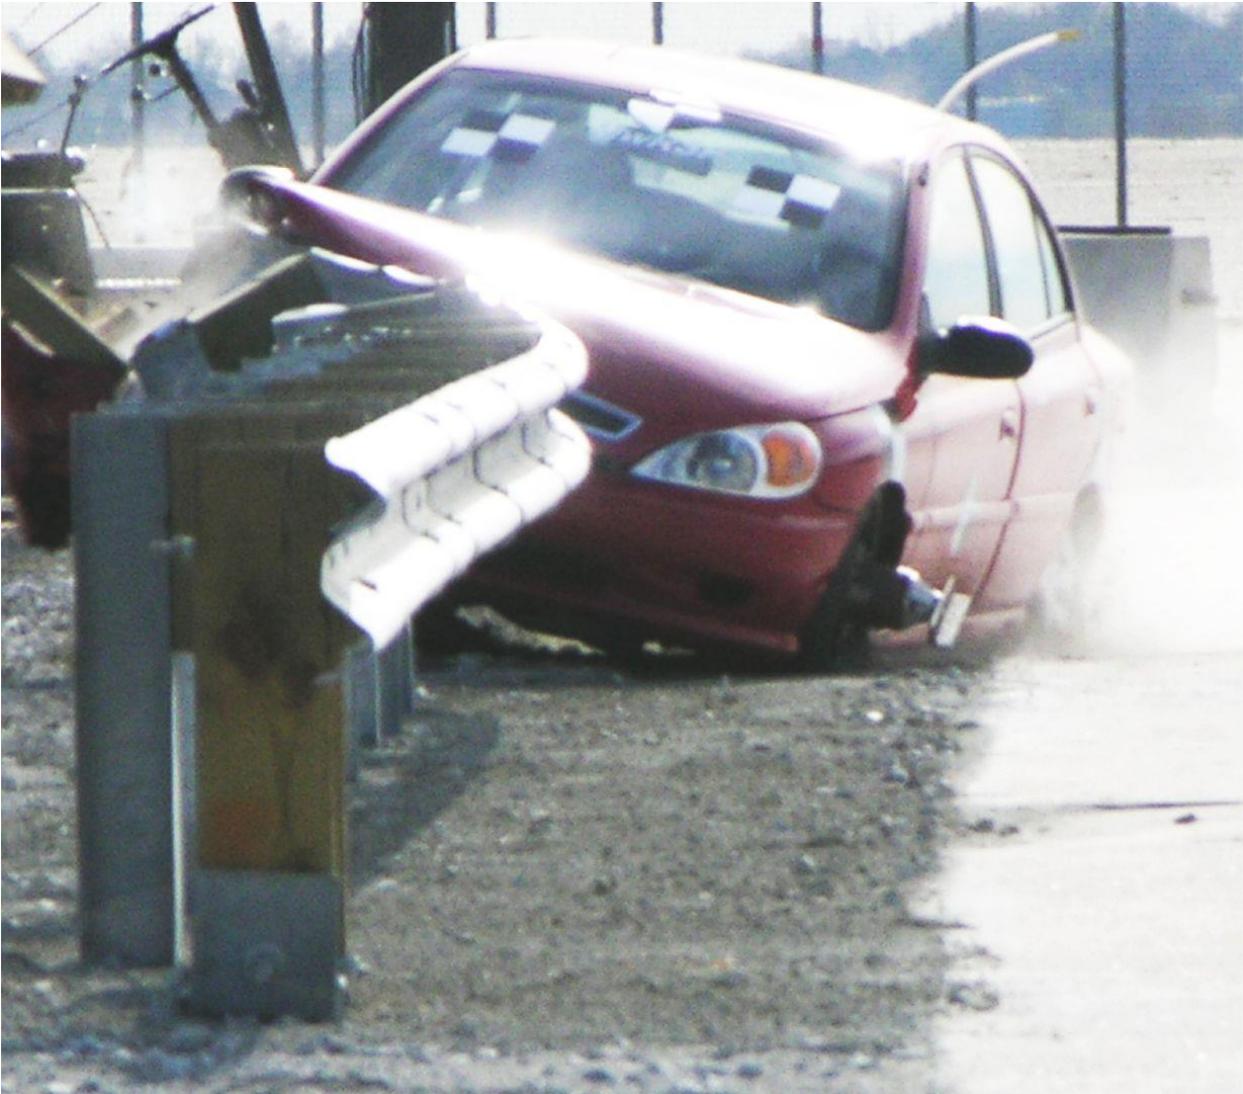
Figure 5. Test No. 2214MG-3, Rail Snags Under the Hood

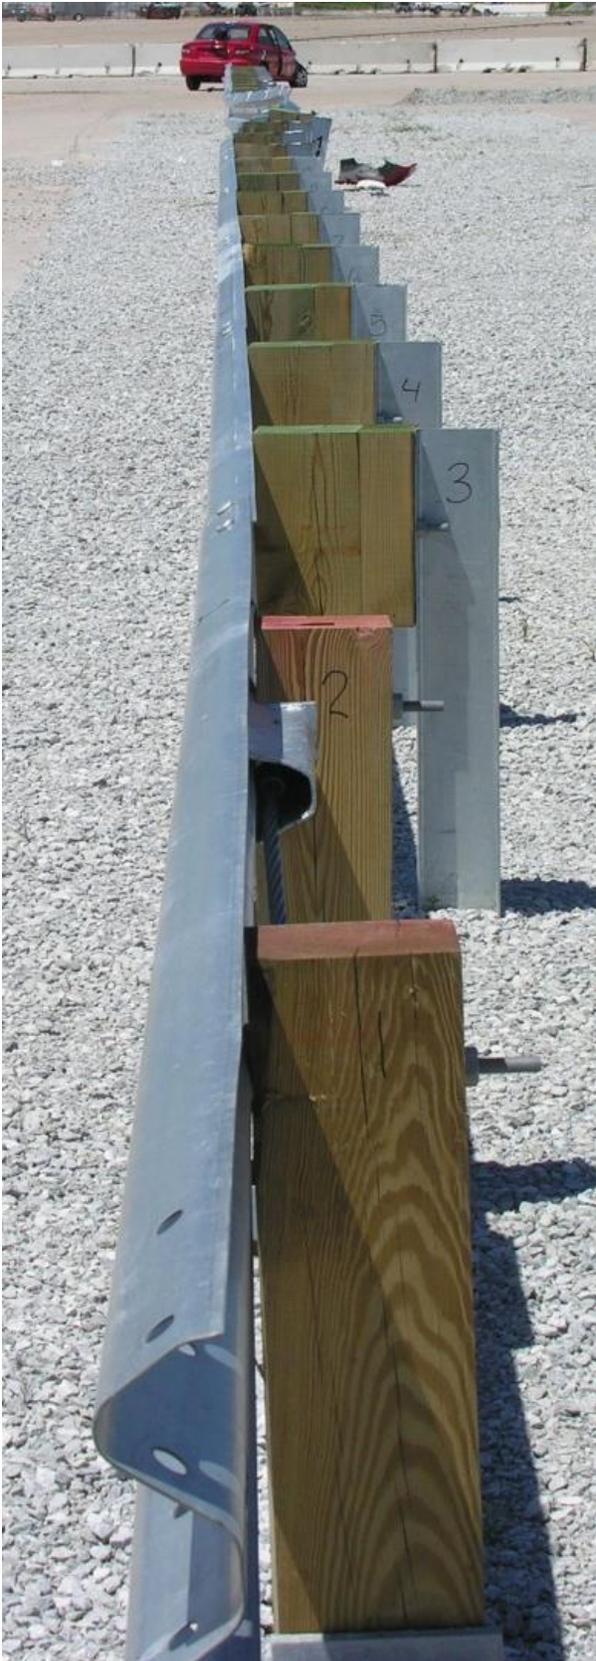
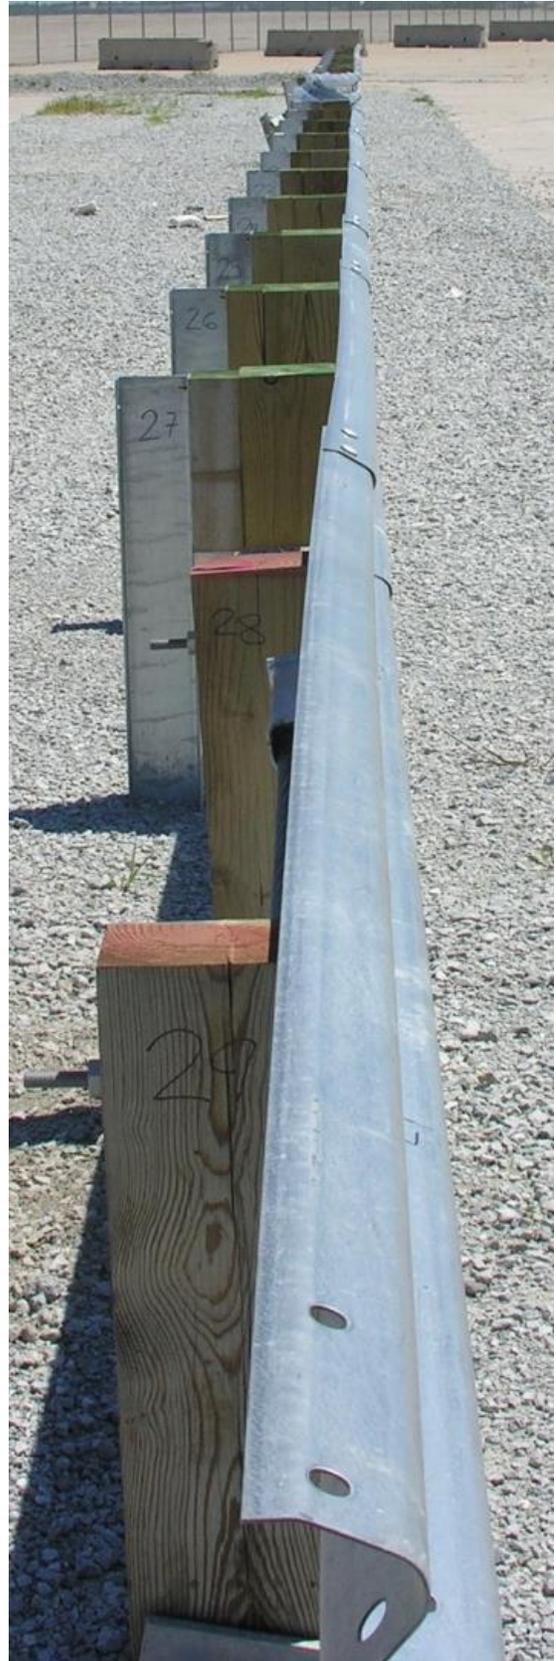
Figure 36. System Damage, Test No. MGSMRH-1

Damage to the barrier was moderate, as shown in Figures 36 through 45. Barrier damage consisted of deformed guardrail posts, disengaged wooden blockouts, contact marks on posts and guardrail, and deformed W-beam rail. The length of vehicle contact along the barrier was approximately 25 ft – 10½ in. (7.9 m) which spanned from 10 ft – 1 in. (3.1 m) upstream of the centerline of post no. 15 to 35½ in. (902 mm) upstream of post no. 18.

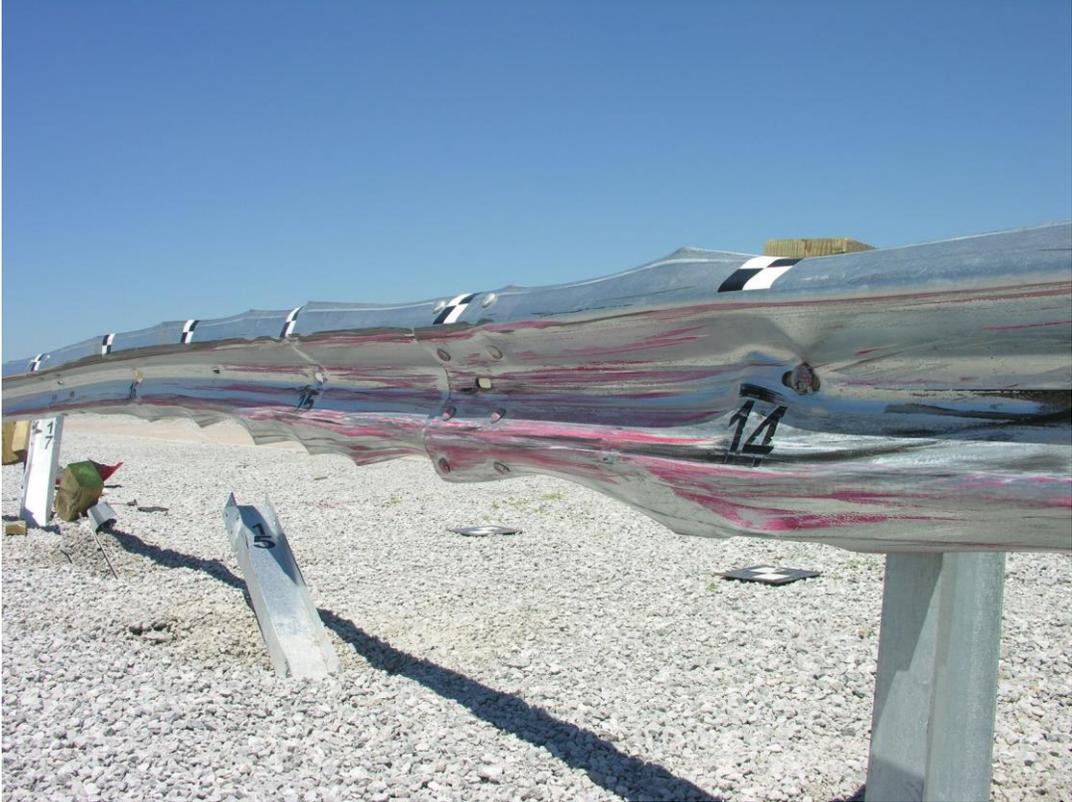
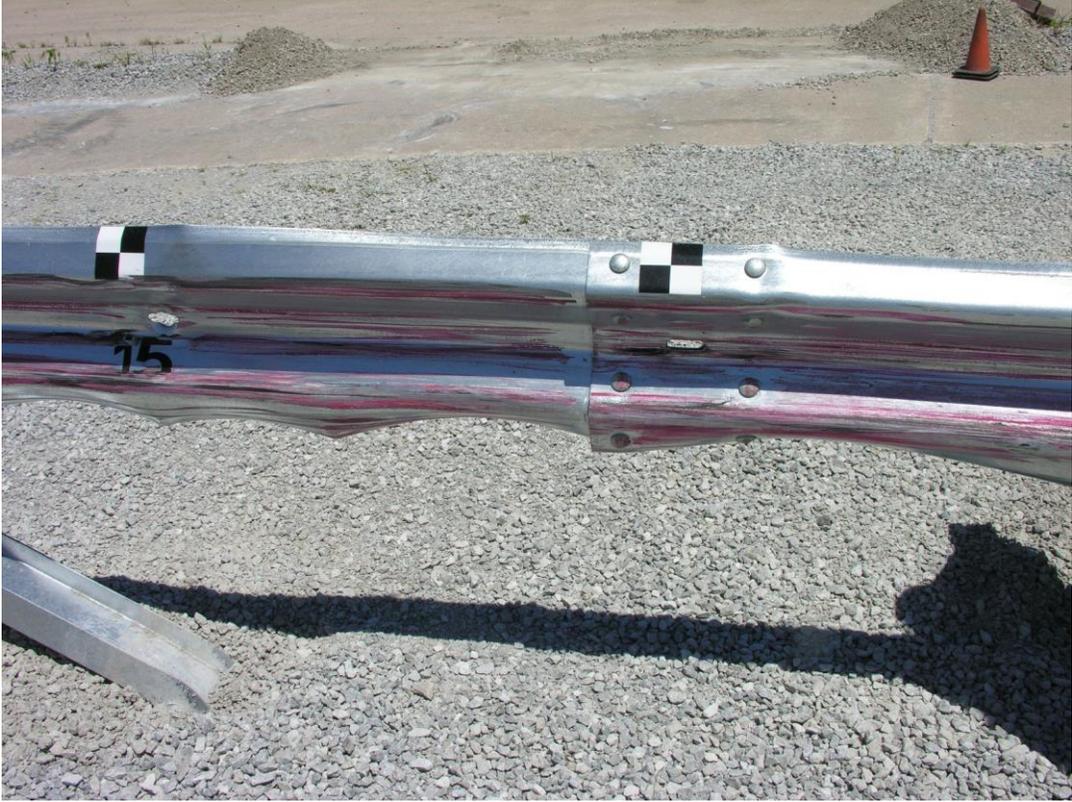
Figure 38. System Damage, Test No. MGSMRH-1

Red paint transfer was found on the rail between the impact location and post no. 18. Minor kinks in the top and bottom corrugations of the rail were found between post nos. 12 and 19, as shown in Figure 38. Flattening and deformation of the rail occurred between post nos. 13 and 18. The bottom corrugation was flattened between post nos. 14 and 16. The bottom edge of the rail was folded upward at post no. 14.

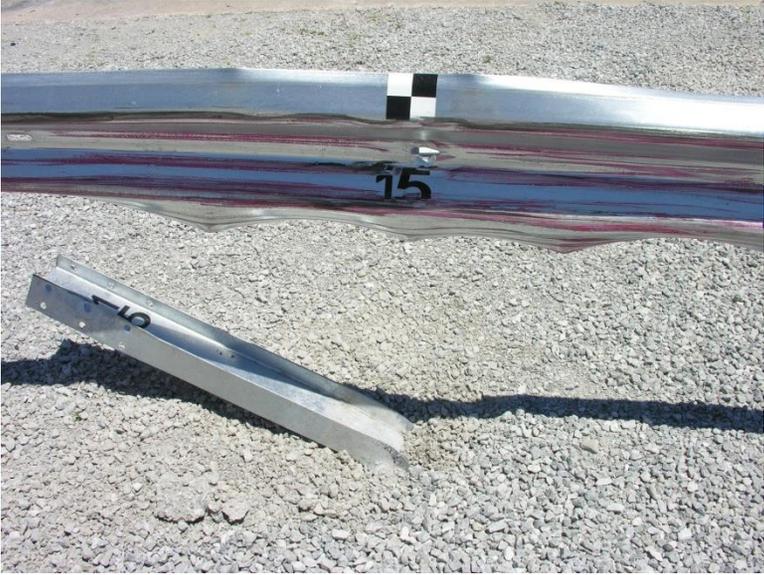
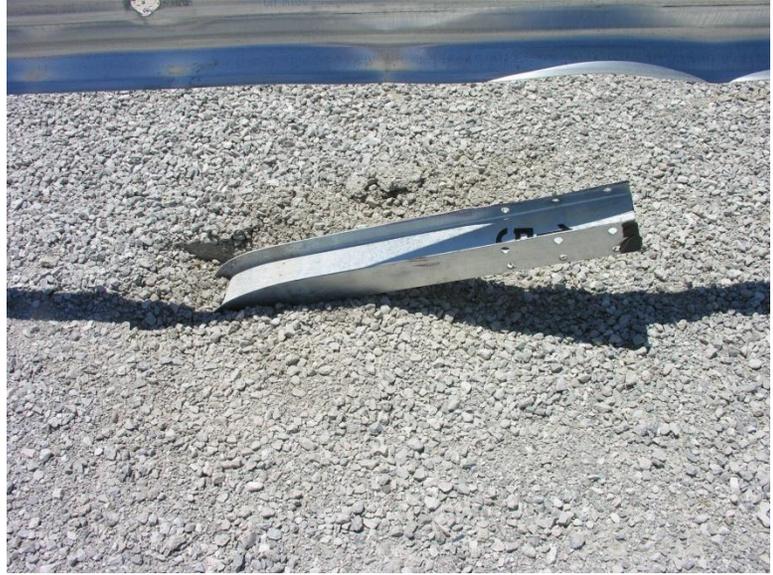
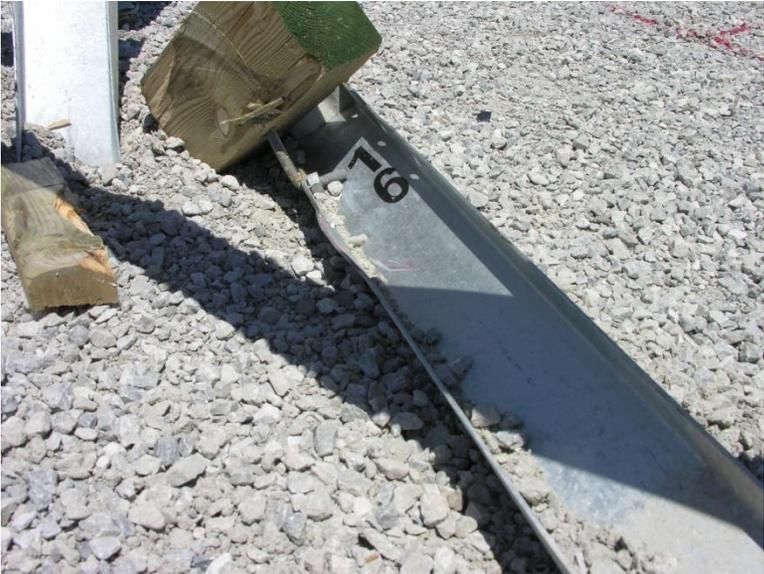
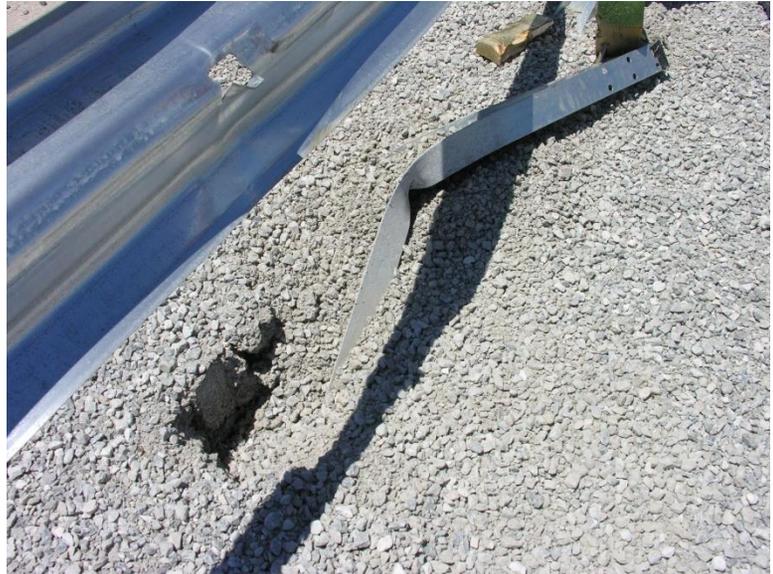
Figure 44. Post Nos. 15 and 16 Damage, Test No. MGSMRH-1

Contact marks were found on the front flange of post no. 14, on the upstream edge of the front flange and on the face of the back flange of post no. 15, on the front flange and the upstream side of the web of post no. 16 as well as on the corresponding blackout, and on both the upstream edge of the front flange on post no. 17 and the corresponding blackout.

The maximum permanent set rail and post deflections of the barrier system were 18¼ in. (464 mm) at the midspan between post nos. 15 and 16 and 17 in. (432 in.) at post no. 16, respectively, as measured in the field. The maximum lateral dynamic rail and post deflections were 29.0 in. (737 mm) at the midspan between post nos. 15 and 16 and 20.2 in. (513 mm) at post no. 16, respectively, as determined from high-speed video analysis. The working width of the system was found to be 49.4 in. (1,255 mm), also determined from high-speed digital video analysis.

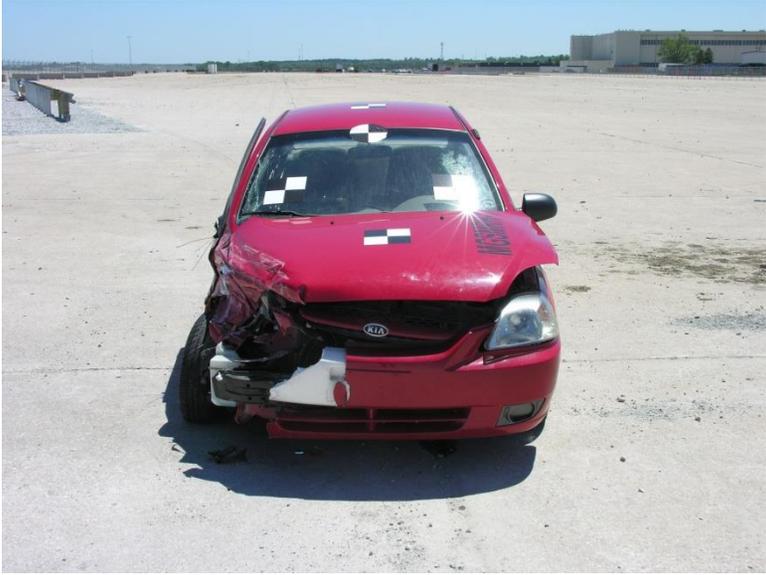
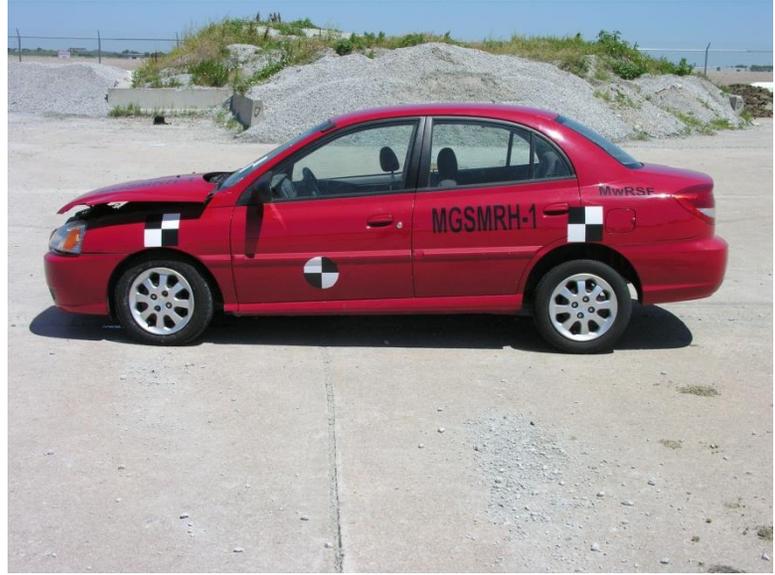
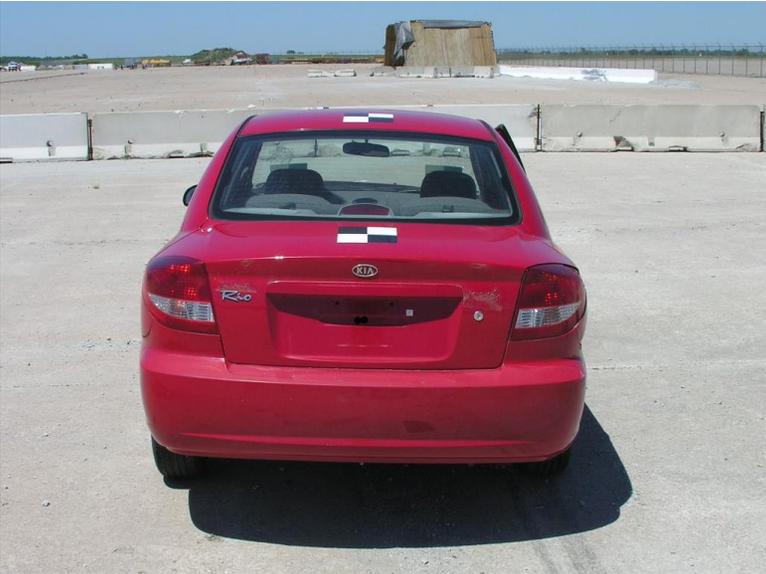
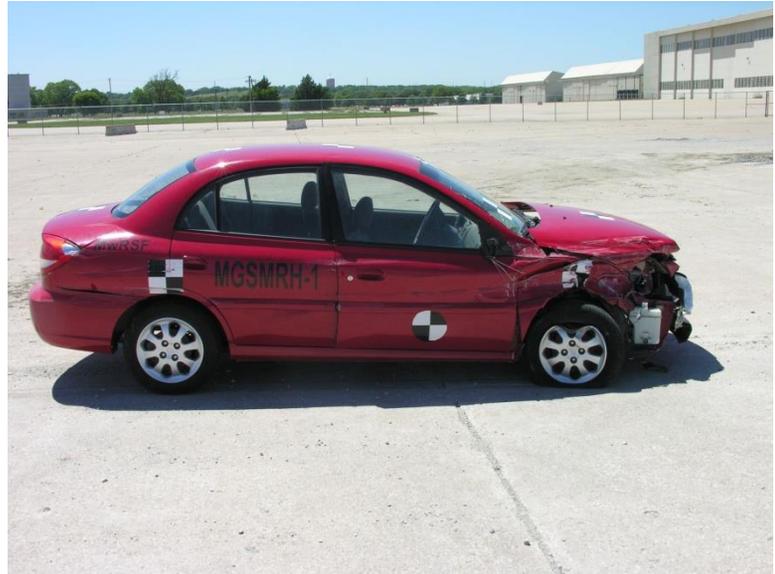
Figure 46. Vehicle Damage, Test No. MGSMRH-1

Contact marks spanned the length of the right side of the vehicle. Part of the plastic covering from the right tail light disengaged. Two dents were located along the right-rear quarter panel, and there was a 1¼-in. (32-mm) gap between the right-rear quarter panel and the right side of the rear bumper. Small dents were found in the right-rear and right-front doors. The right-front fender and wheel well cover crushed inward. A 5-in. (127-mm) long tear was located in the

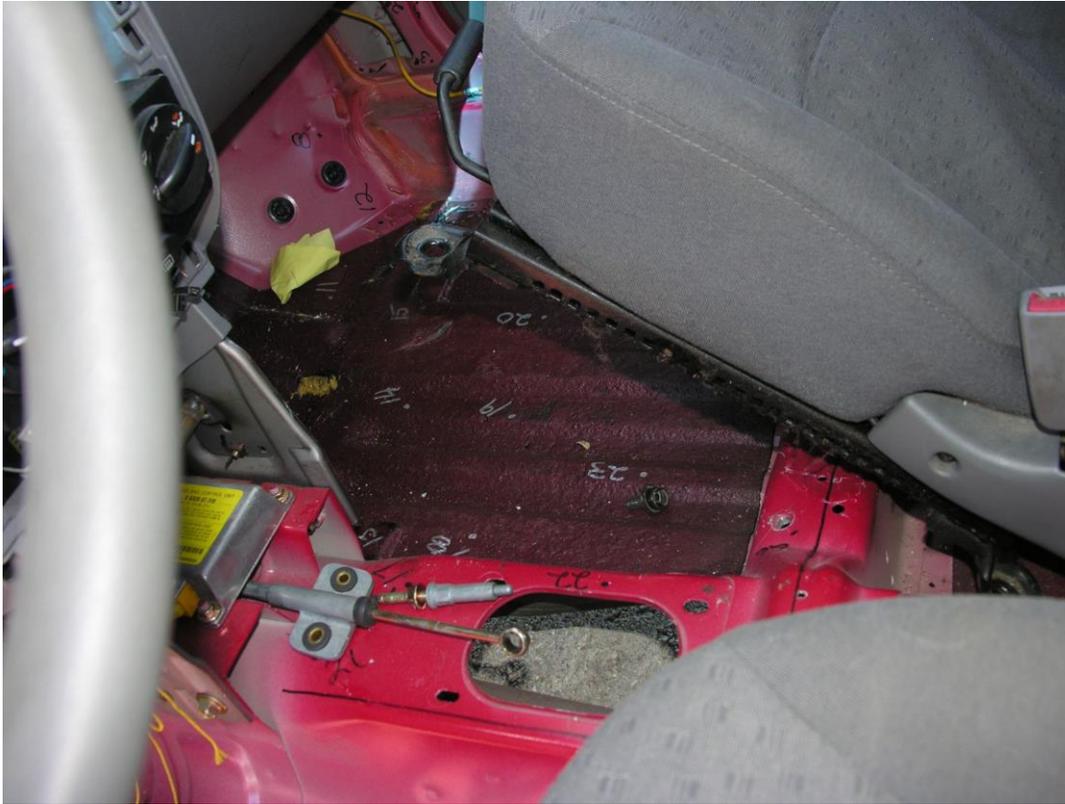
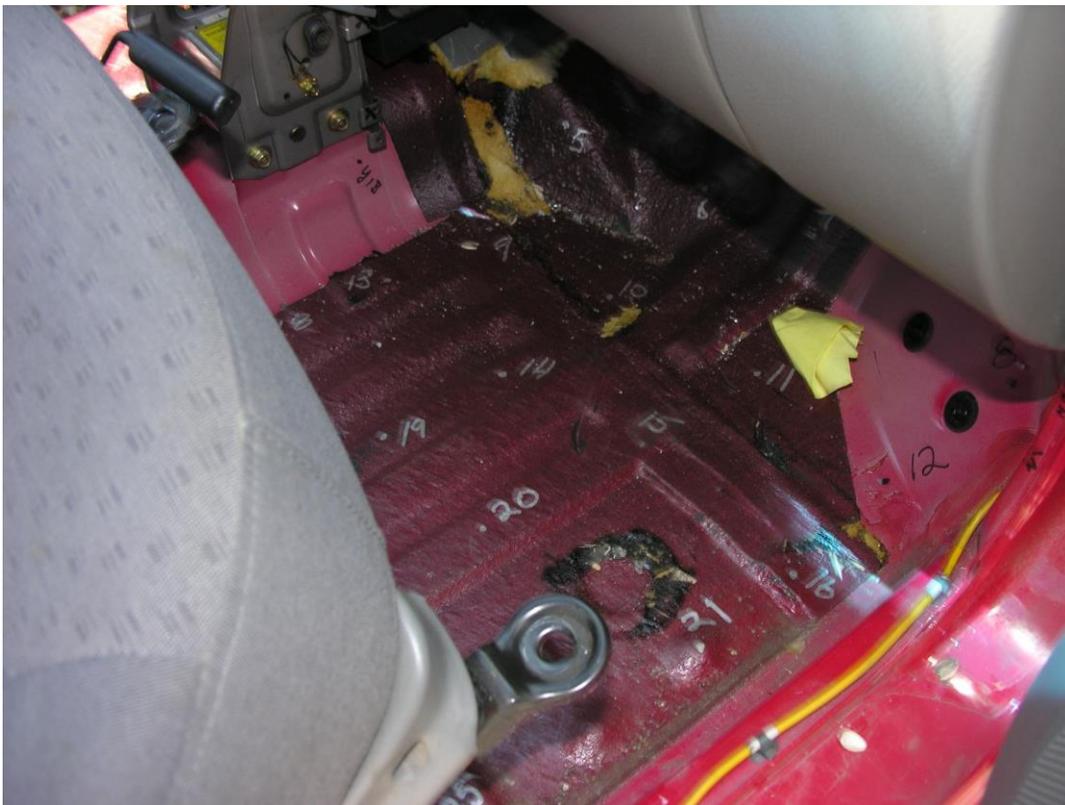
Figure 48. Occupant Compartment Damage, Test No. MGSMRH-1

The damage to the vehicle was moderate, as shown in Figures 46 through 49. The maximum occupant compartment deformations are listed in Table 7 alongside the deformation limits established in MASH for various areas of the occupant compartment. It should be noted that none of the MASH established deformation limits were violated. Complete occupant compartment and vehicle deformations and the corresponding locations are provided in Appendix D.

right-front fender. The right side mirror disengaged, and the mirror mount fractured. The base of the right-side A-pillar crushed inward. The right-front tire deflated and the rim folded inward. The upper control arm connector on the right-front wheel bent at the thread location. The right-front hood corner crushed inward. The right-side bumper cover and foam disengaged. The right-side headlight disengaged and was fractured. The bumper cover was pulled down ½ in. (13 mm). The left side of the hood was ajar. The antenna disengaged. The windshield washer fluid container was dented, cracked, and leaking fluid. The drive linkage was leaking fluid at the transmission housing. Minor scraping was found near the bumper connection to the unibody. Minor spiderweb cracking was found at the right side of the windshield along the entire height of the windshield. All other window glass, the roof, the rear, and the left side of the vehicle were undamaged.
