EVALUATION OF A MODIFIED THREE CABLE GUARDRAIL ADJACENT TO STEEP SLOPE

MwRSF Research Report No. TRP-03-192-08

March 4, 2008

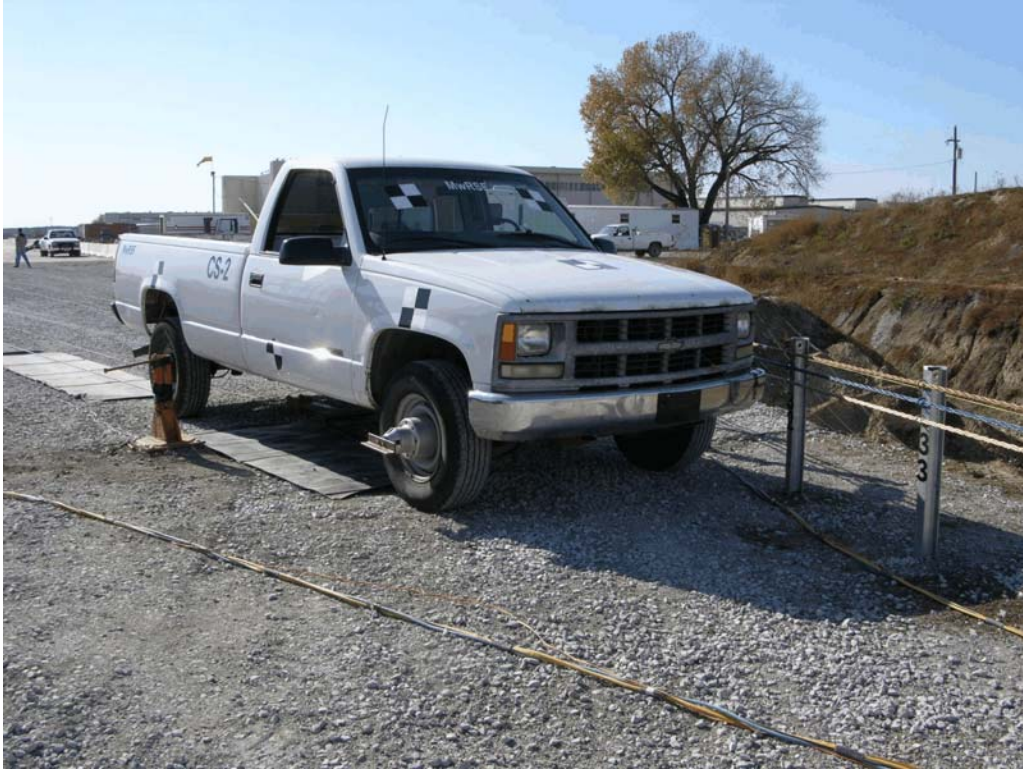
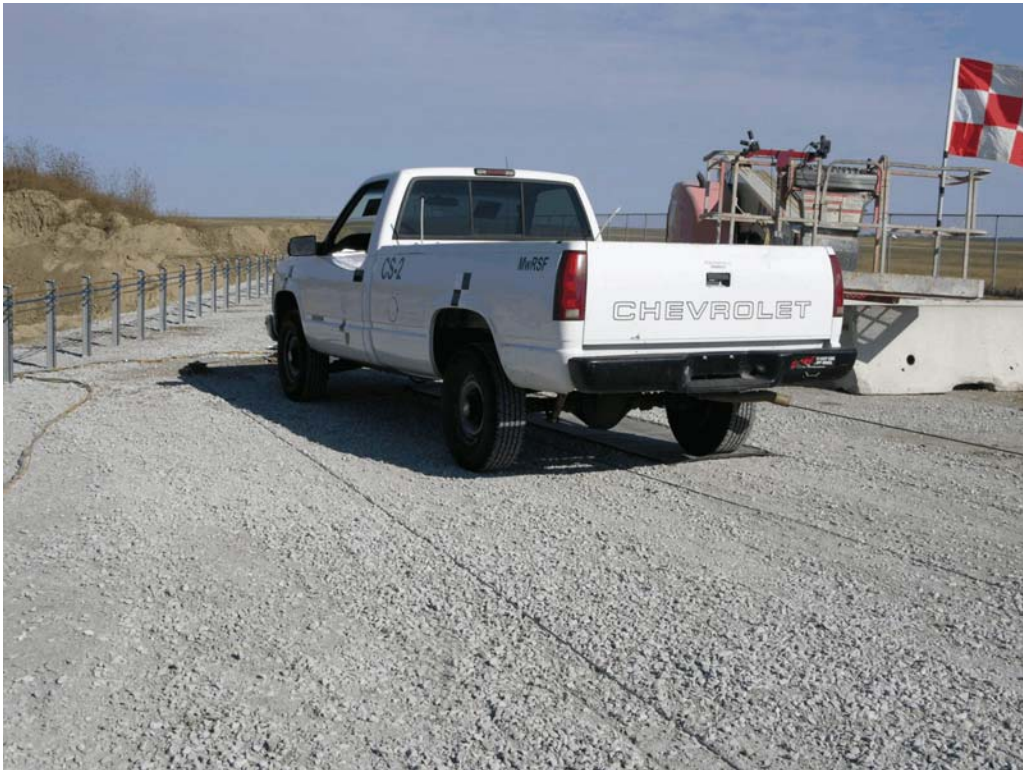
Figure 28. Impact Location, Test CS-2

Initial vehicle impact was to occur between post nos. 31 and 32, or 305 mm (1 ft) upstream from the centerline of post no. 32, as shown in Figure 28. Actual vehicle impact occurred at post no. 32. At 0.002 sec after impact post no. 32 deflected both laterally and longitudinally. At 0.020 sec, the vehicle contacted post no. 33. At 0.028 sec, the three cables wrap around the left-front corner of the truck. At 0.034 sec, the cables caused slight deformation to the left-front quarter panel of the truck. At 0.054 sec, post no. 34 deflected laterally and longitudinally. At 0.064 sec, the left-front tire of the vehicle completely traversed the original post line as the truck continued downstream. At 0.076 sec, the truck ran over post no. 33 with the front of the truck in contact with post no. 34. At 0.094 sec, post no. 35 deflected as the truck continued out over the slope breakpoint. At 0.124 sec, the right-front bumper of the truck contacted post no. 35. At 0.130 sec, post no. 36 deflected. At 0.150 sec, the truck yawed as it began to redirect out of the system. At this same time, post no. 37 deflected. At 0.154 sec, the top cable detached from post no. 36. At 0.156 sec, the front of the truck contacted post no. 36. At 0.160 sec, all three cables released from post no. 36. At 0.178 sec, post no. 38 deflected. At 0.180 sec, the left-front tire of the truck became airborne, and the front

The permanent set of the barrier system is shown in Figure 28. The upstream and downstream cable anchor ends encountered slight permanent set deformations. The maximum lateral permanent set post deflection was 578 mm (22.75 in.) at the centerline of post no. 36 as measured in the field. The maximum lateral dynamic cable deflection was 3,163 mm (124.5 in.), as determined from high-speed digital video analysis. The working width of the system was found to be 3,318 mm (130.6 in.).

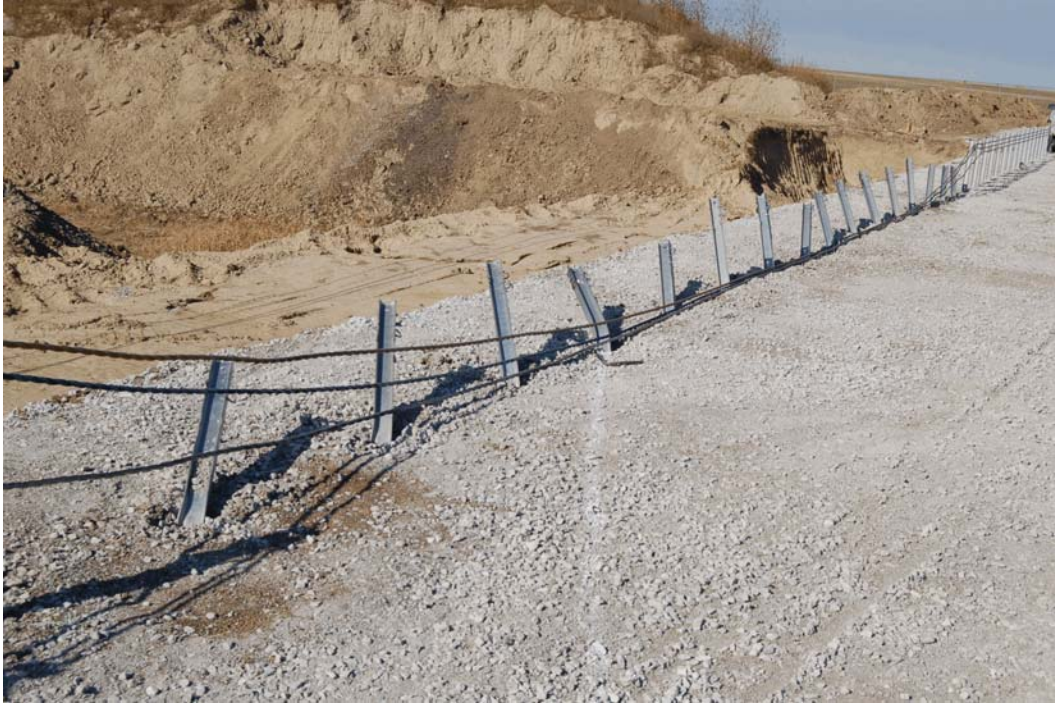
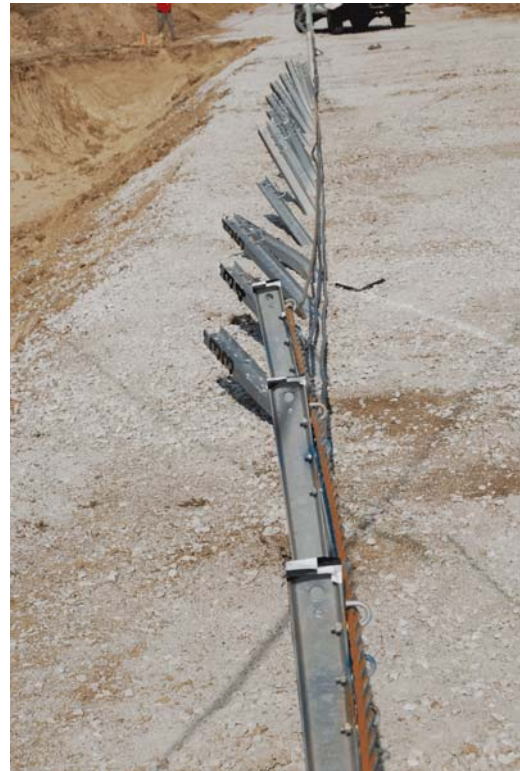
Figure 30. System Damage, Test CS-2

Damage to the barrier was moderate, as shown in Figures 30 through 34. Barrier damage consisted mainly of deformed line posts, stretched cable, and soil failure. The length of vehicle contact was approximately 19.7 m (64 ft - 8 in.), which spanned from the upstream edge of post no. 32 through the upstream edge of post no. 48.

The system's upstream anchor deflected longitudinally 51 mm (2 in.) downstream. Soil cracking with a radius of 356 mm (14 in.) was found on the downstream side of the upstream anchor. The downstream anchor deflected upstream 38 mm (1.5 in.). All three cables were detached from post nos. 33 through 48. The bottom cable released from post nos. 32 and 49. Soil cracking was also found around post no. 7. Post no. 31 deflected backward 25 mm (1 in.). Post no. 32 deflected backward about 51 mm (2 in.). Post no. 33 was rotated and bent backward to where the top of the post was 279 mm (11 in.) above the ground. The top cable hook fractured off of post no. 33. Post

nos. 34 and 35 were also rotated and bent backward with the tops of the posts 356 mm (14 in.) above the ground. Minor gouging was found on post no. 34. Post nos. 36 through 48 experienced weak axis bending. The tops of post nos. 36 through 48 were bent to 152 mm (6 in.), 305 mm (12 in.), 533 mm (21 in.), 533 mm (21 in.), 406 mm (16 in.), 419 mm (16.5 in.), 457 mm (18 in.), 533 mm (21 in.), 533 mm (21 in.), 610 mm (24 in.), 508 mm (20 in.), 470 mm (18.5 in.), and 406 (16 in.) above the ground respectively. Minor gouging was found on the upstream side of post nos. 37 and 41 through 44. Local buckling 279 mm (11 in.) from the top was found on the upstream side of post no. 38. Local buckling was found 305 mm (12 in.) from the top on the upstream-back flange of post no. 39. Minor gouging was found on the front face of post nos. 46 through 48. The remainder of the downstream posts were not damaged.

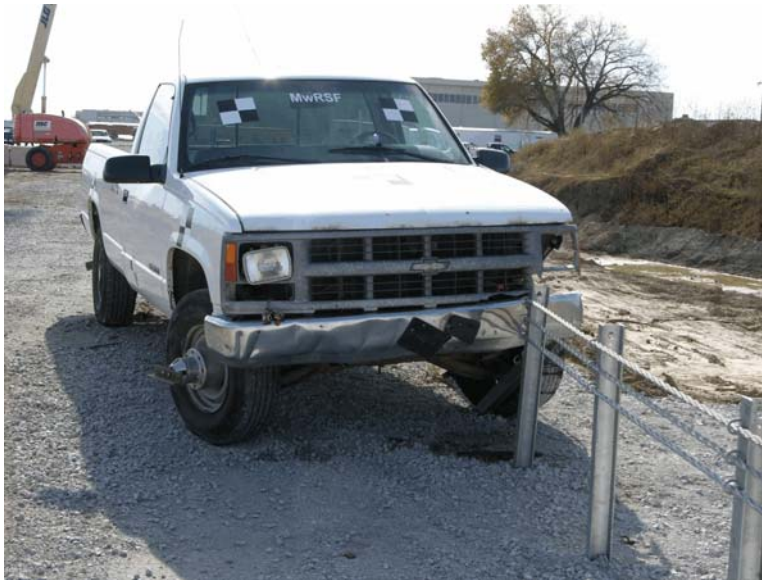
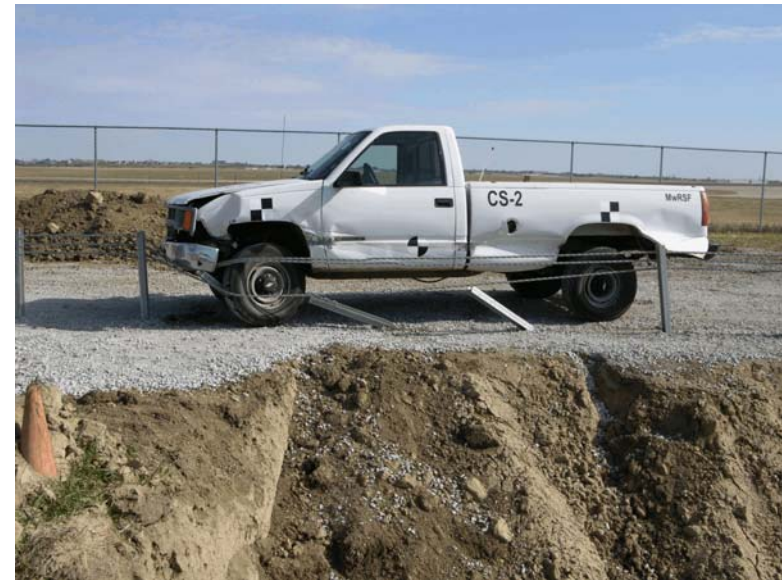
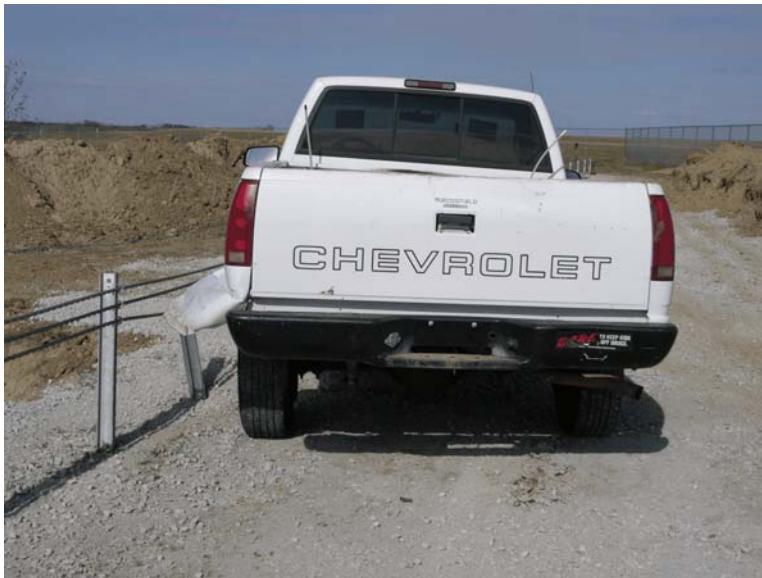
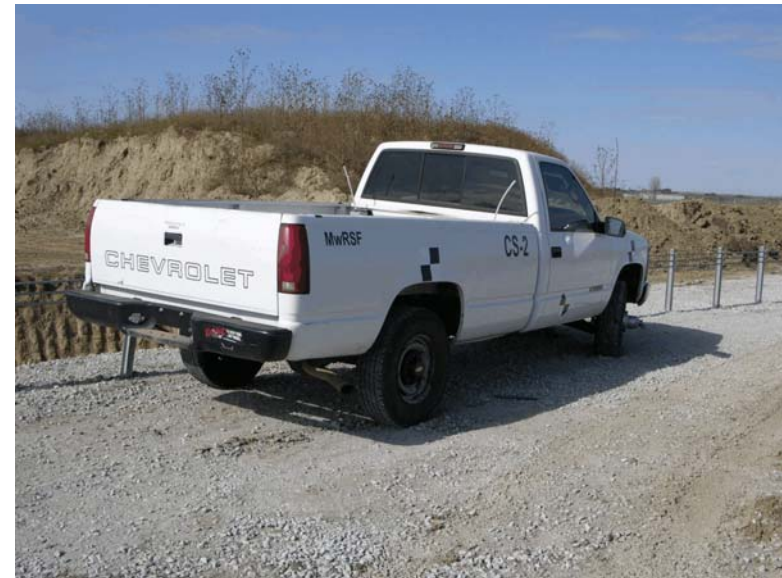
Figure 35. Vehicle Damage, Test CS-2

Exterior vehicle damage was moderate as shown in Figures 35 through 38. Occupant compartment deformations to the left side of the floorboard were judged insufficient to cause serious injury to the vehicle occupants as shown in Figure 38. Maximum longitudinal deflections of 6.35 mm (0.25 in.) were located along the front of the driver's side floor panel. A maximum lateral deflection of 13 mm (0.5 in.) was located on the right-front corner of the driver's side floor panel.

Damage was concentrated on the left-front corner and left side of the vehicle. The left-front quarter panel buckled inward. The left-front corner of the bumper was bent back toward the engine compartment. The inside wall of the left-front tire was punctured and the right-front wheel well was severely damaged. The steering knuckle was pushed into the strut frame. The front of the hood was deformed upward slightly. Significant cable friction damage was found on the entire left side of the vehicle. The left-rear quarter panel was deformed outward. Major denting and gouging was found on the exhaust pipe. The right side, rear, and top of the vehicle as well as all window glass remained undamaged.
