Phase III Development of a Short-Radius Guardrail for Intersecting Roadways

MwRSF Research Report No. TRP-03-183-07

December 6, 2007

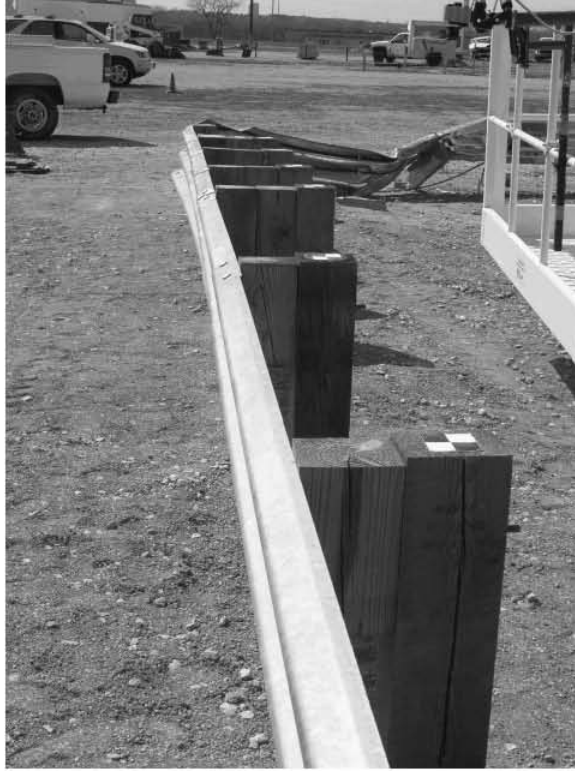
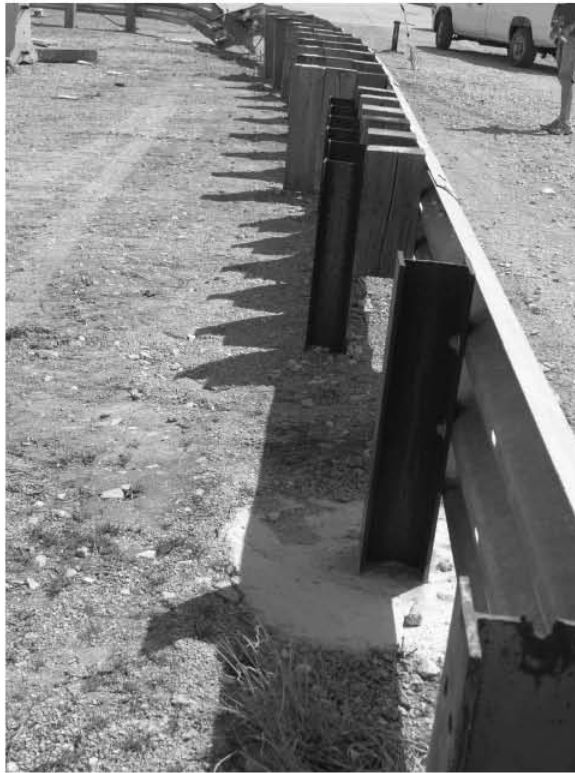
Figure 51. System Damage, Test SR-5

Damage to the short-radius system was moderate, as shown in Figures 51 through 61. Post no. 1P fractured at the foundation tube but remained attached to the rail. Post nos. 2P through 3P fractured at ground level and disengaged from the rest of the system. The tapered blockout at post no. 2P disengaged from the post. Post no. 4P fractured approximately 178 mm (7 in) below the groundline and disengaged from the system. Post no. 5P cracked at the groundline and rotated backwards in the soil. Post no. 6P sustained a 229-mm (9-in.) long crack through the transverse hole and rotated backward in the soil. Post no. 7P also rotated backward in the soil.

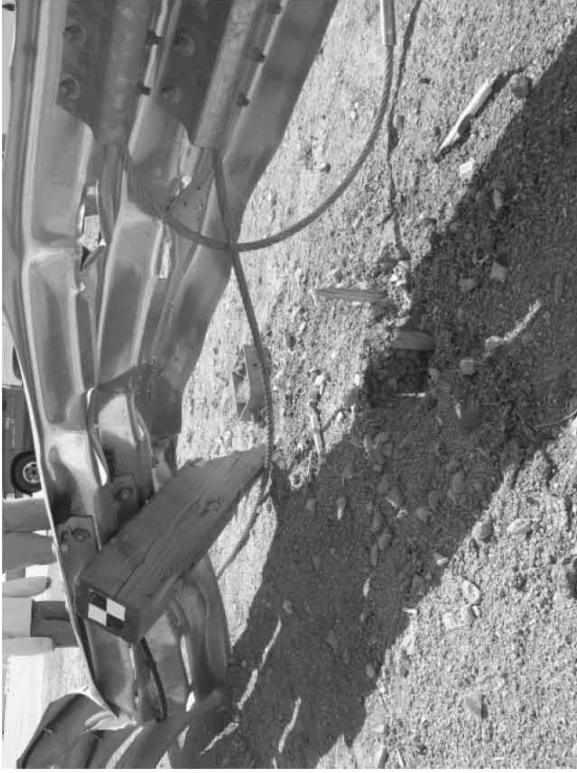
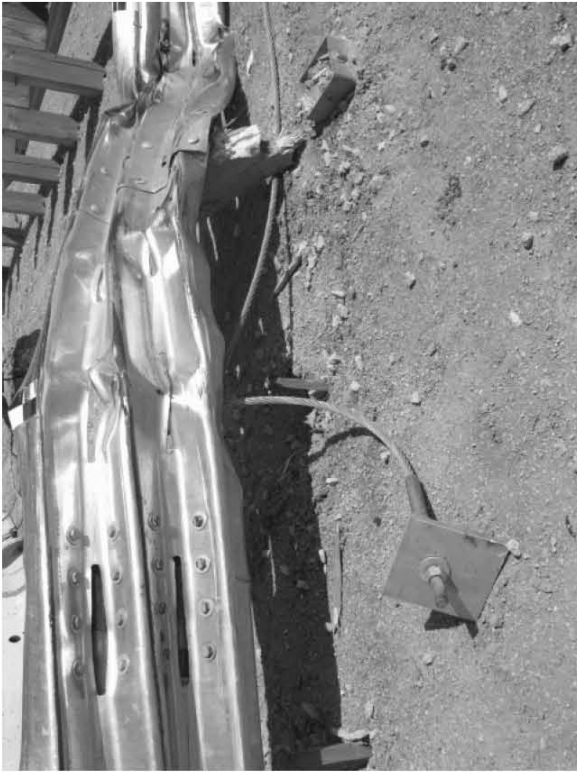
Figure 52. System Damage, Test SR-5

Contact marks were found on all three corrugations between the impact location on the rail and post no. 7P. The rail was flattened and deformed between the center of the nose section and post

no. 2P. Rail flattening also was found between post nos. 3P and 5P. Rail bending was observed along curved nose section. Additional rail bending was found at post nos. 3P, 4P, and 6P through 8P. The post bolts released from the rail at post nos. 2P through 4P. Significant post bolt rail deformation was found at post no. 6P. The rail slots between post nos. 3P and 4P were folded and closed by rail flattening and deformation. The rail was deformed backwards and the bottom corrugation deformed upward between post nos. 3P and 7P.

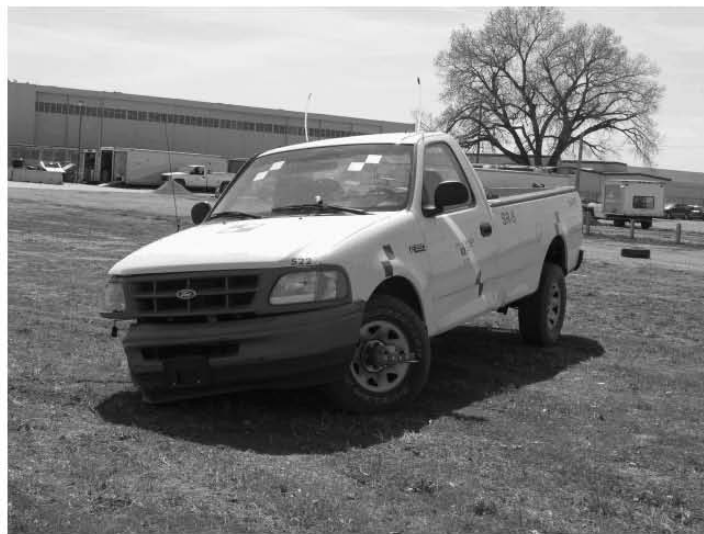
Figure 62. Vehicle Damage, Test SR-5

Exterior vehicle damage was minimal, as shown in Figures 62 through 64. Occupant compartment deformations to the right side and center of the floorboard were judged insufficient to cause serious injury to the vehicle occupants. Maximum longitudinal deflections of 13 mm (0.5 in.) were located near the left side of the right-side floorboard. Maximum lateral deflections of 25 mm (1 in.) were located near the right-front corner of the right-side floor pan. Maximum vertical deflections of 38 mm (1.5 in.) were located near the center of the right-side floorboard. Complete occupant compartment deformations and the corresponding locations are provided in Appendix C.

The right-front bumper corner was deformed inward and encountered significant dents and scratches. The right side of the grill was also deformed inward and fractured around the headlight.

The right-front turn signal cover was fractured and disengaged from the vehicle. The right-front quarter panel was crushed inward and wheel well was severely deformed. The entire right side of the vehicle sustained dents and scratches. The top of the right-side door was jarred open and it could not be opened nor closed. The right-front upper and lower ball joints fractured. The right-side steering arm fractured at the spindle. The right-side lower A-frame control arm was bent. The right-front wheel was separated from the vehicle and encountered significant scratches, dents, deformations, and gouges on both the inside and outside of the rim. The right-rear tire also encountered minor abrasions, but the rim remained undamaged. The spare tire under the vehicle was scratched and torn. The exhaust was fractured, and the gas tank was dented. The left side and rear of the vehicle, the hood, and all window glass remained undamaged.

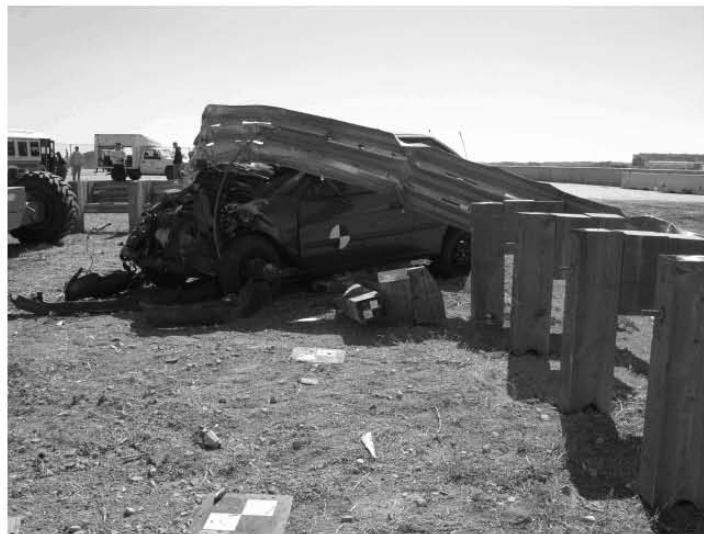
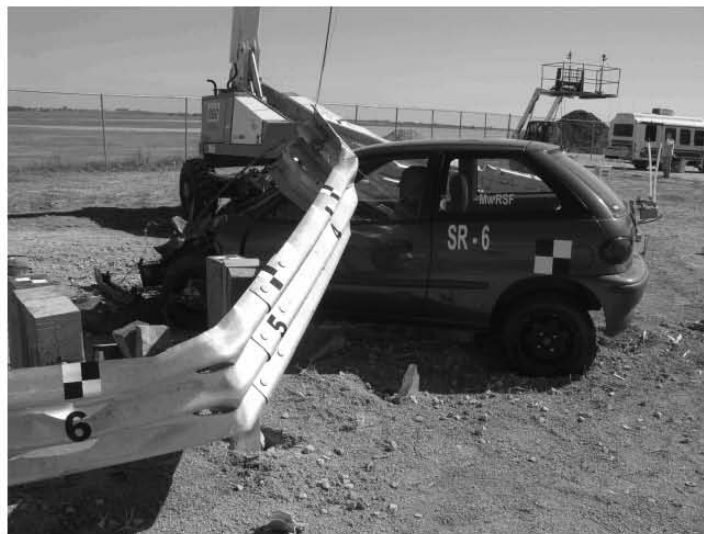
Figure 88. System Damage, Test SR-6

Damage to the short-radius system was moderate, as shown in Figures 88 through 92. Post nos. 1P and 1S fractured at the foundation tube. Post no. 1P disengaged from the rest of the system and post no. 1S remained attached to the rail. Post no. 2P fractured at ground level and disengaged from the rest of the system. Post nos. 3P and 4P also fractured at ground level and disengaged from

the rest of the system. Post no. 5P twisted downstream and encountered a small crack at ground level. The blockout at post no. 5P disengaged from the rail, but remained attached to the post.

Contact marks were found between the center of the nose section and post no. 3P. The rail was flattened and deformed between post nos. 1S and 3P. Rail buckling was found along the curved nose section. Additional rail buckling was found at post nos. 1P through 5P and between post nos. 5P and 8P. The post bolt released from the rail at post nos. 6P through 8P. The lower corrugation encountered a 178-mm (7-in.) long tear 2,134 mm (3 ft) downstream from the impact point. Another 178-mm (7-in) long tear occurred on the middle corrugation of the nose section between the primary-side quarter point and the center of the rail. All rail slots were bent and deformed on the primary side. Minor post bolt slot deformation occurred at post nos. 3P through 7P. The galvanization was removed the nose section.

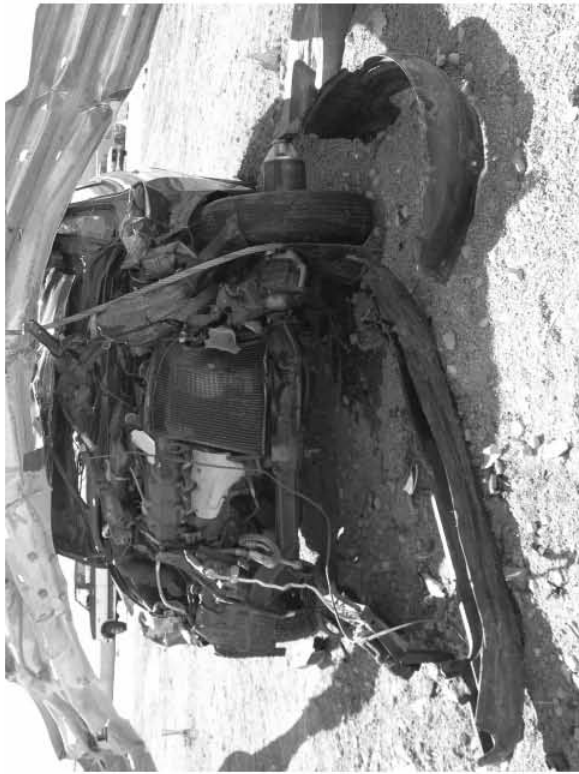
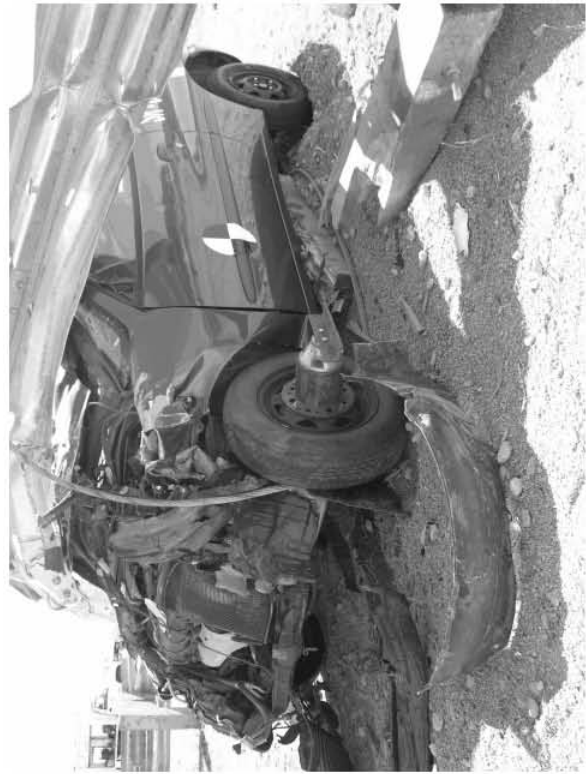
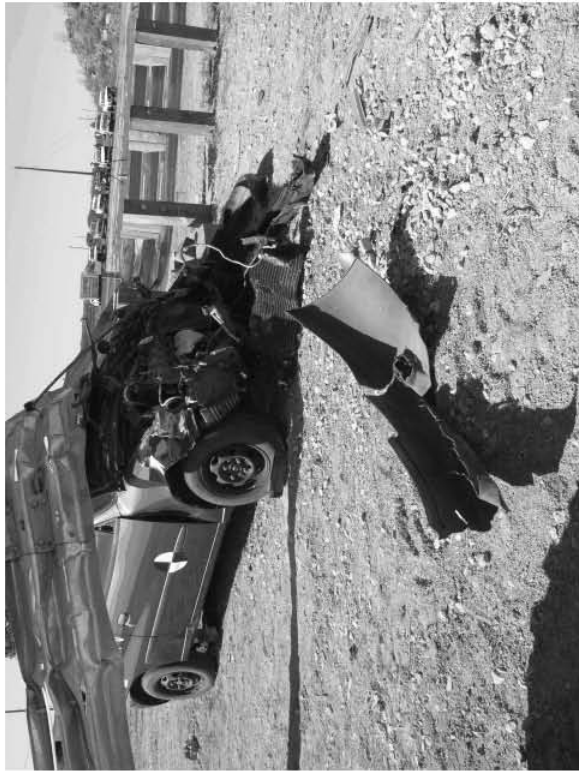
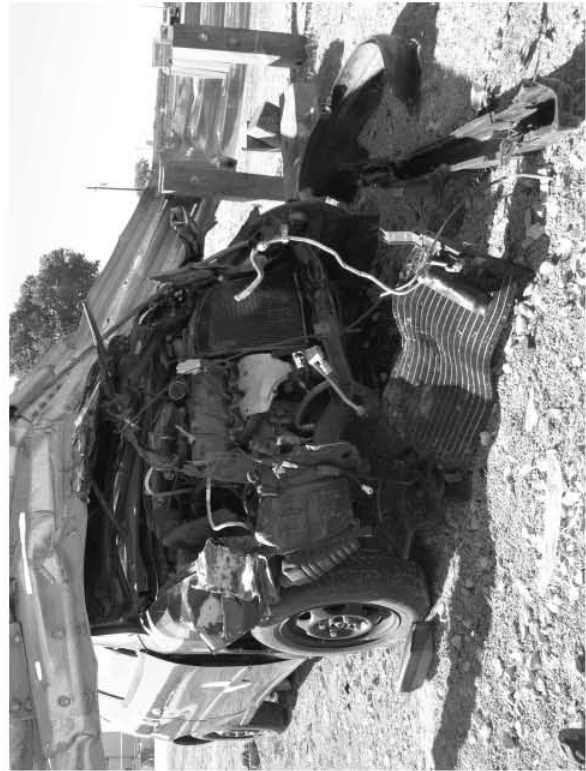
Figure 93. Vehicle Damage, Test SR-6

Exterior vehicle damage was extensive, as shown in Figures 93 through 96. Occupant compartment deformations were negligible, as shown in Figure 96. Complete occupant compartment deformations and the corresponding locations are provided in Appendix G.

The left-front and right-front quarter panels were severely crushed and deformed inward toward the wheel wells and encountered tearing of the sheet metal. The front bumper was also deformed and torn and disengaged from the vehicle due to fractured front bumper mounts. The hood

was folded in half and pushed back into the windshield. Contact marks were found on the right-front wheel rim and hubcap. The front frame was dented and crushed inward. The undercarriage sustained scratches and dents. The radiator and coolant valves and cases were crushed and dented. The radiator fan and belts were disengaged and broken. The engine block was displaced backwards and to the left. The windshield was crushed and sustained extensive “spider-web” cracking throughout. Deformation of the windshield exceeded 76 mm (3 in.) near the center of the glass on the left side. In addition, there were two small holes in the center of the windshield where the hood penetrated the glass. The right-rear and left-rear sides, the rear, and all other window glass remained undamaged.
