Midwest Guardrail System for Long-Span Culvert Applications

MwRSF Research Report No. TRP-03-187-07

November 16, 2007

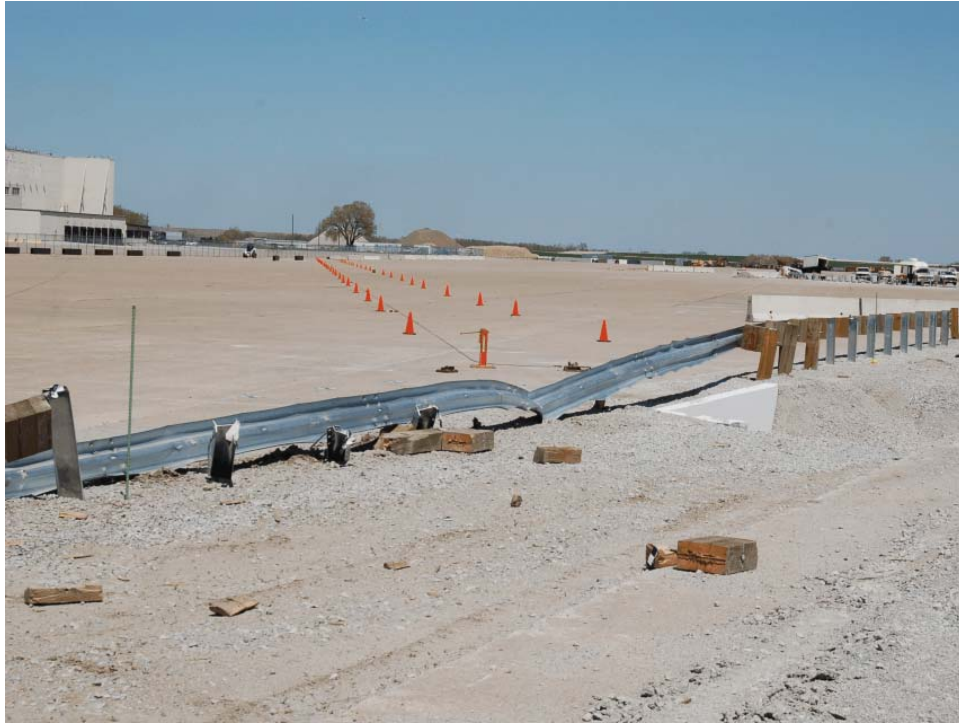
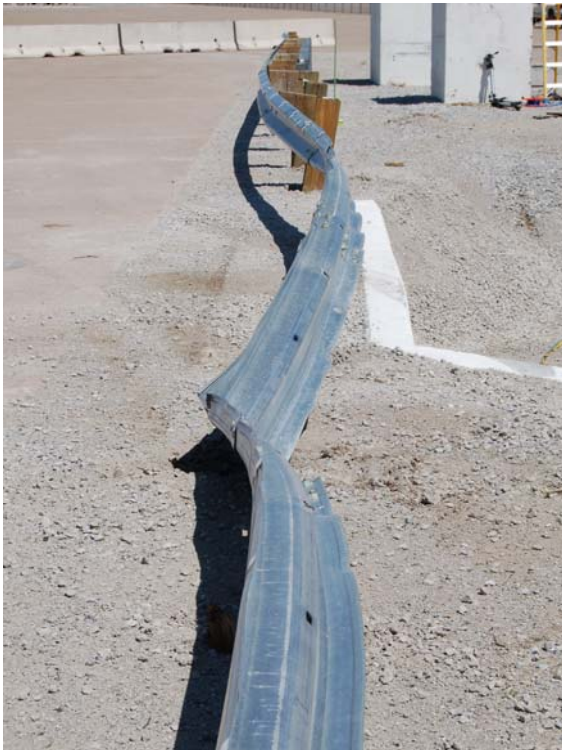
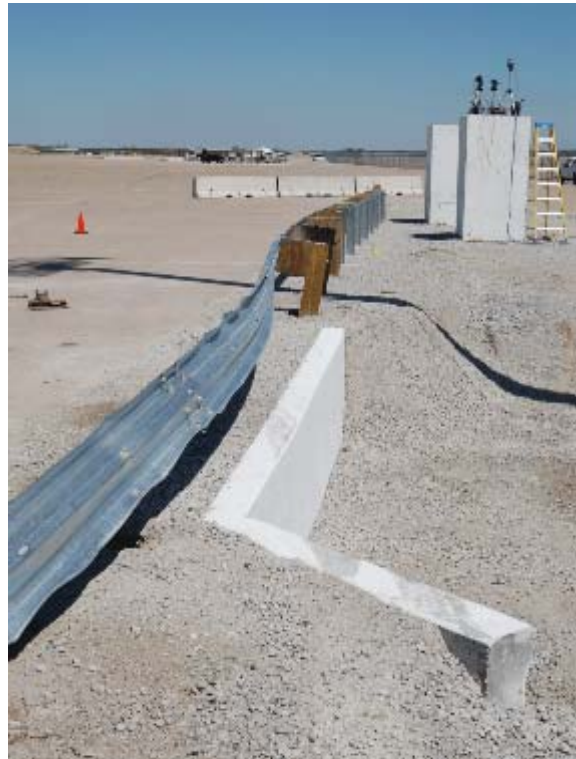
Figure 32. System Overall Damage, Test No. LSC-1

As shown in Figures 32 through 36, damage to the barrier was moderate, consisting mostly of deformed W-beam, contact marks on a guardrail section, and deformed and fractured guardrail posts. The W-beam damage consisted of contact marks and deformation and flattening of the impacted section between post nos. 13 and 20. No indications of rail rupture or tearing were visible on the W-beam. The W-beam rail was pulled off of post nos. 2 through 9. Three CRT posts, post nos. 14 through 16, were completely fractured, while CRT post nos. 12 and 13 were rotated backward. Steel post nos. 17 through 20 were bent and deformed backward and downstream. Neither significant post damage nor deformations occurred to the remaining posts in the system. The maximum lateral permanent set rail deflection was approximately 724 mm (28.5 in.), 1,905 mm (75 in.) upstream of post no. 14, as measured in the field. The maximum lateral dynamic post and rail deflections were 1,205 mm (47.4 in.) at post no. 16 and 2,343 mm (92.24 in.) at the centerline of post no. 15, respectively, as determined from the high-speed video analysis. The working width of the system was 2,373 mm (93.43 in.), as determined from the high-speed film analysis.

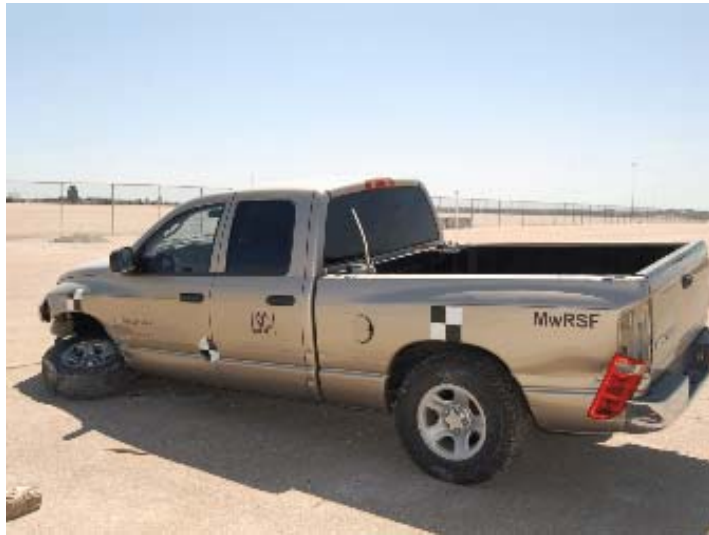
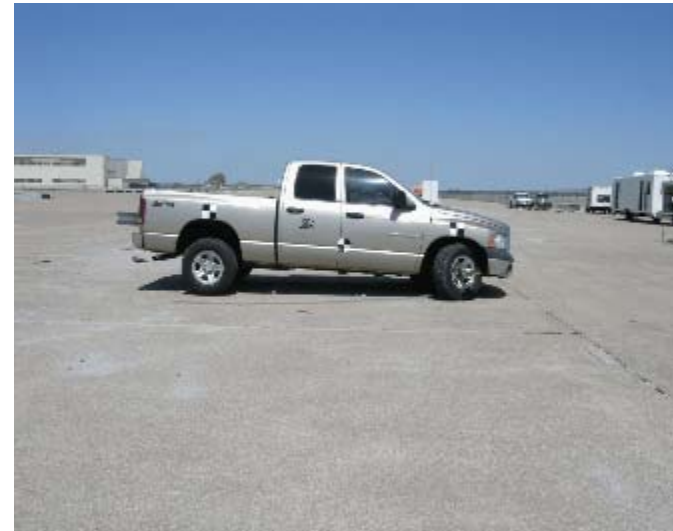
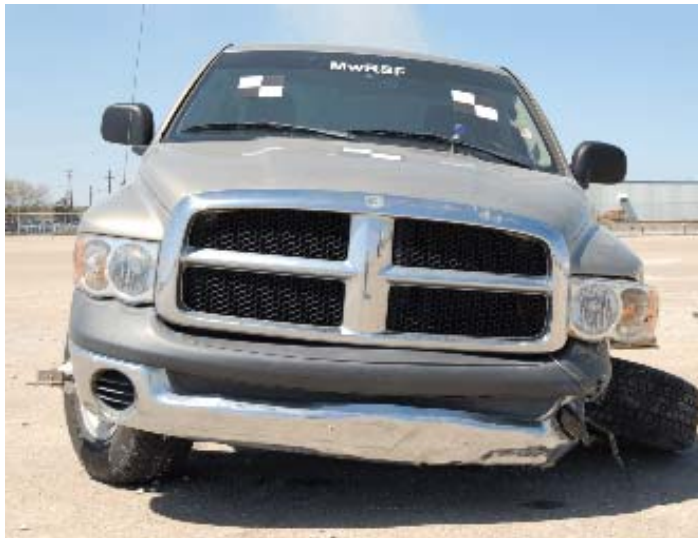
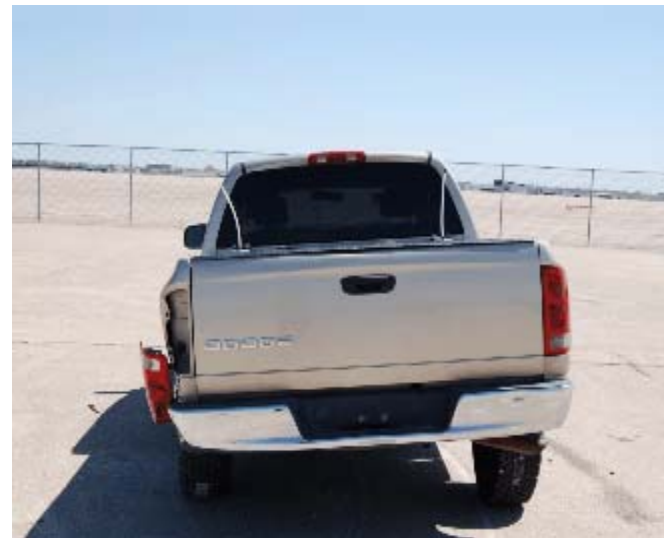
Figure 37. Vehicle Damage, Test No. LSC-1

Exterior vehicle damage was moderate, as shown in Figures 37 and 38. The left-front quarter panel was crushed inward, and the left side of the front bumper was also bent back toward the engine compartment. The left-front wheel assembly was disengaged from the upper and lower control arms but remained attached to the steering linkage. The left-front tire was still

inflated. Some deformation and damage were noted on the left-front suspension components. Contact marks and minor deformation were found along most of the lower-left side of the pickup truck. The left-rear quarter panel and the left corner of the rear bumper were dented as well. The left-rear taillight was disengaged from its housing. Interior occupant compartment damage was minimal, as shown in Figure 39 with a maximum vertical deformation of 19 mm (0.75 in.) measured near the right side of the driver-side footwell on the floorpan.

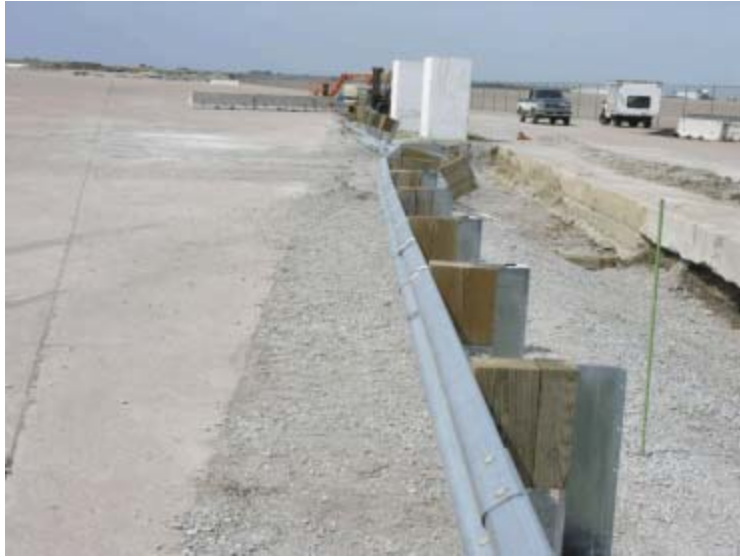
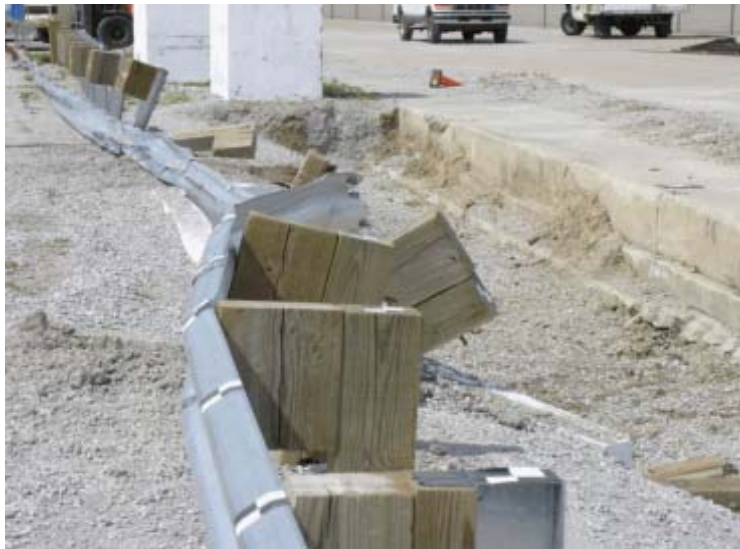
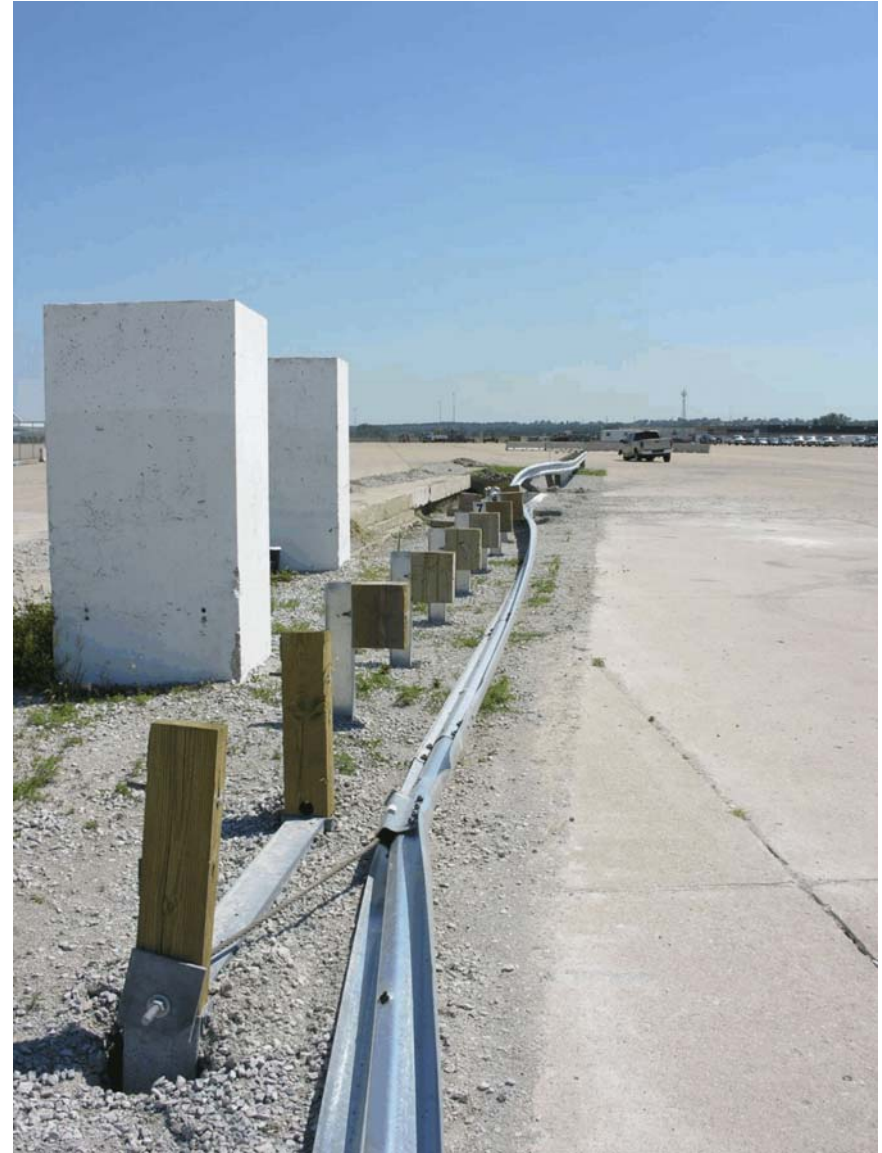
Figure 59. System Overall Damage, Test No. LSC-2

As shown in Figures 59 through 63, damage to the barrier was moderate, consisting mostly of deformed W-beam, contact marks on a guardrail section, and deformed and fractured guardrail posts. The W-beam damage consisted of contact marks and deformation and flattening of the impacted section between post nos. 10 and 16. No indications of rail rupture or tearing were visible on the W-beam. The W-beam rail was pulled off of post nos. 1 through 14. Two CRT posts, post nos. 11 and 13, were completely fractured, while CRT post nos. 12, 14, and 15 were rotated backward in the soil. Steel post nos. 9 and 10 were bent and deformed back and downstream. No significant post damage or deformations occurred to the remaining posts in the system. Contact marks and concrete spalling were visible on the top of the culvert headwall as well as on the downstream wingwall, as shown in Figure 60. The maximum lateral permanent set rail deflection was approximately 1,372 mm (54.0 in.) at 3,810 mm (150 in.) downstream from the centerline of post no. 13, as measured in the field. The maximum lateral dynamic post and rail deflections were 1,186 mm (46.7 in.) at post no. 12 and 1,968 mm (77.5 in.) at 1,905 mm (75 in.) downstream of post no. 13, respectively, as determined from the high-speed video analysis. The working width of the system was 2,133 mm (84.0-in), as determined from the high-speed video analysis.

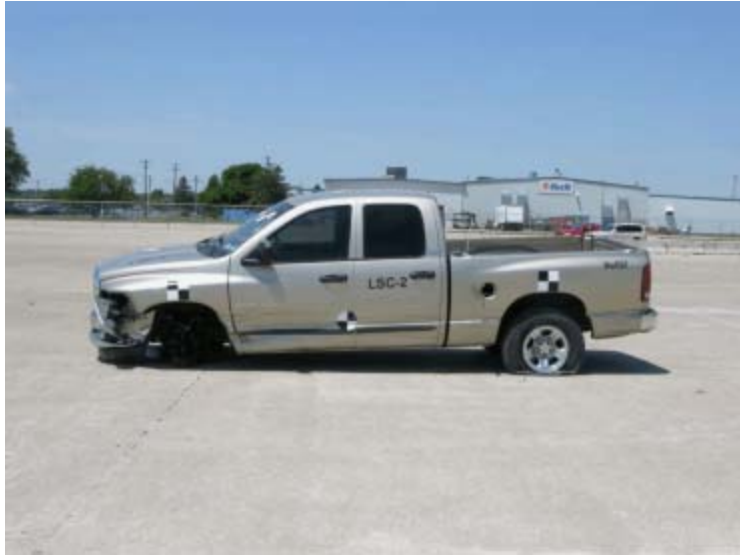
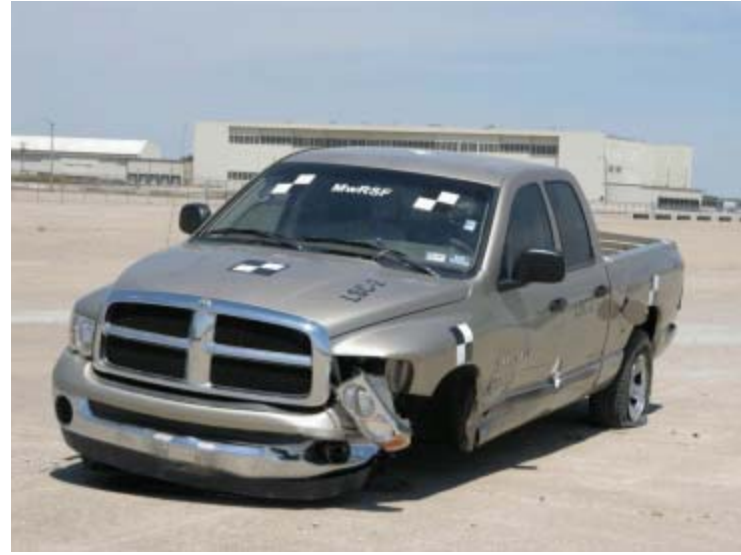
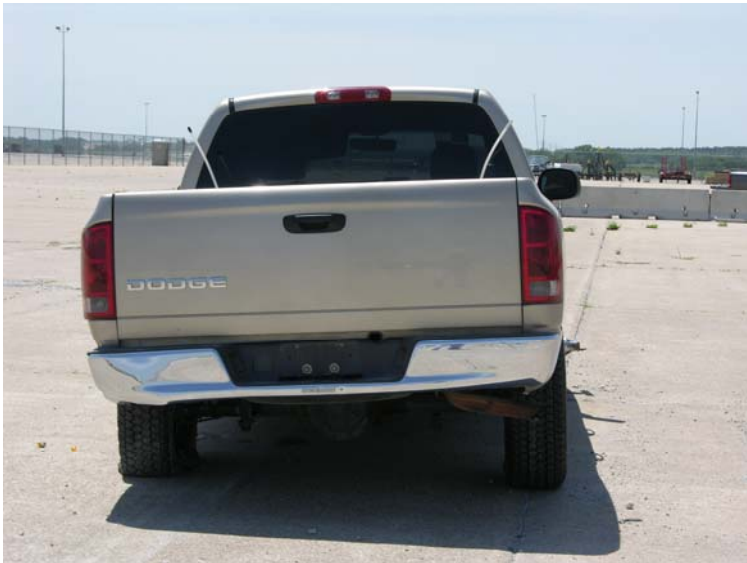
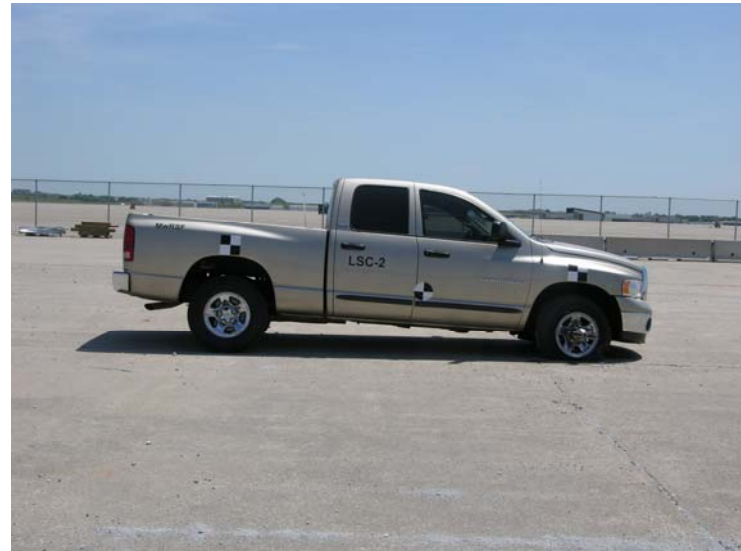
Figure 64. Vehicle Damage, Test No. LSC-2

Exterior vehicle damage was moderate, as shown in Figures 64 through 66. The left-front quarter panel was crushed inward, and the left side of the front bumper was also bent back toward the engine compartment. The left-front wheel assembly was completely disengaged from the axle, suspension, and steering systems. Some deformation and damage were noted on the left-front suspension components, including the upper and lower control arms, the stabilizer bar, and the joints connecting the suspension components. Contact marks and minor deformation were found along most of the lower-left side of the pickup truck. The left-rear quarter panel and the left corner of the rear bumper were dented as well. The left-rear tire was deflated, and the right-front tire de-beaded from the rim. Interior occupant compartment damage was minimal, as shown in Figure 67, with maximum lateral deformations of 19 mm (0.75 in.) measured near both the right and left sides of the driver-side footwell on the floorpan.
