NCHRP Report 350 Compliance Testing of the BEST System

Midwest Roadside Safety Facility
Civil Engineering Department
1901 "Y" St., Bldg. 'C'
P.O. Box 880601
University of Nebraska-Lincoln
Lincoln, NE 68588-0601
(402) 472-9198

TRANSPORTATION RESEARCH REPORT TRP-03-63-96

December 4, 1996

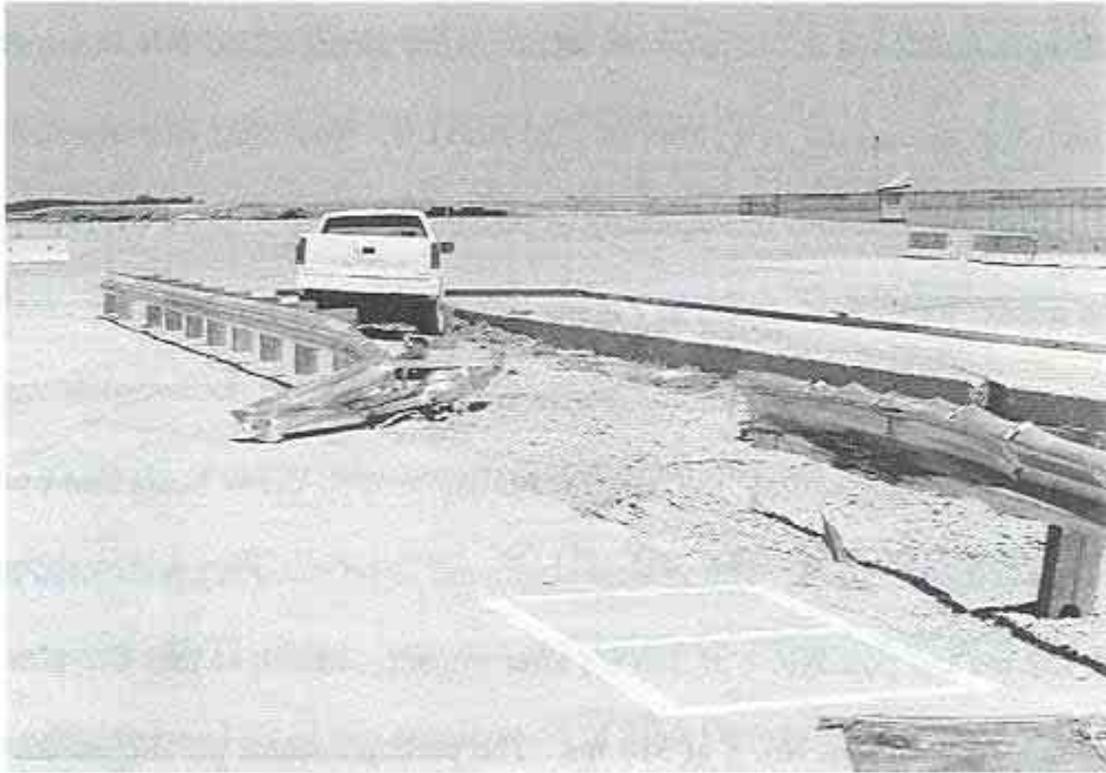
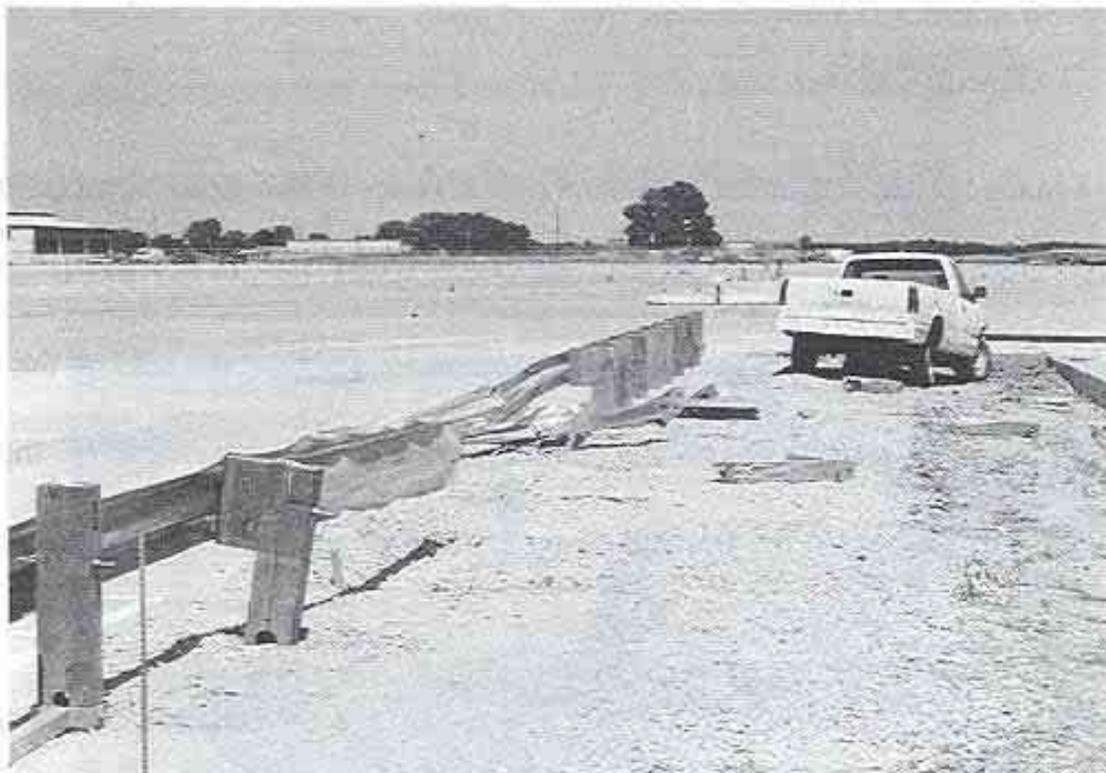
Figure 15. Post-test photographs of Test BEST-2.

The cable anchor system performed well during this test, as the tab system supported the full load of the redirection impact. However, the posts did not rotate normally, and broke off at the groundline before providing an adequate redirection force to the vehicle. This behavior resulted in the pickup continuing into the system further than is normally observed, causing pocketing to occur, and ultimately resulting in the rupture of the W-beam guardrail. After this failure occurred, the vehicle continued through the system and came to rest behind the guardrail. Post-test photos of this system are presented in Figure 15.

After reviewing the high-speed film from this test, it was evident that the primary reason for the failure of the system was the fact that the posts fractured prematurely. This phenomenon was investigated through bogie testing of similar posts under comparable conditions, and several discoveries were made. The first and most significant finding was that the placement of the post next to the 610 cm (24 in.) deep concrete apron significantly affected the soil resistance and contributed to the early failure of the posts. A second contributing factor was that the CRT posts used for this system were 140 mm x 190 mm (5½ in. x 7½ in.) finished posts instead of the standard 152 mm x 203 mm (6 in. x 8 in.) rough cut. This resulted in a reduction in the post section modulus of approximately 22 percent. As a result of the bogie testing, a

revised post design was developed that utilized 152 mm x 203 mm (6 in. x 8 in.) rough cut posts and a total length of 1778 mm (5 ft - 10 in.). The post's embedment depth was thereby cut to 1067 mm (42 in.) which was expected to reduce the soil forces on the post by approximately 10 percent in order to assure that the posts would rotate without fracturing, even under tight soil conditions. The problems associated with installing the guardrail adjacent to the concrete apron were also addressed moving the front face of an additional 1.5 m (5 ft) from the concrete.

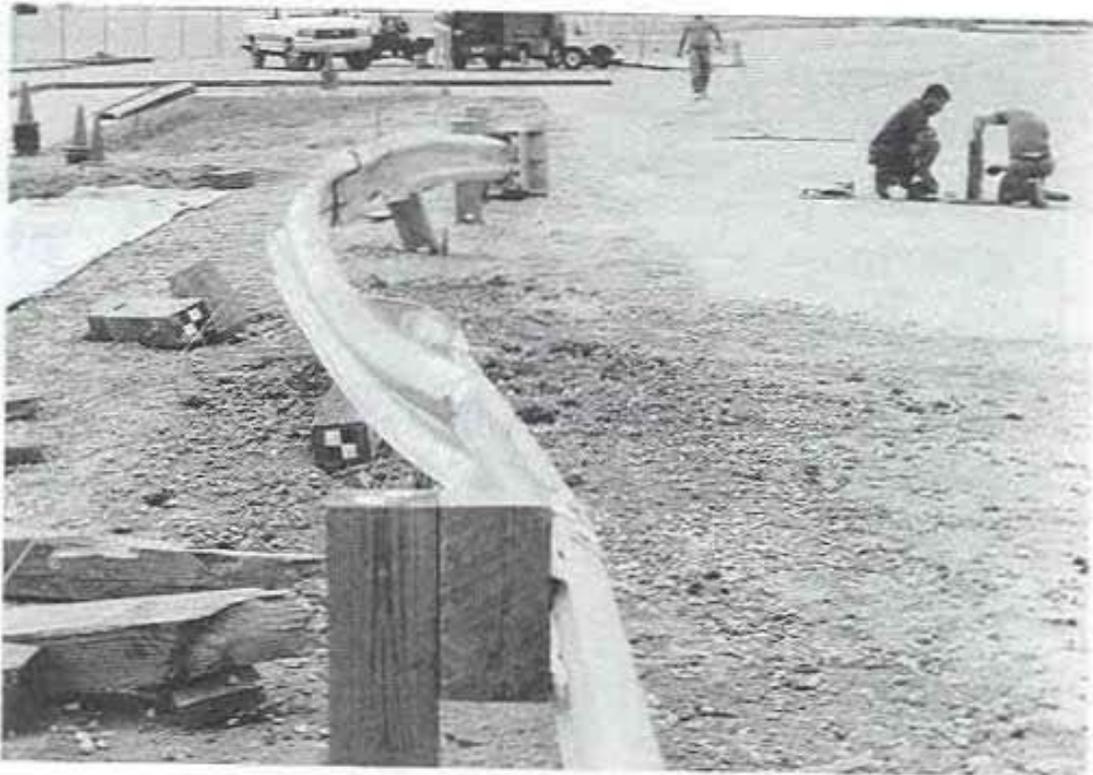
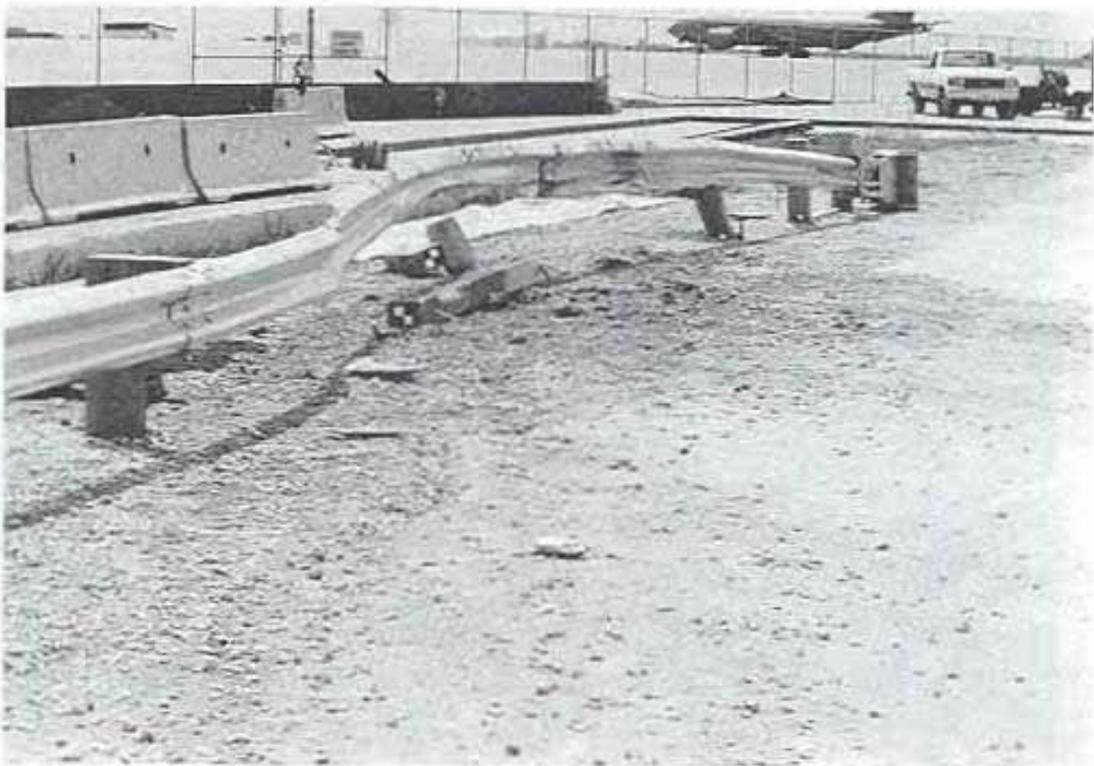
Figure 21. Installation damage, Test BEST-3.

Damage to the system, shown in Figure 21, included the rotation and subsequent fracture of post No. 3 at the top CRT hole. Post Nos. 4 and 5 rotated and fractured at the bottom hole, while post No. 6 rotated and was uprooted without breaking. Post No. 7 rotated and failed at an angle, with the fracture passing through both of the CRT holes. Post No. 8, which was not a CRT post, failed at the groundline,

angle, with the fracture passing through both of the CRT holes. Post No. 8, which was not a CRT post, failed at the groundline, and there was no measurable damage to or deformation of the remaining posts. The total length of contact was approximately 11 m (36 ft), as the last point of contact was 610 mm (2 ft) upstream of post No. 9. There was no sign of damage to the cable anchor box, but a number of the W-beam tabs showed evidence of high loads. The maximum permanent deformation in the rail was 758 mm (29.8 in.) at post No. 6.

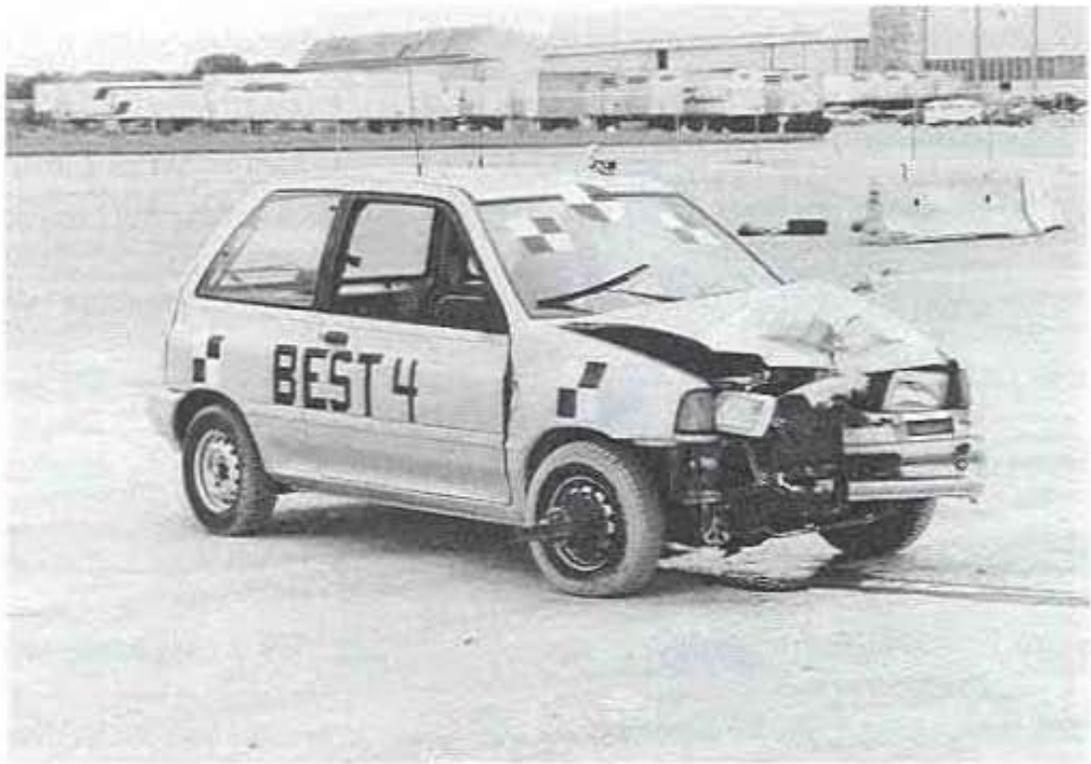
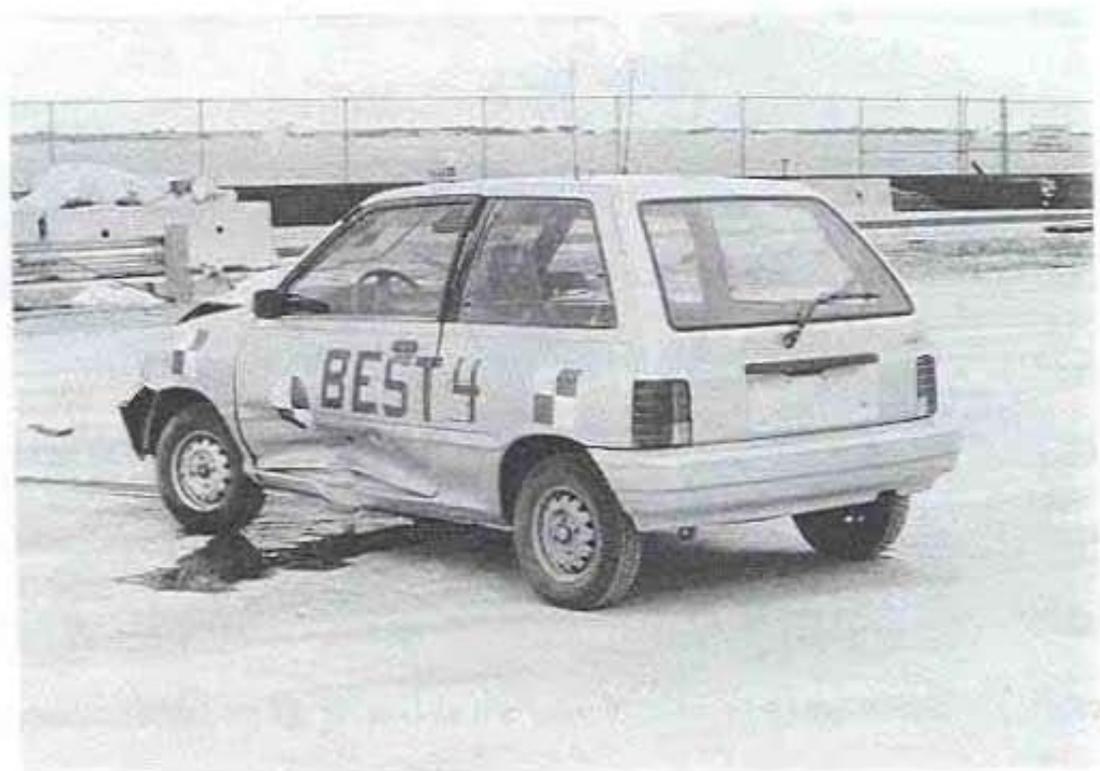
Figure 26. Vehicle Damage, Test BEST-4.

Damage to the vehicle, shown in Figure 26, included approximately 267 mm (10.5 in.) of front end crush resulting from the contact with the impact head. There was also approximately 76 mm (3 in.) of

deformation on the outside of the drivers door resulting from contact with the W-Beam as the vehicle passed by it after losing contact with the head. This resulted in 25 mm (1 in.) of deformation on the inside of the driver's side door. There was only minor deformation of the vehicle floorboard, and the windshield was cracked on the lower driver's side corner.

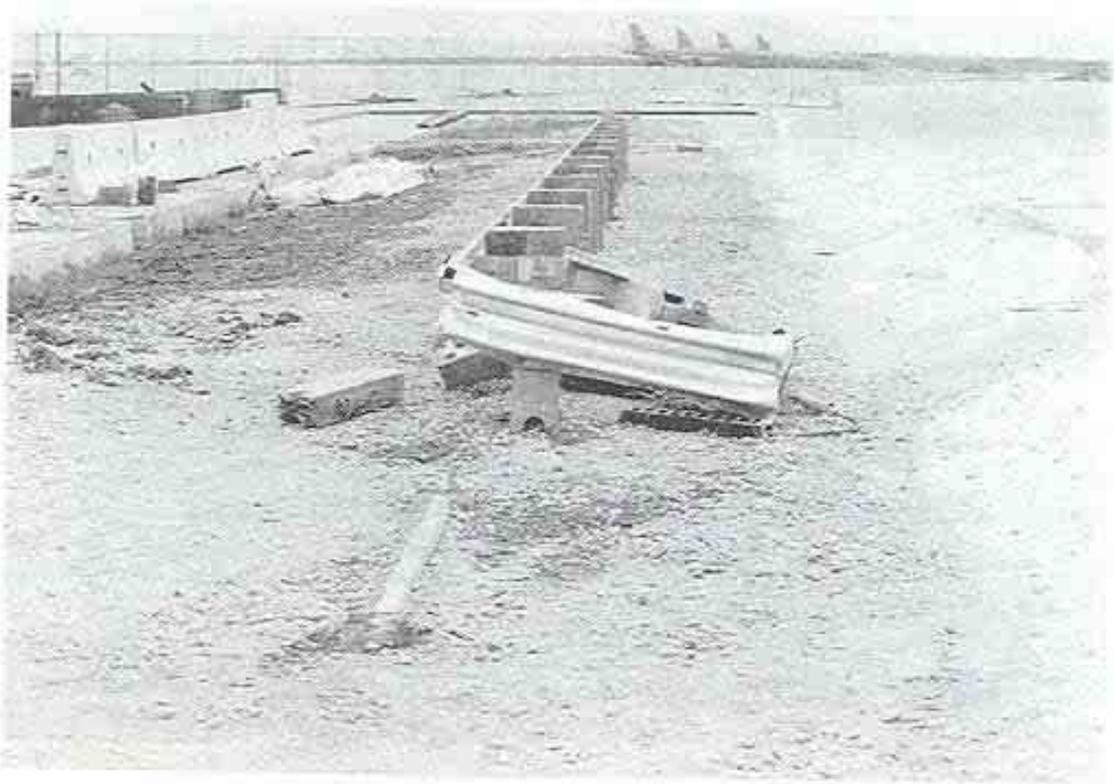
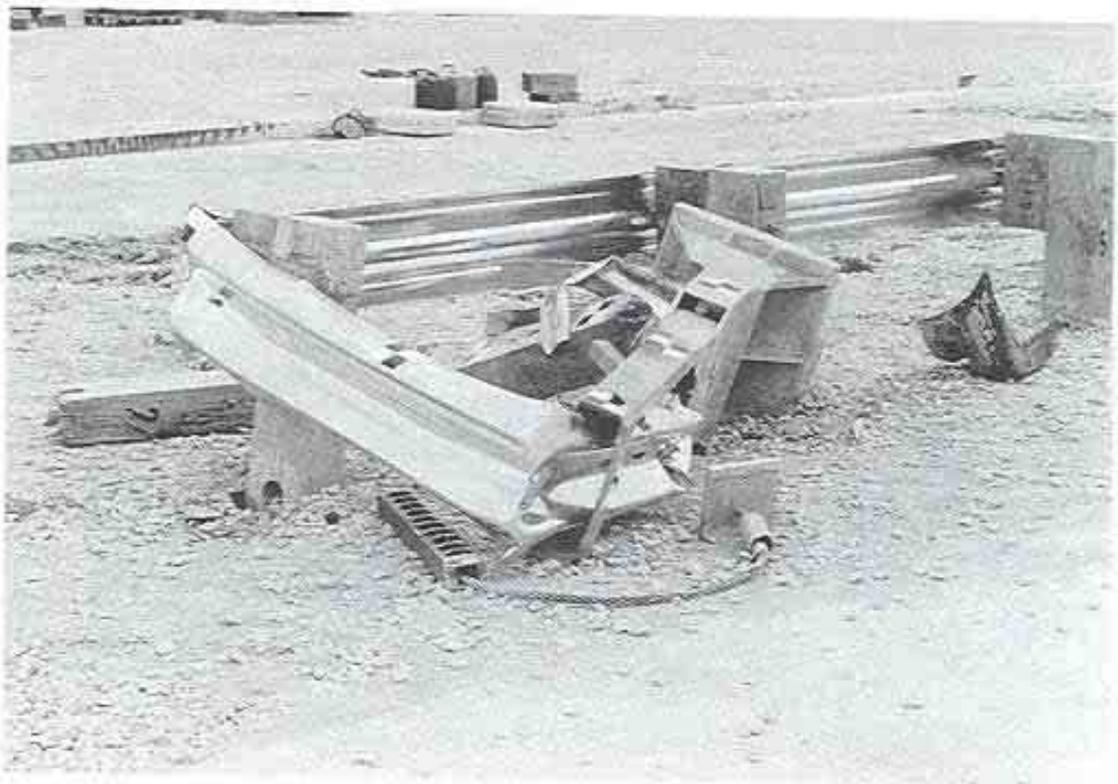
Figure 27. Installation damage, Test BEST-4.

The damage to the system is shown in Figure 27. The head cut through 1.28 m (4 ft - 2¼ in.) before the system buckled out of the path of the vehicle. Post Nos. 1 and 2 were fractured at the groundline, and post No. 3 rotated downstream slightly as a result of contact with the deformed W-Beam. The remainder of the posts were left virtually untouched.

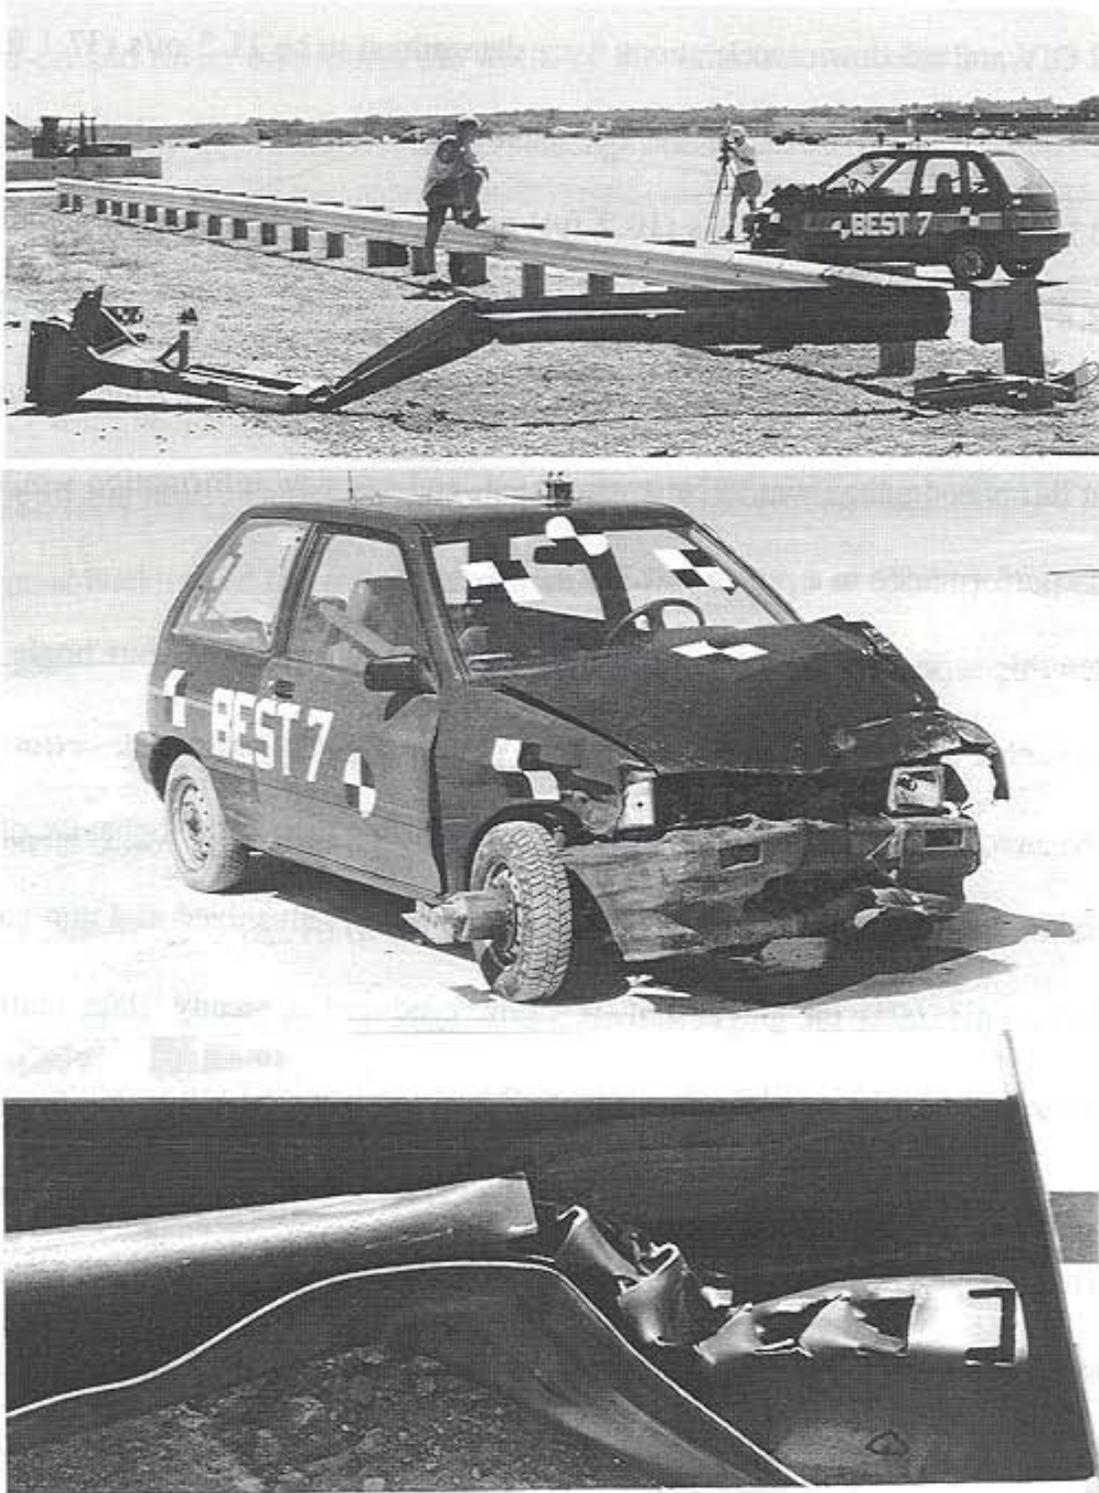
Figure 30. Post-test Photographs of Test BEST-7.

Damage to the vehicle was acceptable, as shown in Figure 30, with 25 cm (10 in.) of crush in the front of the vehicle and a maximum of 73 mm ($2\frac{7}{8}$ in.) internal occupant compartment deformation occurring on the front floorboard.

There was significant deformation of the W-beam rail, as shown in Figure 30. The bottom of the rail was deformed from contact with the end of the chute. The cutting path showed that the blades started cutting in a sharply upward manner almost immediately after impact. When the head was removed from the rail, there was noticeable wear on the cutting blades. The first three posts broke away cleanly, and the

rail buckled at the midspan between post nos. 2 and 3 and at post no. 4. There were also contact marks on the groundline strut and second foundation tube which indicated that the undercarriage of the vehicle had contacted these terminal components.

Since this type of behavior had not been seen in any of the previous bogie or full-scale tests, which had all been conducted on galvanized W-beam, it was decided to perform a series of static and dynamic tests to determine the affect that galvanizing had on the behavior of the system. These tests showed that the system does perform differently on galvanized and non-galvanized W-beam. The bogie tests on galvanized W-beam produced a steady state cutting force of approximately 10 to 12 kips, while the tests on the non-galvanized rail produced a force which started out around 10 kips and climbed quickly to approximately 20 kips throughout the cutting process. This behavior was attributed to the wearing of the cutting blades which was evident after each bogie and full-scale test on ungalvanized beam. The cutters, which are fabricated from abrasion resistant steel and then galvanized, have shown no signs of wearing in all of the tests conducted previously with galvanized W-beam. It was also noted that the cutter teeth did not appear to track as well on the ungalvanized W-beam. These findings led the researchers to

conclude that the poor performance observed in Test BEST-7 was a result of the use of ungalvanized W-beam. A special stock of lengthened galvanized W-beam was obtained for the remaining tests, and this test was conducted again as test BEST-8.

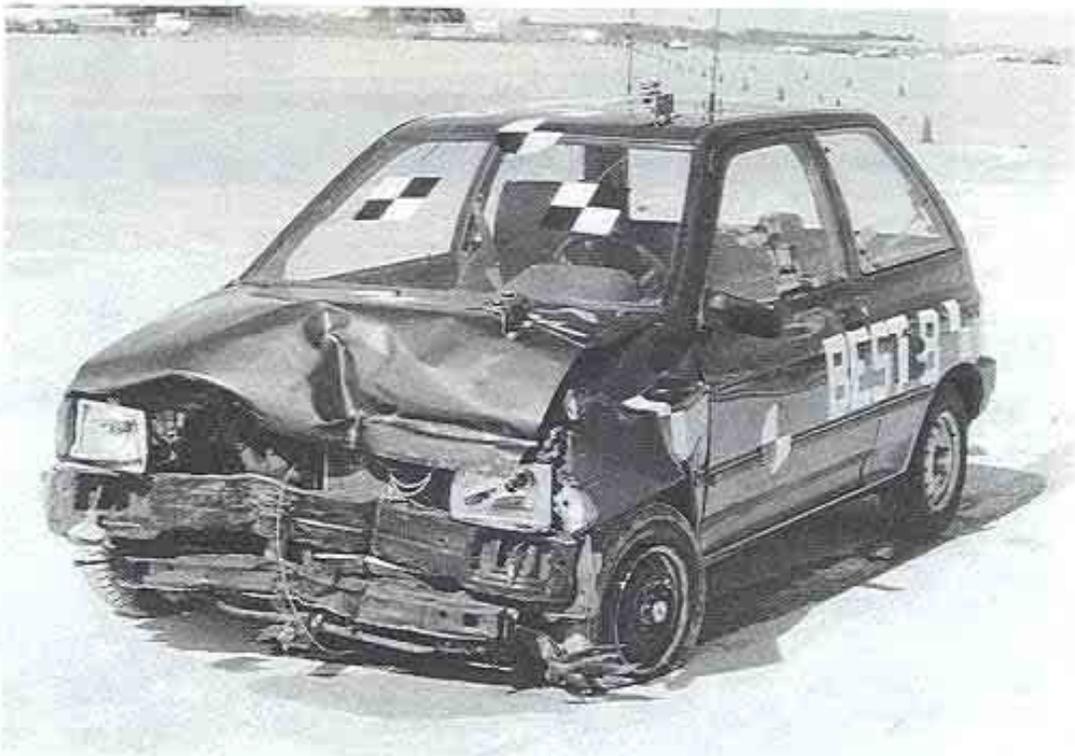
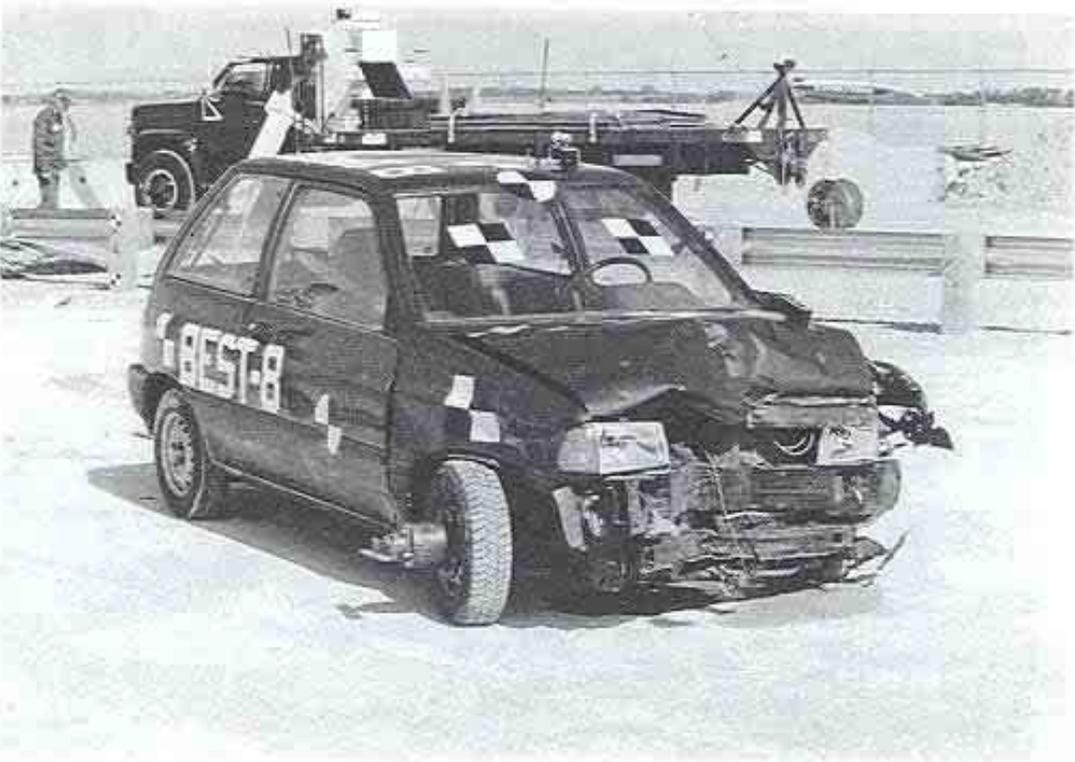
Figure 35. Vehicle Damage, Test BEST-8.

Damage to the vehicle was minimal, as shown in Figure 35, with 25 cm (10 in.) of crush on the front of the vehicle. The only occupant compartment deformation occurred on the driver's side floorboard, and the maximum deformation was measured to be 76 mm (3 in.).

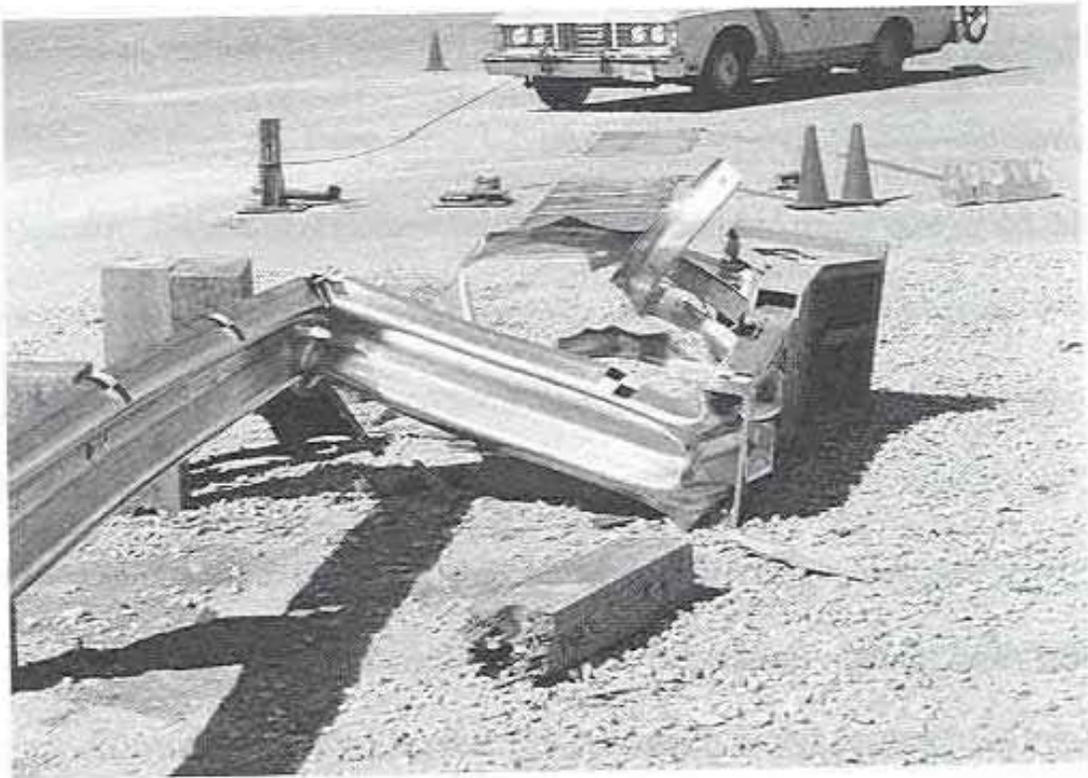
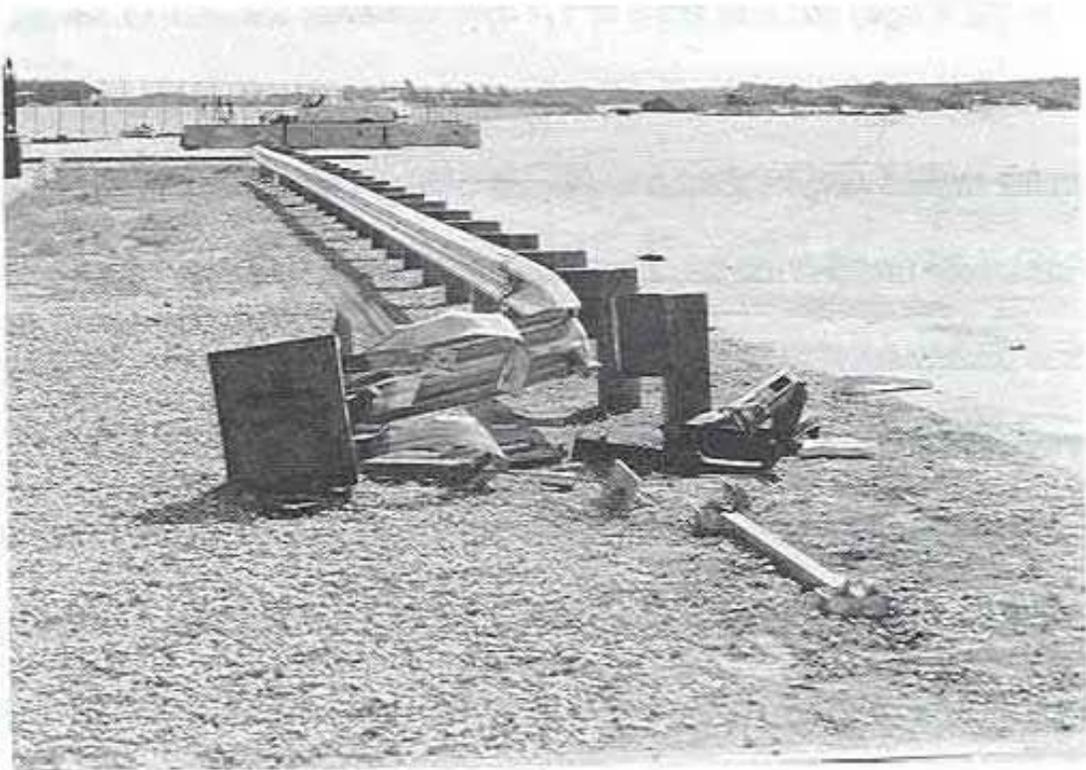
Figure 36. Installation damage, Test BEST-8.

Damage to the system, shown in Figure 36, consisted of posts 1 and 2 breaking cleanly at the top of the foundation tubes. Post No. 3 was pushed downstream slightly, with a 19 mm ($\frac{3}{4}$ in.) gap in the soil visible on the upstream side of the post at ground level. The W-beam rail was buckled at the end of the

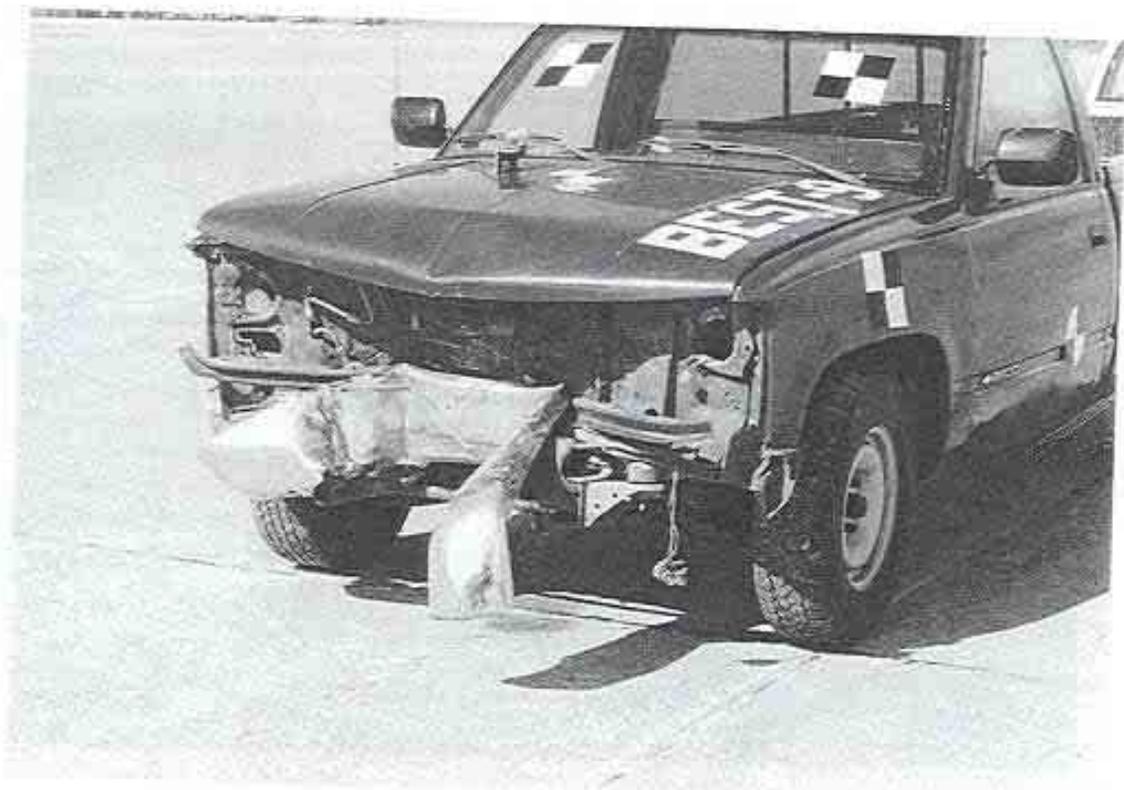
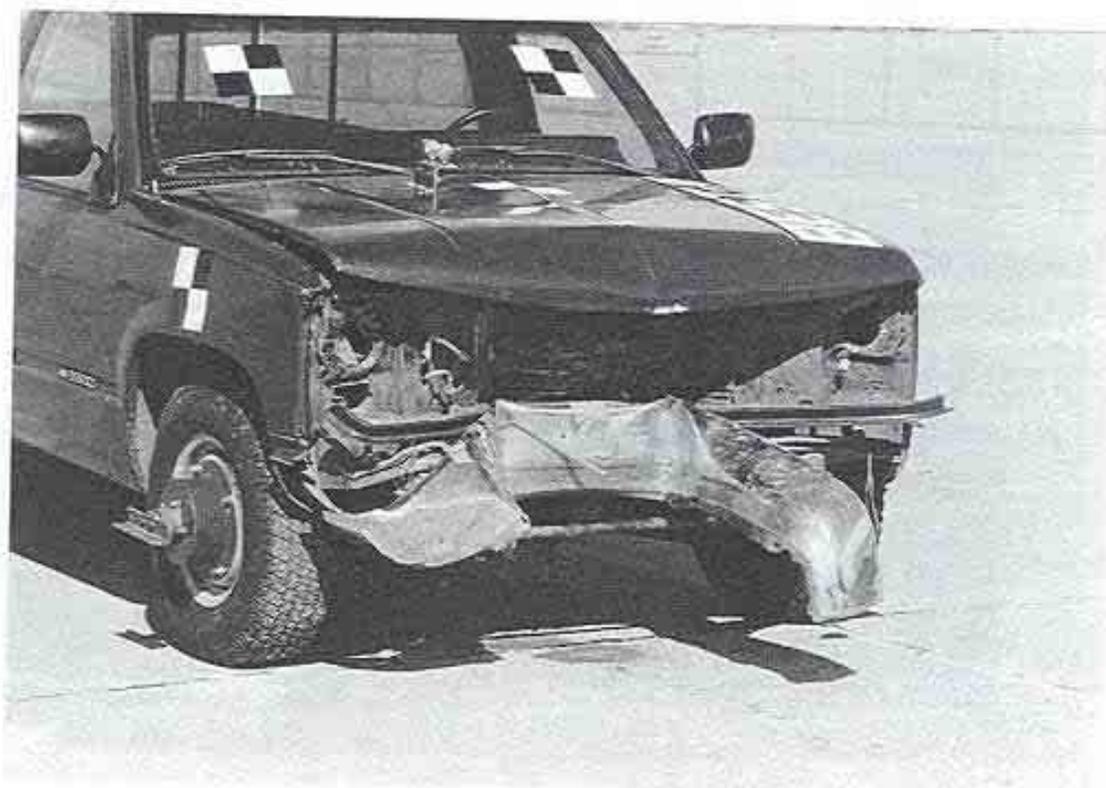
Figure 41. Vehicle Damage, Test BEST-9.

Damage to the vehicle was minimal, as seen in Figure 41. There was no visible occupant compartment deformation, and there was 29.2 cm (11½ in.) of crush in the front of the vehicle where the impact head contacted the test vehicle.

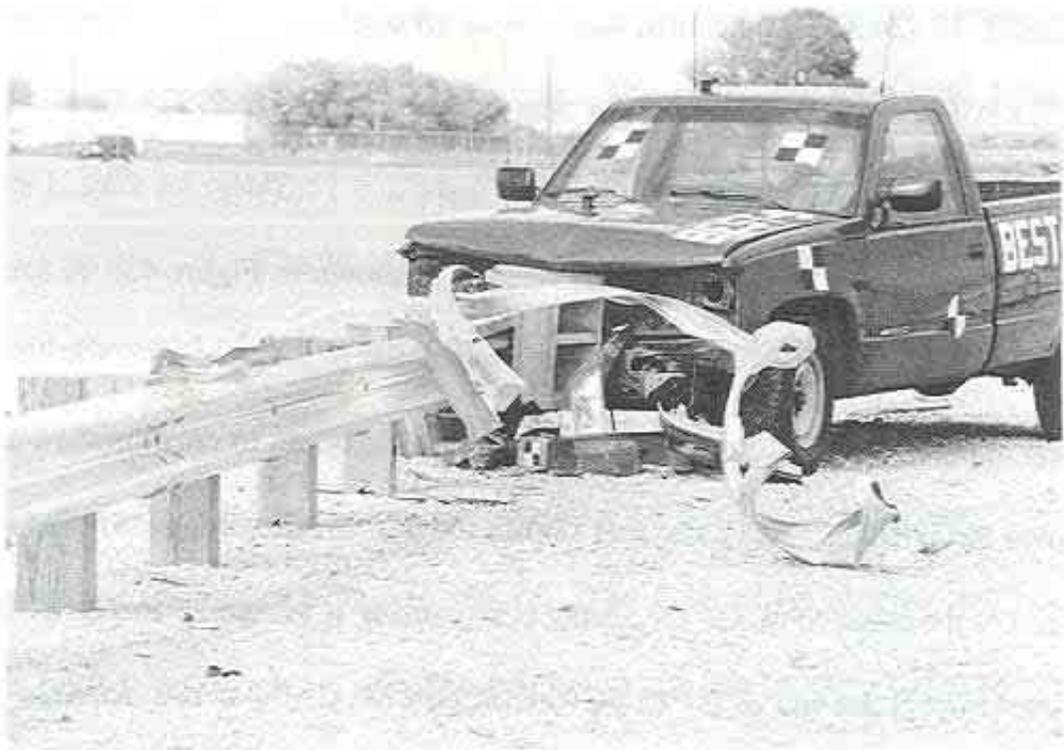
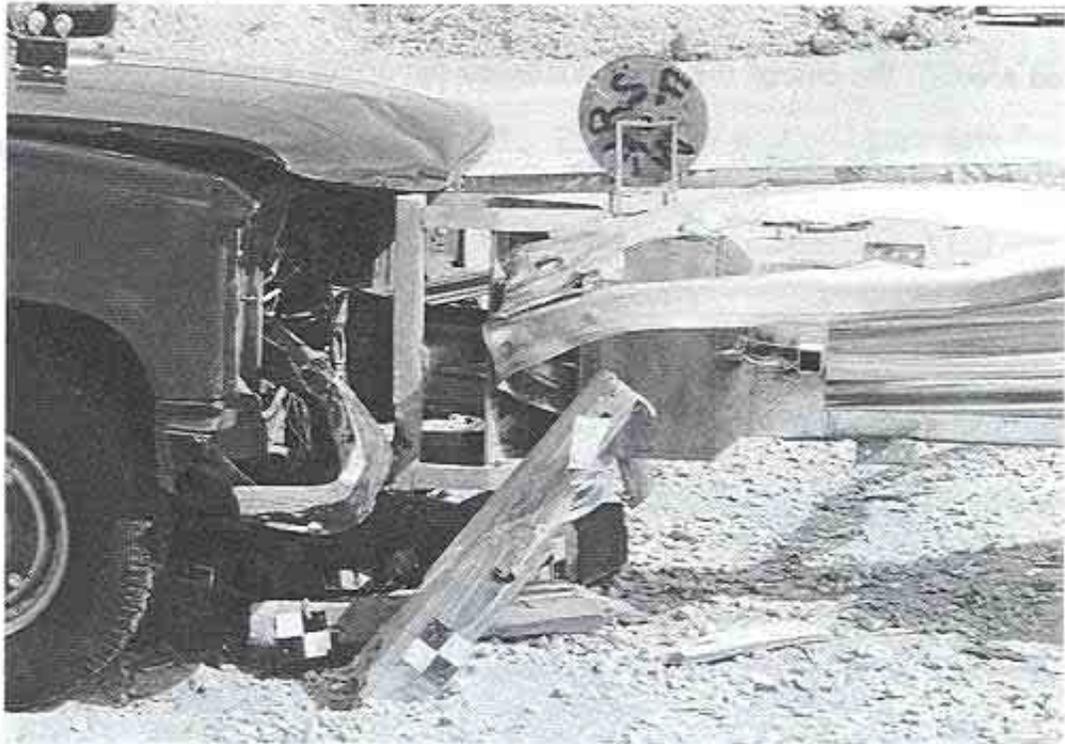
Figure 42. Installation damage, Test BEST-9.

The system damage can be seen in Figure 42. The cable system released properly and post nos. 1 through 4 were broken cleanly at ground level. Post No. 5 was split longitudinally and partially broken at the base. The head cut cleanly through the splice, with the first and third strips from the top becoming detached at the point of the splice, while the other two strips remained attached. The impact head was deformed slightly on the front face at the point where the test vehicle's bumper contacted it upon impact. The cutters contacted several of the splice bolts as they cut through the splice and, even though one of these bolts became wedged between two blades, the rail continued to be cut smoothly.

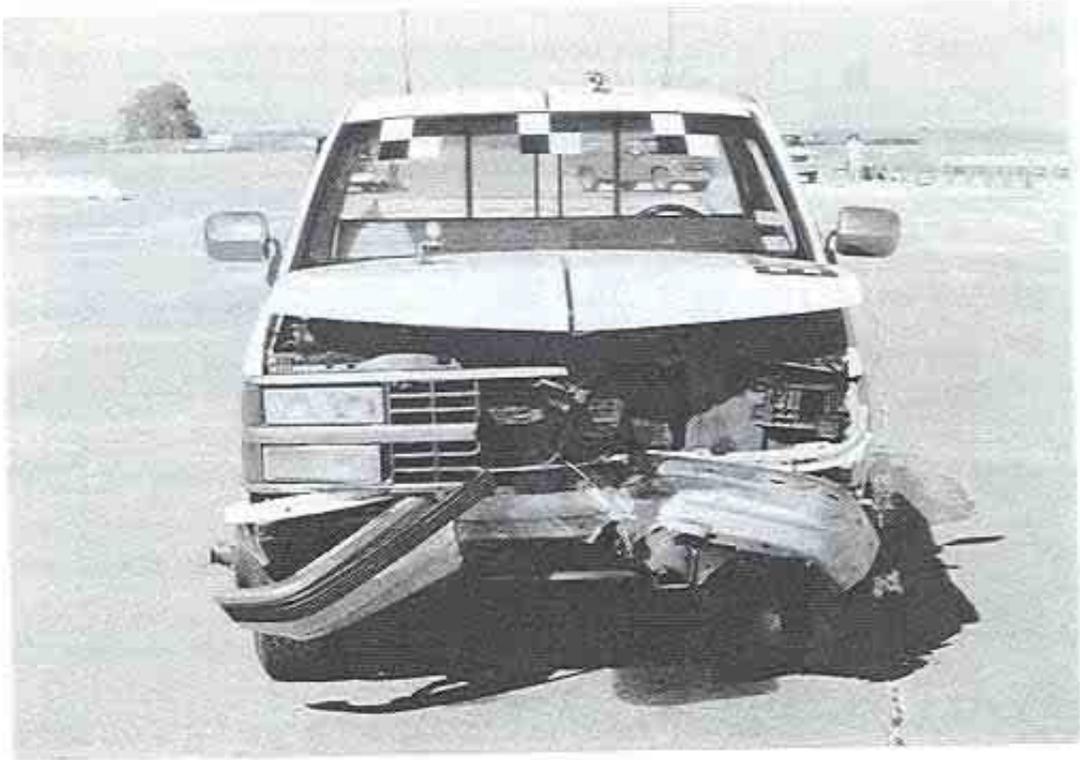
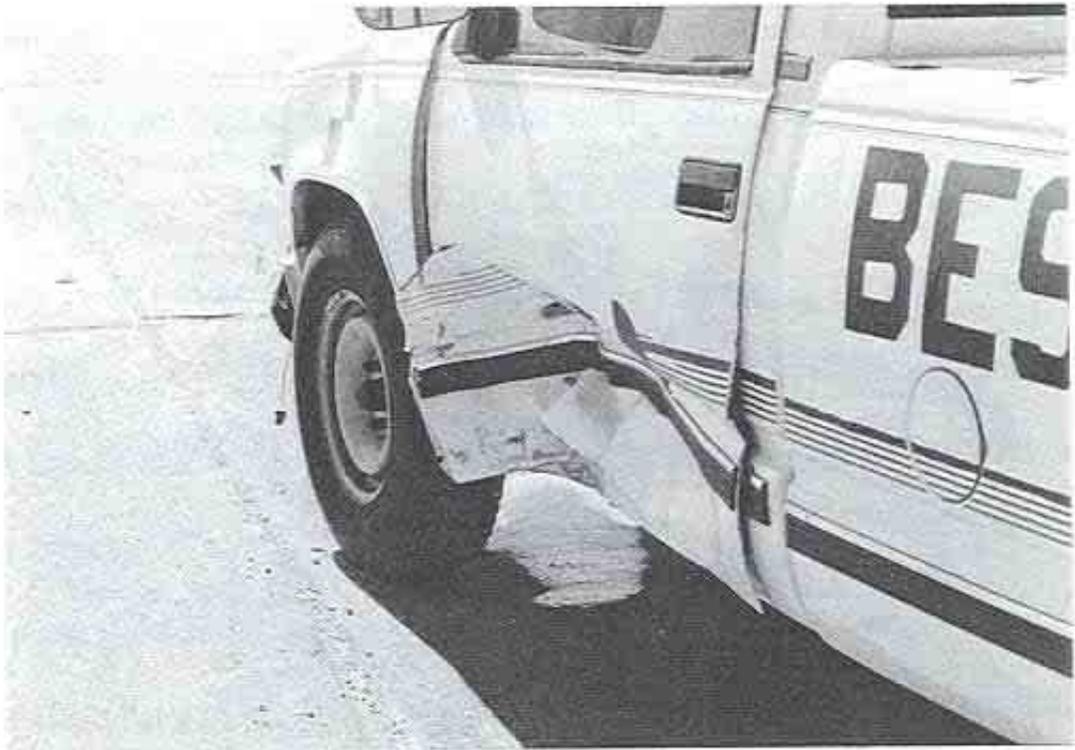
Figure 47. Vehicle Damage, Test BEST-10.

Damage to the vehicle was relatively minor, with 34.3 cm (13.5 in.) of crush in the front and no visible undercarriage damage. The driver's side door was damaged from contact with the impact head as the vehicle passed by it. This damage, shown in Figure 47, consisted of the tearing of the outer sheet metal and approximately 229 mm (9 in.) of crush on the outside of the door. This resulted in approximately 114 mm (4.5 in.) of deformation on the inside of the driver's door. There was no other occupant compartment deformation.

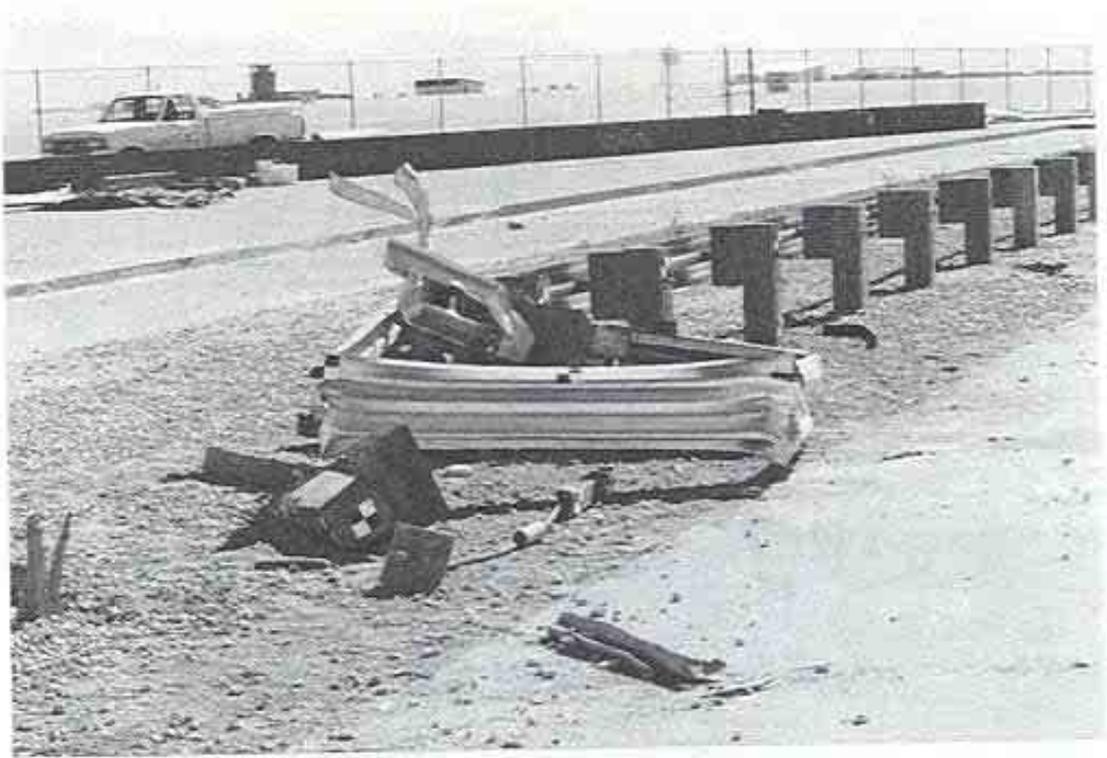
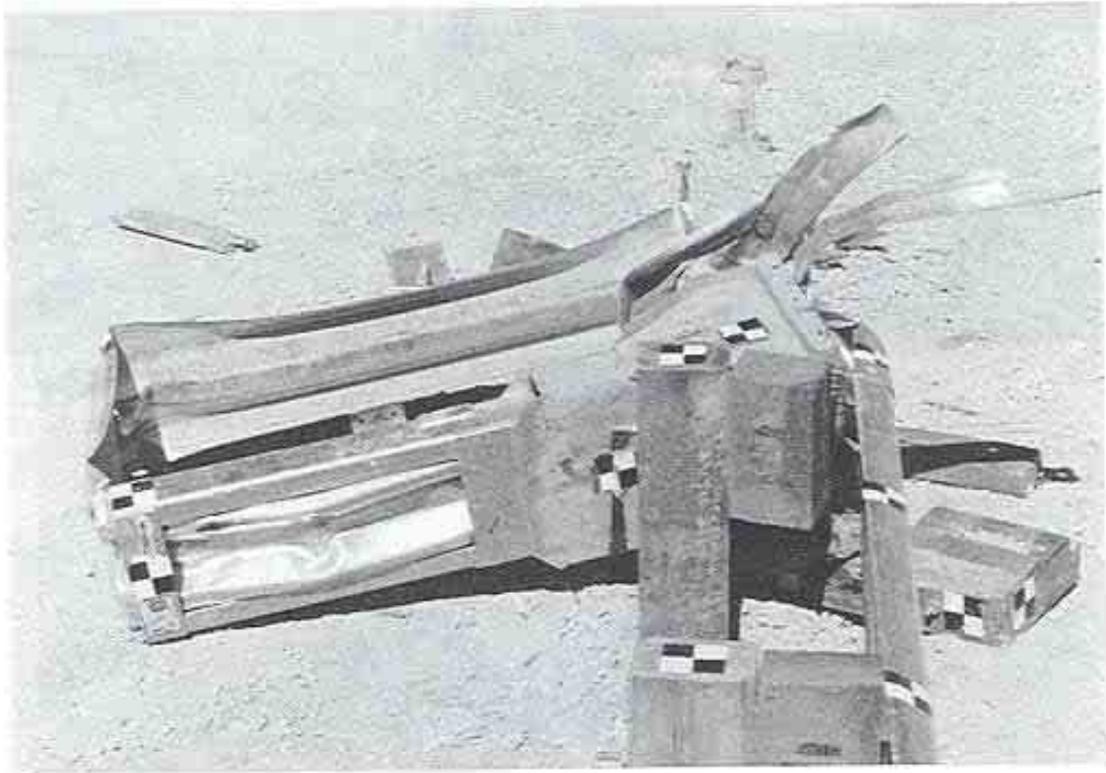
Figure 48. Installation damage, Test BEST-10.

Damage to the system can be seen in Figure 48. Post nos. 1 and 2 were broken cleanly

at the top of the foundation tube. Post No. 3 broke at the groundline CRT hole, while post No. 4 rotated more and broke at the bottom CRT hole. The system cut for a total distance of 2.16 m (7 ft - 1 in.), with buckling occurring at the end of the chute when it was 0.97 m (3 ft - 2 in.) upstream of post no. 3. The W-beam also buckled at post locations 3 and 4. Damage to the impact head consisted of deformation of the front plate where the initial contact with the test vehicle occurred.

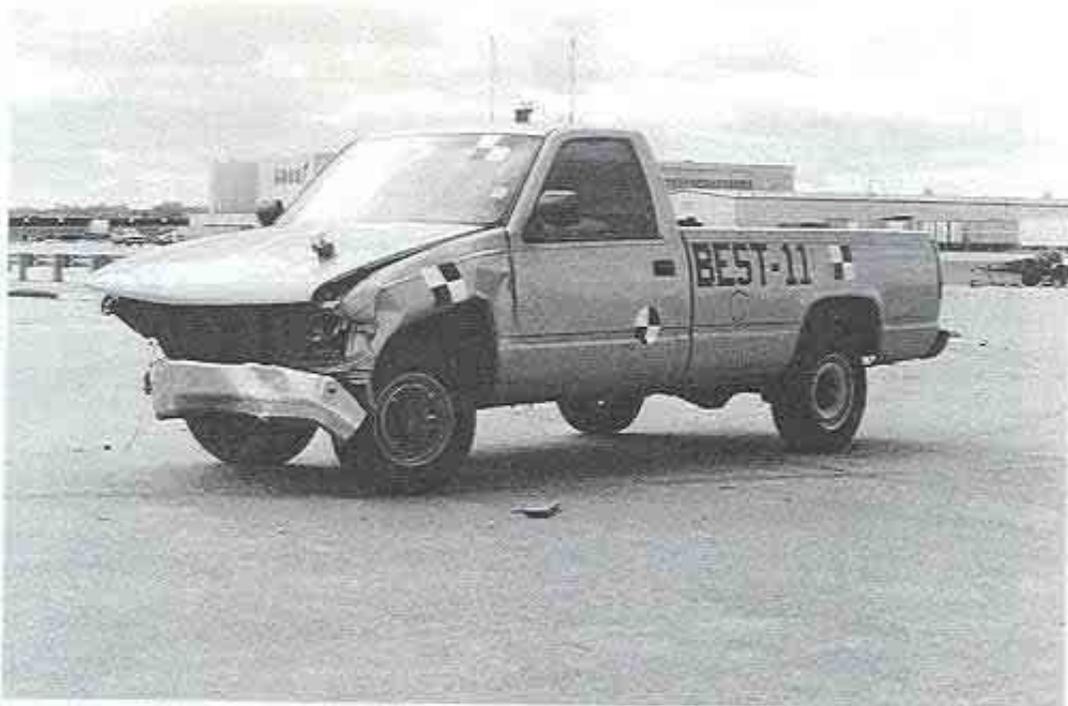
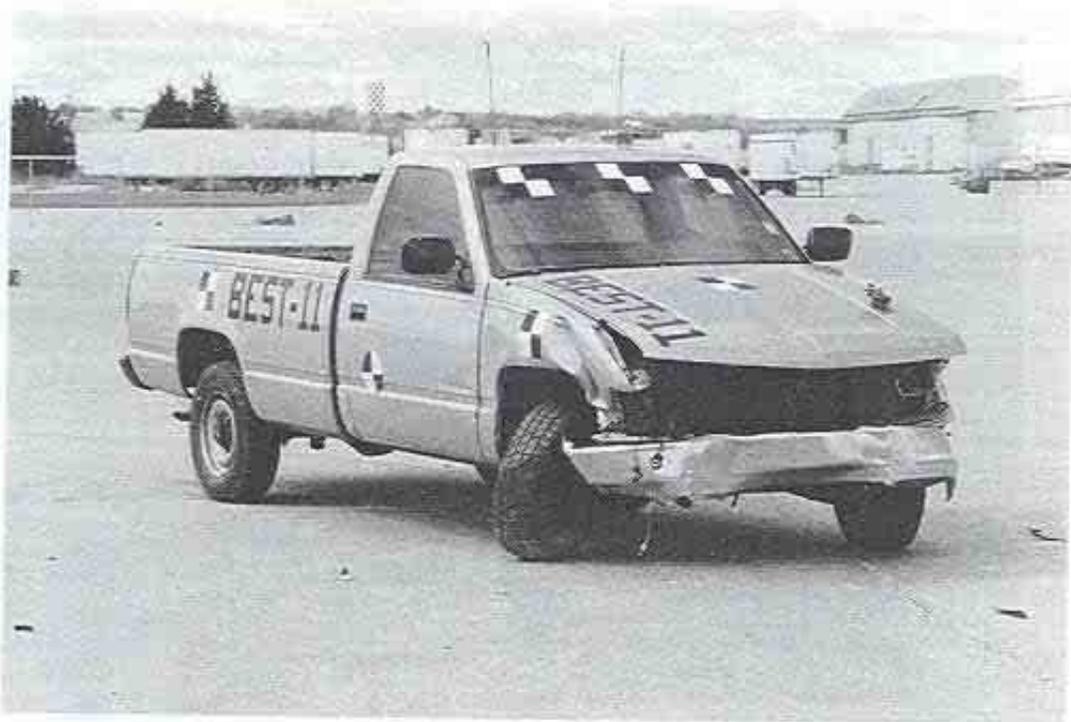
Figure 53. Vehicle Damage, Test BEST-11.

Damage to the vehicle, shown in Figure 53, consisted of crushing of the right-front quarter panel and failure of the front-right tie-rod which allowed the tire to rotate freely outward. All four tires remained inflated throughout the crash test and there were only minor contact marks along the passenger side of the vehicle. The manual transmission shifted as a result of the impact and caused slight damage to the center of the floorboard where the gear selector is located. There was no damage to the driver's side floorboard, but the passenger's side floorboard was deformed slightly, with a maximum deformation of 64 mm (2.5 in.).
