NCHRP Report 350 Compliance Testing of the BEST System

Midwest Roadside Safety Facility
Civil Engineering Department
1901 "Y" St., Bldg. 'C'
P.O. Box 880601
University of Nebraska-Lincoln
Lincoln, NE 68588-0601
(402) 472-9198

TRANSPORTATION RESEARCH REPORT TRP-03-63-96

December 4, 1996

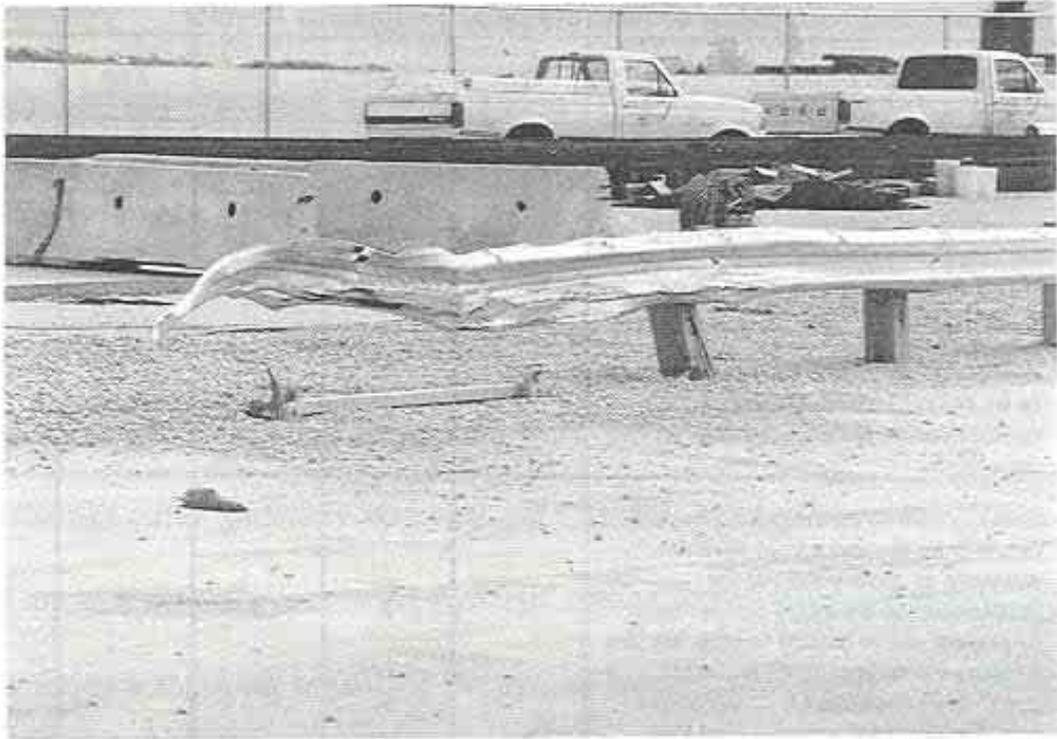
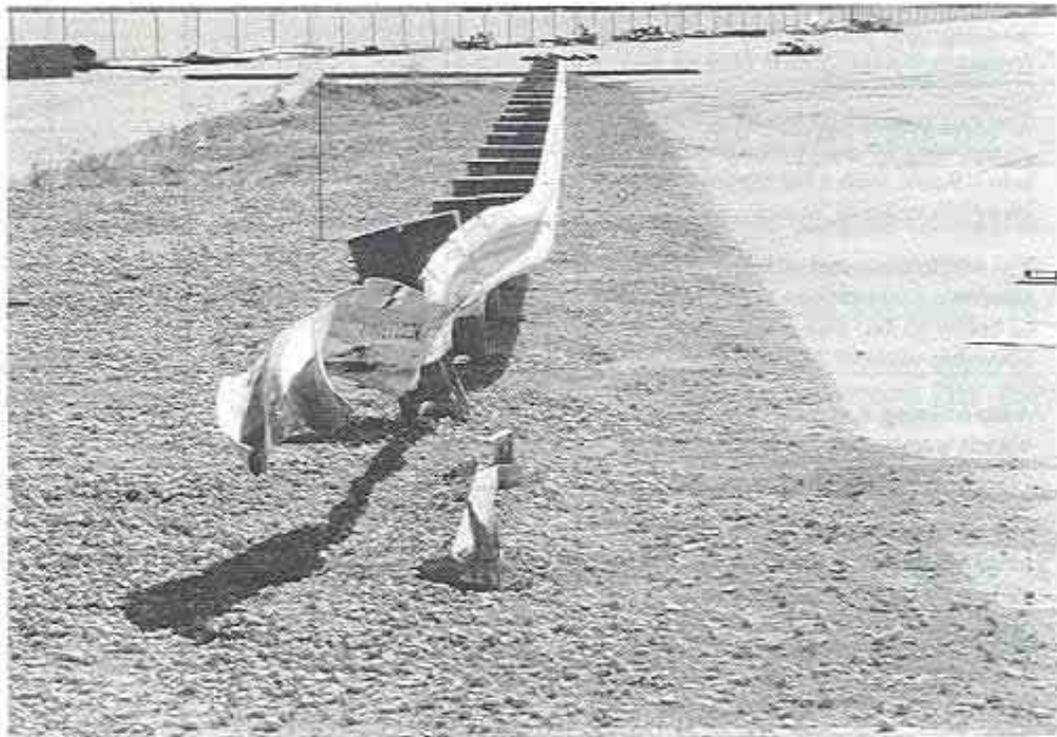
Figure 54. Installation damage, Test BEST-11.

Damage to the system, shown in Figure 54, consisted of post nos. 1, 2, and 3 breaking at the groundline and post no. 4 rotating slightly so that there was a 25 mm (1 in.) gap in the soil at the front of the post. The impact head was undamaged and there was some noticeable deformation of the cable anchor box. There was a 229 mm (9 in.) long tear approximately 51 mm (2 in.) from the bottom of the W-beam just below the bolt hole location for post no. 2.
