EVALUATION OF A NEW JERSEY SAFETY SHAPE, SEGMENTED CONCRETE BARRIER FOR USE ON COMPOSITE PANEL BRIDGE DECKS

MwRSF Research Report No. TRP-03-181-07

June 5, 2007

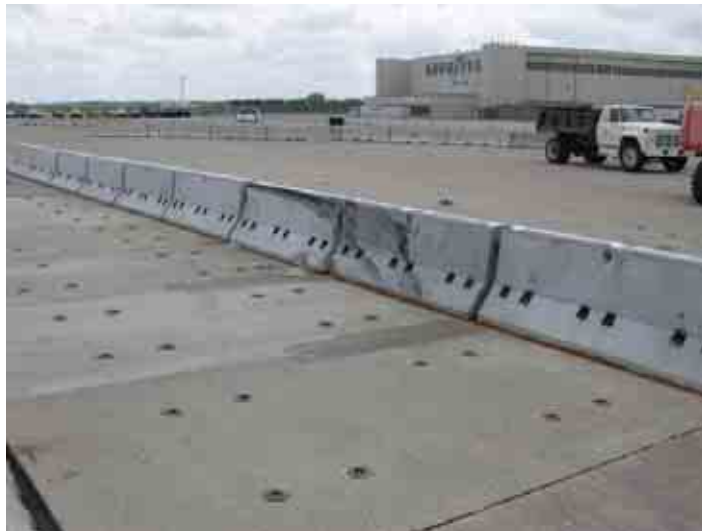
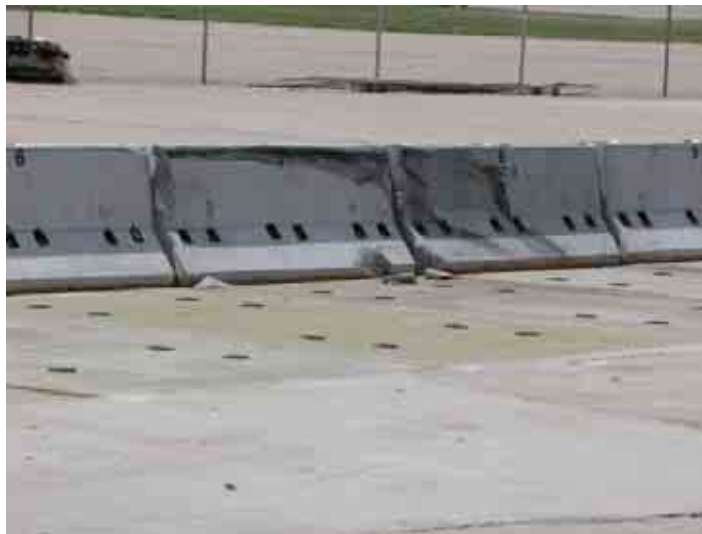
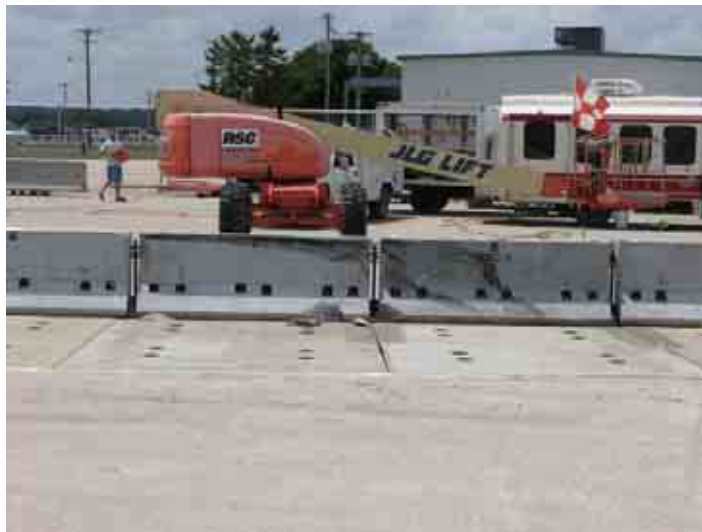
Figure 31. System Damage, Test KSC-1

Damage to the barrier was moderate, as shown in Figures 31 through 41. Barrier damage consisted of contact marks on the front face of the concrete barriers, spalling of the concrete, and concrete cracking and failure. The length of vehicle contact along the barrier was approximately 5.1 m (16.7 ft) which spanned from 1,619 mm (63.75 in.) upstream from the center of the joint between barrier nos. 7 and 8 to the center of barrier no. 6.

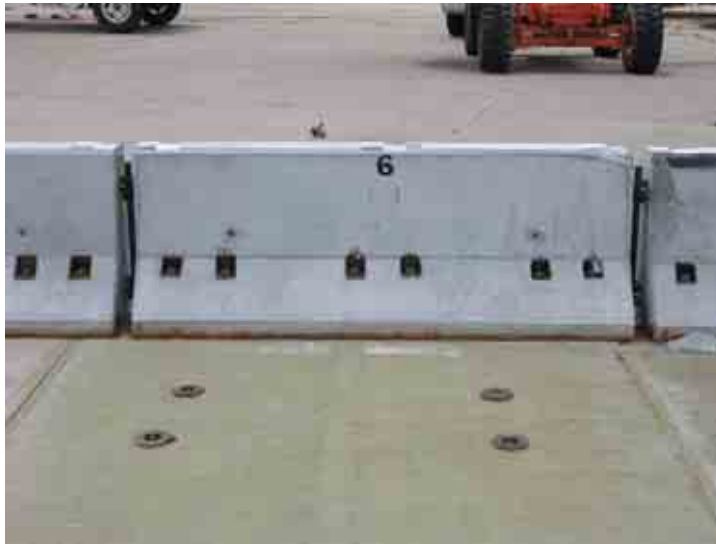
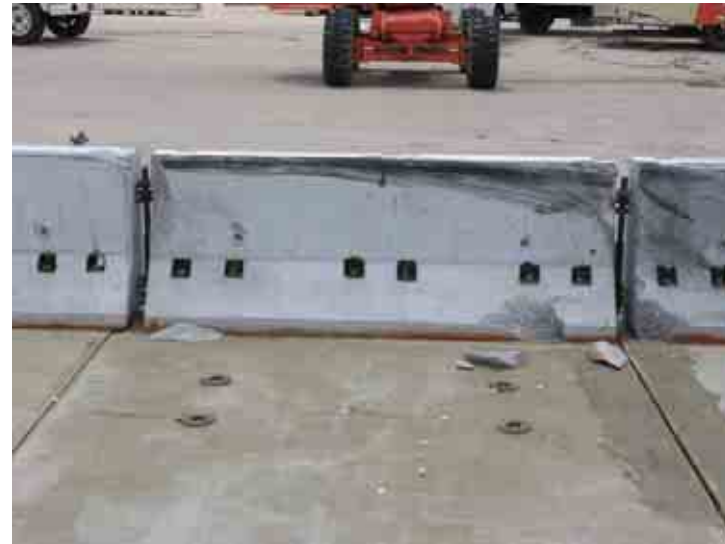
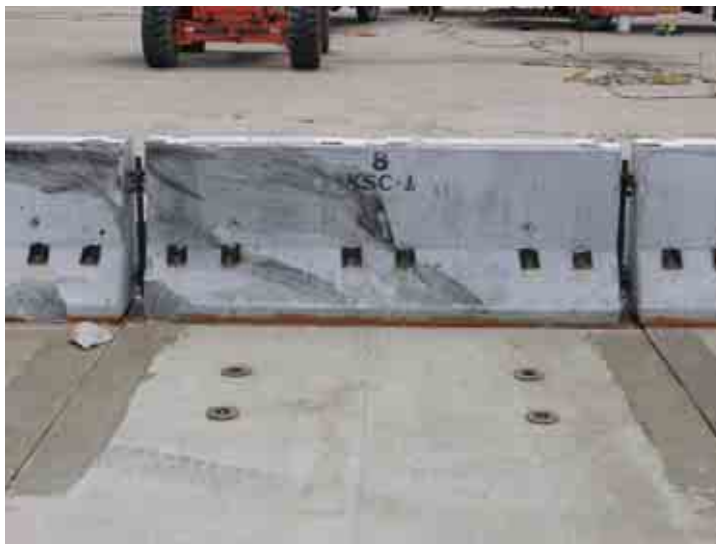
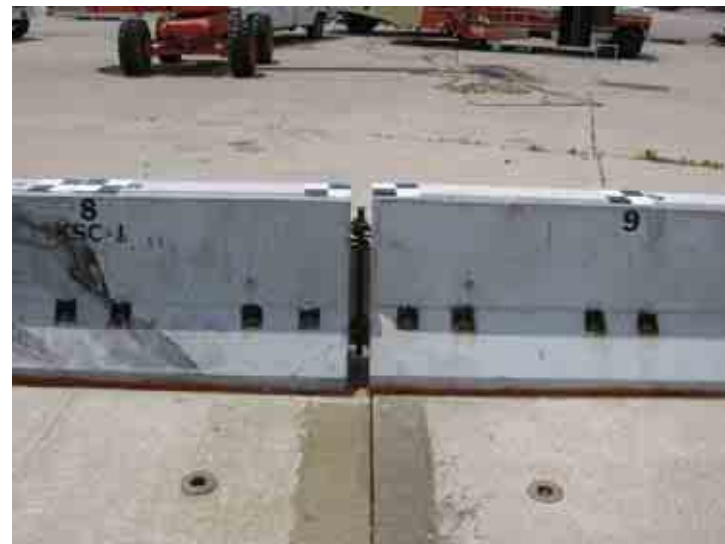
Figure 34. Barrier Nos. 6 through 9 Damage, Test KSC-1

Tire marks were visible on the front face of barrier nos. 7 and 8 and the top edge of barrier no. 6. Concrete failure occurred at both upstream and downstream bottom corners of barrier nos. 6 through 8. A 191-mm (7.5-in.) wide by 254-mm (10-in.) long piece of concrete was removed from the downstream end of barrier no. 8. A 279-mm (11 in.) wide by 216-mm (8.5-in.) long piece of concrete was fractured from the upstream corner of barrier no. 8, but remained attached to the barrier. A 610-mm (24 in.) wide by 229-mm (9-in.) long piece of concrete, beginning 1,270 mm (50 in.) downstream of impact, was removed from the front-bottom face of barrier no. 7. A 121-mm (4.75 in.) wide by 451-mm (17.75-in.) long piece of concrete was removed from the front face of barrier no. 7 at the downstream end. A 229-mm (9.0 in.) wide x 610-mm (24.0 in.) long x 55-mm (2.125 in.) deep piece of concrete was removed from the downstream end of barrier no. 7. A 70-mm

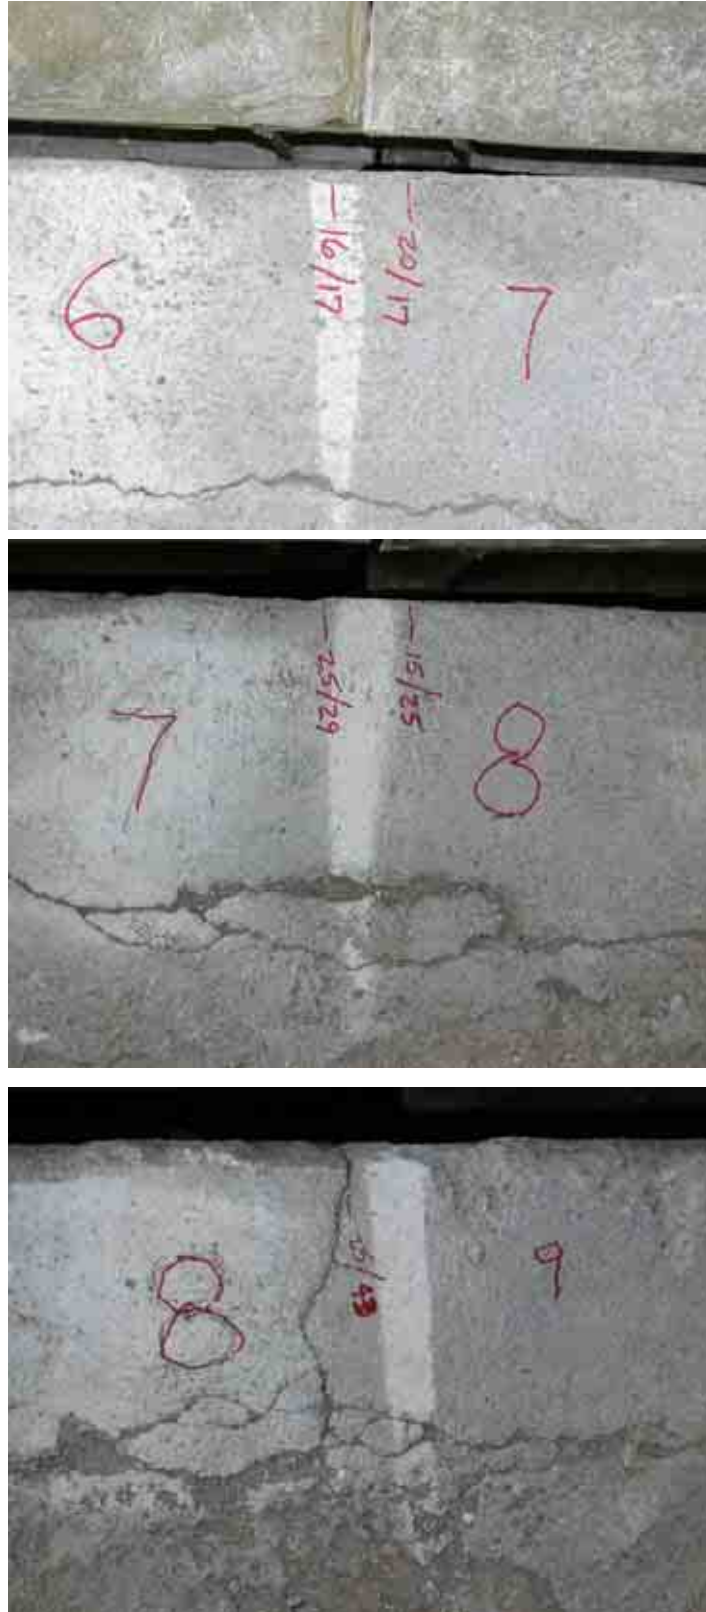
Figure 40. Composite Bridge Deck Damage, Test KSC-1

Composite deck failure did not occur at any of the anchor locations. Photographs of the bridge deck cracking and displacement are shown in Figures 40 and 41. Deck panel nos. 7 through 9 encountered resin coating delaminating and random bubbling of the resin coating. The vertical C-beam of panel no. 9 separated from the top layer of the deck. Panel no. 9 was displaced backward

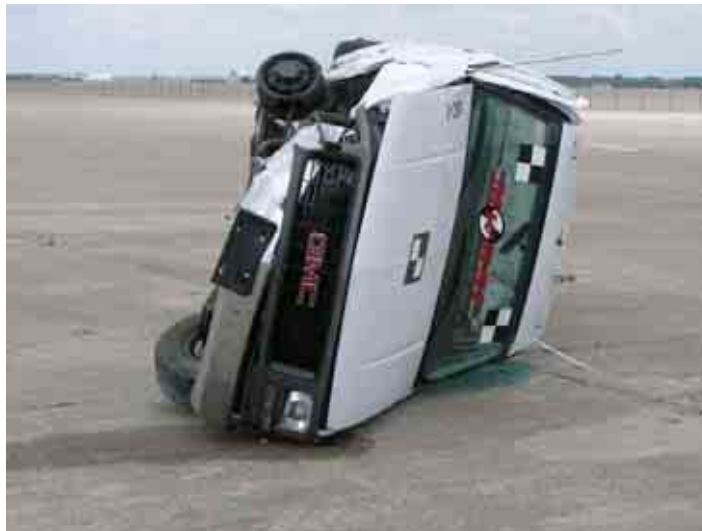
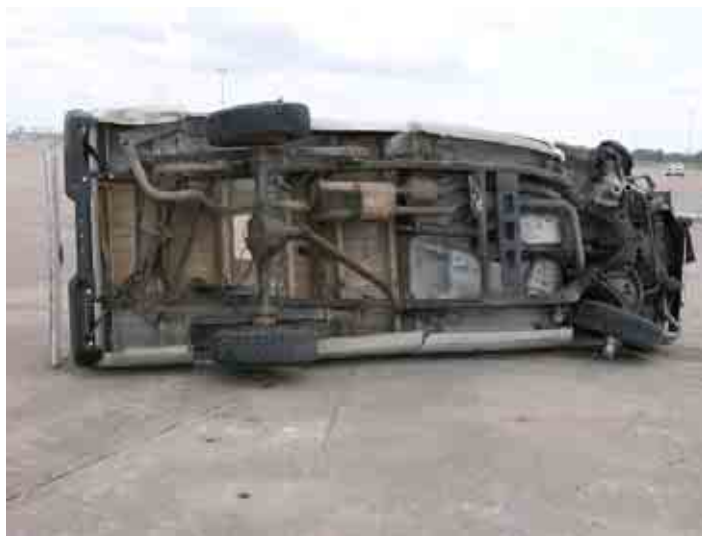
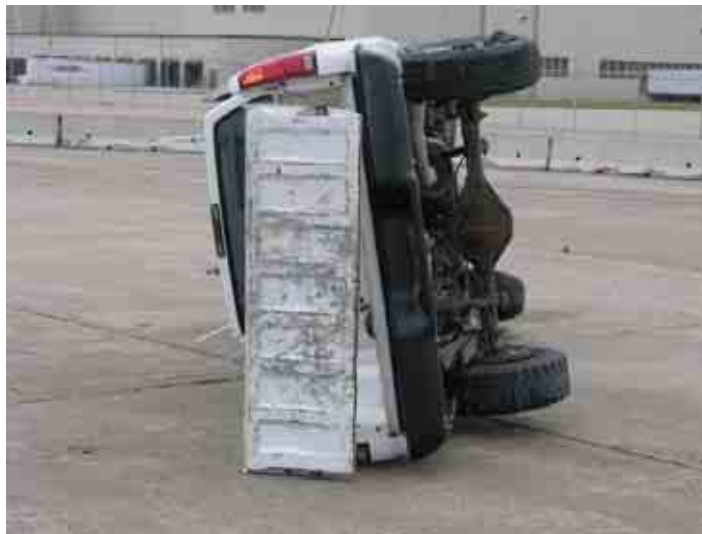
Figure 42. Vehicle Damage, Test KSC-1

Exterior vehicle damage was extensive, as shown in Figures 42 through 46. The majority of the damage was concentrated on the right-front corner and right side of the vehicle where the impact occurred, as well as the left side where the vehicle rolled over. The right-front corner of the vehicle was crushed inward and back, including the fender, bumper, and frame rail. Buckling points were found at the center and the right-front edge of the front bumper. Major frame damage was observed, including fracture of the flange at the right-front box attachment. The lower-right control arm was bent upwards. The right-rear leaf spring bracket was deformed, and the right-rear leaf spring was fractured. The exhaust pipe was bent. The starter housing, starter, and rear axle housing were fractured. The drive shaft disengaged at the yoke. Both right-side and left-side tie rod connections failed with bent and fractured tie rods. The right-front and right-rear steel rims were severely deformed. All four tires encountered scuff and scrape marks. Denting and scraping were observed between the right-front quarter panel and the door. The top of the right-side door was ajar with a 133-mm (5.25-in.) gap. Minor scrapes and dents were also observed on both the right and left sides

of the vehicle due to contact with the barrier and vehicle rollover, respectively. The A-pillar and top of the door frame on the left side were deformed inward. The grill was broken around the right-side headlight assembly. The truck's box twisted and produced an inconsistent gap between the box and cab portions. The hood locking mechanism was deformed. The tailgate hinges fractured, but it remained attached to the vehicle. Minor dents were found at the left-front corner of the roof. The left-side window was shattered and removed, while the left side of the windshield encountered severe cracking. The roof, the box, and remaining window glass remained undamaged.

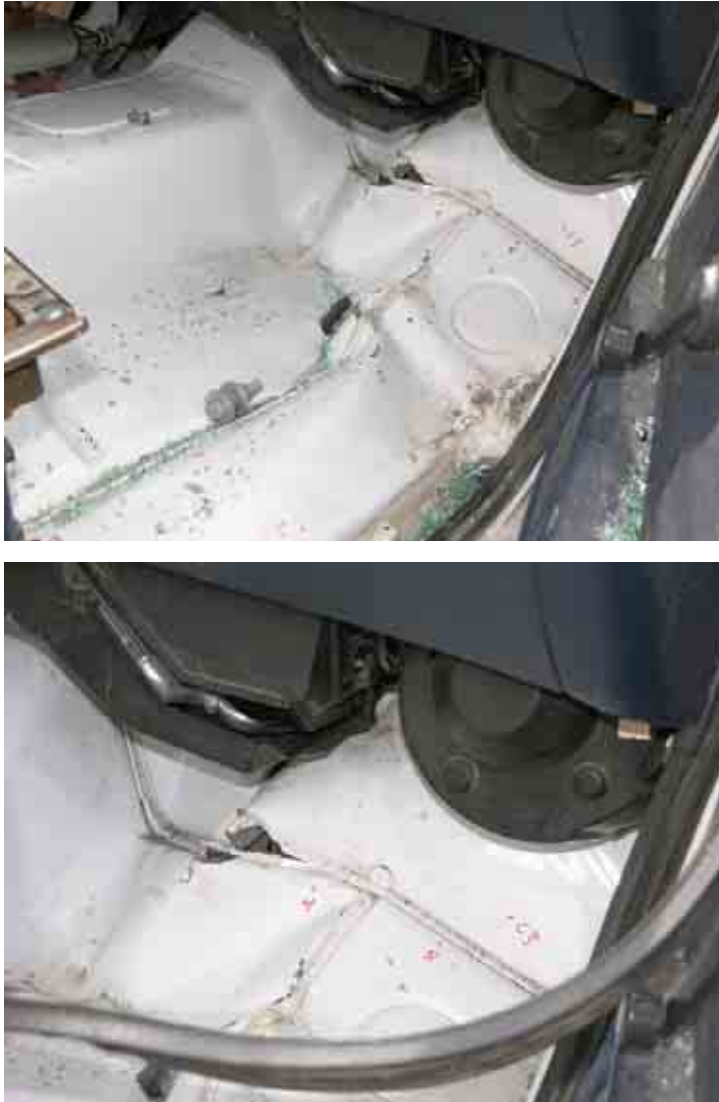
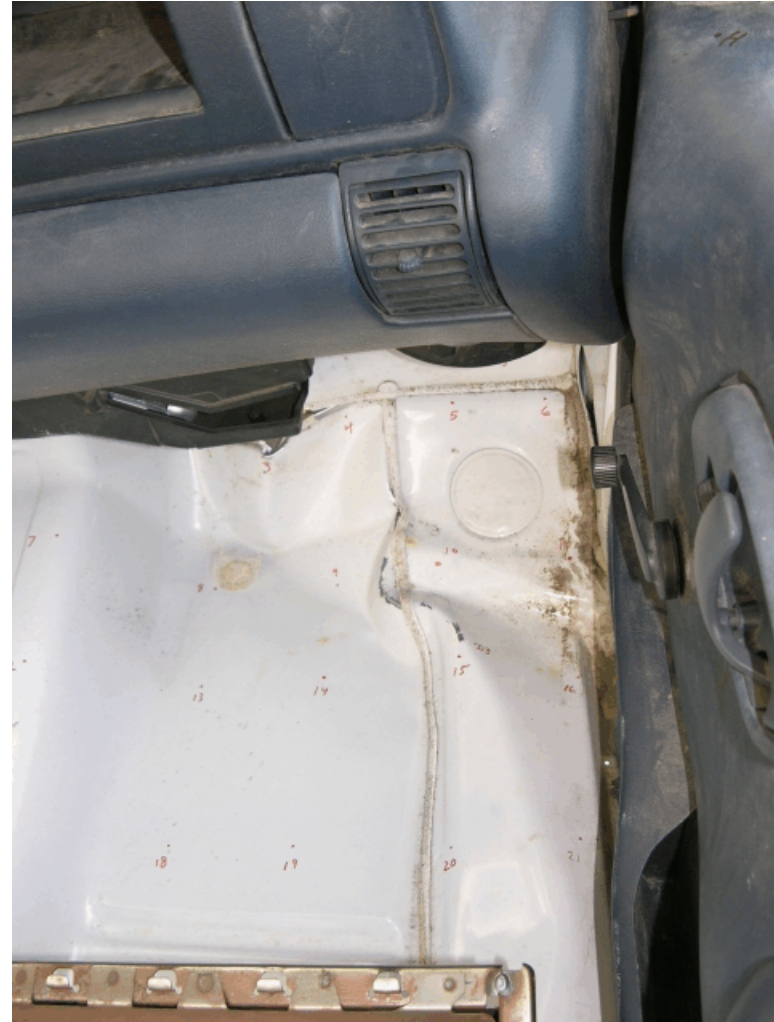
Figure 46. Occupant Compartment Deformations, Test KSC-1

Moderate occupant compartment deformations occurred with deformations to the right-side floor pan and firewall, as shown in Figure 46. A tear in the floorboard occurred at the weld near the front of the right-side floorboard. Occupant compartment deformations and the corresponding locations are provided in Appendix B. Maximum longitudinal deflections of 83 mm (3.25 in.) were located near the center of the right-side firewall. Maximum lateral deflections of 70 mm (2.75 in.) were located near the right-side of the right-side floorboard. Maximum vertical deflections of 32 mm (1.25 in.) were found near the center of the right-side firewall. Maximum dash deflection was found to be approximately 13 mm (0.5 in.).
