EVALUATION OF A NON-PROPRIETARY, HIGH-TENSION, FOUR-CABLE MEDIAN BARRIER ON LEVEL TERRAIN

MIDWEST ROADSIDE SAFETY FACILITY

MwRSF Research Report No. TRP-03-258-12

November 29, 2012

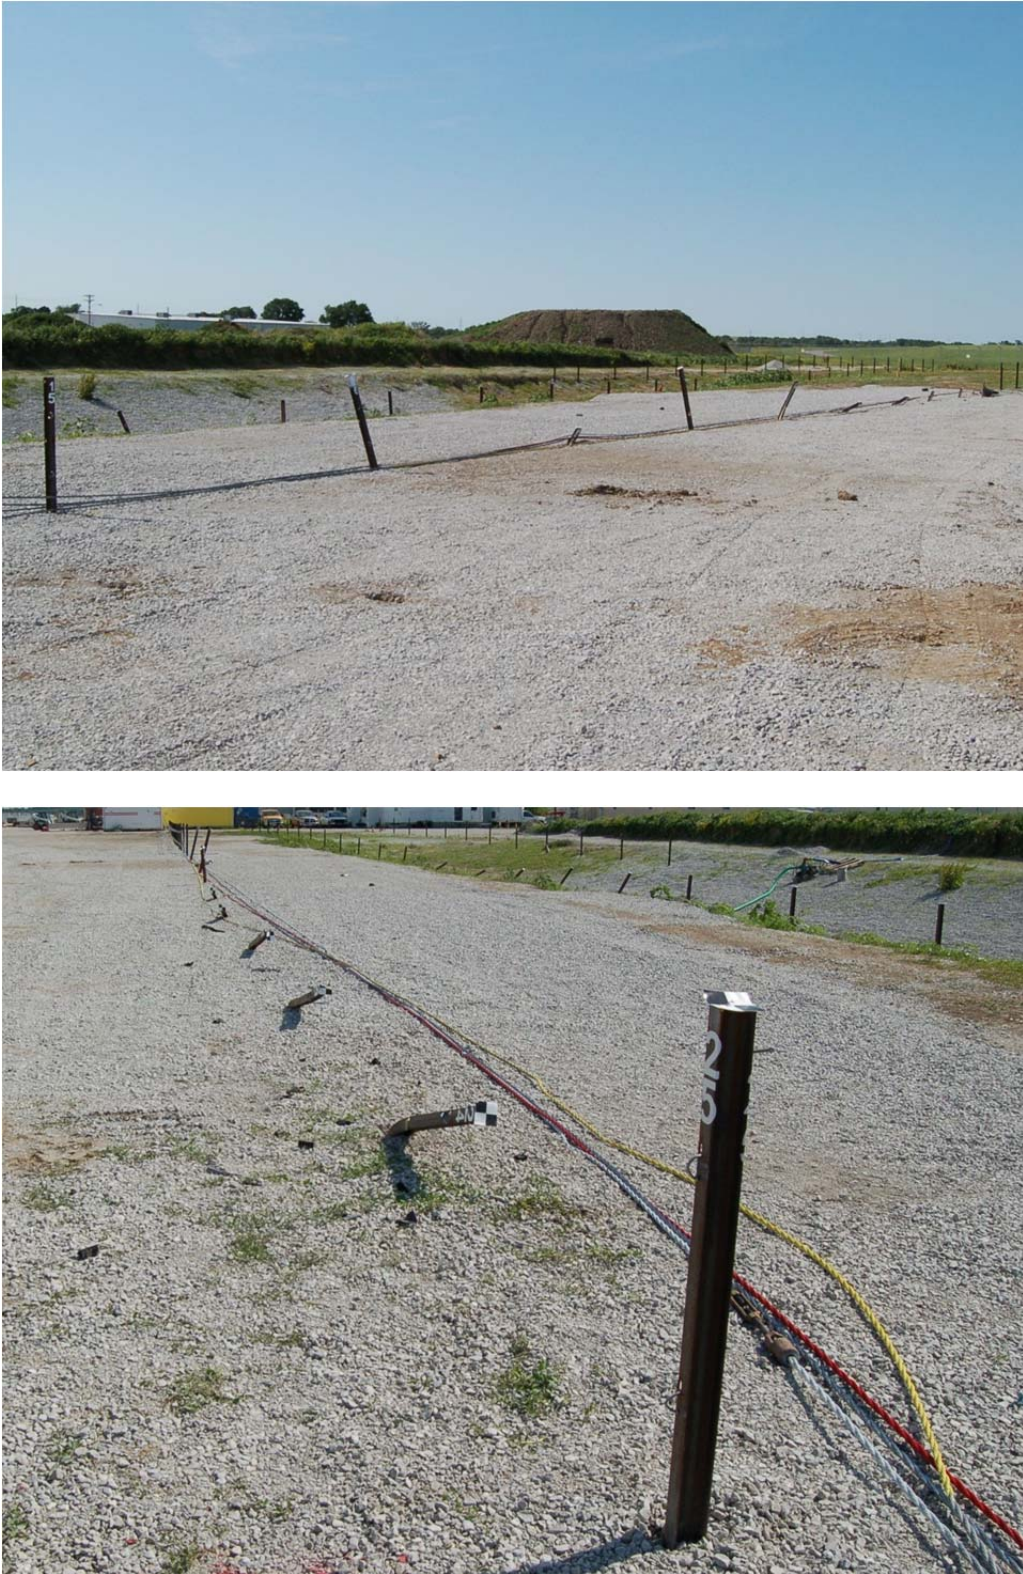
Figure 36. System Damage, Test No. 4CMBLT-1

Damage to the barrier was moderate, as shown in Figures 36 through 49. Barrier damage consisted of detached cables and bent and rotated posts. The length of vehicle contact along the barrier was approximately 123 ft (37.5 m), which spanned from 5 ft – 4 in. (1.6 m) upstream

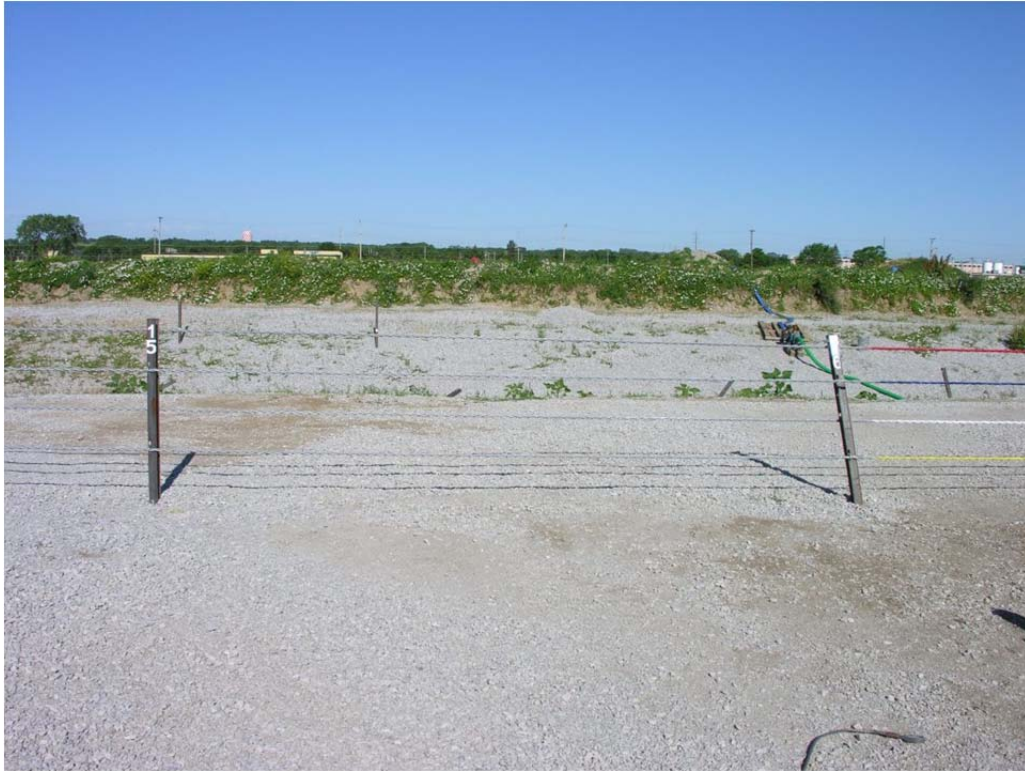
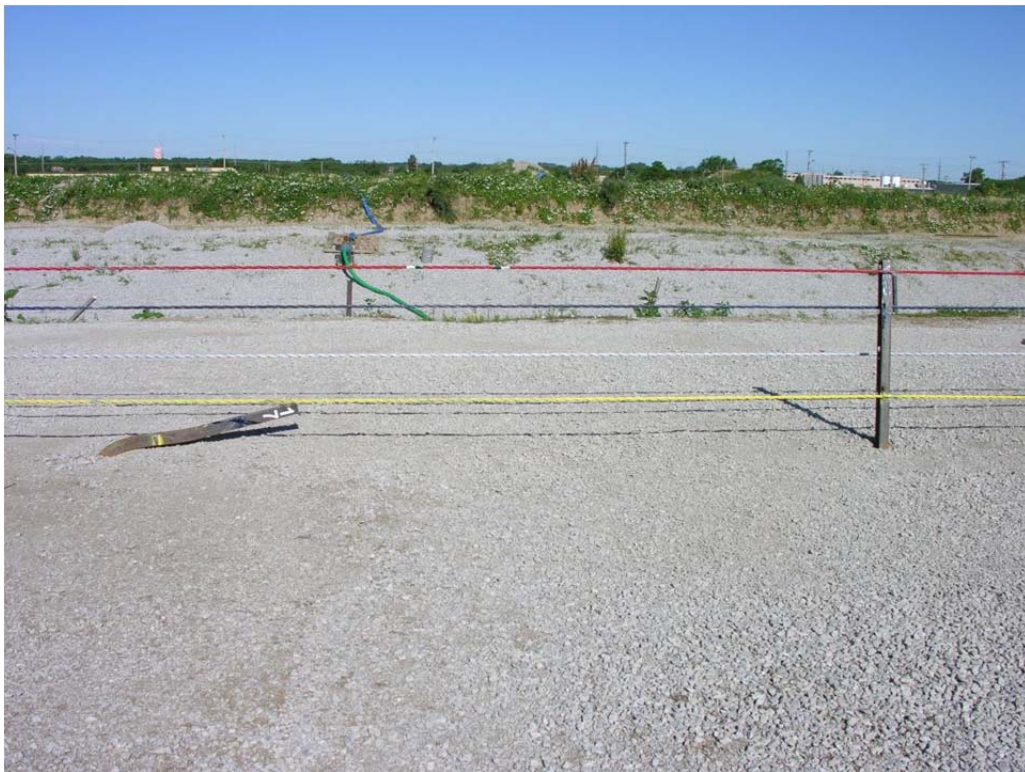
Figure 37. Post Nos. 15 through 18 System Damage, Test No. 4CMBLT-1

The button head of cable no. 2 keyway bolt on post no. 16 released from the keyway, but the bolt remained attached to the post. The button head of cable nos. 1 and 2 keyway bolts on post no. 17 released from the keyway and deformed. The keyway bolt for cable no. 3 on post no. 17 fractured through the shank, while the keyway bolt for cable no. 4 fractured through the threads and disengaged. The button head of the keyway bolts for cable nos. 1 and 2 on post nos. 18 and 19 disengaged from the keyway and deformed. Cable no. 3 keyway bolt on post nos. 18 and 19 disengaged. The keyway bolts for cable nos. 1 and 2 on post no. 20 released from the keyway and deformed, the keyway bolt for cable no. 3 fractured through the threads, and the keyway bolt for cable no. 4 disengaged. The keyway bolts for cable nos. 1, 2, and 3 on post nos. 21 and 23 disengaged and deformed, and the keyway bolt for cable no. 4 disengaged. Keyway bolts for cable nos. 1 and 4 on post no. 22 fractured through the shank. The keyway bolt for cable no. 2 on post no. 22 disengaged and flattened, while the keyway bolt for cable no. 3 disengaged. The keyway bolts for cable nos. 1 and 2 on post no. 24 disengaged and flattened, while the keyway bolts for cable nos. 3 and 4 on post no. 24 disengaged. The keyway bolt for cable no. 1 on post no. 25 disengaged and flattened, while the keyway bolt for cable no. 2 on post no. 25 pushed upward and began to disengage.

The maximum permanent set of the post was 20¼ in. (514 mm), which occurred at post no. 17, as measured in the field. The maximum lateral dynamic deflection of the post and rail was 24.0 in. (610 mm) and 94.5 in. (2,400 mm), respectively, at post no. 20 as determined from high-speed digital video analysis. The working width of the system was found to be 111.2 in. (2,824 mm), also determined from high-speed digital video analysis.

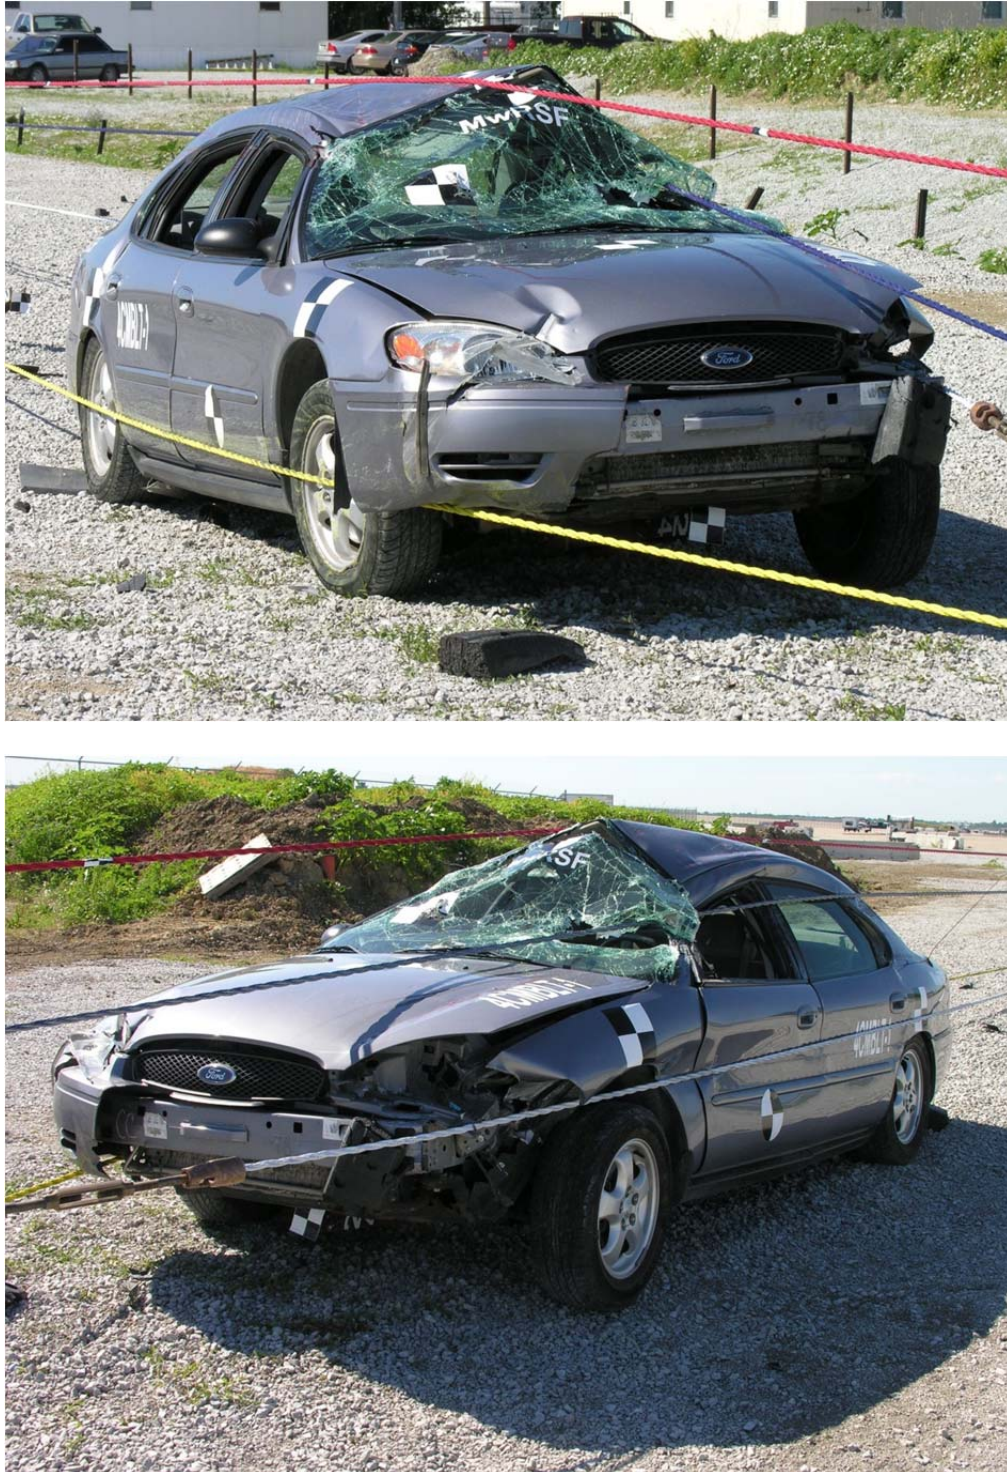
Figure 50. Vehicle Damage, Test No. 4CMBLT-1

The damage to the vehicle was extensive, as shown in Figures 50 through 52. The maximum occupant compartment deformations are listed in Table 7 along with the deformation limits established in MASH for various areas of the occupant compartment. Complete occupant compartment and vehicle deformations and the corresponding locations are provided in Appendix D.

The damage to the vehicle was concentrated on the left-front corner with substantial damage to the sides and roof of the vehicle. The windshield experienced extensive damage with spider-web cracking throughout. The windshield disengaged from the roof near the middle of the vehicle spanning approximately 16 in. (406 mm). A 6-in. vertical by 15-in. horizontal (152-mm by 381-mm) tear occurred to the bottom left corner of the windshield where cable no. 2 laid on the vehicle. The front bumper cover fractured and disengaged, except for an 18-in. (457-mm) segment attached to the right-front corner. Foam from the front bumper disengaged and came to rest 127 ft (38.7 m) downstream and 3 ft (0.9 m) in front of the impact location. The left side of the engine hood sustained contact marks from cable nos. 1 and 2.

The left-front headlight disengaged and came to rest 129 ft (39.3 m) downstream and 57 ft (17.4 m) behind the impact location. The left-front quarter panel folded behind itself and encountered a 4-in. (102-mm) long tear. The left-front wheel well liner sustained a 12-in. (305-mm) long tear. The left-front steel rim encountered contact marks from cable nos. 3 and 4. A gouge was found along the entire left side with cable no. 3 in contact with the left side of the vehicle. Contact marks from the cable no. 2 were located on the left-side A-pillar, the left-side B-pillar, the left-rear door window, and the left-side C-pillar. The left-side A-pillar was crushed inward and the left-side C-pillar was flattened. The left-side mirror disengaged from the vehicle. The left-side of the roof was kinked above the B-pillar. The left-front and left-rear window glass were shattered. The left-rear door panel bowed away from the window, and the bottom of the door bent outward. Contact marks from cable no. 3 were found on the left-rear tire and the left portion of the rear bumper cover.

After reviewing the high-speed video of test no. 4CMBLT-1, it was determined that the excessive damage to the roof, windshield, and A-pillar was caused by cable no. 2. While the vehicle was redirecting, this cable was in contact with the A-pillar and did not slide up and over the top of the vehicle as anticipated. The cable also did not release away from post no. 18 (the second post downstream from initial impact) as early as predicted. These two phenomena

resulted in a high lateral load being imparted to the vehicle's A-pillar, which eventually caused it to crush along with the windshield and roof.

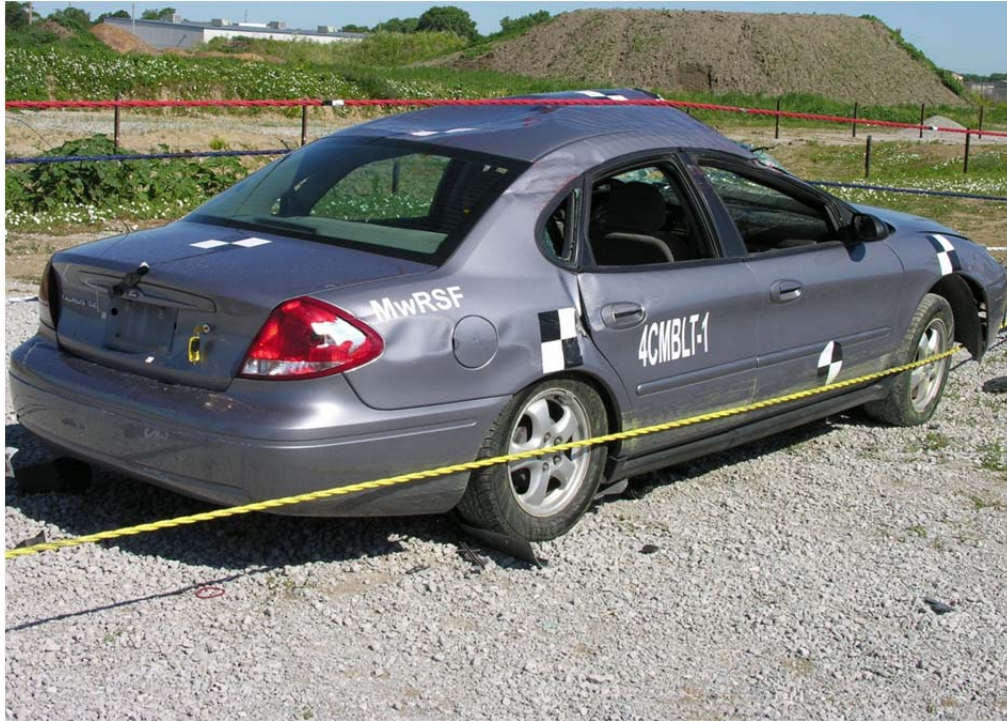
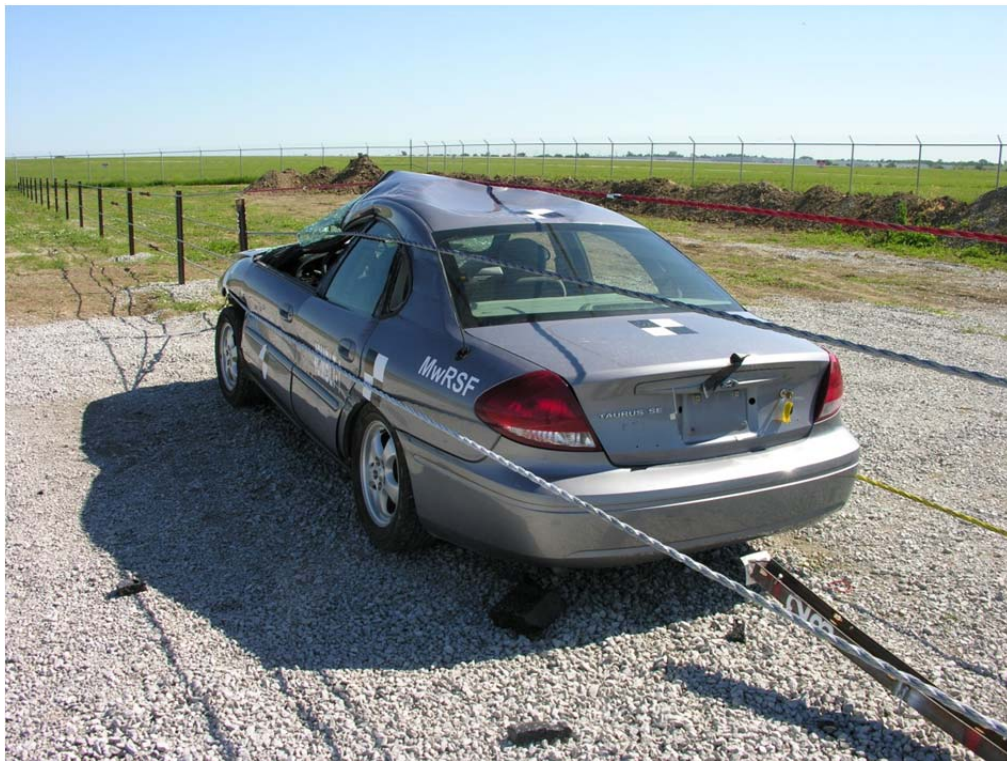
Figure 51. Vehicle Damage, Test No. 4CMBLT-1

The right-rear tail light shattered. The right-rear quarter panel encountered contact marks from cable no. 4, 2- and 3-in. (51- and 76-mm) diameter dents, and folding near the right-rear door. Contact marks from cable no. 4 and a 2-in. (51-mm) diameter dent were found on the right-rear door. The right-front, and rear, windows were shattered. Contact marks from cable no. 4 were found on the right-rear tire. Contact marks from cable no. 1 were found on the right-side A-pillar, B-pillar, and C-pillar. The right-side A-pillar was crushed inward. Contact marks from cable no. 4 extended the length of the right side of the vehicle. The right-front steel rim sustained contact marks from cable no. 4 and 4-in (102-mm) gouge. The right-front wheel well liner was partially disengaged. The right-front bumper cover bent and sustained a 5- and 8-in. (127- and 203-mm) tear. The right-front headlight cracked. The right-front corner of the hood kinked above the right-front headlight. The entire roof sustained contact marks from cable no. 1, and it buckled upward at the midpoint of the windshield. The right-side of the roof bent downward from the front to approximately the B-pillar. A 2.5-ft (0.8-m) diameter dent was located near the right-side of the roof. A 2-in. (51-mm) long tear with an 8-in. (203-mm) crease was found in the left-side floor pan.

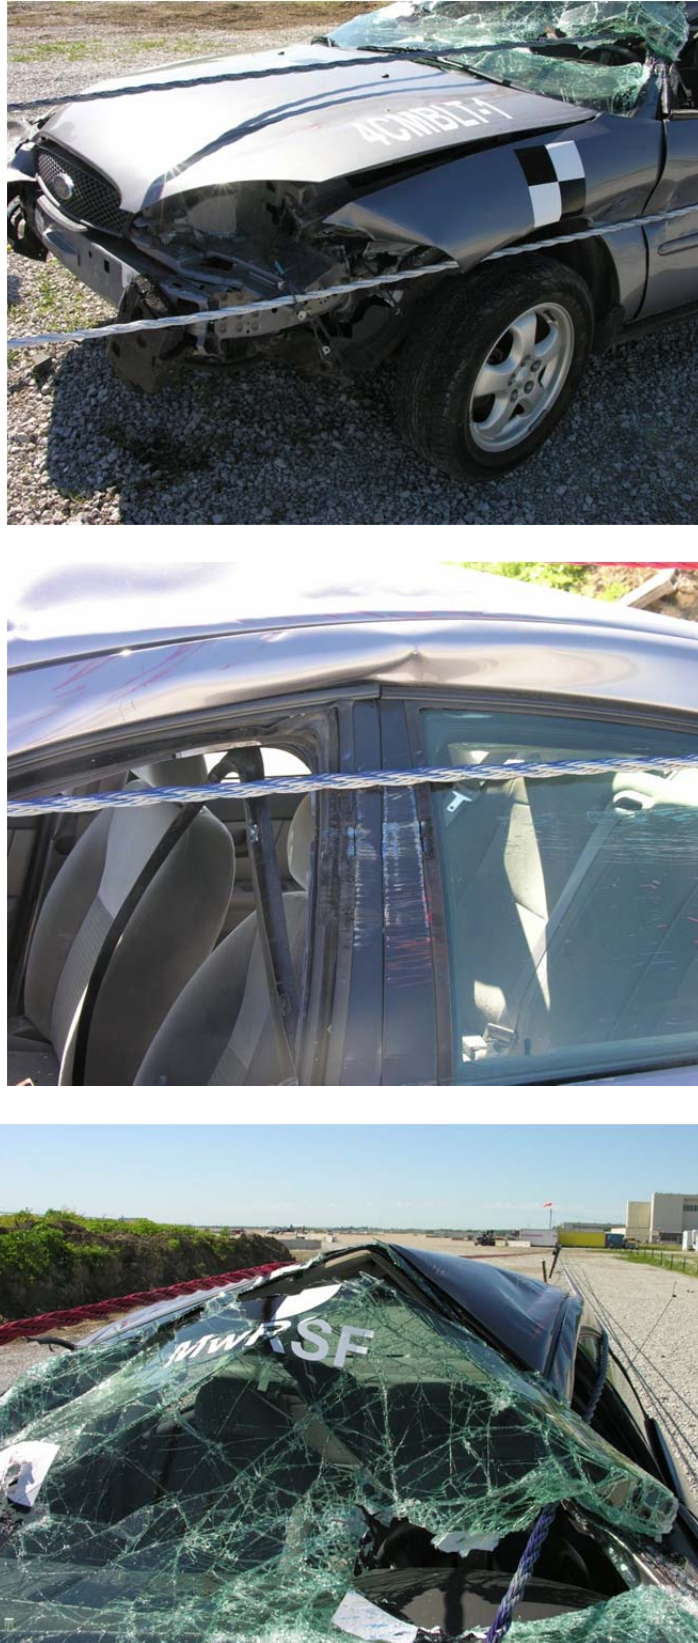
Figure 52. Vehicle Damage, Test No. 4CMBLT-1

Deformation to the roof was not measured post-test because a suitable reference point was unavailable due to the damage sustained. It was believed that the maximum deformation
