**PERFORMANCE EVALUATION OF THE  
MODIFIED G4(1S) GUARDRAIL – UPDATE TO  
NCHRP 350 TEST NO. 3-11 WITH 28" C.G.  
HEIGHT (2214WB-2)**

**MIDWEST ROADSIDE SAFETY FACILITY**

MwRSF Research Report No. TRP-03-169-06

October 9, 2006

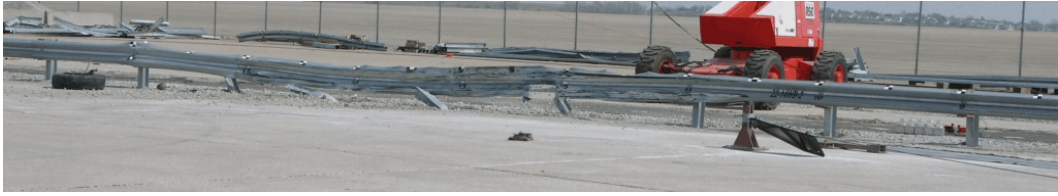
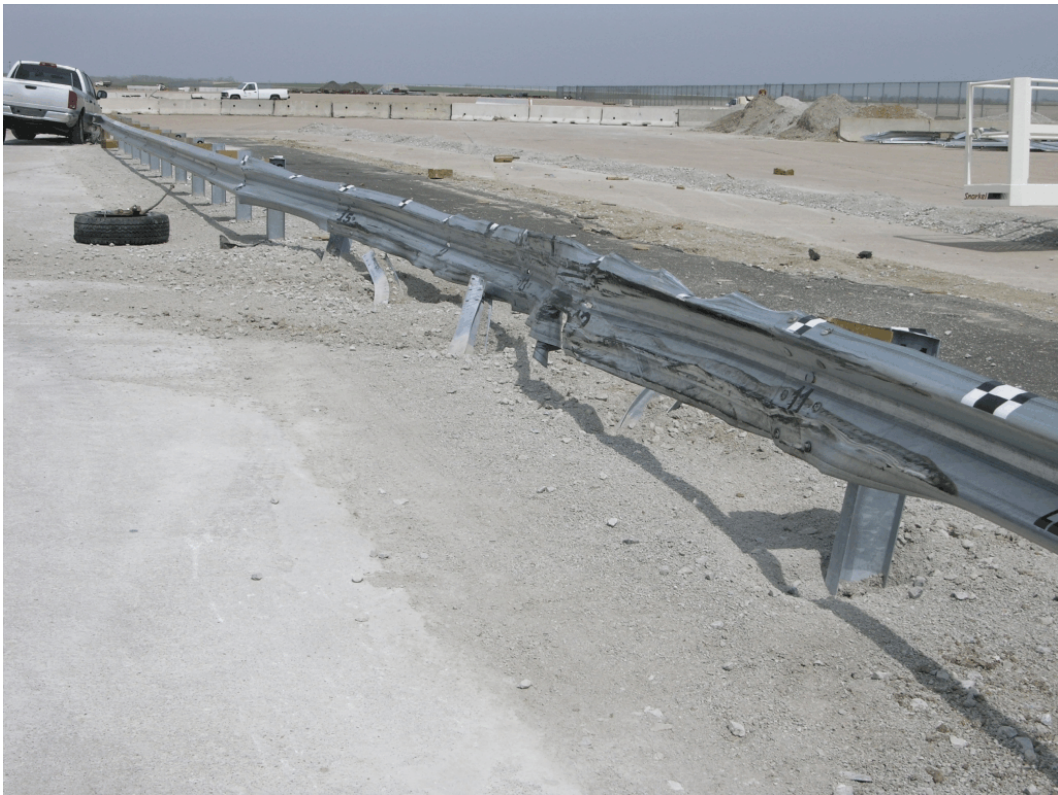
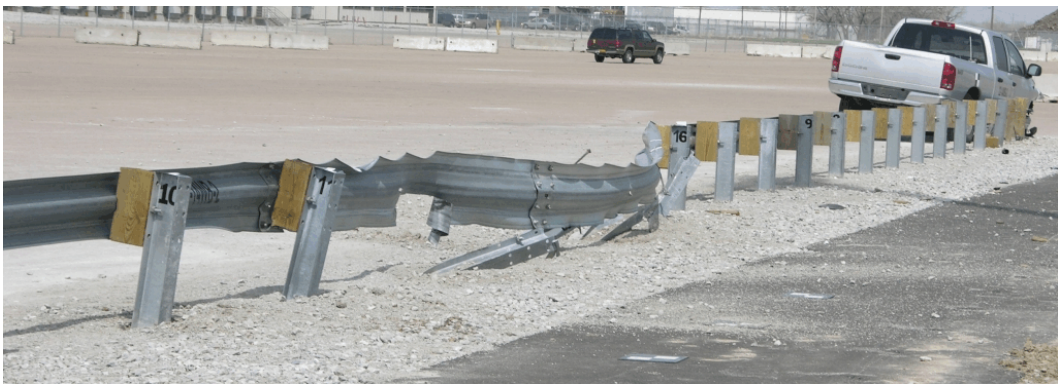
Figure 23. Standard Strong-Post, WoodBlockout, W-beam Guardrail System Damage, Test 2214WB-2

Damage to the barrier was moderate, as shown in Figures 23 through 27. Barrier damage consisted of deformed guardrail posts, disengaged wooden blockouts, contact marks on a guardrail section, and deformed and torn W-beam rail. The length of vehicle contact along the W-beam guardrail system was approximately 10.5 m (34.5 ft), which spanned from 940 mm (39 in.) upstream from the centerline of post no. 11 through the centerline of post no. 16.

marks were found on the guardrail between post nos. 10 and 16. The guardrail buckled 279 mm (11 in.) upstream of post no. 15 and at post no. 16. A 495-mm (19.5-in.) long tear was found in the lower corrugation beginning 76 mm (3 in.) downstream of post no. 12. The W-beam was pulled off of post nos. 3, 6, and 12 through 15. Due to the secondary impact after vehicle exit and redirection, the W-beam rail was flattened between post nos. 26 and 29.

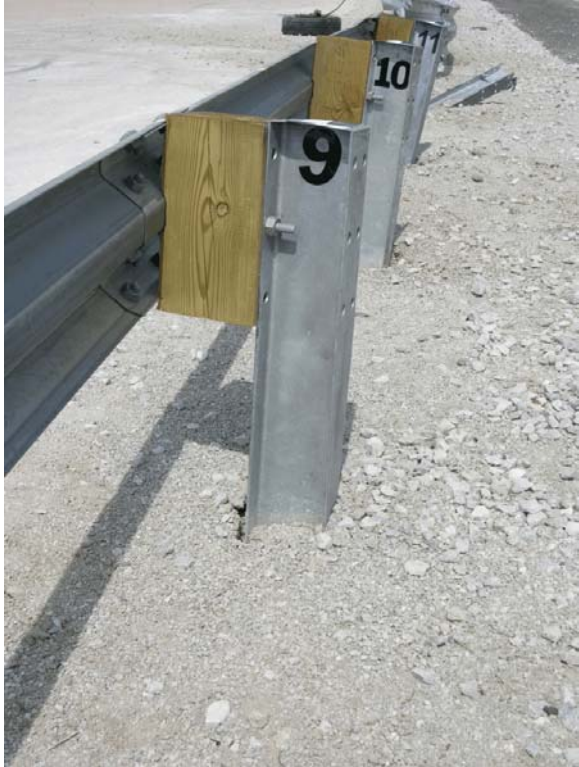
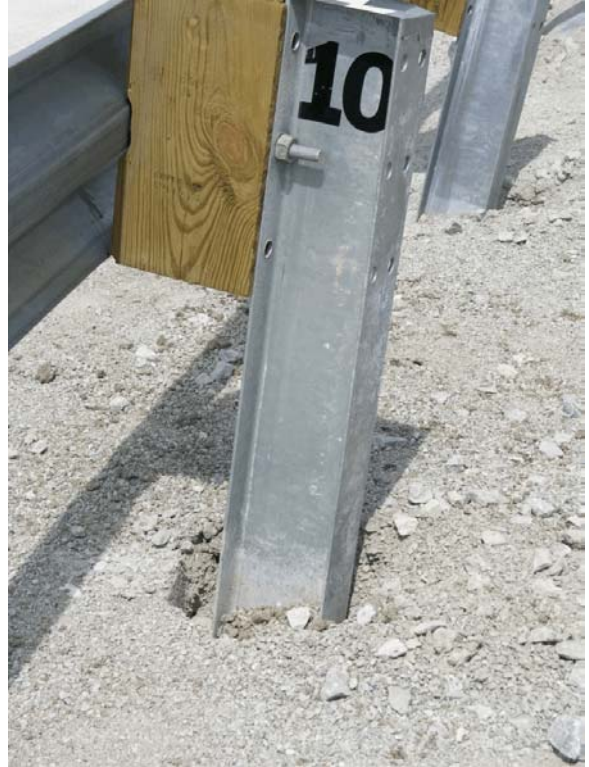
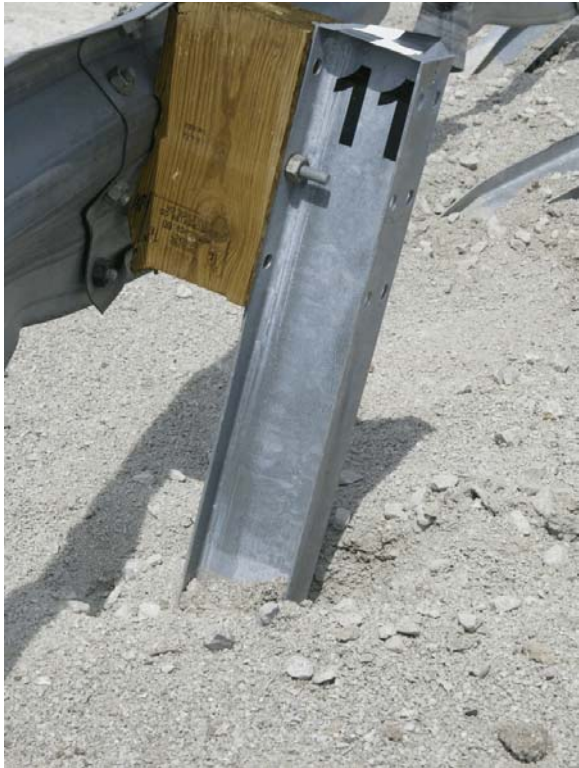
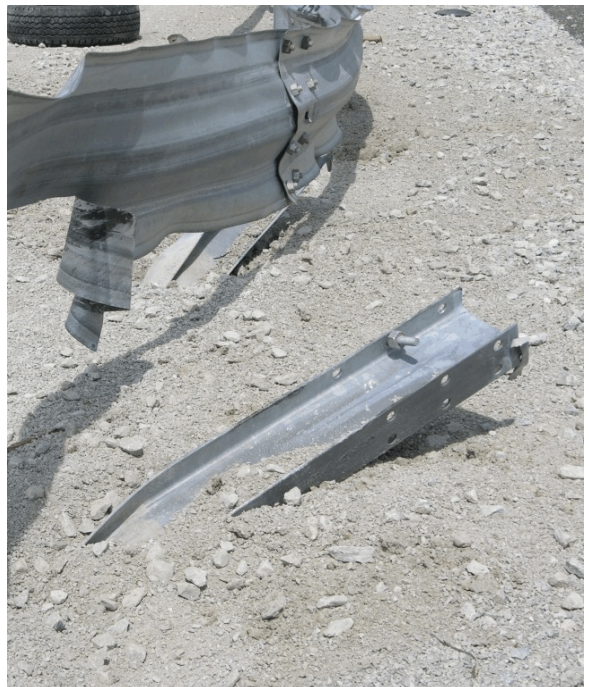
Figure 25. Post Nos. 9 through 12 Damage, Test 2214WB-2

Steel post nos. 3 through 9 encountered minor twisting. Post nos. 10 and 11 rotated backward and twisted. Post no. 12 through 15 encountered significant twisting and were bent longitudinally downstream to the ground. Tire contact marks were found on the front flange of post no. 12, the upstream edge of both the front and back flanges of post no. 13, and the upstream edge of the back flange of post no. 14. Post no. 14 also encountered severe chipping in the galvanization on the upstream edge of the front flange of the post. The upstream edge of the front flange of post no. 15 buckled 305 mm (12 in.) from the top. The post bolt for post no. 15 tore through the hole in the post's flange. Post no. 16 rotated backward slightly. The upstream anchorage system slightly moved longitudinally, however the posts in the anchorage system were not damaged. Due to the secondary impact after vehicle exit and redirection, post no. 27 deflected back ward and the downstream anchorage system shifted backward slightly with post no. 28 partially fractured at the breakaway hole. The wooden blockout at post nos. 12 through 15 were fractured and disengaged from the posts.

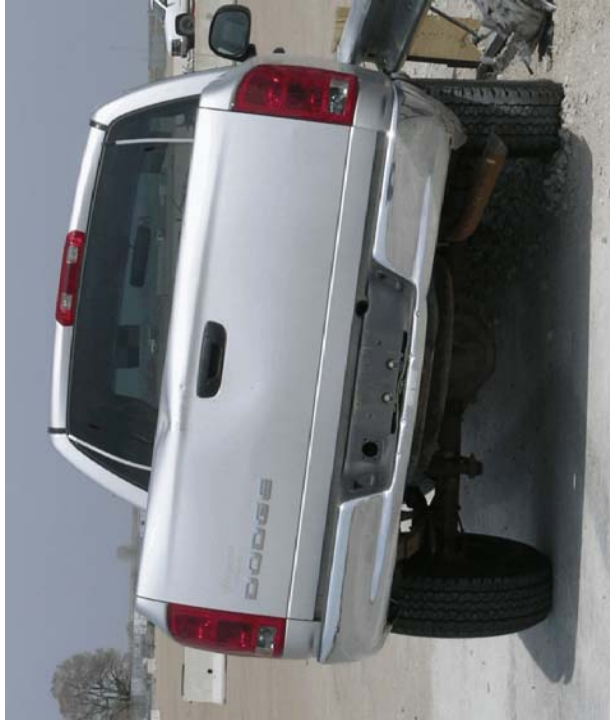
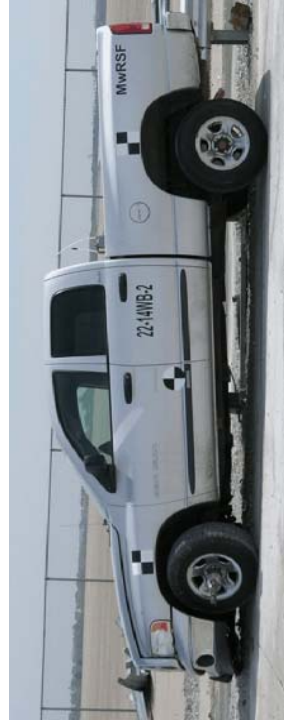
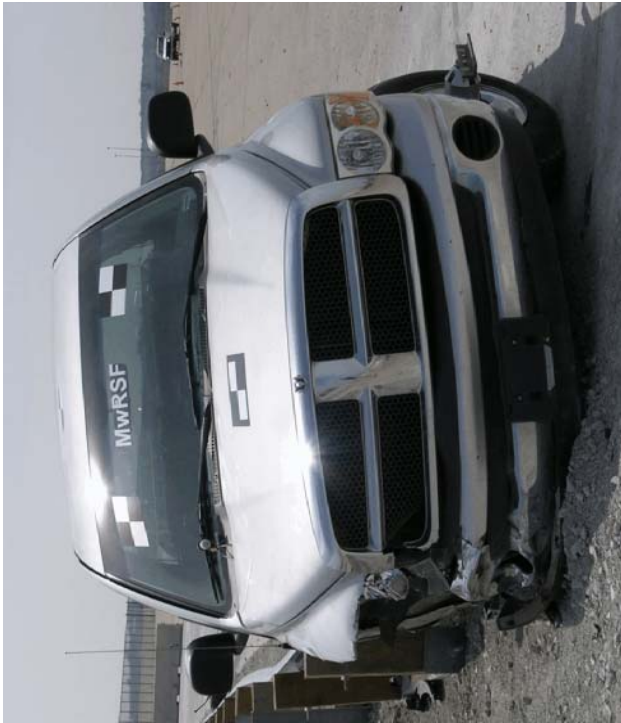
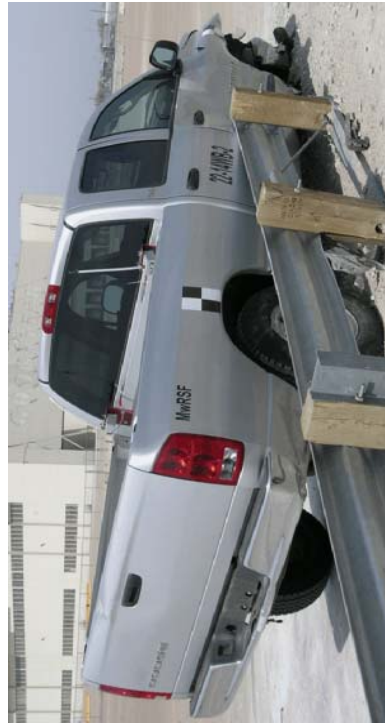
Figure 28. Vehicle Damage, Test 2214WB-2

Exterior vehicle damage was moderate, as shown in Figures 28 and 29. Occupant compartment deformations to the right side and center of the floorboard were judged insufficient to cause serious injury to the vehicle occupants. Maximum longitudinal deflections of 13 mm (0.5 in.) were located near the left side of the right side of the floorboard. Maximum lateral deflections of 13 mm (0.5 in.) were located near the right-front corner of the right-side floor pan and the center of the right side of the floorboard. Maximum vertical deflections of 6 mm (0.25 in.) were located throughout the right side of the floorboard. Complete occupant compartment deformations and the corresponding locations are provided in Appendix C.

Damage was concentrated on the right-front corner of the vehicle. The right-front quarter panel was deformed inward and upward toward the engine compartment. The right side of the front bumper was bent back toward the engine compartment. The both right-side doors encountered deformations and flattening of sheet metal. Contact marks from vehicle-rail interlock were observed along the entire right side of the vehicle. The right-rear quarter panel was deformed inward and away from the bumper. The right side of the rear bumper was dented. The top of the right-front door was ajar. The right side of the grill was fractured. The right-side tail light cover was deformed away from the vehicle. The exhaust pipe was dented and deformed. The right-front wheel assembly deformed and crushed inward toward the engine compartment. The right-side sway bar and lower control arm connection along with the right-front tire disengaged from the rest of the wheel assembly. The right-
