PERFORMANCE EVALUATION OF THE MODIFIED G4(1S) GUARDRAIL – UPDATE TO NCHRP 350 TEST NO. 3-11 (2214WB-1)

MwRSF Research Report No. TRP-03-168-06

October 6, 2006

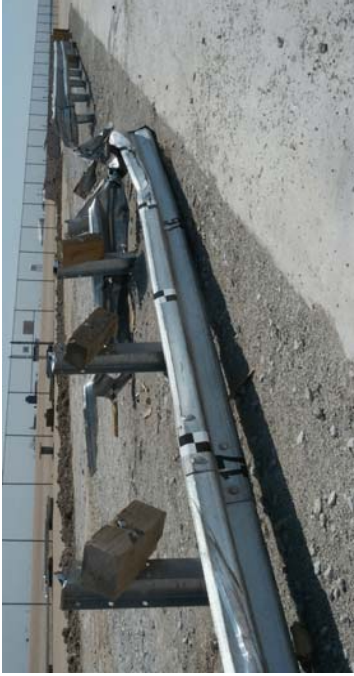
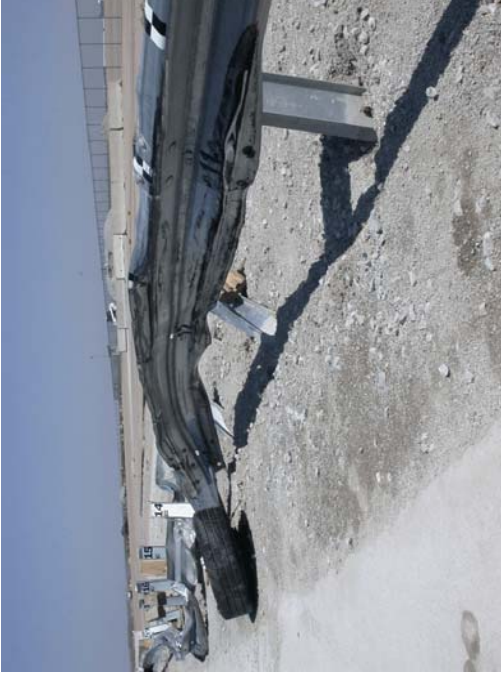
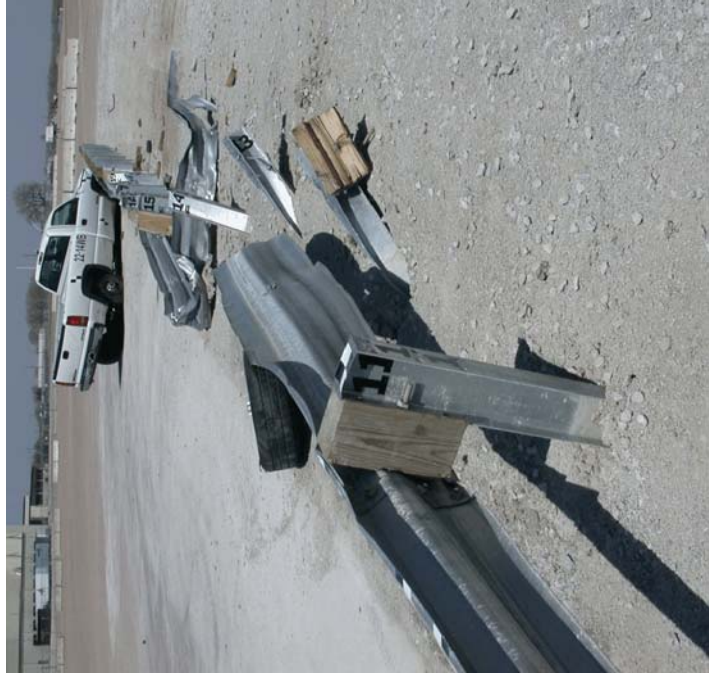
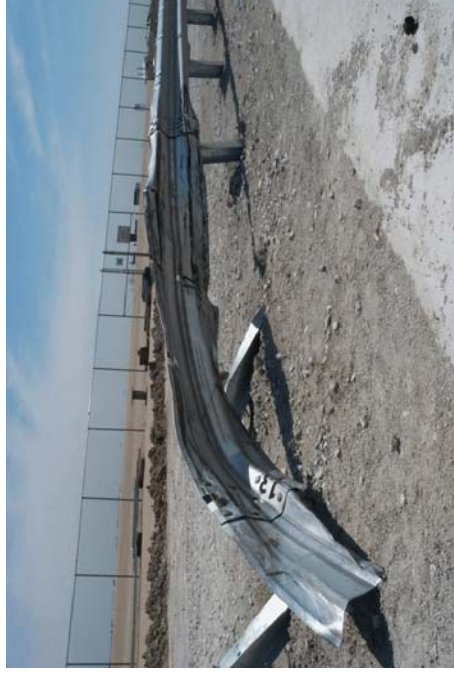
Figure 23. Standard Strong-Post, Wood-Blockout, W-beam Guardrail System Damage, Test 2214WB-1

Damage to the barrier was extensive, as shown in Figures 23 through 27. Barrier damage consisted of deformed guardrail posts, disengaged wooden blockouts, contact marks on a guardrail section, and deformed and fractured W-beam rail. The length of vehicle contact along the W-beam guardrail system was approximately 18.4 m (60.4 ft), which spanned from 1,143 mm (45 in.) downstream from the centerline of post no. 10 through 508 mm (20 in.) downstream from the centerline of post no. 20.

The failure of the W-beam splice at post no. 13 caused significant damage to the posts and the guardrail located downstream. Moderated deformation and flattening of the impacted section of W-beam rail occurred between post nos. 11 and 14. The top corrugation in the rail was deformed downward between post nos. 17 and 19. Contact marks were found on the guardrail between post nos. 10 and 19. The guardrail buckled at post no. 10 and 508 mm (20 in.) downstream of post no. 20. A gouge was found in the lower corrugation at 635 mm (25 in.) upstream of post no. 13 and in the upper corrugation at 203 mm (8 in.) downstream of post no. 14. A small tear was found in the

top corrugation 686 mm (27 in.) downstream of post no. 19. The W-beam guardrail was torn through the cross section, beginning at the bottom downstream splice bolt at post no. 13, propagating through the rail section between post nos. 13 and 14, and ending at the top of the W-beam rail 737 mm (29 in.) downstream from post no. 13. A partial tear, measuring 381 mm (15 in.) long, was found near the midspan between post nos. 13 and 14. The W-beam was pulled off of post nos. 14 through 18 and 20. The W-beam rail sustained significant yielding around the post bolt slots at pos nos. 14 through 20.

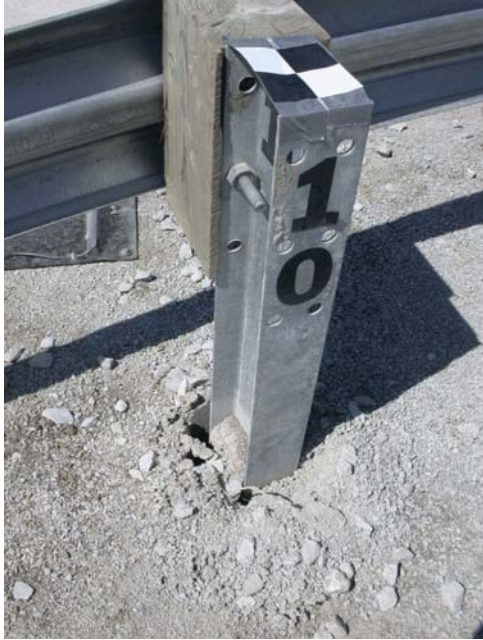
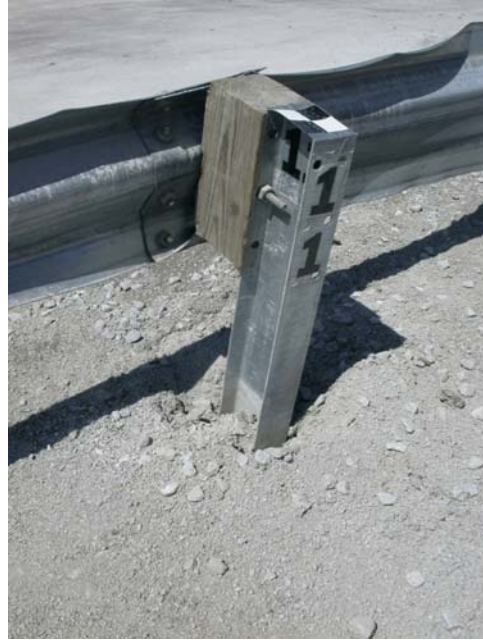
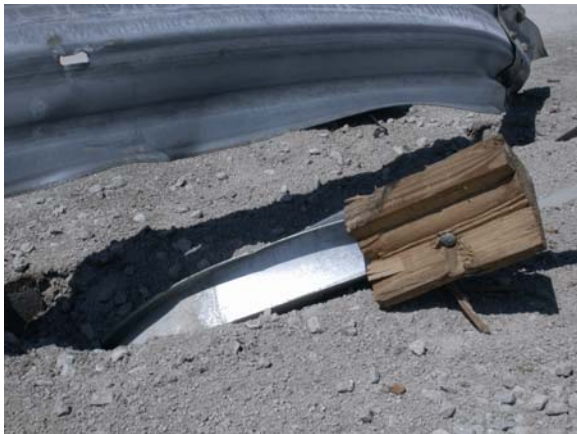
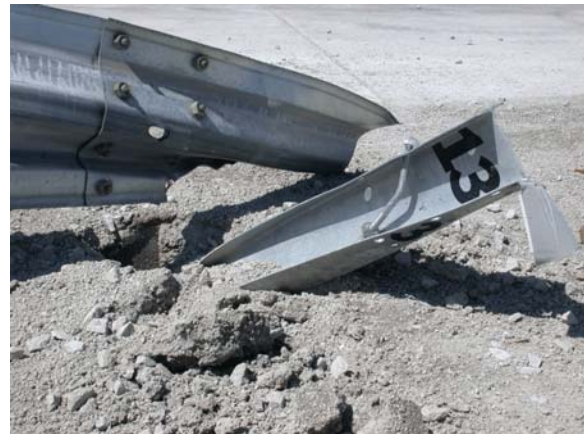
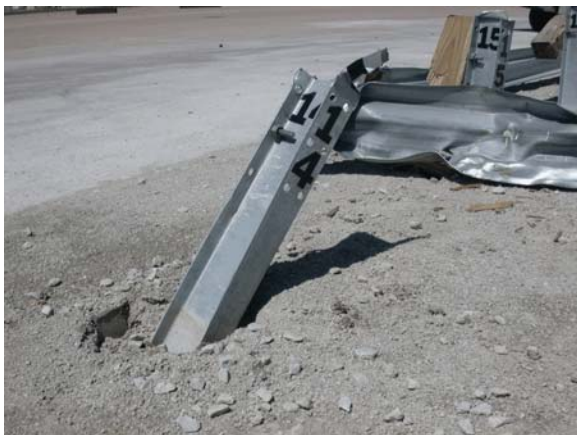
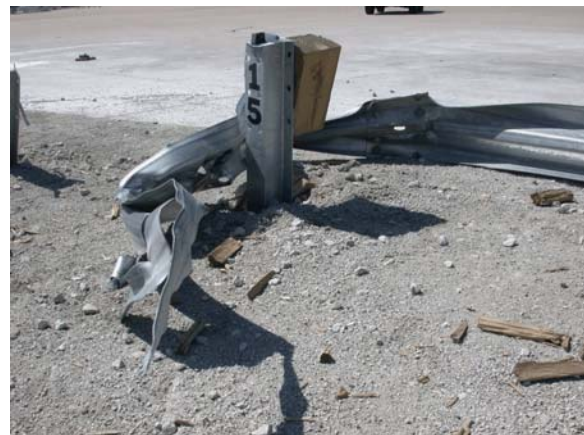
Figure 26. Post Nos. 10 through 15 Damage, Test 2214WB-1

The wooden blockout at post no. 12 was fractured and a portion of it disengaged from the post. The wooden blockouts at post nos. 13 and 14 were fractured and removed from the post. The wooden blockouts at post no. 15 encountered minor splitting and contact marks on the upstream-top edge. The wooden blockouts at post nos. 16 and 17 were slightly damaged on the top-upstream edge.

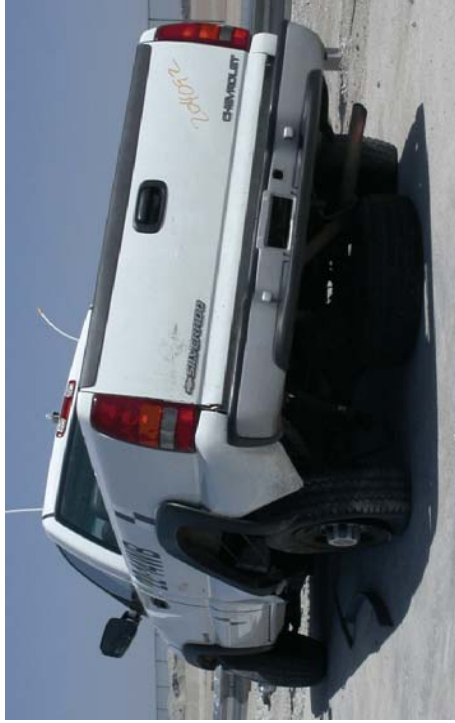
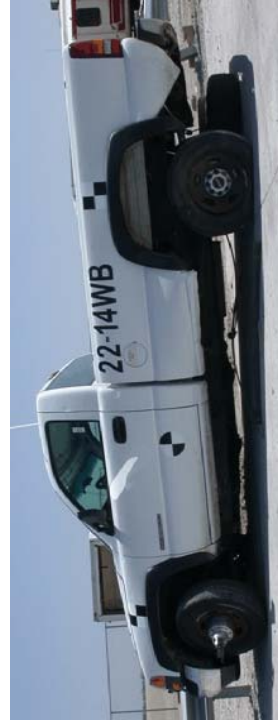
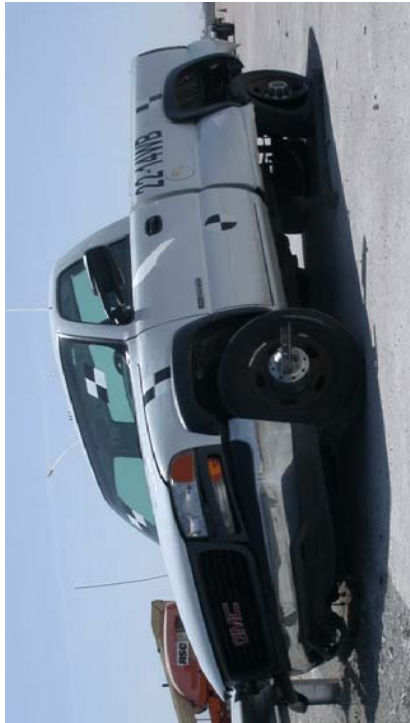
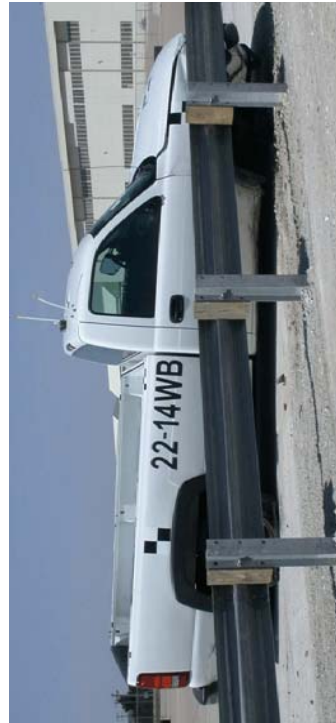
Figure 28. Vehicle Damage, Test 2214WB-1

Exterior vehicle damage was moderate, as shown in Figures 28 through 30. Occupant

compartment deformations to the right side and center of the floorboard were judged insufficient to cause serious injury to the vehicle occupants. Maximum longitudinal deflections of 19 mm (0.75 in.) were located near the center of the right side of the floorboard. Maximum lateral deflections of 13 mm (0.5 in.) were located near the left-front corner of the right-side floor pan and the center of the right side of the floorboard. Maximum vertical deflections of 6 mm (0.25 in.) were located throughout the right side of the floorboard. Complete occupant compartment deformations and the corresponding locations are provided in Appendix C.

Damage was concentrated on the right-front corner of the vehicle. The right-front quarter panel was deformed inward and downward toward the engine compartment. The right side of the front bumper was flattened and bent back toward the engine compartment nearly contacting the lower frame rail. The right-side door encountered a deformation and tearing near front quarter panel. The front-right corner of the hood was deformed and dented. The box encountered a tear in front of the left-rear tire. The drive shaft was fractured and disconnected from the vehicle. The rear axle was displaced out of alignment. The right-front wheel assembly deformed and crushed inward toward the engine compartment. The right-side upper ball joint, lower ball joint, and steering linkage were fractured. The right-side sway bar and lower control arm connection was bent approximately 25 degrees. The right-front tire disengaged from the rest of the wheel assembly. The right-rear and left-rear tires were deflated. The left-side rear suspension was fractured. All window glass remained undamaged.
