**PERFORMANCE EVALUATION OF THE  
PERMANENT NEW JERSEY SAFETY SHAPE  
BARRIER – UPDATE TO NCHRP 350  
TEST NO. 4-12 (2214NJ-2)**

MwRSF Research Report No. TRP-03-178-06

October 13, 2006

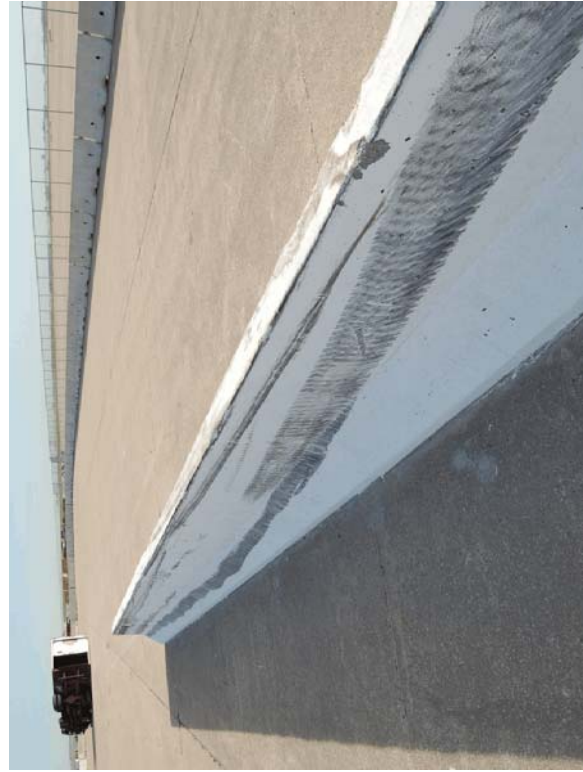
Figure 20. Permanent New Jersey Safety Shape Barrier Damage, Test 2214NJ-2

Damage to the barrier was minimal, as shown in Figures 20 through 22. Barrier damage consisted of contact and gouge marks. The length of vehicle contact along the concrete barrier system was approximately 31.29 m (102 ft - 8 in.), which spanned from 5,283 mm (208 in.) downstream from the upstream end of the barrier through the downstream end of the barrier.

A 368-mm (14.5-in.) long tire mark was found on the lower face of the barrier. Another tire mark began 9.14 m (30 ft) upstream from the downstream end of the barrier. A 279-mm (11-in.) wide by 229-mm (9-in.) high by 13-mm (0.5-in.) deep wheel gouge began at the targeted impact point. The center of a 406-mm (16-in.) wide by 203-mm (8-in.) high by 6-mm (0.25-in.) deep wheel gouge was located at 635 mm (25 in.) downstream from the targeted impact point. The center of a 356-mm (14-in.) wide by 229-mm (9-in.) high by 13-mm (0.5-in.) deep wheel gouge was located at 1,245 mm (49 in.) downstream from the targeted impact point. Spalling on the back side of the barrier began 6.71 m (22 ft) downstream from the impact point and continued to the end of the barrier. Minor spalling was located on the top front side of the barrier at 7.62 m (25 ft) downstream from the targeted impact point. The front side of the barrier also encountered spalling which began 6.10 m (20 ft) upstream from the downstream end of the barrier and continued through the end of the barrier. The permanent set of the barrier system was negligible.

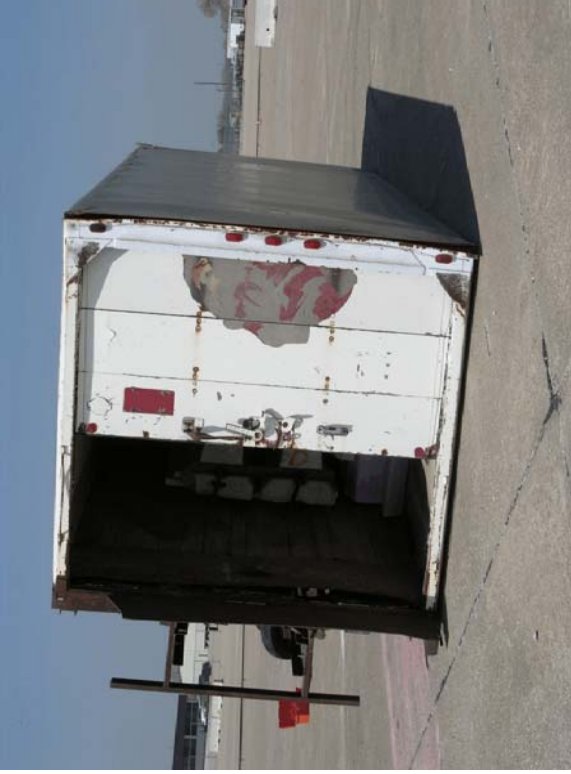
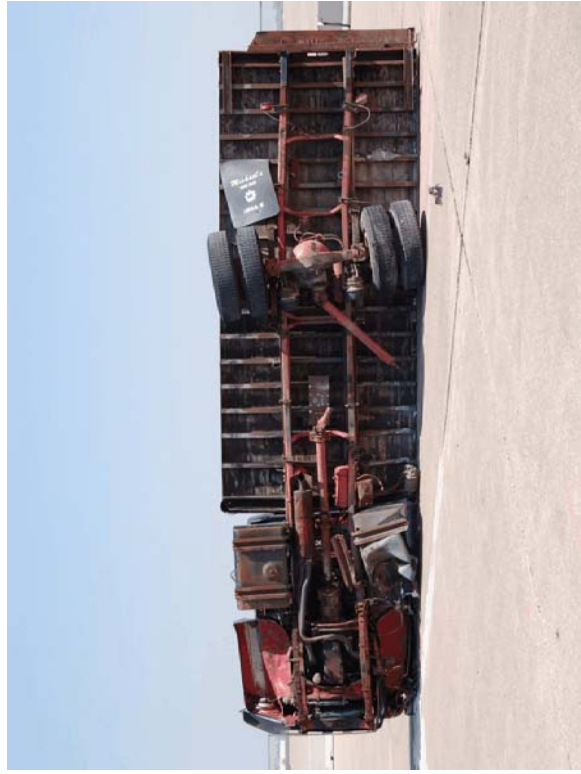
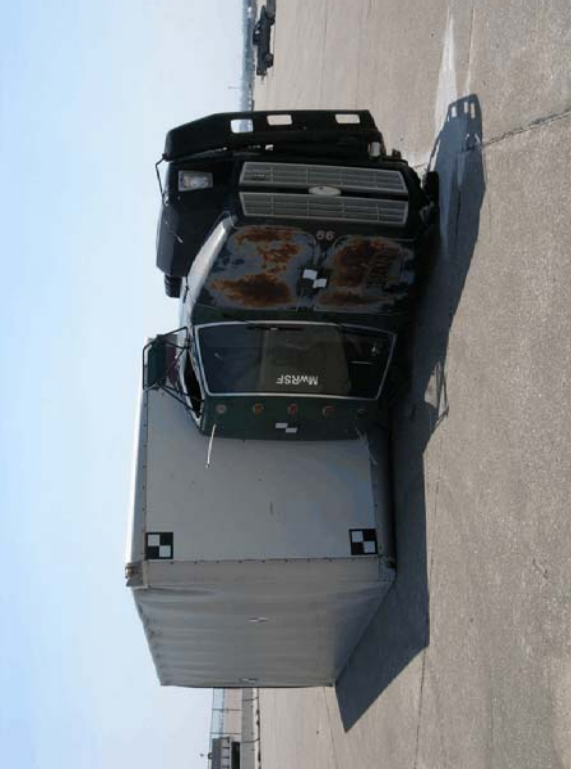
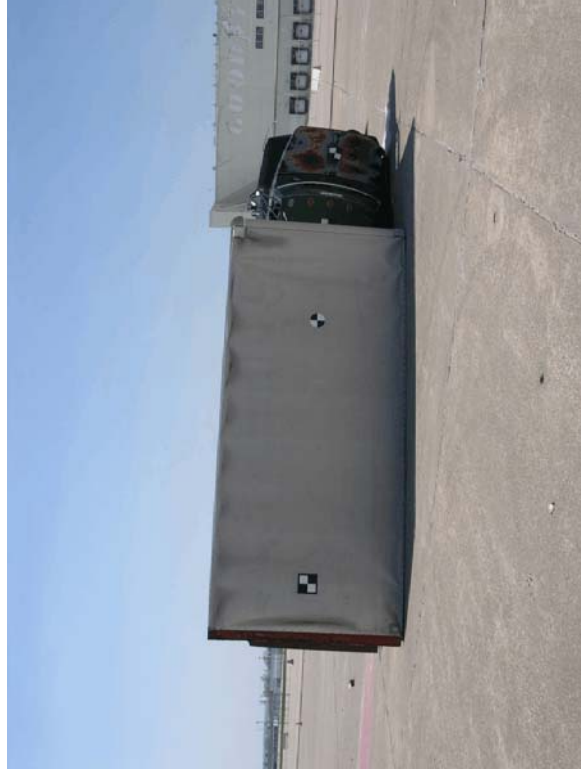
Figure 23. Vehicle Damage, Test 2214NJ-2

Exterior vehicle damage was extensive, as shown in Figures 23 through 26. Occupant compartment deformations to the right side and center of the floorboard were judged insufficient to cause serious injury to the vehicle occupants. Complete occupant compartment deformations and the corresponding locations are provided in Appendix C.

Damage was concentrated on the right side of the vehicle. The right-front quarter panel was deformed inward toward the engine compartment. The right side of the front bumper was flattened and bent back toward the engine compartment. The left side of the front bumper was also deformed inward toward the engine compartment. The right-front fuel tank was severely dented. The right-front exhaust disengaged from the truck and was dented. The bracket attaching the right-right front exhaust was bent backward 90 degrees. The right side of the frame buckled at the front flange and was bent and twisted near the rear end. The front axle and drive shaft disengaged from the truck. Scratches and contact marks were found along the entire right side. The hood deformed slightly. The third and fourth U-bolts attaching the cargo box to the frame fractured. The cargo box frame at the rear axle was bent backward. The top rear of the cargo box encountered minor buckling. Contact marks were found on the bottom of the cargo box and the steel cross beams were deformed. The right leaf spring disengage at the front of the rear tire. The right-rear inside tire encountered a severe gouge. The right-front mirror was broken. All window glass remained undamaged.
