# **PERFORMANCE EVALUATION OF THE SKT-MGS TANGENT END TERMINAL – UPDATE TO NCHRP 350 TEST NO. 3-34 (2214TT-1)**

MwRSF Research Report No. TRP-03-176-06

October 12, 2006

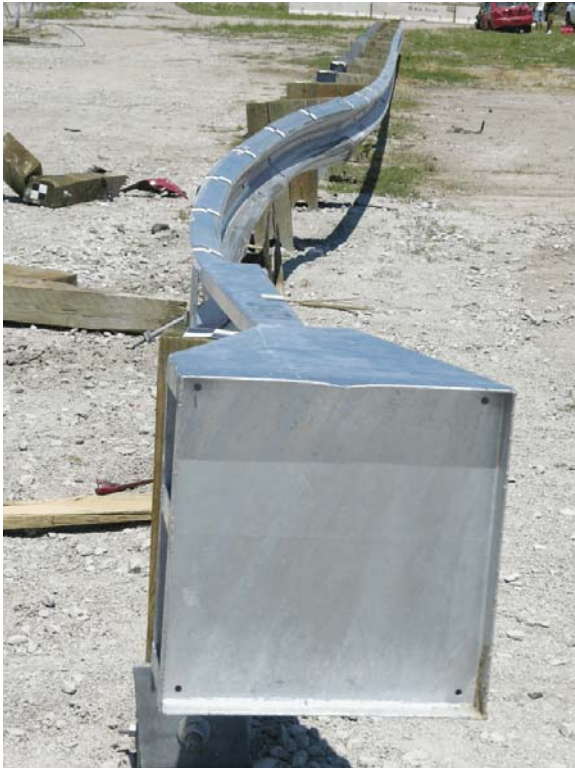
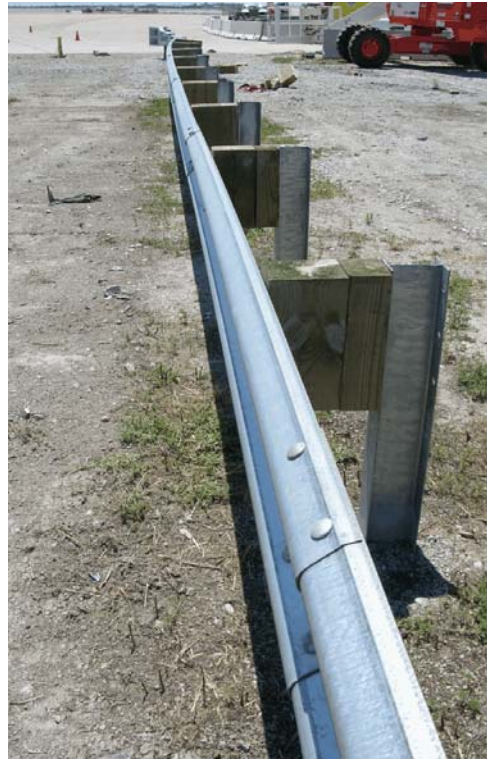
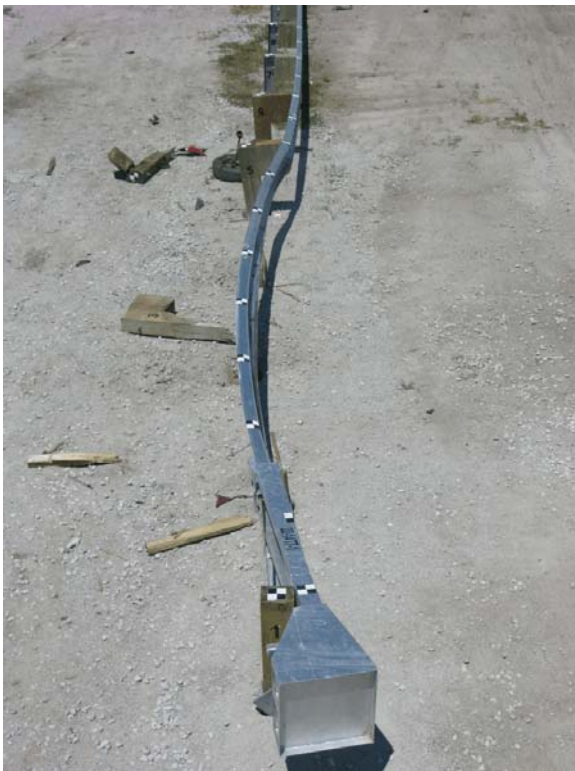
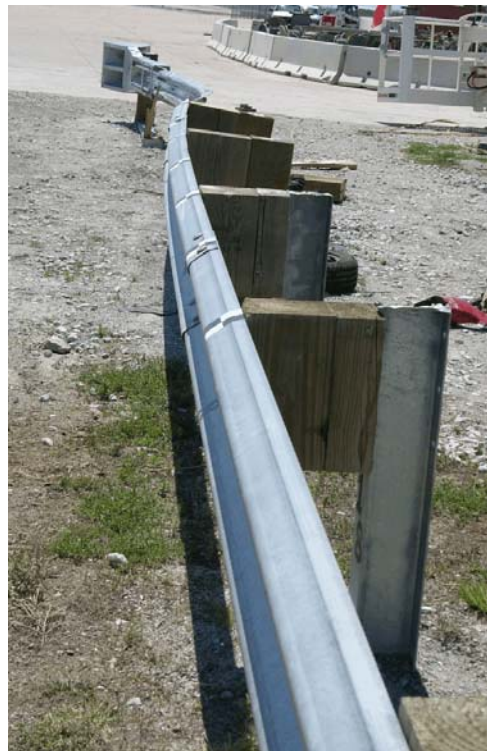
Figure 32. Midwest Guardrail System End Terminal Damage, Test 2214TT-1

Damage to the barrier was moderate, as shown in Figures 32 through 35. Barrier damage consisted of deformed W-beam, fractured and deformed guardrail posts, and contact marks on a guardrail section. The length of vehicle contact along the W-beam guardrail system was approximately 8.4 m (27.5 ft), which spanned from 1,013 mm (39.9 in.) downstream from the centerline of post no. 1 through 1,651 mm (65 in.) downstream from the centerline of post no. 5.

Moderate deformation and flattening of the impacted section of W-beam rail occurred between post nos. 1 and 6. The guardrail buckled significantly at post no. 5 while minor buckling was found between post nos. 6 and 7. Contact marks were found on the guardrail between post nos. 1 and 6. The W-beam was pulled off of post nos. 2 through 4. The W-beam rail sustained yielding around the post bolt slots at post nos. 3 and 4. Wood post nos. 2 through 4 fractured with their blockouts remaining attached to the posts. Wood post nos. 5 and 6 rotated backward slightly but otherwise remained undamaged. Steel post no. 7 encountered slight CCW twist. The downstream end of the impact head was turned backward slightly but post no. 1 remained undamaged.

permanent set rail deflection was 584 mm (23 in.) at the centerline of post no. 3, as measured in the field. The maximum lateral dynamic rail deflection was 703 mm (27.7 in.) at the midspan between post nos. 3 and 4, as determined from high-speed digital video analysis. The working width of the system was found to be 1,233 mm (48.5 in.).

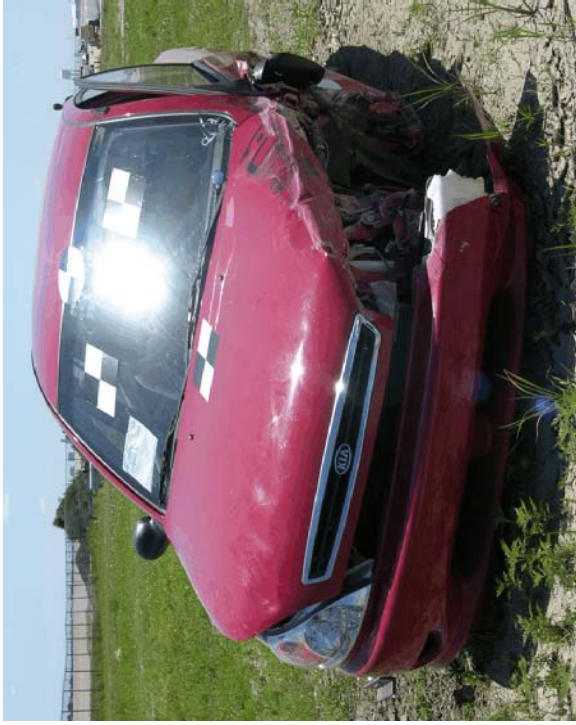
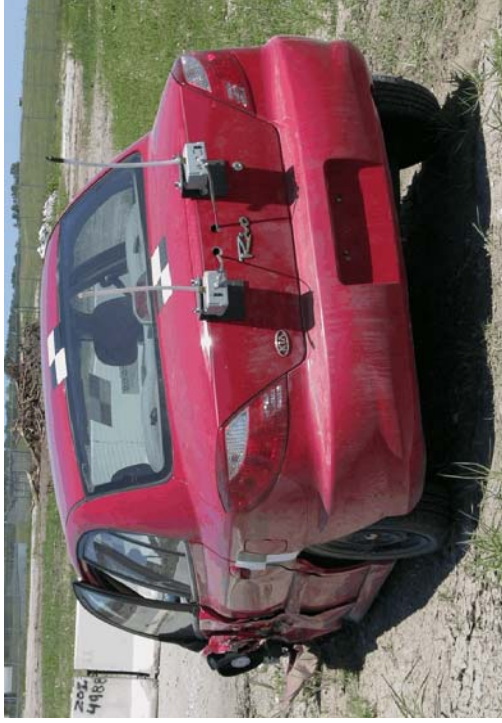
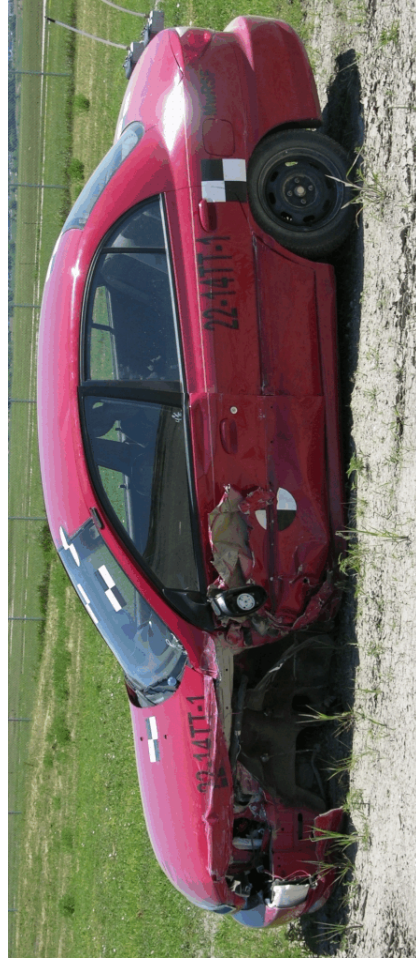
Figure 36. Vehicle Damage, Test 2214TT-1

Exterior vehicle damage was moderate, as shown in Figures 36 through 39. Occupant compartment deformations to the left side of the floorboard were judged insufficient to cause serious injury to the vehicle occupants, as shown in Figure 39. Maximum longitudinal deflections of 89 mm (3.5 in.) were located near the left-front corner of the left-side floorboard. Maximum lateral deflections of 152 mm (6 in.) were located near the left-front corner of the left-side floorboard. Maximum vertical deflections of 57 mm (2.25 in.) were located near the left center of the left-side floorboard. Complete occupant compartment deformations and the corresponding locations are provided in Appendix C.

Damage was concentrated on the left-front corner of the vehicle. The left side of the front bumper was fractured. The front bumper was pushed back toward the engine compartment. The radiator was pushed back into the engine compartment and buckled at its midpoint. The left-front corner and rear corners of the hood encountered dents and scratches. The left-front quarter panel sheet metal was deformed, torn, and peeled back into the left-front door. The right-front quarter panel encountered minor dents and deformations behind the front tire. The left-front door encountered deformations and sheet metal tears, while the left-rear door was dented and scratched. The entire left side was dented and deformed. The left-side headlight was fractured and detached and the light assembly was shifted toward the right. The left-side door mirror was broken off, but

remained attached by the mechanism wires. The left side of the roof between the front and back doors was dented. The left-front wheel assembly deformed and crushed inward toward the engine compartment. The left-side tire bearing and ball joints were fractured. The left-side steering knuckle and left-front tire disengaged from the rest of the wheel assembly. The rear suspension was damaged. The gear box and numerous underside components were scratched and dented. The windshield encountered minor cracking at the lower-left side of the windshield. All other window glass remained undamaged.
