**PERFORMANCE EVALUATION OF THE  
GUARDRAIL TO CONCRETE BARRIER  
TRANSITION – UPDATE TO NCHRP 350 TEST  
NO. 3-21 WITH 28" C.G. HEIGHT (2214T-1)**

MwRSF Research Report No. TRP-03-175-06

October 12, 2006

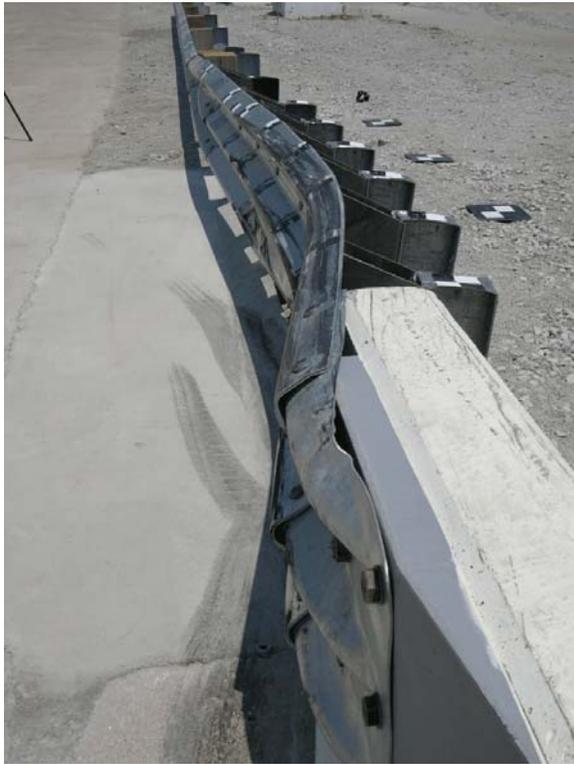
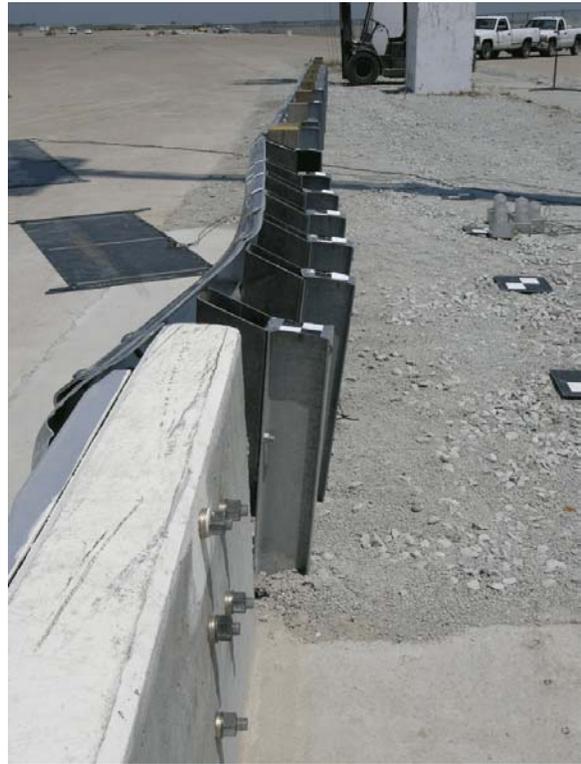
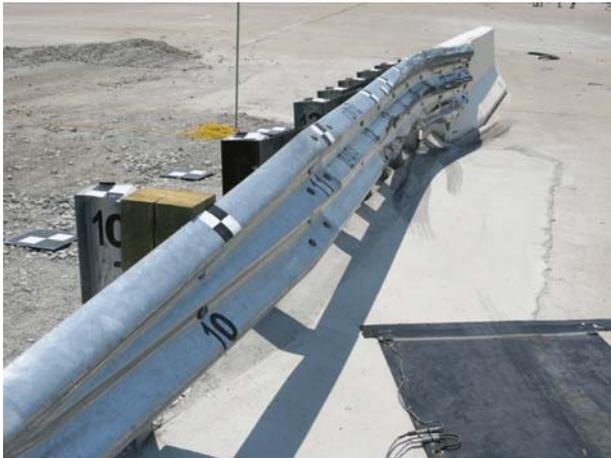
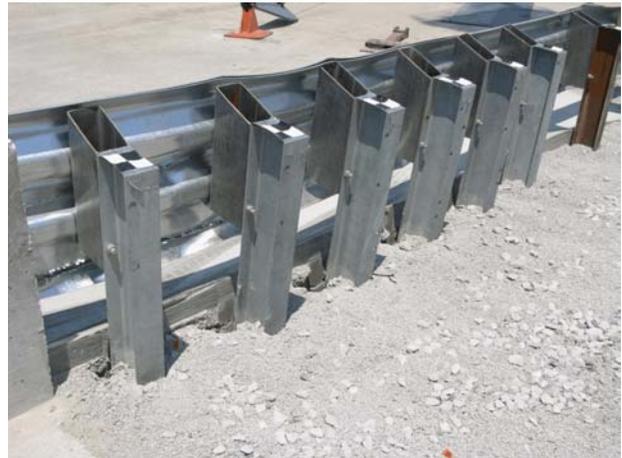
Figure 33. Approach Guardrail Transition System Damage, Test 2214T-1

Damage to the barrier was minimal, as shown in Figures 33 through 35. Barrier damage consisted of contact marks on a guardrail section and deformed thrie beam rail. The length of vehicle contact along the thrie beam guardrail system was approximately 2.4 m (8 ft), which spanned from

Minor deformation and flattening of the impacted section of thrie beam rail occurred between post nos. 12 and 17. Minor buckling in the lower portion of the rail was found between post nos. 16 and 17. Contact marks were found on the guardrail between post no. 12 and the end of the concrete barrier. The guardrail buckled slightly at the upstream end of the concrete barrier. The head of the second splice bolt from the bottom on the upstream side of the thrie beam connector fractured and was removed, as shown in Figure 35. Steel post nos. 12 through 17 rotated backward slightly, but otherwise remained undamaged. Minor black contact marks were found on the bottom toe of the concrete barrier.

The permanent set of the barrier system is shown in Figure 33. The maximum lateral permanent set rail and post deflections were 194 mm (7.625 in.) at the centerline of post no. 15 and 191 mm (7.5 in.) at the centerline of post no. 15, respectively, as measured in the field. The maximum lateral dynamic rail and post deflections were 289 mm (11.4 in.) at the centerline of post no. 15 and 251 mm (9.9 in.) at the centerline of post no. 15, respectively, as determined from high-speed digital video analysis. The working width of the system was found to be 552 mm (21.7 in.).

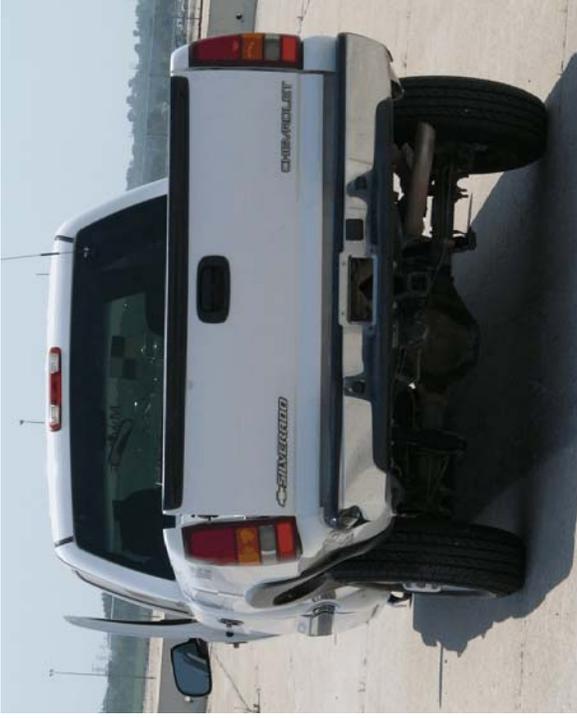
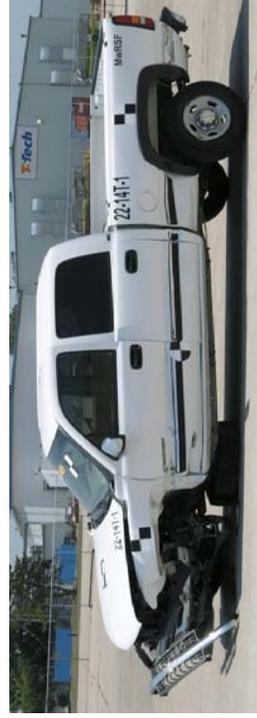
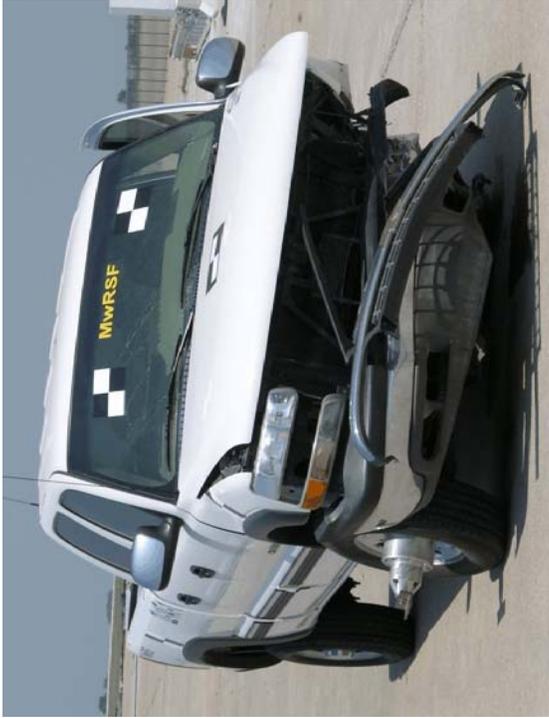
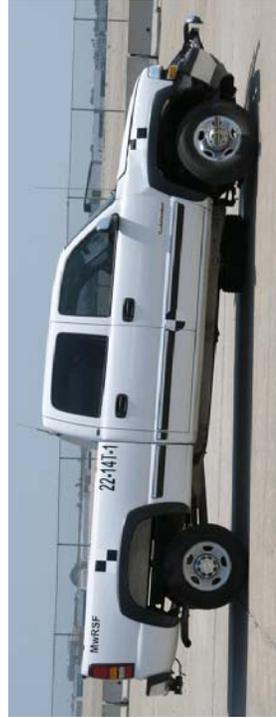
Figure 36. Vehicle Damage, Test 2214T-1

Exterior vehicle damage was moderate, as shown in Figures 36 through 40. Occupant compartment deformations to the left side and front of the floorboard were judged insufficient to cause serious injury to the vehicle occupants. Maximum longitudinal deflections of 102 mm (4 in.) were located near the left-front corner of the left side of the floorboard. Maximum lateral deflections of 44 mm (1.75 in.) were located near the right-front corner of the left-side floorboard. Maximum

Damage was concentrated on the left-front corner of the vehicle. The left-front quarter panel was deformed inward and downward toward the engine compartment. The left side of the front bumper was flattened and bent back toward the engine compartment. Buckle points at the third points were found on the front bumper. The left-front door encountered deformations and sheet metal tears. The left-rear door encountered scratches and contact marks. The front of the vehicle shifted toward the right while the hood remained in place. The box was dented and deformed along the entire left side. The grill and plastic around the left-side headlight was fractured and removed. The left-front plastic wheel well protection disengaged. The right side of the rear bumper was dented. The tail gate was misaligned. The left side of the frame was bent inward. The drive shaft encountered a dent in the housing. The left-front wheel assembly deformed and crushed inward toward the engine compartment. The left-side tire bearing and ball joint were fractured. The left-side sway bar and control arm connection was bent. The left-front tire disengaged from the rest of the wheel assembly. All hydraulic lines for the left-front wheel were sheared off. The left-rear rim, hub, and tire encountered scratch and scuff marks, and the rim was dented. The exhaust pipe and mount were dented and deformed. The front engine mount was fractured. The windshield encountered cracking in a radial pattern beginning at the lower center of the windshield. All other window glass remained undamaged.
