**PERFORMANCE EVALUATION OF THE
FREE-STANDING TEMPORARY BARRIER –
UPDATE TO NCHRP 350 TEST NO. 3-11 WITH 28"
C.G. HEIGHT (2214TB-2)**

MIDWEST ROADSIDE SAFETY FACILITY

MwRSF Research Report No. TRP-03-174-06

October 12, 2006

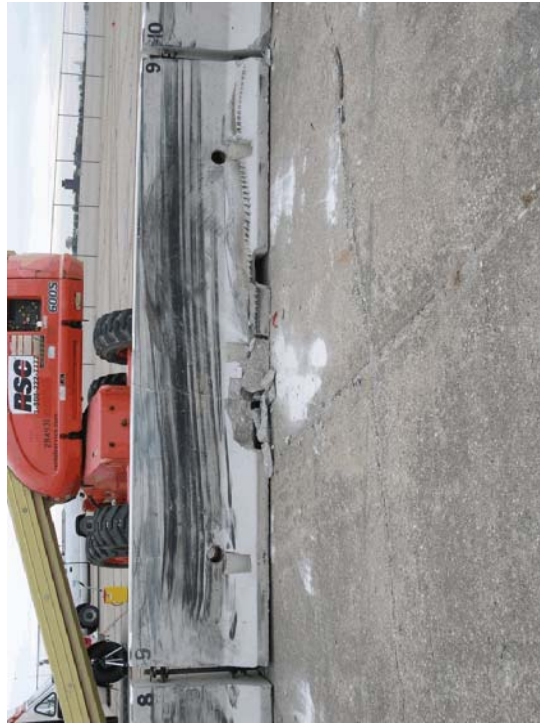
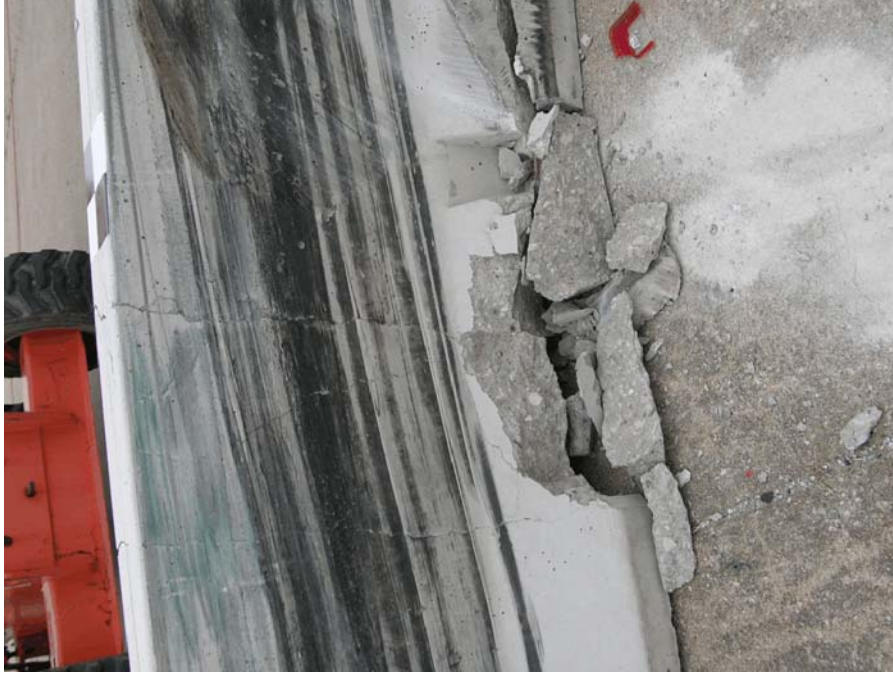
Figure 24. Temporary Barrier Damage, Test 2214TB-2

The downstream end of barrier no. 8 encountered concrete spalling located 241 mm (9.5 in.) from the top of the barrier and was 191 mm (7.5 in.) long. Concrete spalling, 127 mm (5 in.) in length, was found 102 mm (4 in.) from the top of the barrier on the upstream end of barrier no. 9. Concrete spalling occurred on the lower-front face of barrier no. 9 from 1,270 mm (50 in.) to 2,216 mm (87.25 in.) downstream from the barrier's upstream end. Minor concrete spalling was also found on the lower-front corner of the upstream and downstream ends of barrier no. 9 and the upstream end of barrier no. 10.

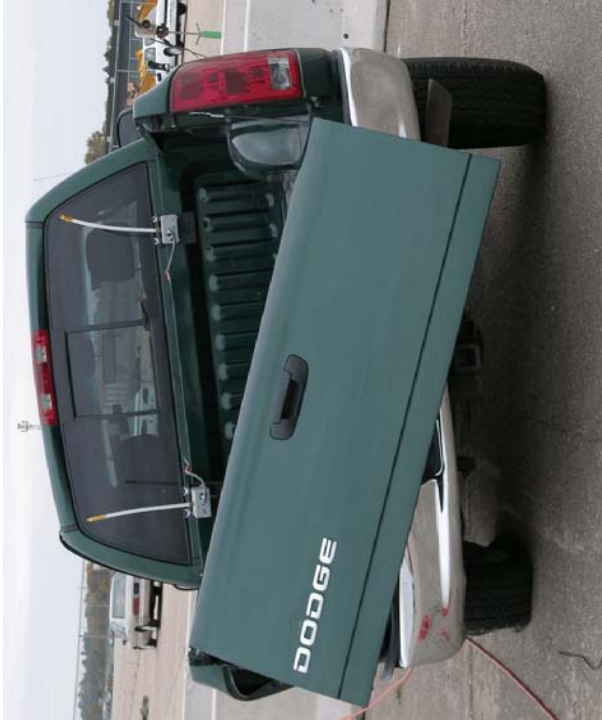
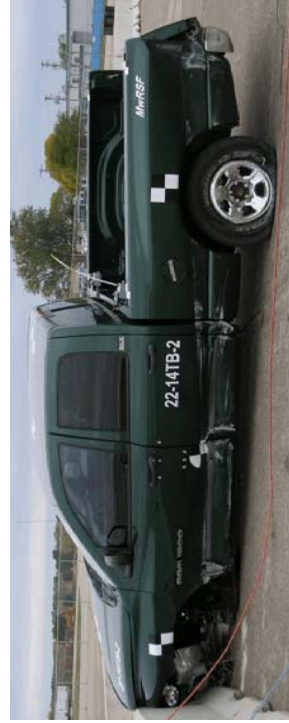
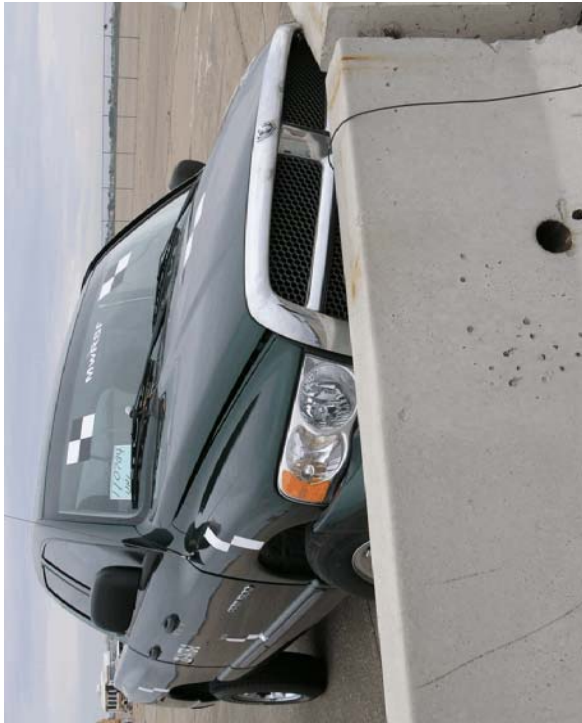
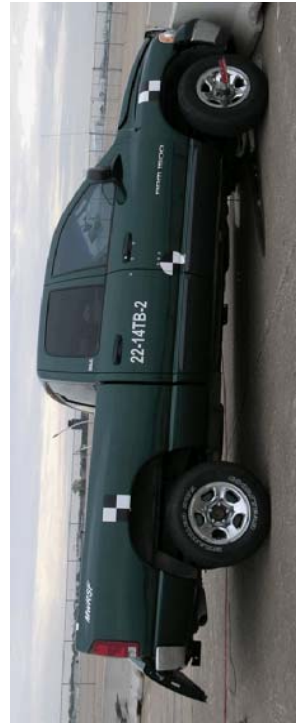
Figure 26. Vehicle Damage, Test 2214TB-2

Exterior vehicle damage was moderate, as shown in Figures 26 through 28. Occupant

Damage was concentrated on the left-front corner of the vehicle. The hood, front bumper, grill, and the left-side and right-side front-quarter panels shifted toward the right. The left-front quarter panel was deformed inward and downward toward the engine compartment. The left side of the front bumper was flattened and bent back toward the engine compartment. A buckle point was located near the center of the front bumper. The left side of the grill fractured and was deformed inward toward the engine compartment. The radiator and air conditioning units were deformed into the engine. Minor paint scratches were observed on the front of the hood and on the tailgate. The top of the left door was ajar. The vehicle encountered numerous sheet metal scratches and tears along its left side. The left-front side of the frame and engine mount were bent inward toward the center of the vehicle. The left-front upper A-arm was bent. The left-side lower ball joint was fractured and removed from the lower A-arm. The left-side tie rod disengaged from the rest of the wheel assembly. The left-side bump stop bracket was deformed upward and the brake line was severed. The left-front and left-rear steel rims were deformed and dented. The left-front tire's lug nuts were scratched. The left-rear tire's hub cap was bent and deformed. The left-front and left-rear tires' side walls were torn, and the tires deflated. The rear bumper was dented on the left side. The

right-side tailgate connection fractured, but the tailgate remained attached to the vehicle. The left-front wheel assembly disengaged from the vehicle. The left-side headlight and park light were fractured. The left-side tail light was detached from the vehicle. All window glass remained undamaged.
