# **Performance Evaluation of Missouri's 6-in. Barrier Curb Under W-Beam Guardrail**

**Midwest Roadside Safety Facility (MwRSF)  
Center for Infrastructure Research**

April 1994

MwRSF Research Report No. TRP-03-40-94

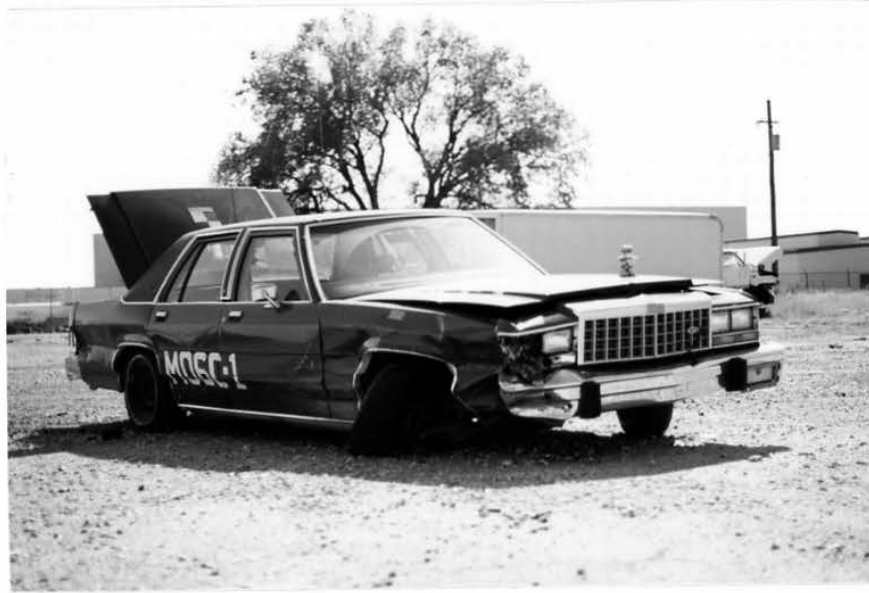
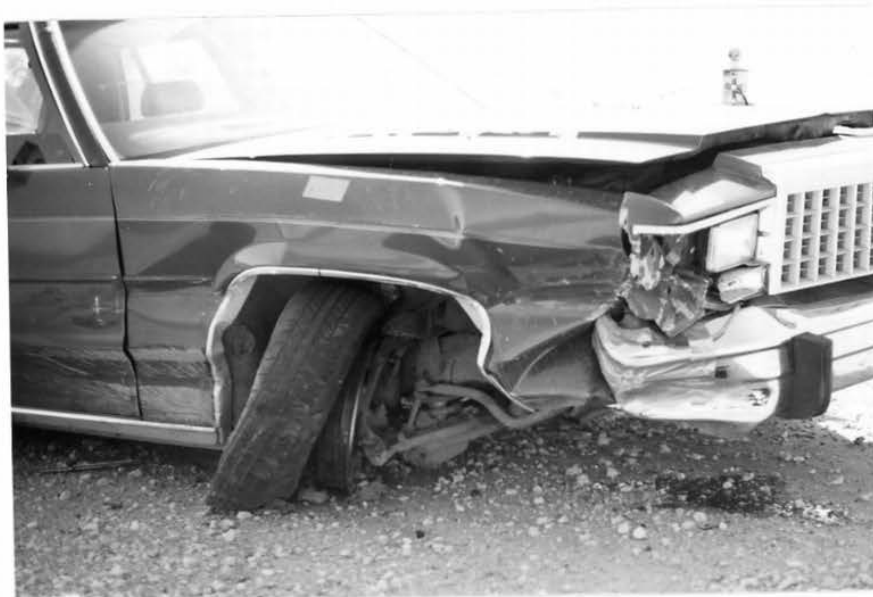
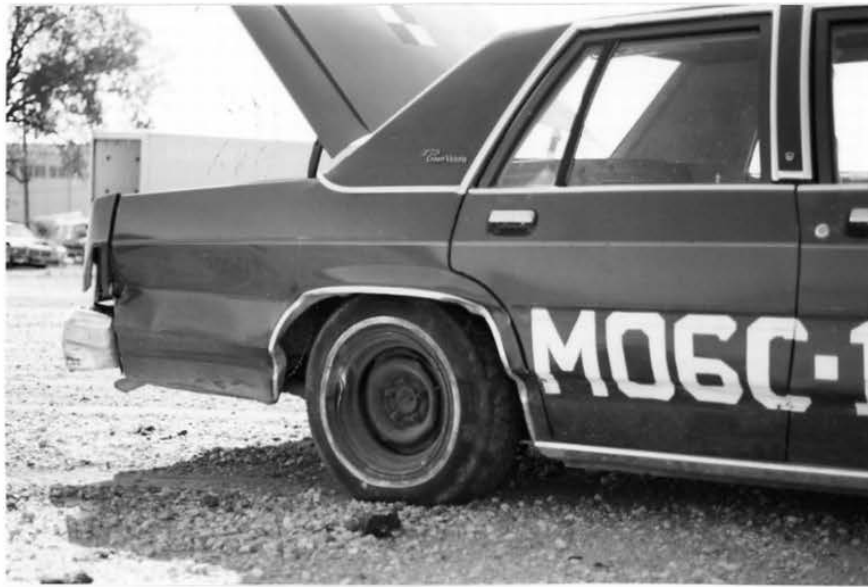
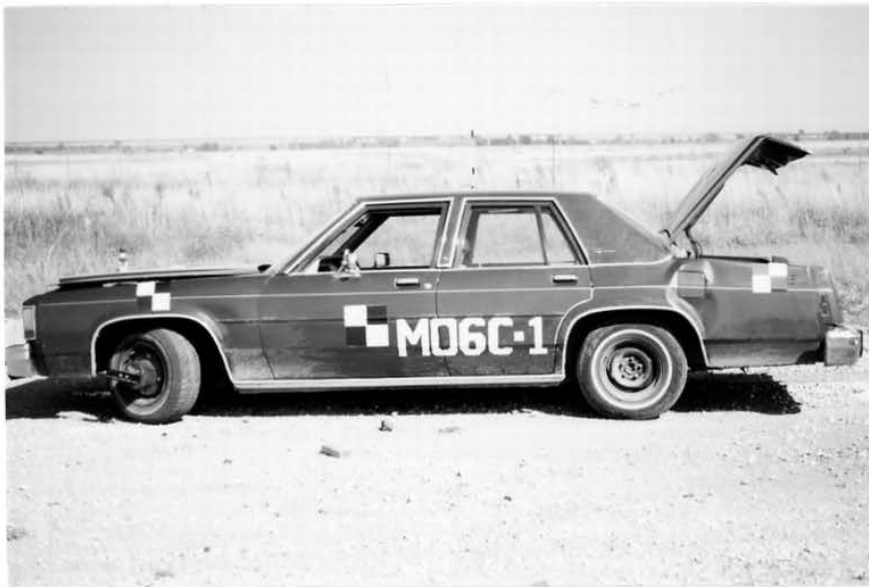
Figure 15. Test Vehicle Damage

Vehicle damage is shown in Figures 15 and 16, and consisted primarily of right front corner crushing, including tire blowout and rim damage, and passenger side W-beam interlock damage. The right rear rim was slightly deformed, but the tire was not deflated. There was no interior occupant compartment damage detected.

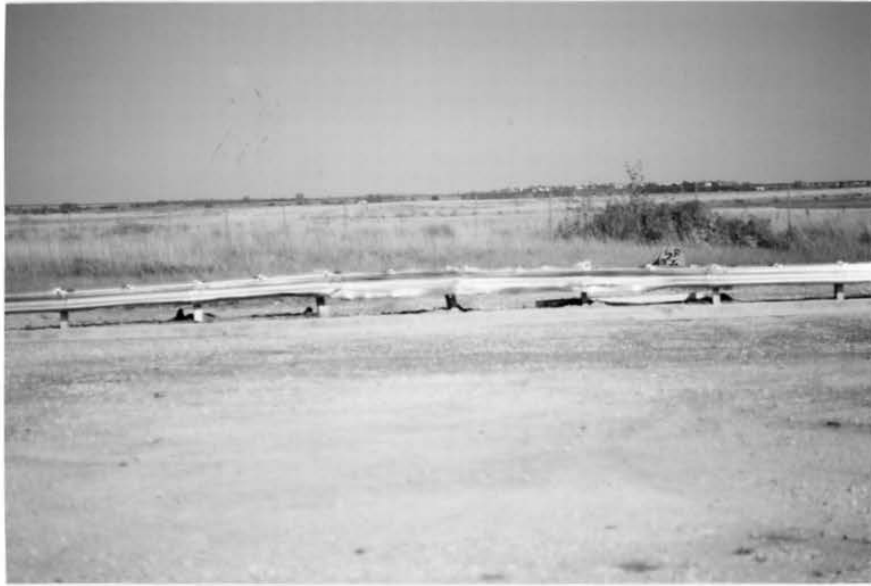
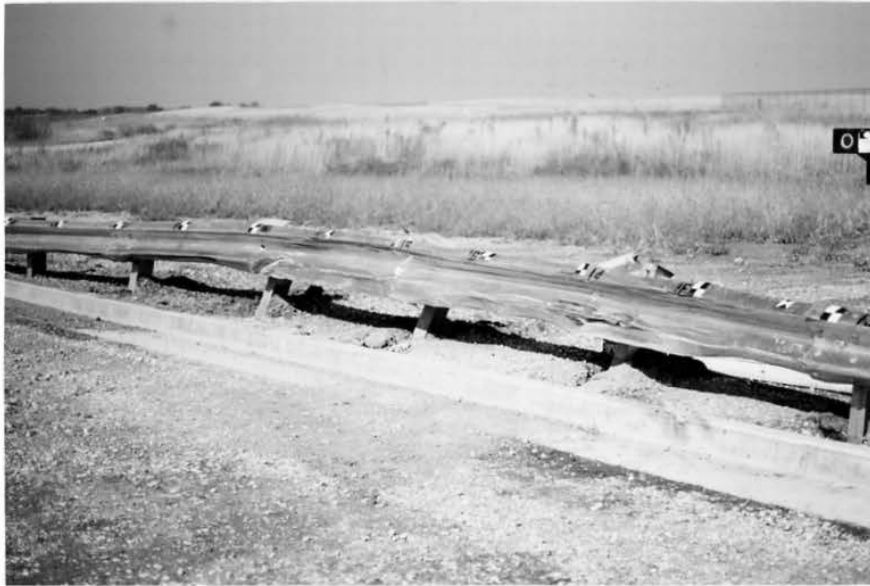
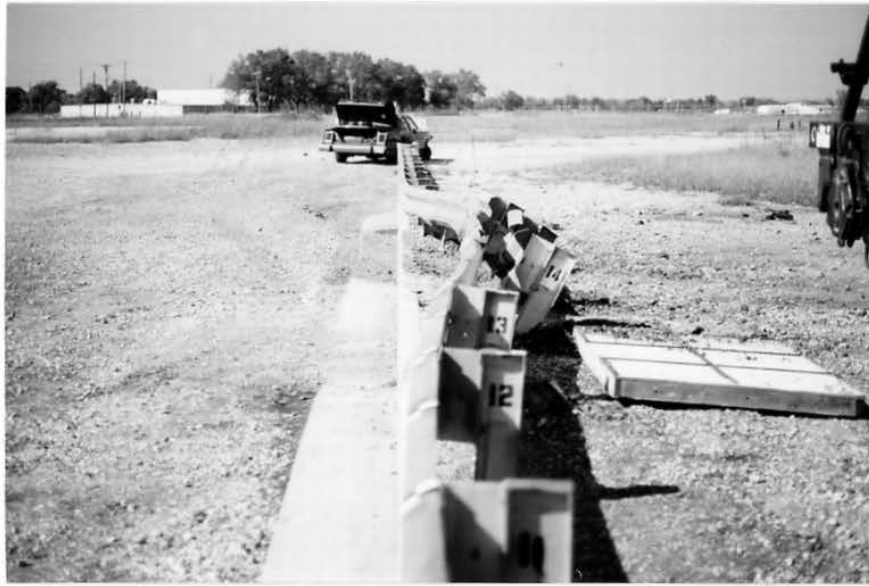
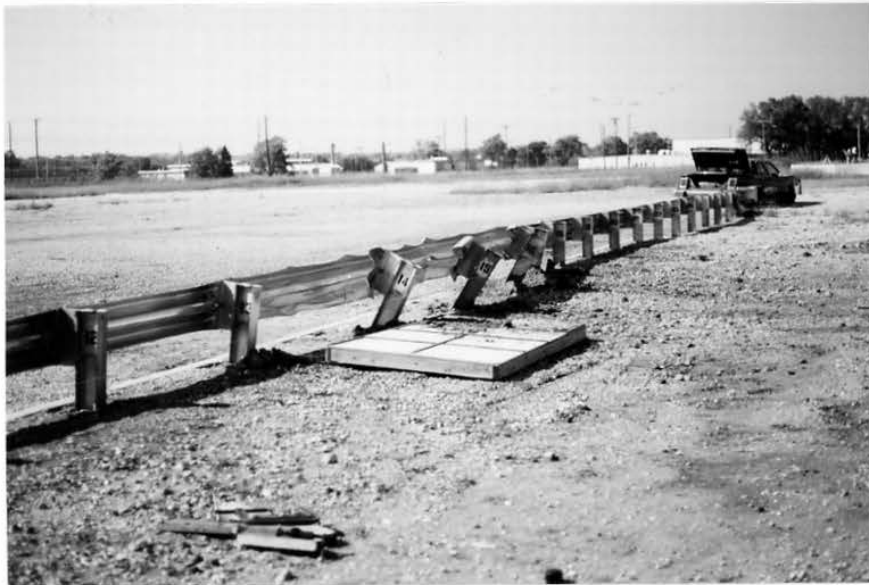
Figure 17. W-Beam Guardrail Damage

The W-beam guardrail damage is shown in Figures 17 and 18. Four 25-ft sections of guardrail were damaged during the test; the target impact section (section 4), the ends of the sections upstream and downstream of the target section (sections 3 and 5), and the section that was impacted during the secondary impact (section 7). The measured contact length between the vehicle and the rail (impact to Post No. 18) was approximately 30 ft. The permanent set and maximum dynamic deflections were 30.1 and 31.7 in., respectively. Maximum guardrail and post permanent set and dynamic deflections are shown in Figures 19 and 20, respectively.

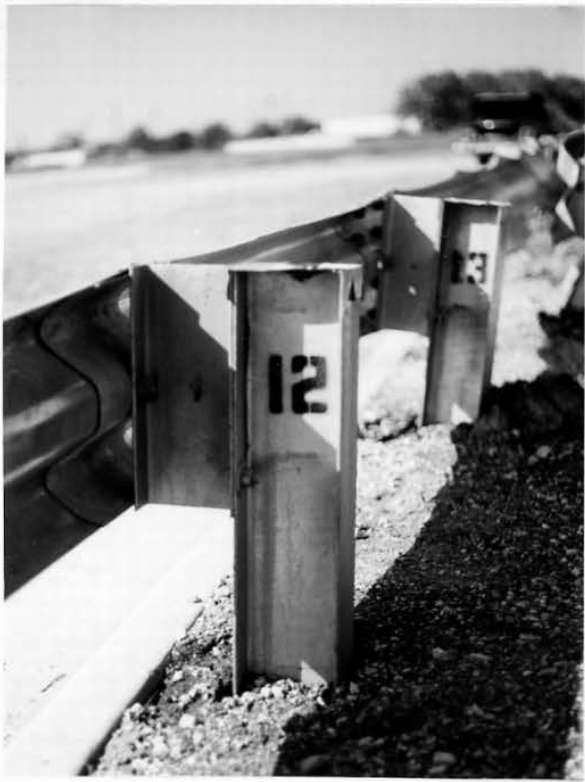
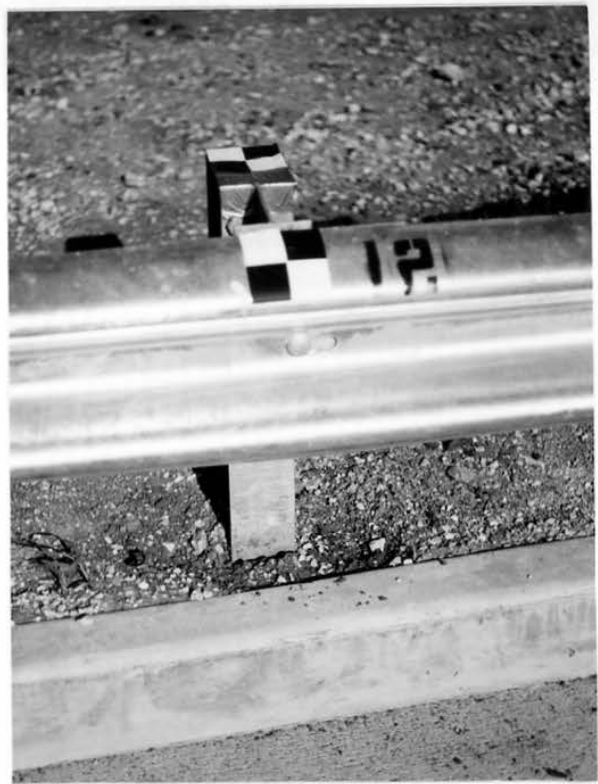
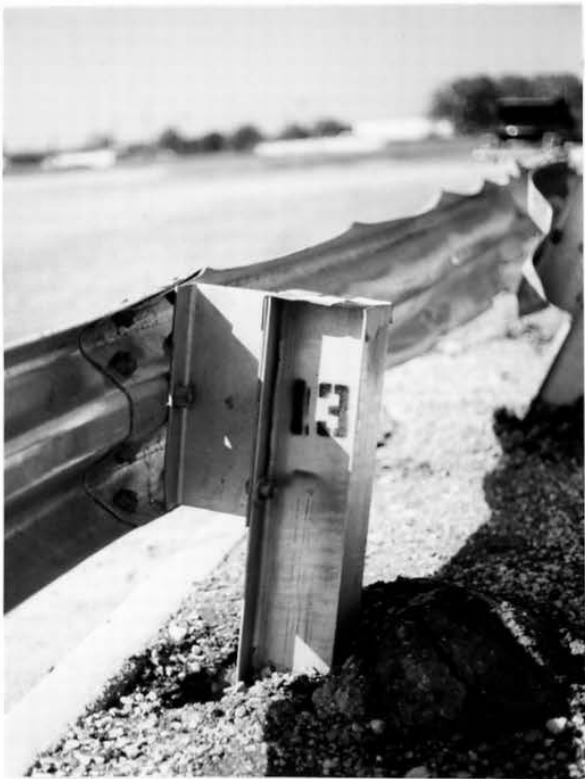
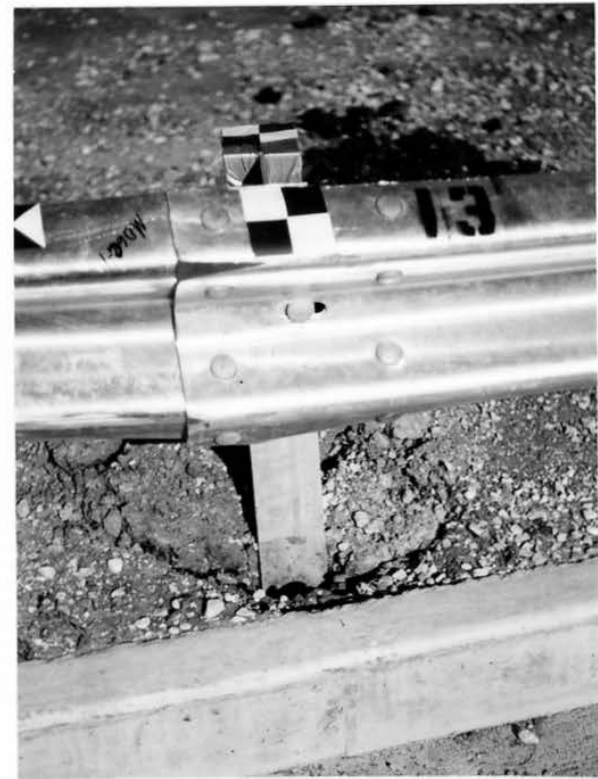
Figure 21. Barrier and Post Permanent Deformation Near Post Nos. 12 and 13

Guardrail and post damage at Post Nos. 12 and 13 are shown in Figure 21. Post Nos. 14 and 15 were disengaged during the test as shown in Figure 22. Post No. 16 was also disengaged during the test as shown in Figure 23. The end of the contact length occurring at Post No. 18 is shown in Figure 24. There was no permanent set twist or bending to the disengaged posts or any of the other posts as a result of the impact. There was no observed vehicle contact with the posts due to the wheel underriding the guardrail and contacting the posts. The damage to the concrete curb consisted of only a 3-ft long tire mark beginning 7 in. downstream of impact and a 2-in. long concrete gouge located approximately 16 in. downstream of the impact point.
