# Analysis of Existing Work-Zone Devices with MASH Safety Performance Criteria

**Final Report**  
**February 2009**

MwRSF Research Report No. TRP-03-225-10

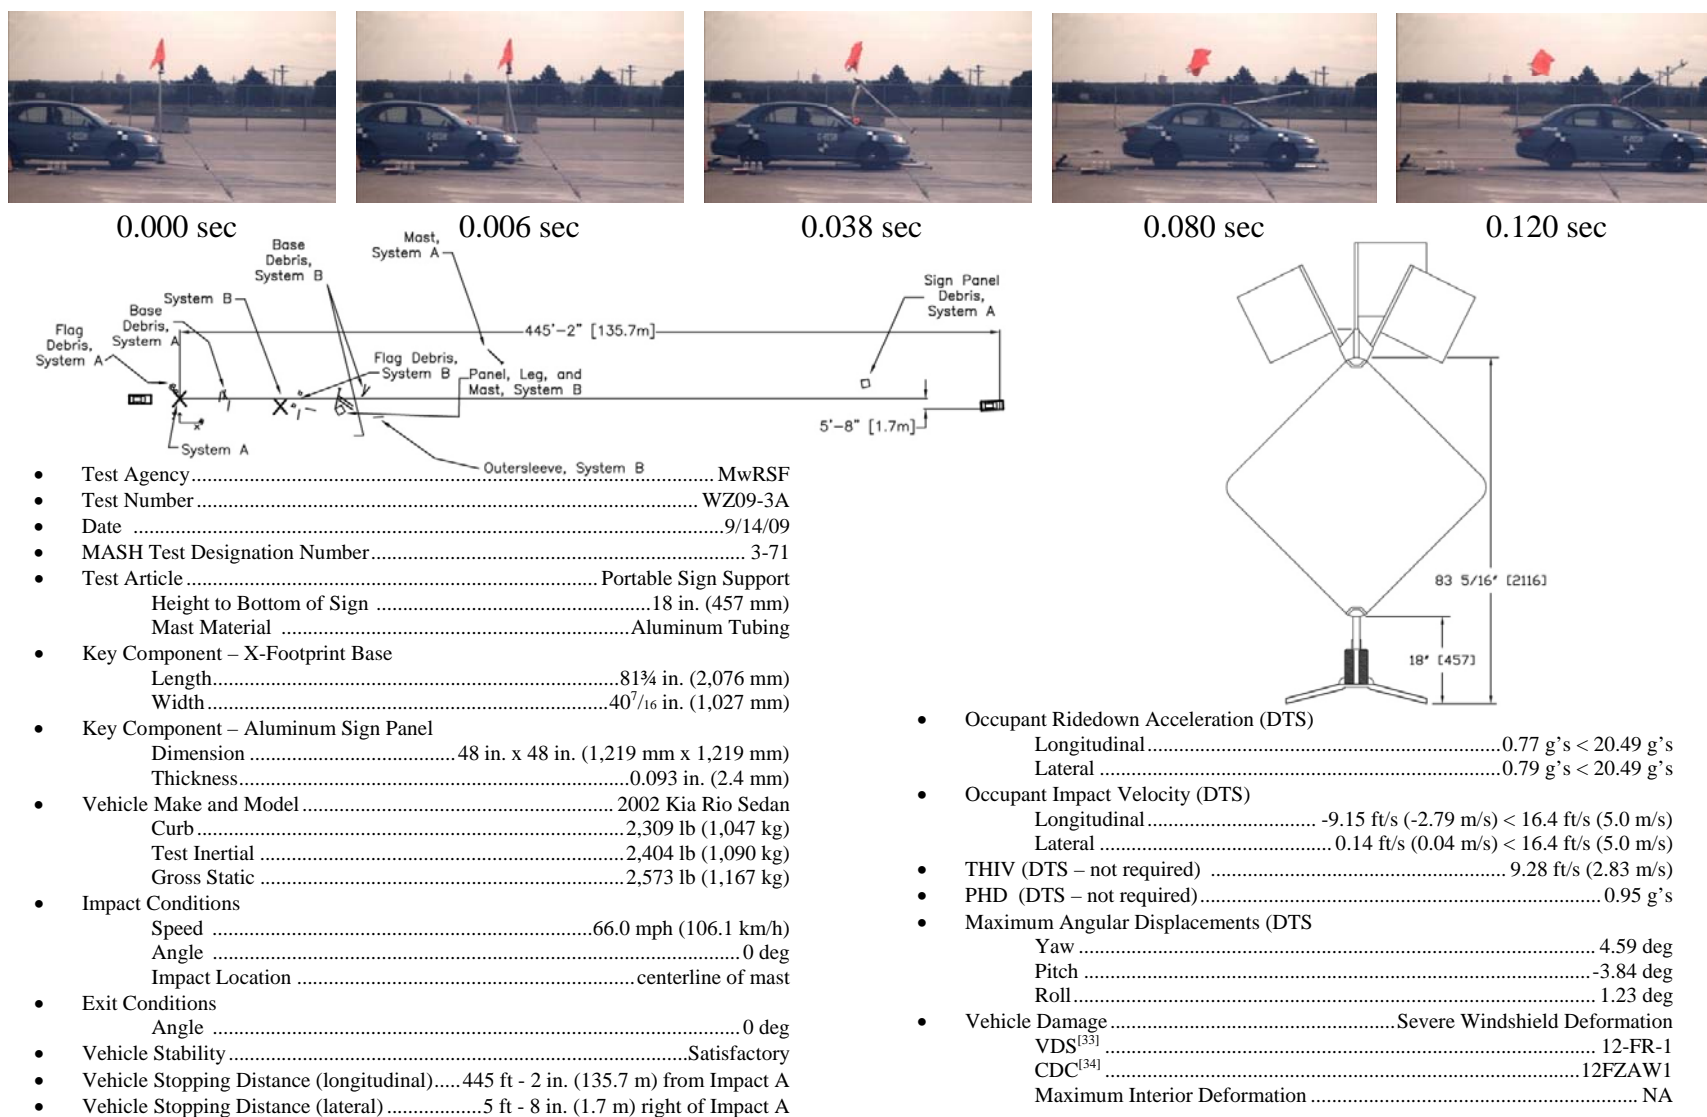
Figure 73. Summary of Test Results and Sequential Photographs, Test No. WZ09-3A

indentation greater than 3 in. (76 mm). Deformations of the occupant compartment did occur as the sign panel from System No. 3A contacted and indented the windshield a maximum of 4 in. (102 mm). The top of the mast contacted the back of the sign panel that was intact with the windshield and roof and left a small hole in the panel. In the event that the sign panel would have released from the windshield, there is a potential for the mast to contact and penetrate the roof.

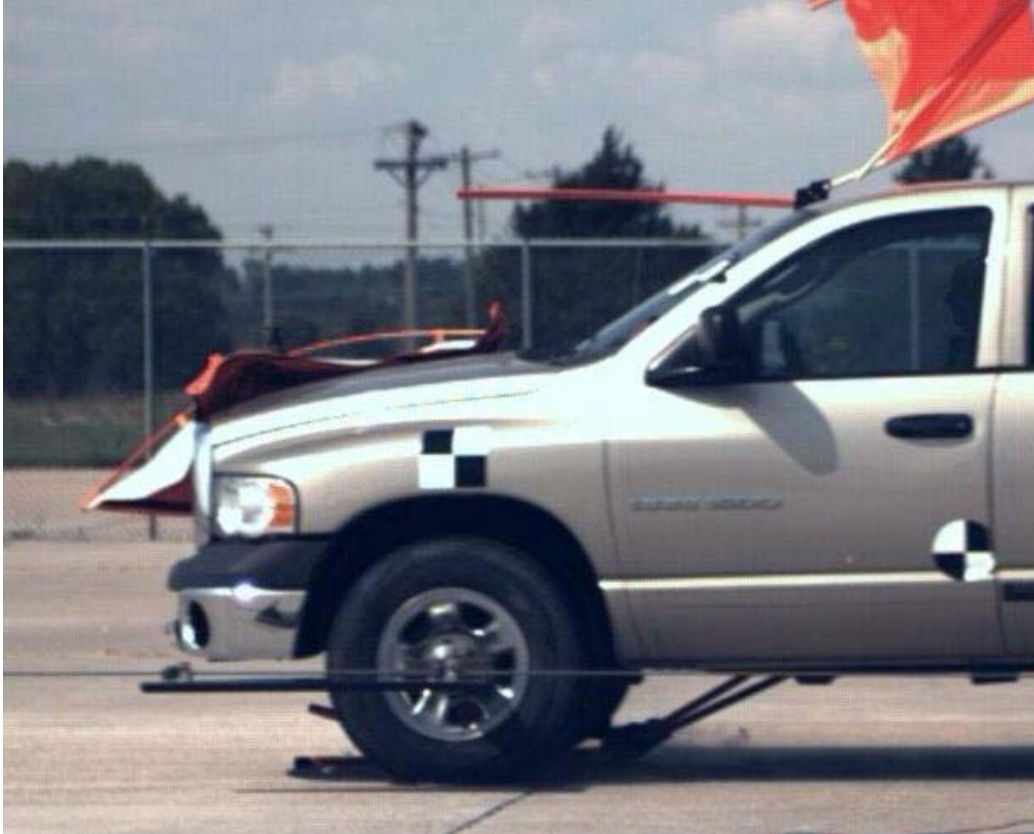
Figure 102. System No. 4A, X-Footprint Base Floorboard Penetration

Stands with excessive stub lengths remaining after impact can potentially catch on the undercarriage of the vehicle and drag along under the vehicle with heavy contact (System No. 4A). When the legs are oriented head-on to the vehicle, the stand can rotate such that the legs contact and penetrate the vehicle's floorboard. Even though the ground clearance is much greater for the pickup truck when compared to the small car, the potential for penetration has been shown to be a problem with both vehicles. As shown in Figure 102, when the vertical springs at the base were pushed over, the two front legs of the system were forced upward into the undercarriage of the pickup truck, resulting in one leg penetrating the left-side floorboard.

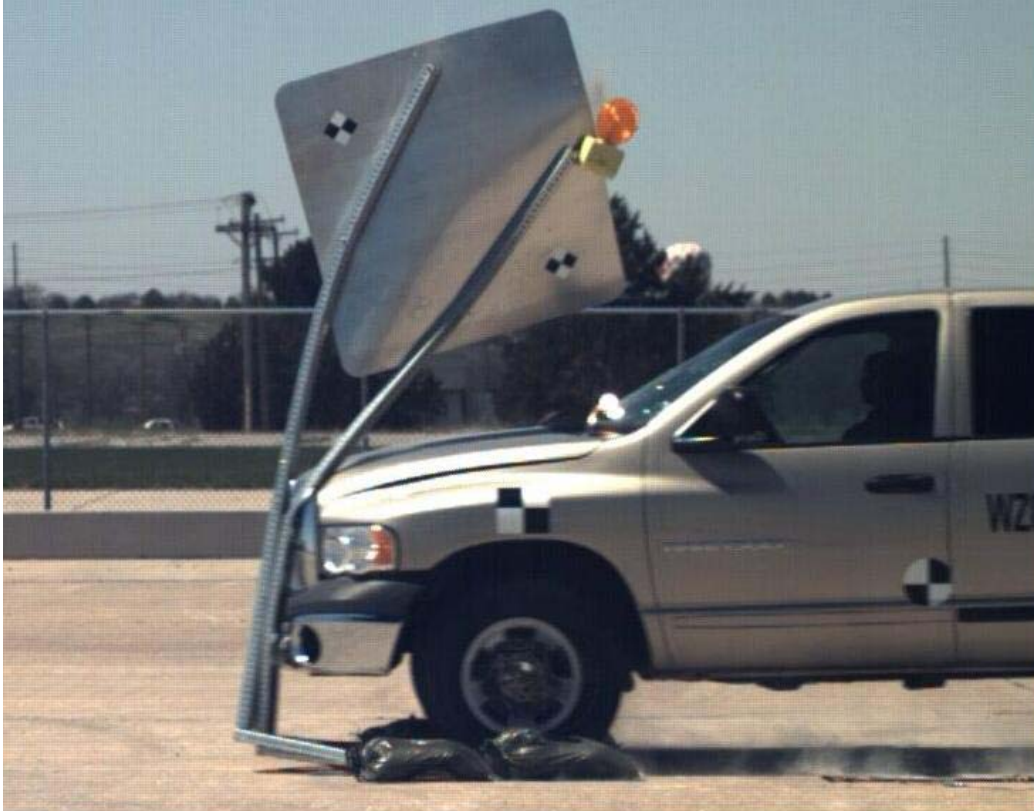
Figure 104. System No. 1B, Base-Bending Mast

mast typically releases from the stand late in the event, if at all, which adds to the amount of flex in the sign panel and mast. When the mast bends or has a delayed fracture, it is more likely that the sign panel or flag assembly will impact the windshield at a high rate of speed. When the connection between the upper and lower masts fails upon impact, the mast and sign panel cause insignificant damage (System Nos. 3B and 4B).

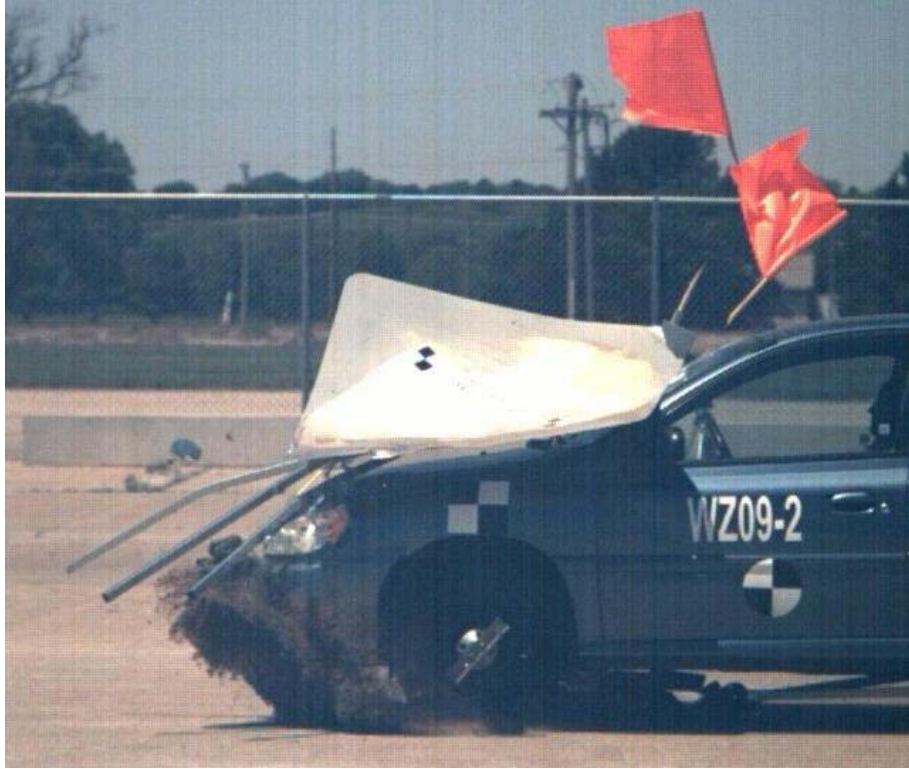
Figure 105. System No. 2B, Tripod Oriented at 90 Degrees

Sign stands that resemble a tripod shape when oriented 90 degrees to the vehicle were found to have a potential to rotate and rise into the air, resulting in the top of the support impacting and penetrating the windshield, as shown in Figure 105 (System No. 2B). Since the legs and mast were not intended to breakaway or yield significantly, the motion and weight of the entire system had the potential for significant windshield damage.

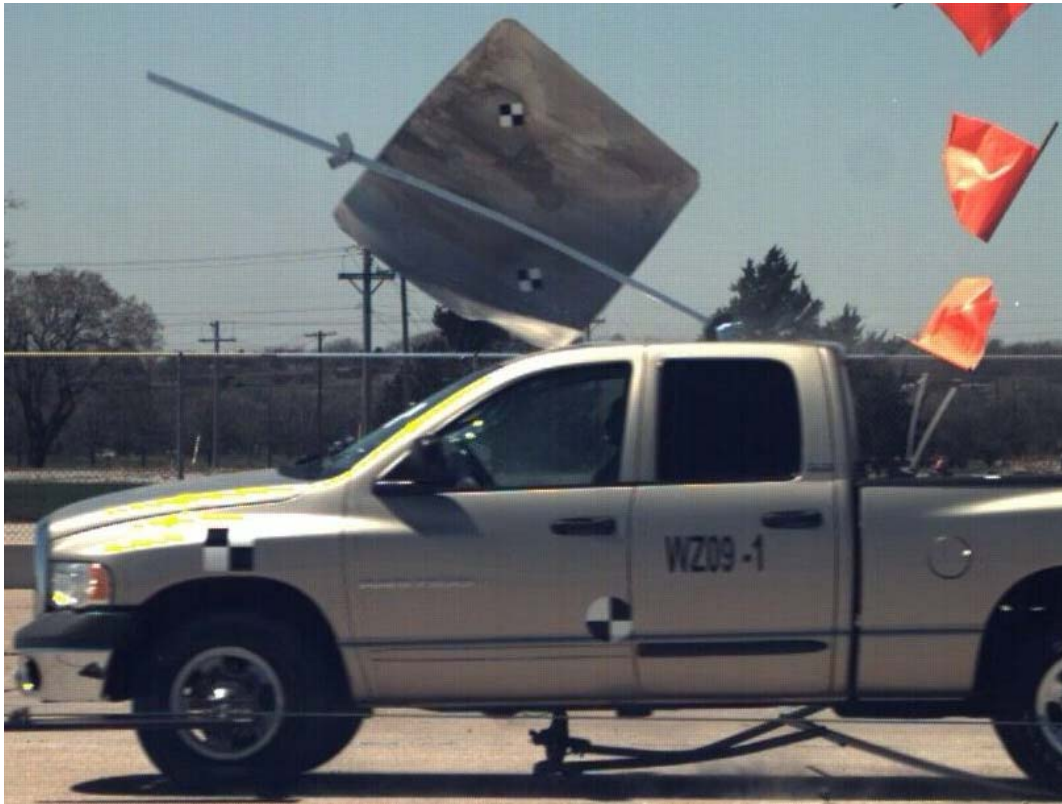
Figure 106. System No. 1A, Flag Holder Penetrating the Roof

Many of the wood-dowel flags disengaged from the flag holder without contacting the vehicle (System Nos. 1A, 3A, and 3B). In some cases, the lack of flags left the flag holder or

mast end exposed with the potential to rotate into and penetrate the roof, as shown in Figure 106 (System Nos. 1A). Some of the wood dowels fractured in their holders, thus disengaging the flags. However, the flags and the exposed flag holder did not show any potential for vehicle damage (System No. 2A). Some flag holders did not disengage the flags upon impact; therefore, these flags and holders followed the trajectory of the mast (System No. 4B). Most of the time, the addition of flags did not negatively affect the safety performance of a work-zone traffic control device. However, if the wood dowels fracture as the flag holder or mast penetrates the windshield, the fractured ends become flying debris and a potential hazard to the occupants of vehicles (System No. 2B). Fiberglass flag staffs would have performed in a different manner than the wood-dowel flags, but it is unclear what effect they would have on the safety performance of any of the work-zone traffic control devices.
