# **Performance Evaluation of a Dual Support Sign with Ground Mounted Pipe Posts and Multi-Directional Slip Bases**

**September 1995**

1. Performing Organization Report No. TRP-03-50-95	2. Report Date September 20, 1995	3. Type of Report and Period Covered Final Report: December 1994 to September 1995

4. Title and Subtitle Performance Evaluation of a Dual Support Sign with Ground Mounted Pipe Posts and Multi-Directional Slip Bases		
5. Author(s) Holloway, J.C., Reid, J.D.

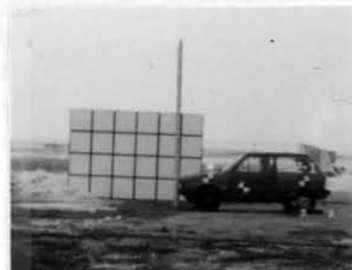
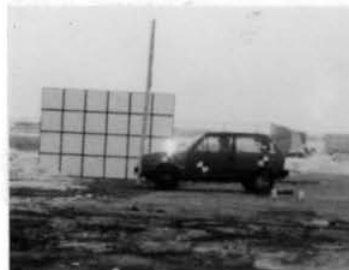
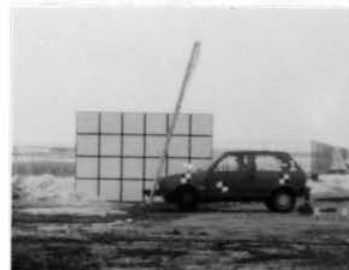
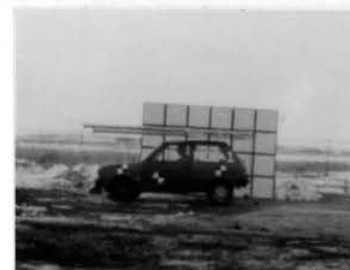
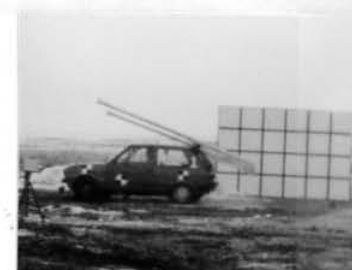
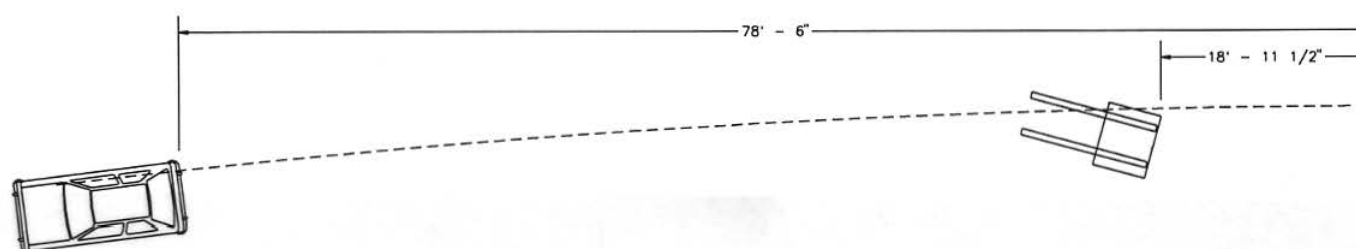
Figure 4. Summary and Sequential Photographs, MO2-1

After the initial impact with the sign post, the front bumper crushed inward for approximately 0.019 sec before the slipbase began to activate. The post lost contact with the car at approximately 0.078 sec. Approximately 0.409 sec after impact, the sign made contact with the top of the vehicle, causing a slight crease in the roof.

Test Number	MO2-1
Date	3/9/95
Appurtenance	Dual Support Highway Sign with Ground Mounted Pipe Posts and Multi-Directional Slip Bases
Sign Size	1829 mm x 1524 mm (6 ft x 5 ft)
Sign Panel	Aluminum Flat Sheet
Sign Panel Thickness	3 mm (0.125 in.)
Sign Mounting Height From Ground Level	2362 mm (7 ft - 9 in.)
Support Size	76 mm (3 in.) Nominal Diam. Pipe
Post Spacing	1118 mm (3 ft - 8 in.)
Concrete Footing Size	305 mm (12 in.) x 1372 mm (4½ ft) deep
Multi-directional Slip Base	
Slip Bolt Size	12.7 mm (½ in.) x 89 mm (3½ in.)
Bolt Torque	15.8 N-m (140 in-lbs)
Stub Height	101.6 mm (4 in.)
NCHRP 350 Vehicle Class	820C
Model	1987 Yugo GV
Mass	
Curb	821 kg (1810 lb)
Test Inertial	845 kg (1862 lb)
Gross Static	908 kg (2002 lb)

Vehicle Speed	
Impact	36.4 km/h (22.6 mph)
Exit	32.0 km/h (19.9 mph)
Vehicle Angle	
Impact	0.0 deg
Exit	0.0 deg
Vehicle Impact Location	Center of both posts
Vehicle Snagging	None
Vehicle Stability	Satisfactory
Occupant Impact Velocities	
Longitudinal	NA (no occupant impact)
Lateral	NA (no occupant impact)
Occupant Ridedown Decelerations	
Longitudinal	NA (no occupant impact)
Lateral	NA (no occupant impact)
Vehicle Damage	
TAD (4)	12-FL-1, 12-FR-1
VDI (5)	12FLEN1, 12FREN1
Front End Crush	64 mm (2.5 in.)
Vehicle Change in Speed	1.2 m/s (4.0 fps)
Sign Damage	None

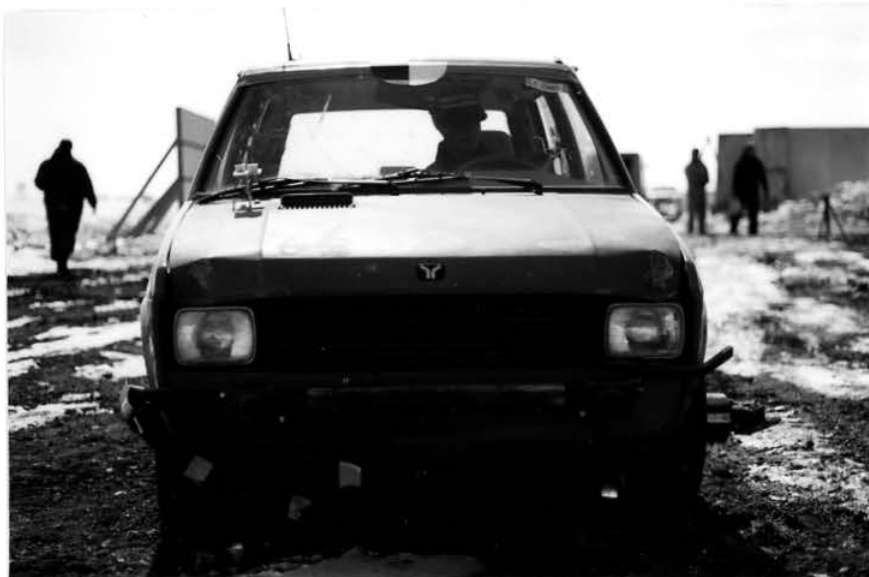
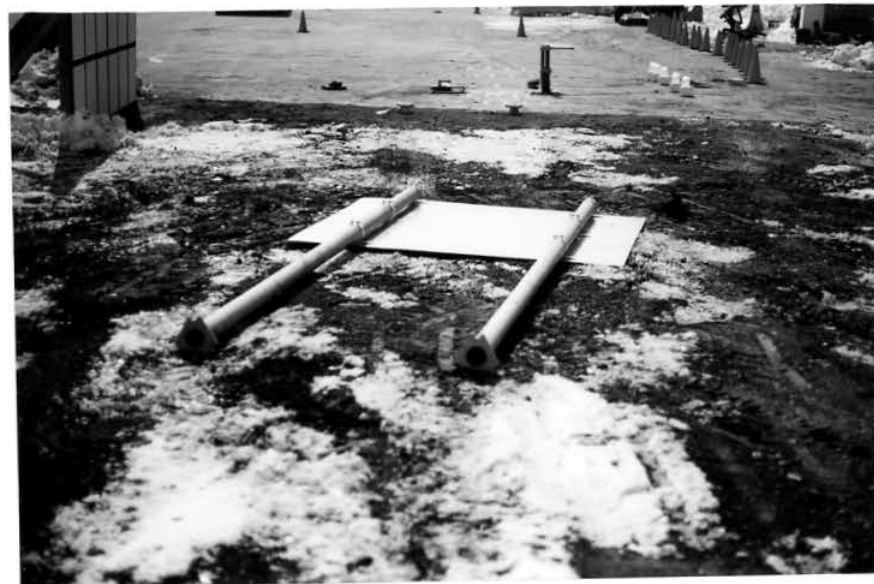
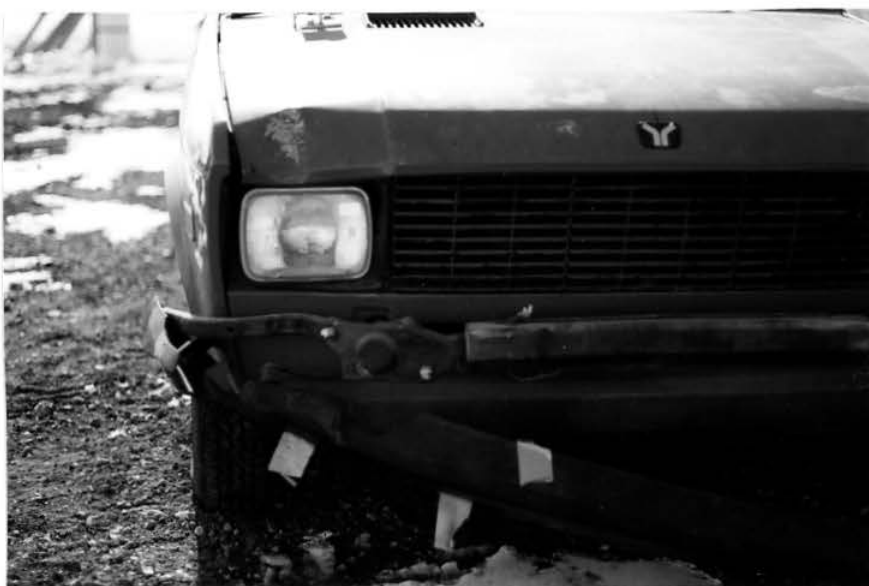
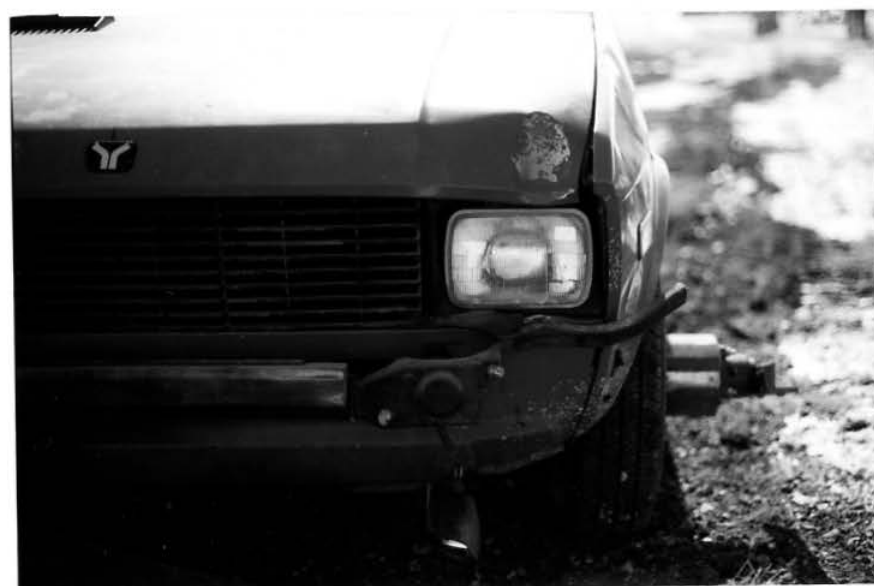
Figure 6. Vehicle and Installation Damage, MO2-1

Test vehicle damage consisted of frontal crush to the bumper and hood, as shown in Figure 6. A maximum crush depth of 64 mm (2.5 in.) was measured on the front bumper. Other damage included scrapes and minor dents on the right-side door handle and roof from sign and post contact. The vehicle safely passed over the post stub, resulting in no suspension or undercarriage damage, although two of the left-front wheel screw-type lugs pulled out during the test. The pipe posts and sign were undamaged and remained connected together by the clamp type sign supports, as shown in Figure 6. The final resting position of the sign was approximately 5.8 m (19 ft) downstream of the stub posts. The vehicle came to rest approximately 24 m (79 ft) downstream of the stub posts, as shown in Figure 4.

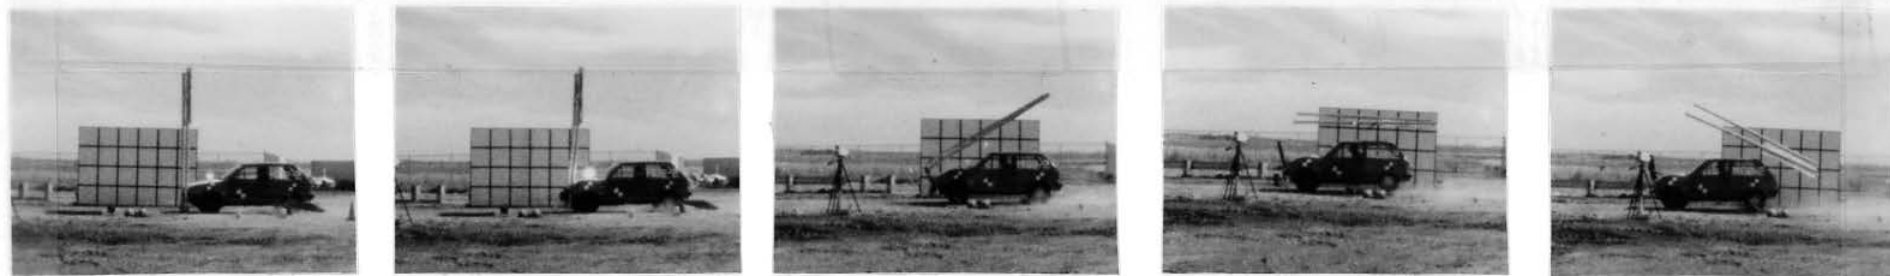
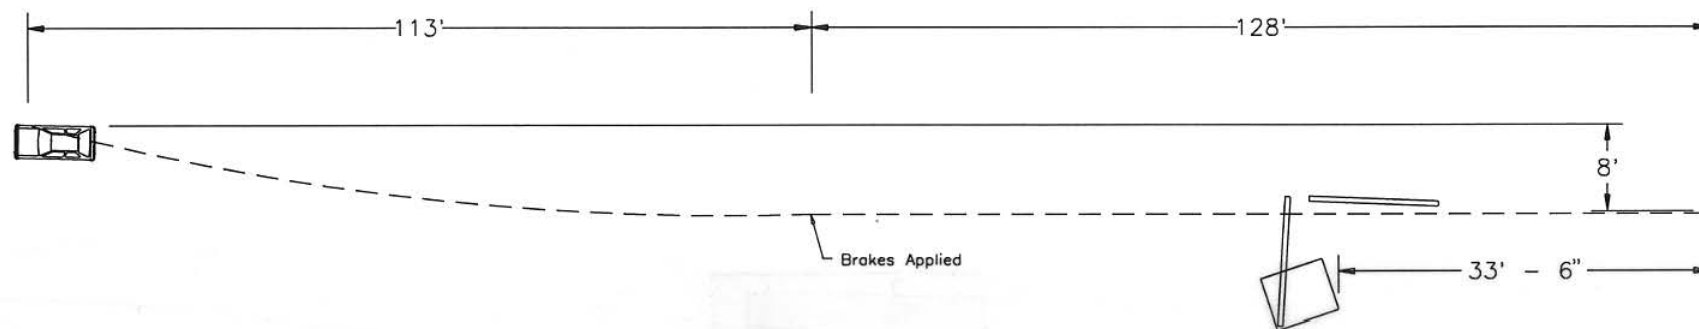
Figure 7. Summary and Sequential Photographs, MO2-2

After the initial impact with the sign post, the front bumper crushed inward for approximately 0.006 sec before the slipbase began to activate. The post lost contact with the car at approximately 0.069 sec after impact. At 0.099 sec, the rear tires of the test vehicle hit the stub post causing the vehicle's rear end to leave the ground. The rear wheels returned to the ground at 0.187 sec. The sign hit the ground at approximately 0.266 sec and became detached from the passenger side post at 0.720 sec. The vehicle came to rest approximately 73.5 m (241 ft) downstream of the stub posts, as shown in Figure 7.

Test Number	MO2-2
Date	3/21/95
Appurtenance	Dual Support Highway Sign with Ground Mounted Pipe Posts and Multi-Directional Slip Bases
Sign Size	1829 mm x 1524 mm (6 ft x 5 ft)
Sign Panel	Aluminum Flat Sheet
Sign Panel Thickness	3 mm (0.125 in.)
Sign Mounting Height From Ground Level	2362 mm (7 ft - 9 in.)
Support Size	76 mm (3 in.) Nominal Diam. Pipe
Post Spacing	1118 mm (3 ft - 8 in.)
Concrete Footing Size	305 mm (12 in.) x 1372 mm (4½ ft) deep
Multi-directional Slip Base	
Slip Bolt Size	12.7 mm (½ in.) x 89 mm (3 ½ in)
Bolt Torque	15.8 N-m (140 in-lbs)
Stub Height	101.6 mm (4 in.)
NCHRP 350 Vehicle Class	820C
Model	1987 Yugo GV
Mass	
Curb	821 kg (1810 lb)
Test Inertial	845 kg (1862 lb)
Gross Static	908 kg (2002 lb)

Vehicle Speed	
Impact	96.7 km/h (60.1 mph)
Exit	90.4 km/h (56.2 mph)
Vehicle Angle	
Impact	0.0 deg
Exit	0.0 deg
Vehicle Impact Location	Center of both posts
Vehicle Snagging	None
Vehicle Stability	Satisfactory
Occupant Impact Velocities	
Longitudinal	NA (no occupant impact)
Lateral	NA (no occupant impact)
Occupant Ridedown Decelerations	
Longitudinal	NA (no occupant impact)
Lateral	NA (no occupant impact)
Vehicle Damage	
TAD (4)	12-FL-1, 12-FR-1
VDI (5)	12FLEN1, 12FREN1
Vehicle Front End Crush	203 mm (8 in.)
Vehicle Change in Speed	1.8 m/s (5.8 fps)
Sign Damage	Minor

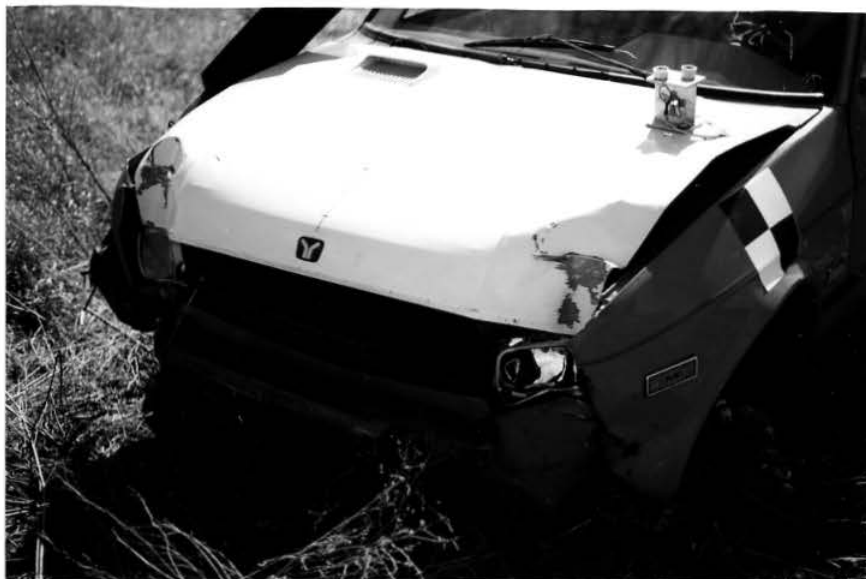
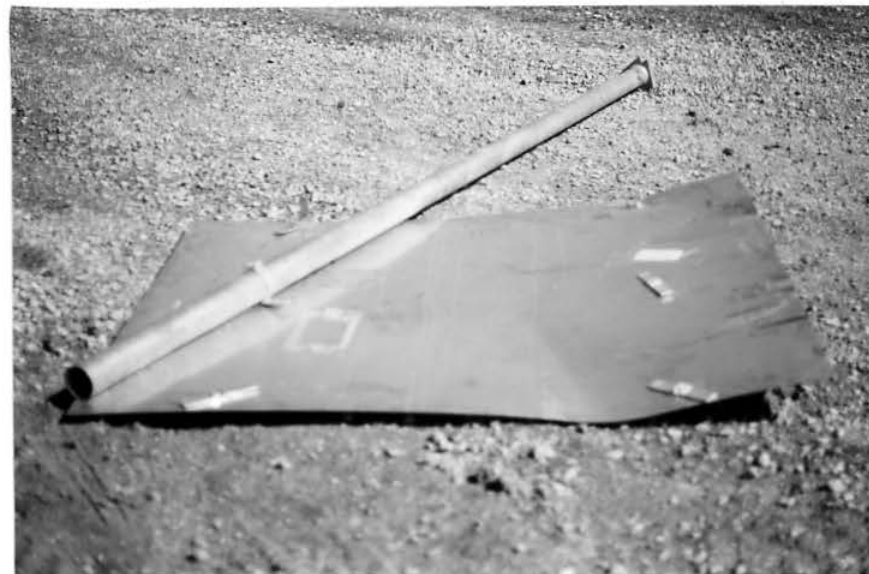
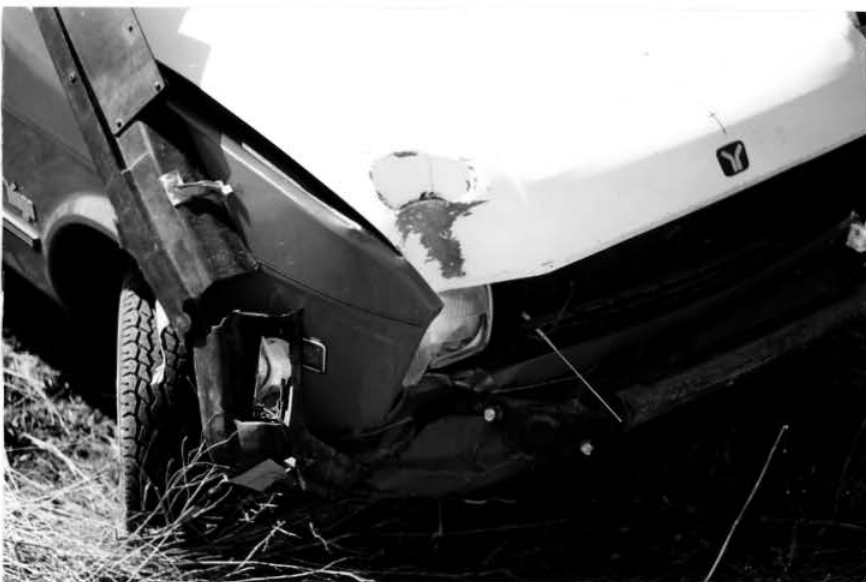
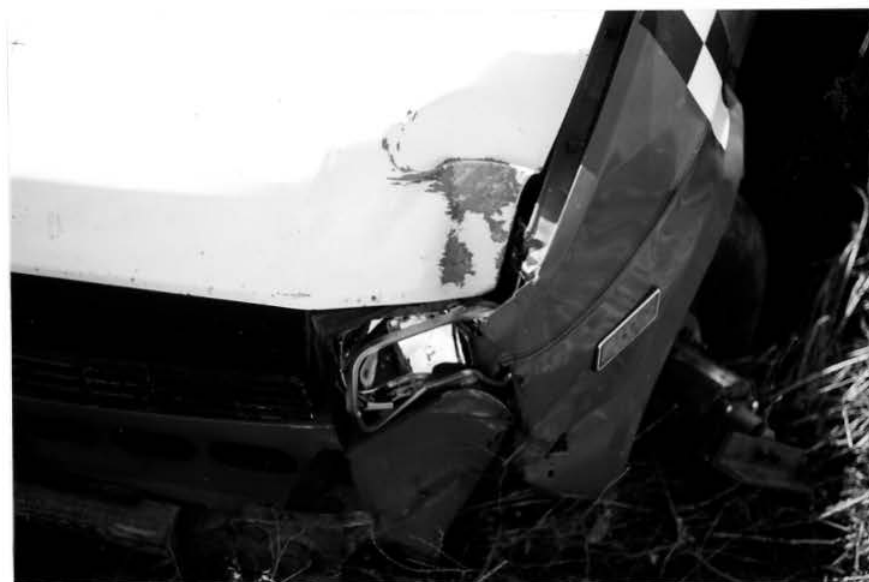
Figure 9. Vehicle and Installation Damage, MO2-2

Vehicle damage consisted of frontal crush to the bumper and hood at the impact location. A maximum crush depth of approximately 203 mm (8 in.) was measured on the hood at the driver's side impact location. Both fenders were curved inward around the headlights. Other damage included the disengagement of the left front bumper connection, buckling of the hood, and minor scrapes and dents on the right rear corner of the roof and the right-rear quarter panel. There was no significant damage to the suspension or the undercarriage and no broken glass or occupant compartment damage occurred. The damage to the test vehicle is shown in Figure 9.

Five of the six clamps that connect the sign to the posts were broken off after the sign contacted the ground. Other damage included buckling of the sign, and tire marks on the stub post. There was no damage to the posts. The components of the sign were scattered, as shown in Figure 7.
