# **CRASH TESTING OF MISSOURI'S W-BEAM TO THRIE-BEAM TRANSITION ELEMENT**

## **MIDWEST ROADSIDE SAFETY FACILITY**

MwRSF Research Report No. TRP-03-94-00

September 12, 2000

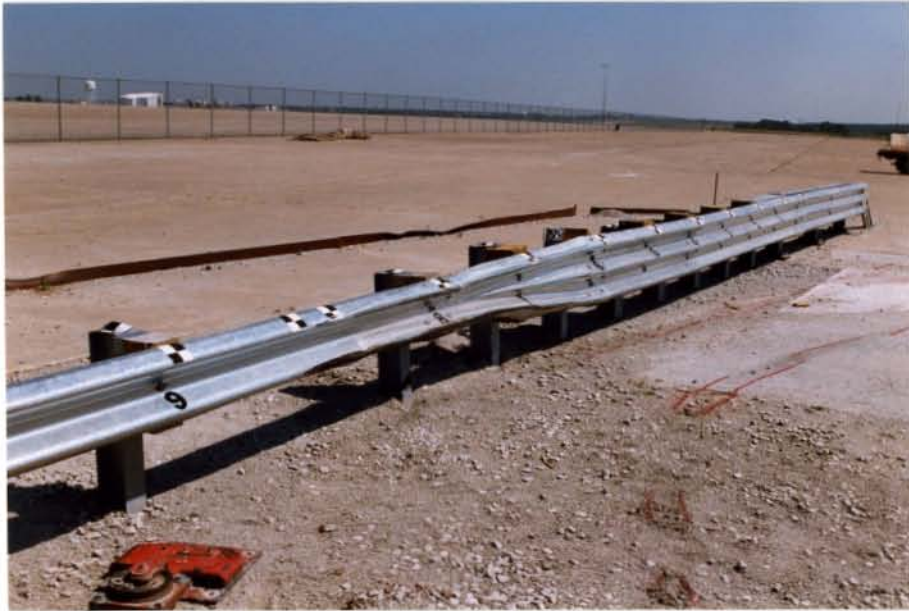
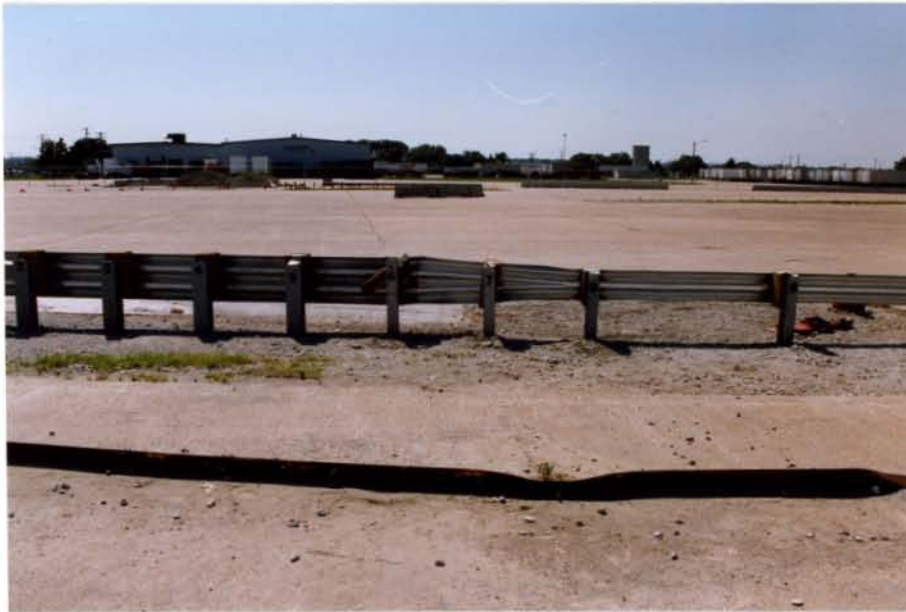
Figure 28. W-beam to Thrie Beam Transition Damage, Test MWT-1

Damage to the barrier was minimal, as shown in Figures 28 through 32. Barrier damage consisted mostly of deformed W-beam, contact marks on a guardrail sections, deformed guardrail posts, and damaged spacer blocks. The W-beam to thrie beam transition element damage consisted of moderate deformation and flattening of the lower corrugation. Contact marks were found on the W-beam and W-beam to thrie beam section between post nos. 6 and 9. Black marks were found along the bottom corrugation and green and red marks were found on the top and middle

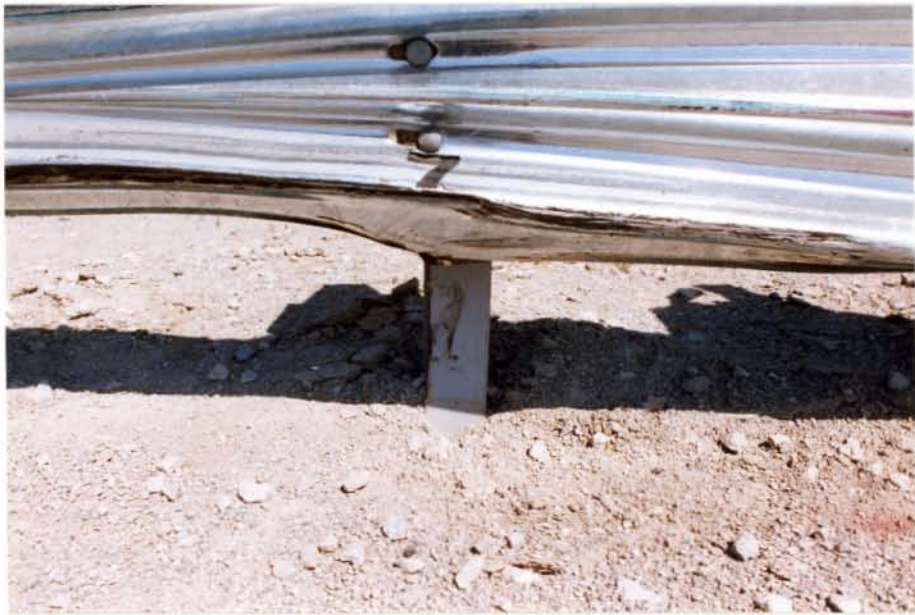
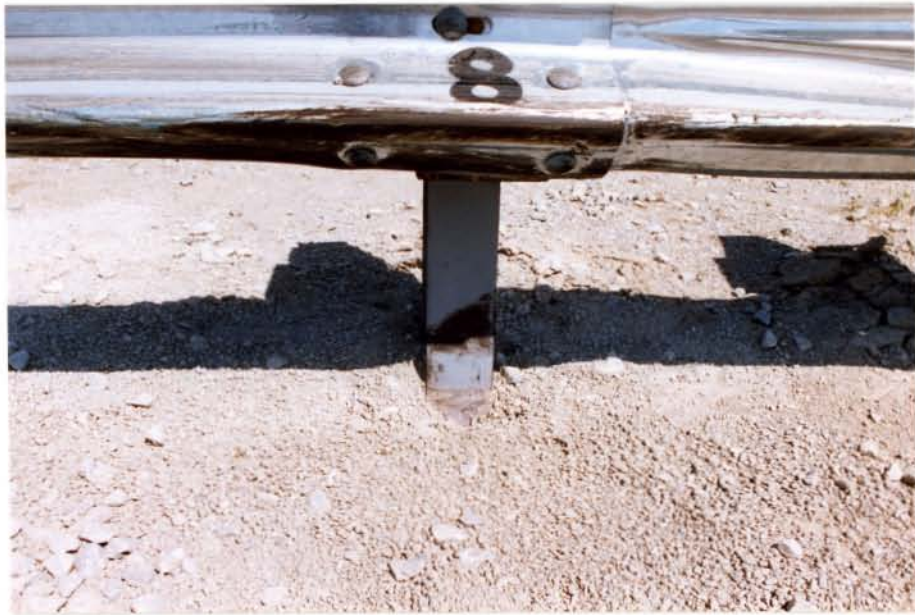
Figure 30. Post Nos. 7 and 8 Damage, Test MWT-1

During the impact event, damage and deformations were observed at several post locations and consisted of permanent post deformations, contact marks, and damaged wooden blockouts. Post nos. 5 through 8 deflected backwards. Post no. 7 also was twisted. Black contact marks were found on the front faces of post nos. 6 through 8 and the wood blockouts of post nos. 7 and 8. The wood blockouts at post nos. 6, 9, and 10 were cracked. The wood blockout at post no. 6 also was split. No significant post or guardrail damage occurred upstream of post no. 10 nor downstream of post no. 4.

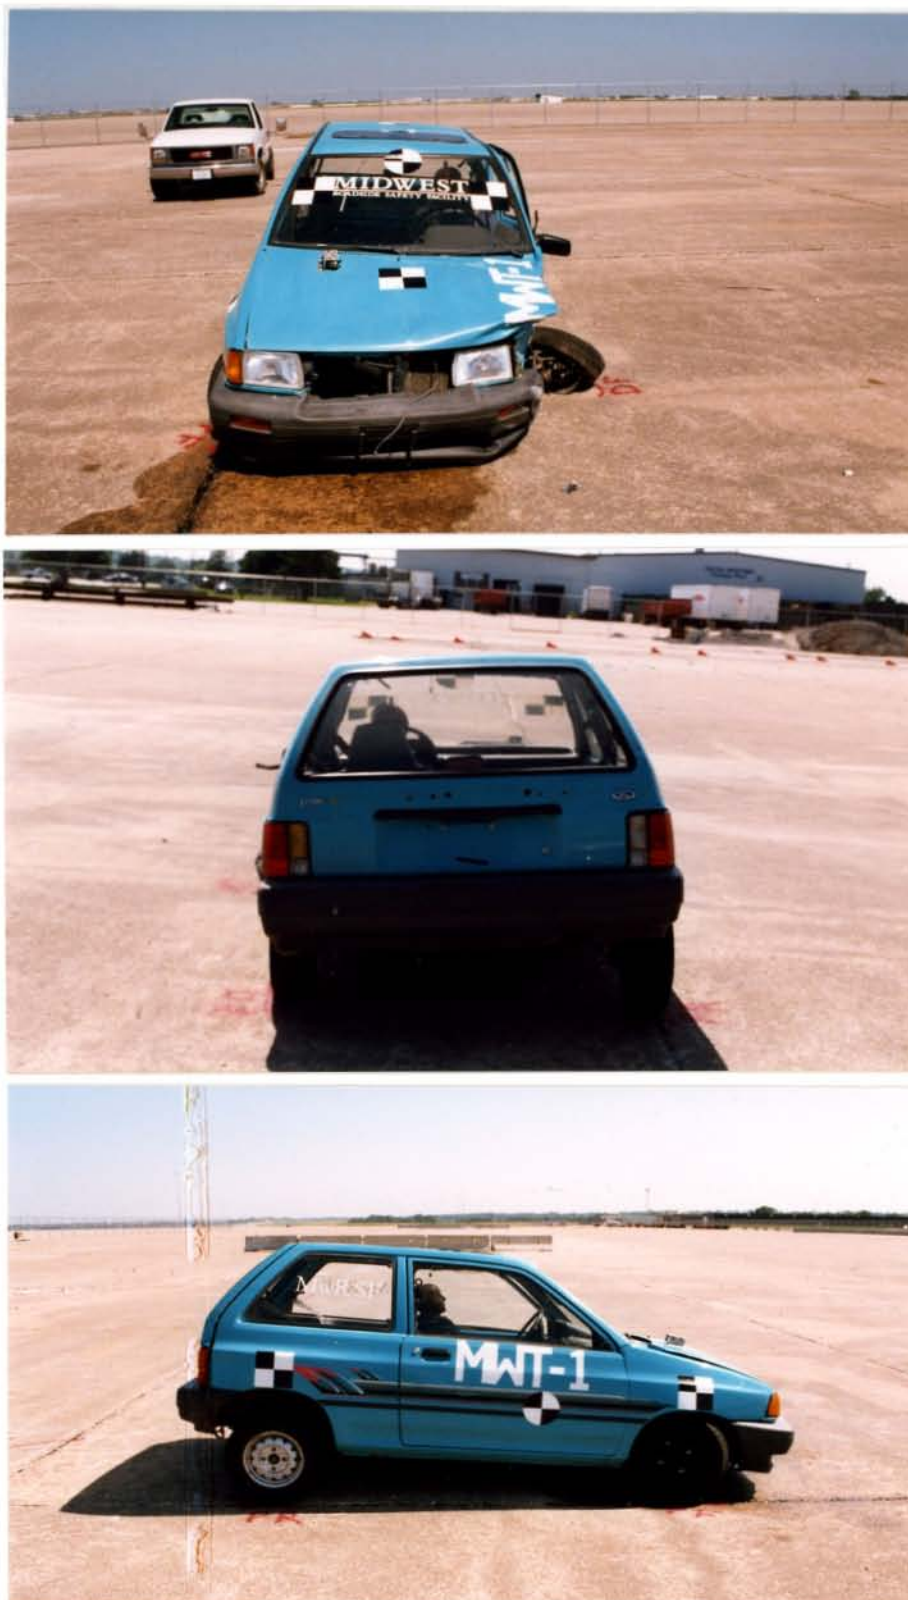
Figure 33. Vehicle Damage, Test MWT-1

Exterior and interior vehicle damage was moderate, as shown in Figures 33 through 35. Most of the vehicle damage occurred near the left-front corner of the vehicle, as shown in Figure 34. The left-front corner was crushed inward toward the engine. The major left-front wheel components, such as the lower A-frame, the tie rod end, the brake line, and the shock attachment, disengaged. Major damage occurred to the left-front tire rim, and the tire was slashed. The vehicle's left side encountered contact marks and deformations due to the vehicle/rail interlock. The engine hood was shifted to the right, and the grill disengaged from the front mounts. The plastic, front-bumper cover

was also deformed. The left-door's window was shattered. The top of the left door was ajar, and the lower portion of the door was deformed inward. A longitudinal buckling point was found on the left side of the roof, 660 mm from the A-pillar. The maximum occupant compartment deformation occurred near the lower-left corner of floorboard as the sheet metal was pushed inward 104 mm. The right side and rear remained undamaged.

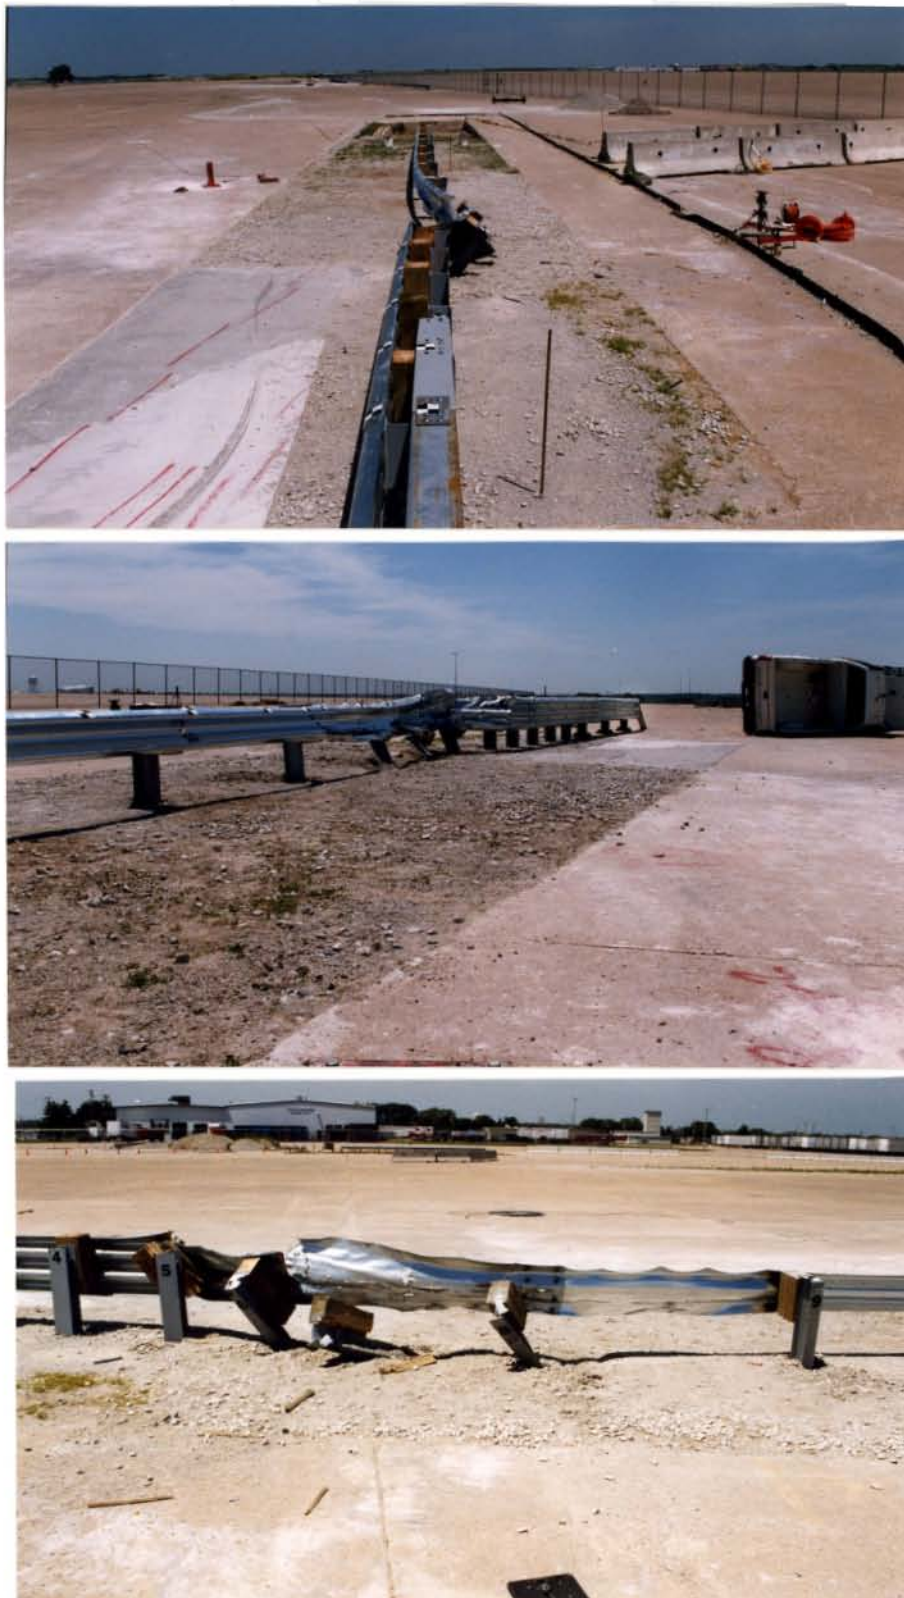
Figure 44. W-beam to Thrie Beam Transition Damage, Test MWT-2

Damage to the barrier was moderate, as shown in Figures 44 through 50. Barrier damage consisted mostly of deformed guardrail including W-beam, W-beam to thrie beam transition, and thrie beam, contact marks on a guardrail, deformed guardrail posts, and damaged spacer blocks. The W-beam damage consisted of moderate deformation and flattening of the lower portion of the impacted section between post nos. 8 and 9. The W-beam to thrie beam transition damage consisted of moderate deformation and flattening of the impacted section of transition between post nos. 6 and 8. The thrie beam damage consisted of moderate deformation and flattening of the impacted section of rail between post nos. 4 and 6. The W-beam to thrie beam transition element ripped at the guardrail splice located on the upstream side of post no. 6, as shown in Figure 45. Contact marks were found on the guardrail between post nos. 4 and 10.

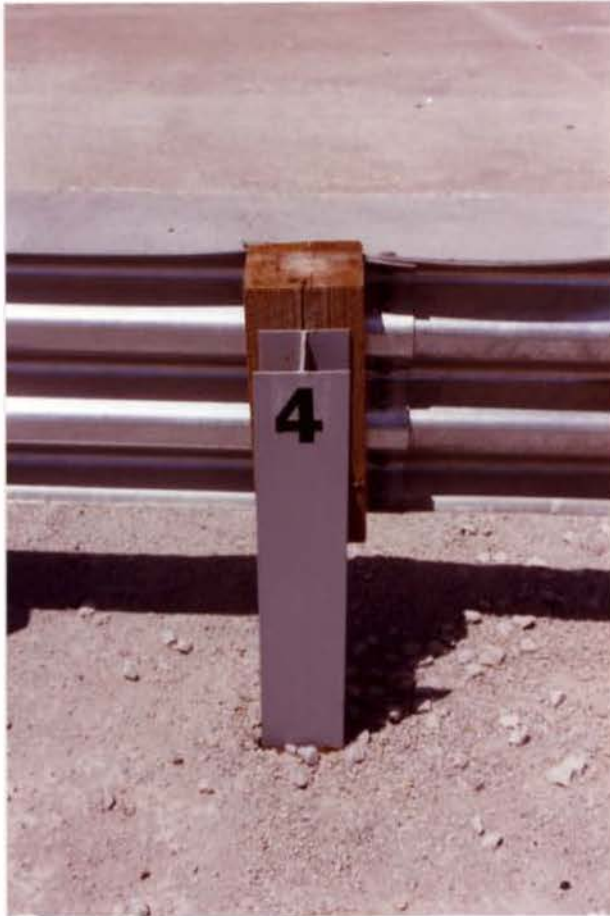
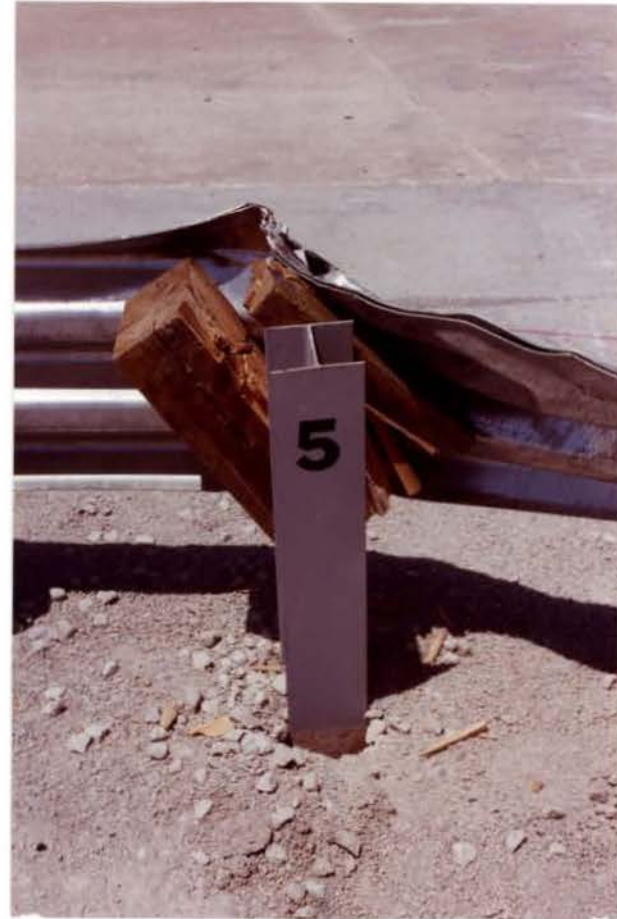
Figure 47. Post Nos. 4 and 5 Damage, Test MWT-2

contacted on the front edge and nearly flattened. Post no. 7 was not contacted, but was rotated and deformed to the ground. Post no. 6 was not contacted, but was twisted and flattened. Post nos. 2 through 5 were not contacted, but moved slightly with soil failure. The wood blockout at post no. 5 split down the blockout's length at the traffic-side quarter-point. No significant post or guardrail damage occurred downstream of post no. 1.

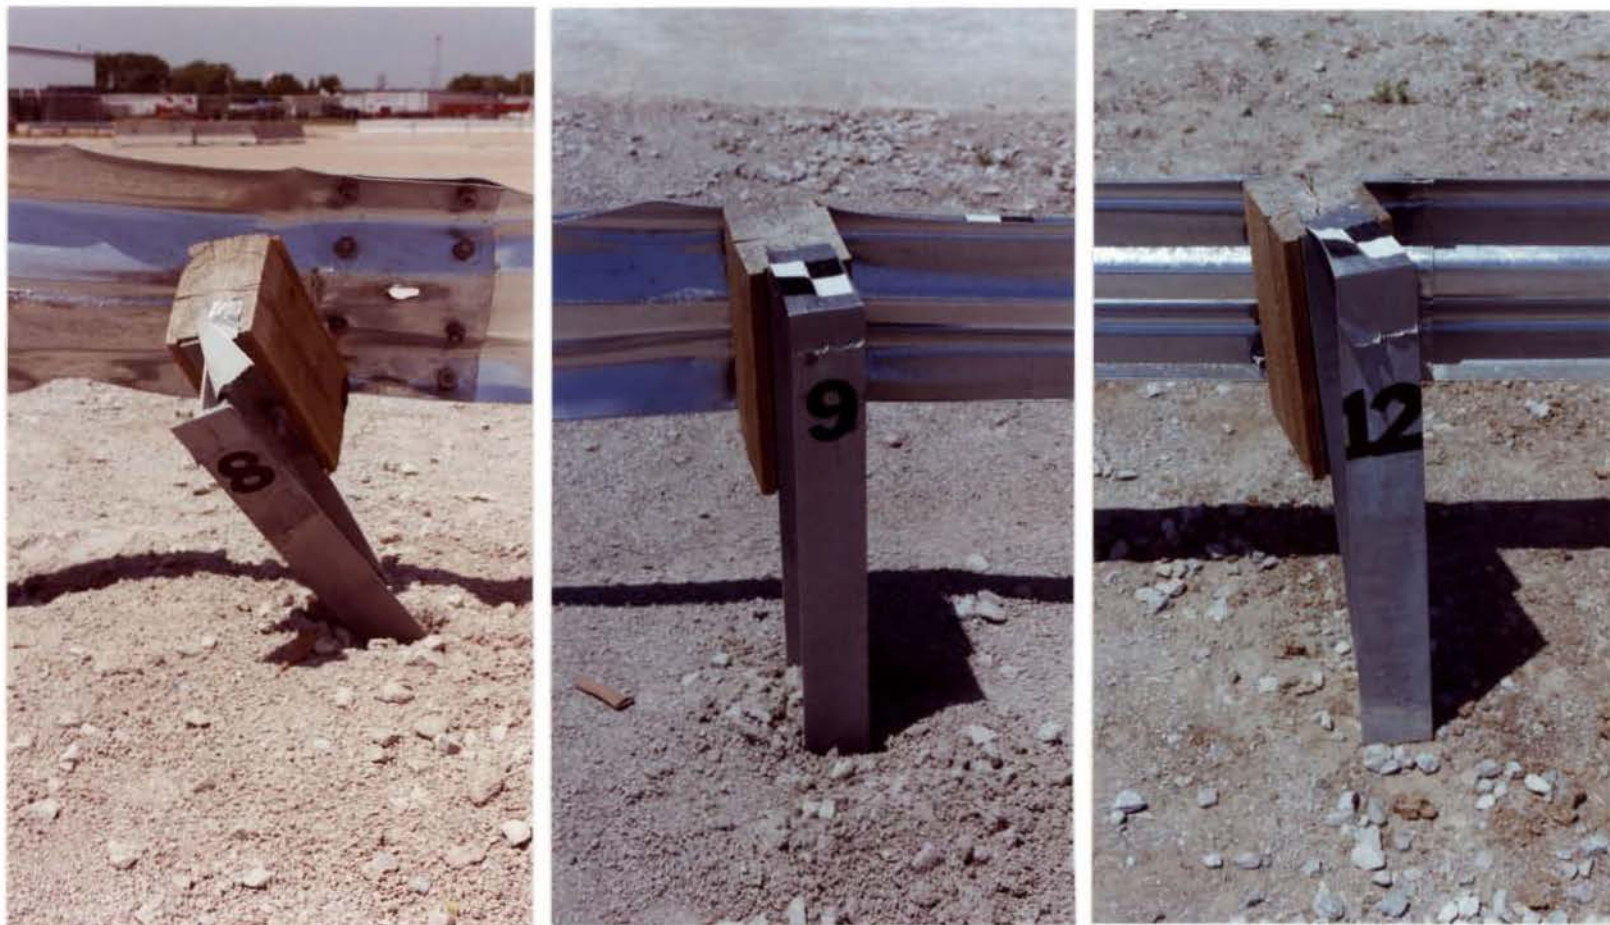
Figure 49. Post Nos. 8, 9, and 12 Damage, Test MWT-2

During the impact event, damage and deformations were observed at several post locations and consisted of permanent post deformations, contact marks, and damaged wooden blockouts. Post nos. 10 through 14 were twisted and the bolts pulled through the bolt holes in the guardrail causing slot damage. Post no. 9 was not contacted but twisted and rotated backward. Post no. 8 was

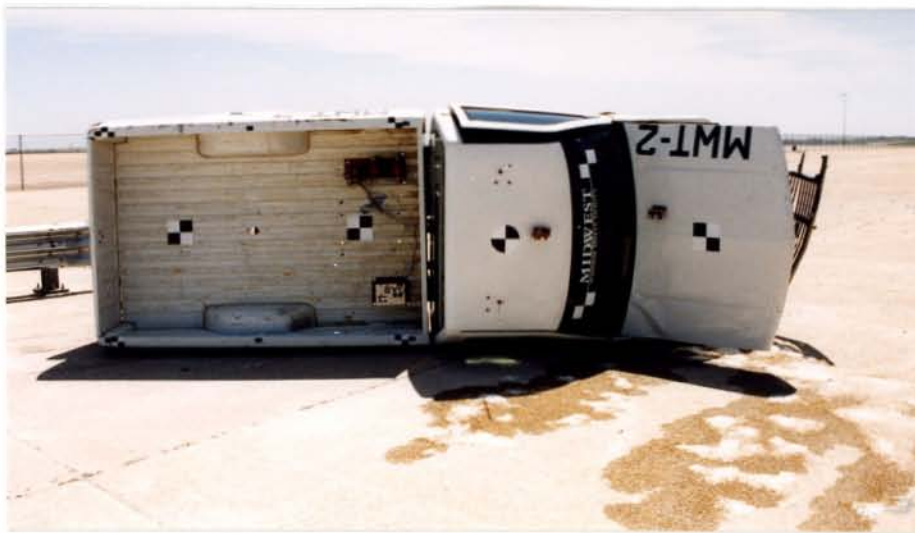
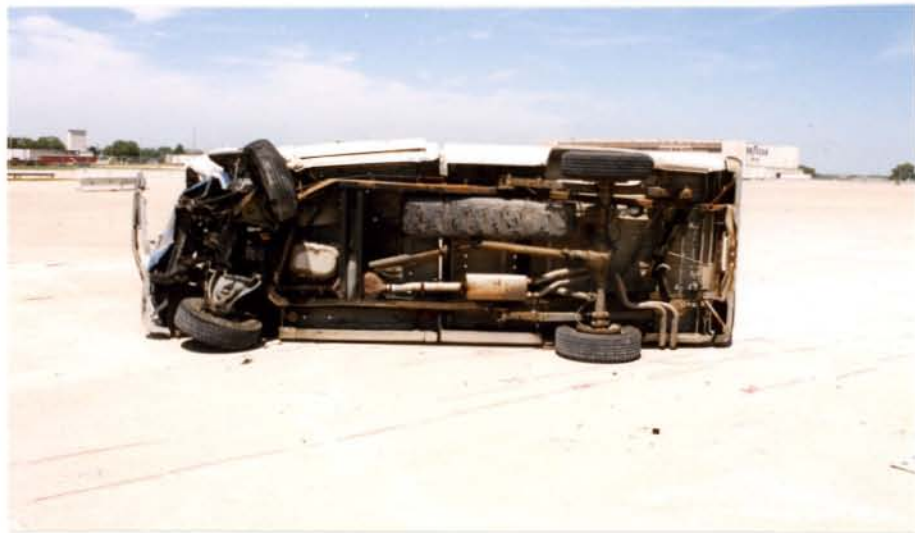
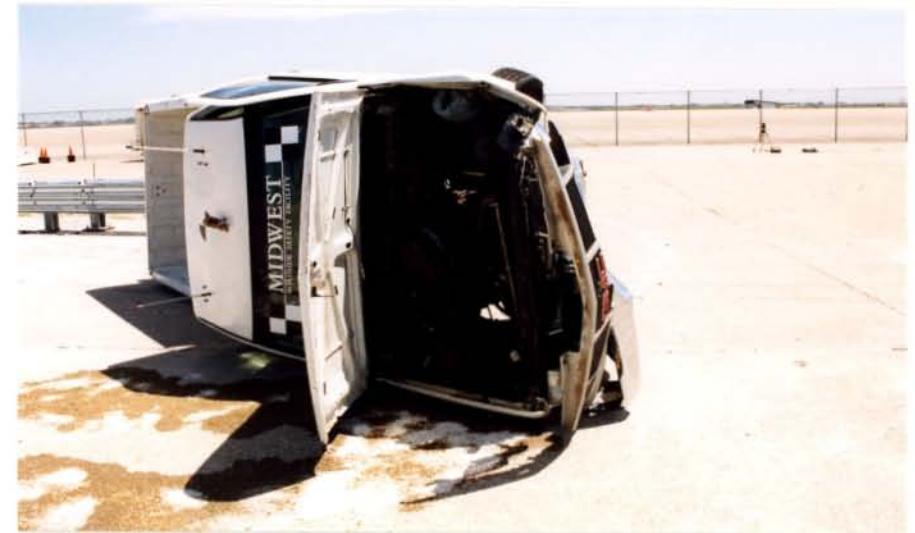
Figure 51. Vehicle Damage, Test MWT-2

Exterior and interior vehicle damage was extensive and occurred at several body locations, as shown in Figures 51 through 53. Most of the vehicle damage occurred to the left-front corner of the vehicle. Severe deformation and damaged occurred to the left-front frame and bracket, the left-front wheel and suspension, and the front bumper. All of the major left-front wheel linkages, including the tie rod, the ball joint, and the sway bar, disengaged. The engine and transmission mounts also disengaged. Deformation occurred to the drive shaft. The left-front steel rim encountered major damage. The floorboard's center hump buckled toward the occupant compartment's rear wall. The firewall of the occupant compartment crushed inward under the brake pedal. All the window glass remained undamaged.
