DESIGN AND EVALUATION OF MINNESOTA'S TIMBER RUB-RAIL FOR NOISE BARRIERS

MIDWEST ROADSIDE SAFETY FACILITY

MwRSF Research Report No. TRP-03-156-05

March 8, 2005

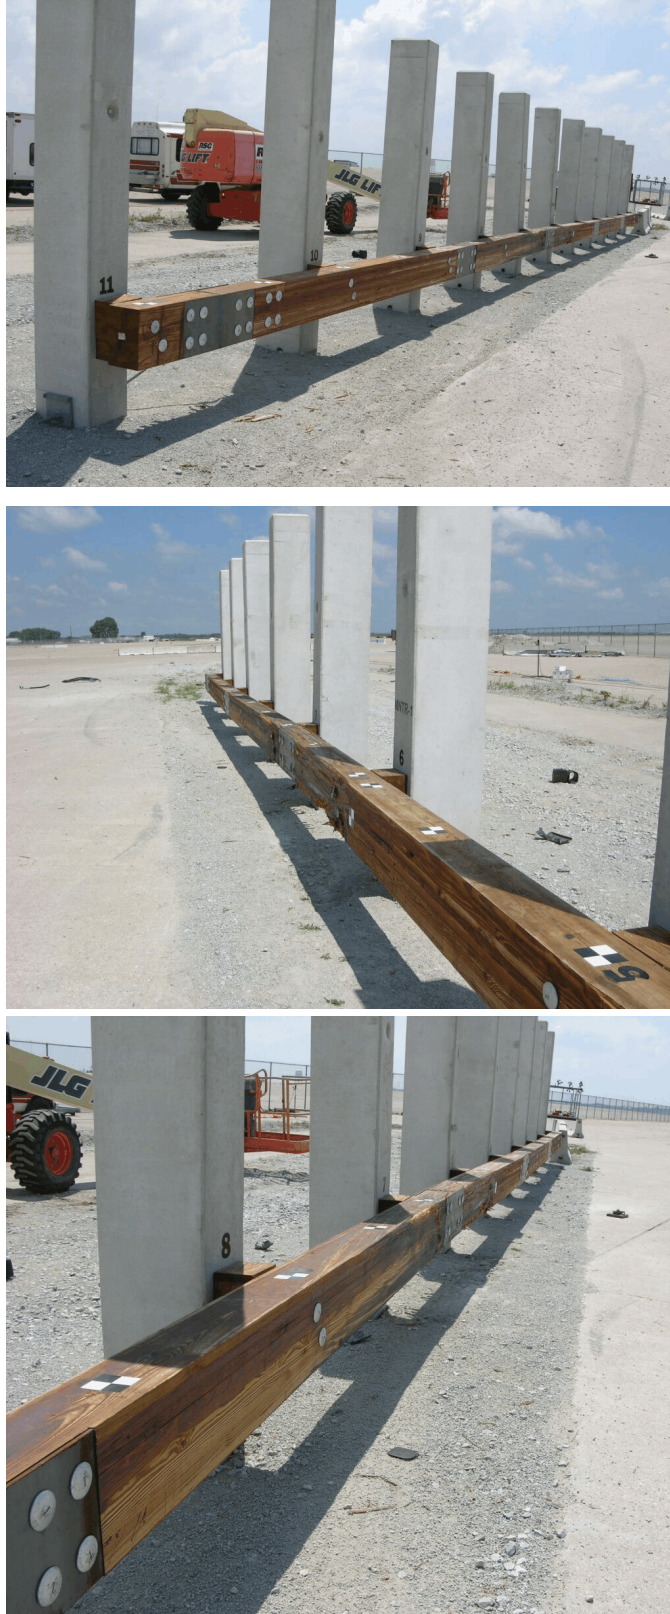
Figure 32. System Damage, Test MNTR-1

Damage to the timber rub rail for noise barriers was minimal, as shown in Figures 32 through 39. Barrier damage consisted of contact and gouge marks on a timber rail section, contact marks on posts, a damaged wooden blockout, and deformed bolts. The length of vehicle contact along the timber rub rail was approximately 5 m (16.5 ft), which spanned from 254 mm (10 in.) upstream from the centerline of post no. 6 through the upstream edge of post no. 8.

Significant gouging occurred to the top and front faces of the timber rail between post nos. 6 and 8. Contact marks were also found on the top and front faces of the timber rail between post nos. 6 and 8. Black contact marks and scratches were found on the splice plate between post nos. 6 and 7 and bolts within this splice. No significant timber rail damage occurred upstream of post no. 6 nor downstream of post no. 9.

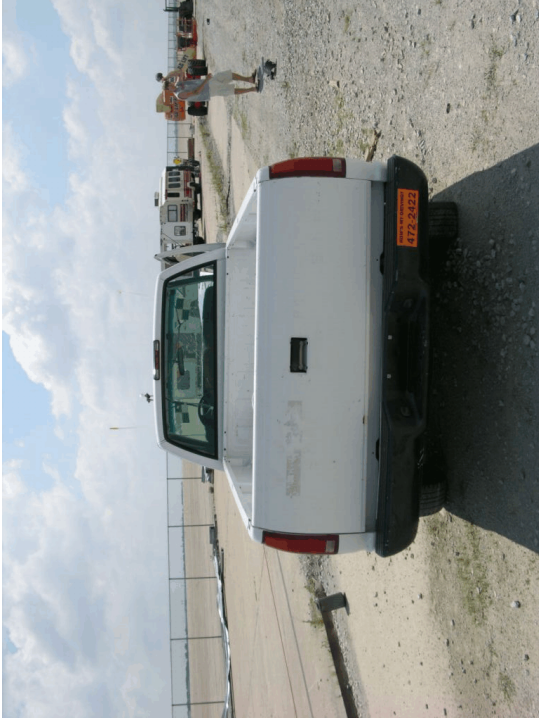
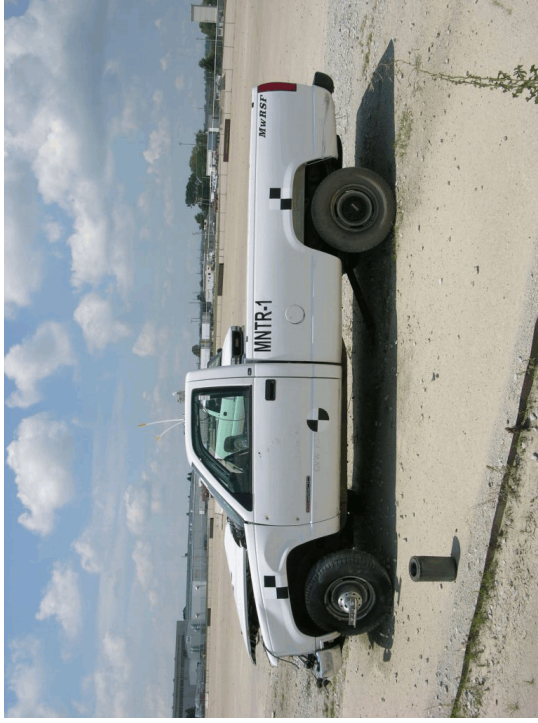
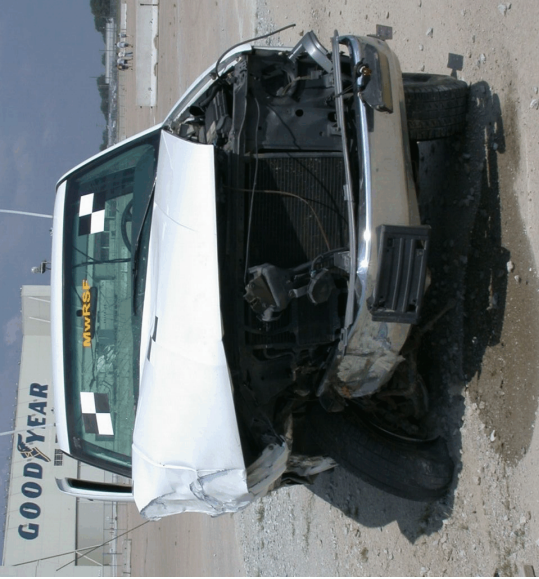
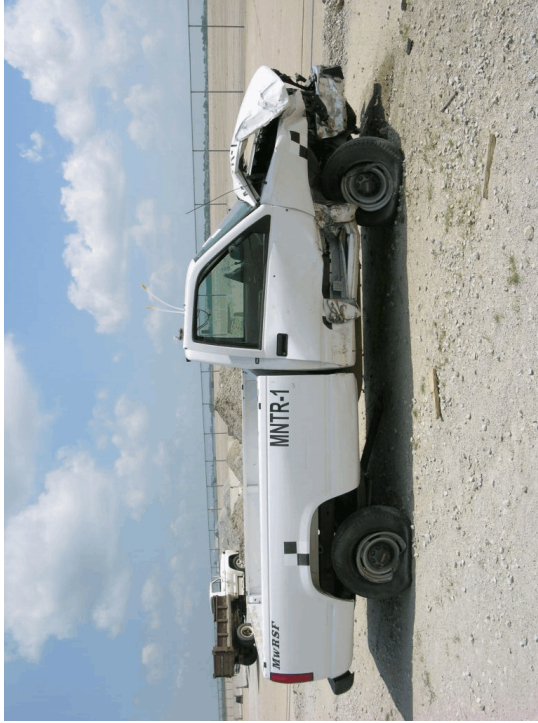
Figure 40. Vehicle Damage, Test MNTR-1

Exterior vehicle damage was moderate, as shown in Figures 40 through 45. Occupant compartment deformations to the right side and center of the floorboard, as shown in Figure 45, were judged insufficient to cause serious injury to the vehicle occupants. Maximum longitudinal deflections of 89 mm (3 ½ in.) were located near the left-front corner of the right-side floor pan. Maximum lateral deflections of 159 mm (6 ¼ in.) and 190.5 mm (7 ½ in.) were located near the right-front corner and front-center of the right-side floor pan, respectively. Maximum vertical deflections of 95 mm (3 ¾ in.) were located near the right-front corner and left-front corner of the right-side floor pan. Complete occupant compartment deformations and the corresponding locations are provided in Appendix C.

Damage was concentrated on the right-front corner of the vehicle. The right-front quarter

panel was crushed inward and downward. The left-front quarter panel was dented near the front of the left-side door. The right side of the front bumper was flattened and bent back toward the engine compartment. The right-rear fender was deformed upward behind the wheel well. The box encountered numerous dents along the entire right side. The cab portion of the vehicle was shifted to the left. Rubber contact marks were found on the left rear of the truck box. Severe sheet metal tearing was found on the lower portion of the right-side door. The lower rear of the right-side door encountered dents. The top of the left door was ajar. The hood was buckled and jarred open. The grill was fractured and completely disengaged from the rest of the vehicle. Both the right-side and left-side headlights were fractured. The right-front wheel assembly deformed and crushed inward toward the engine compartment with severe frame damage occurring at the right-front wheel assembly. The right side of the frame was bent and deformed, and a buckle point was found on the lower flange at the center of the right-side door. A tear was found in the frame at the right-front spring attachment. The right-side tie rod and control arm were bent. The right-front suspension sustained severe damage and included the fracturing of the bolt at the frame-suspension attachment. The right-front and right-rear steel rims were deformed and dented. The both the right-front and right-rear tires' seals were broken, and the tires deflated. The drive shaft fractured. The right side of the roof buckled. The windshield encountered severe cracking on the right side, while the left side only sustained minor cracking. The rear of the vehicle and all window glass except for the windshield remained undamaged.
