## **Phase II Development of a Short-Radius Guardrail for Intersecting Roadways**

### **MIDWEST ROADSIDE SAFETY FACILITY**

MwRSF Research Report No. TRP-03-137-03

September 9, 2003

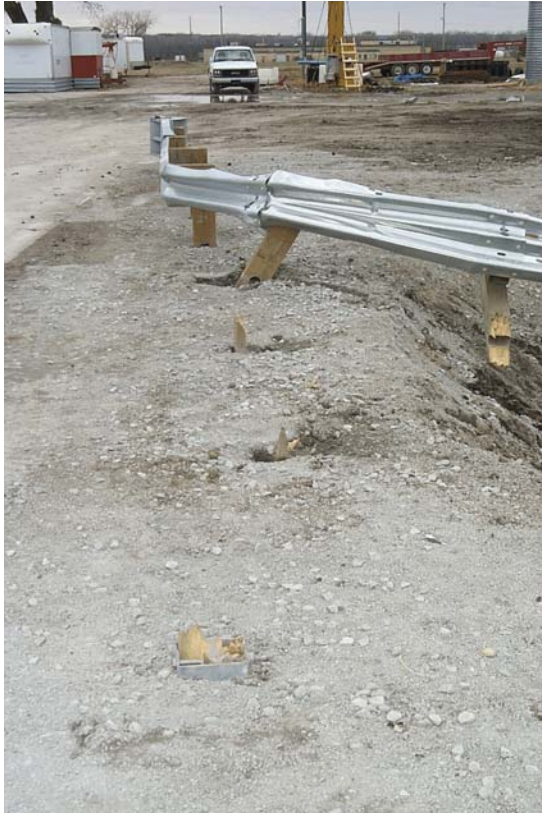
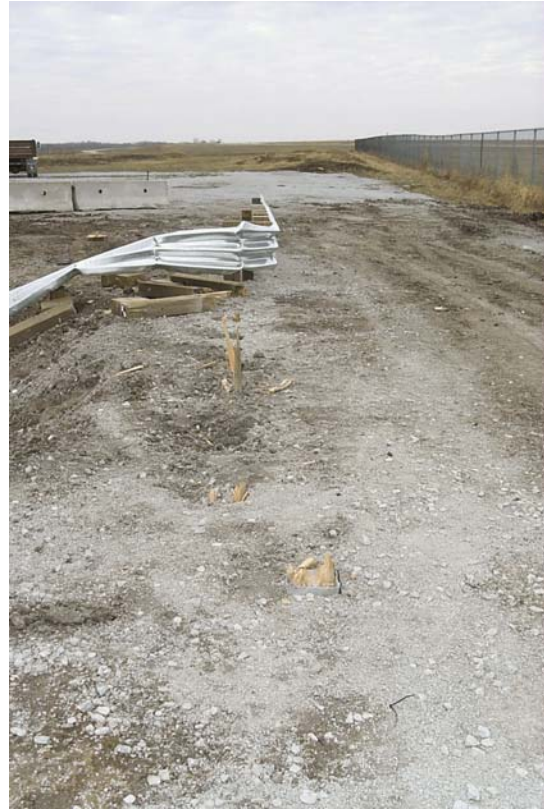
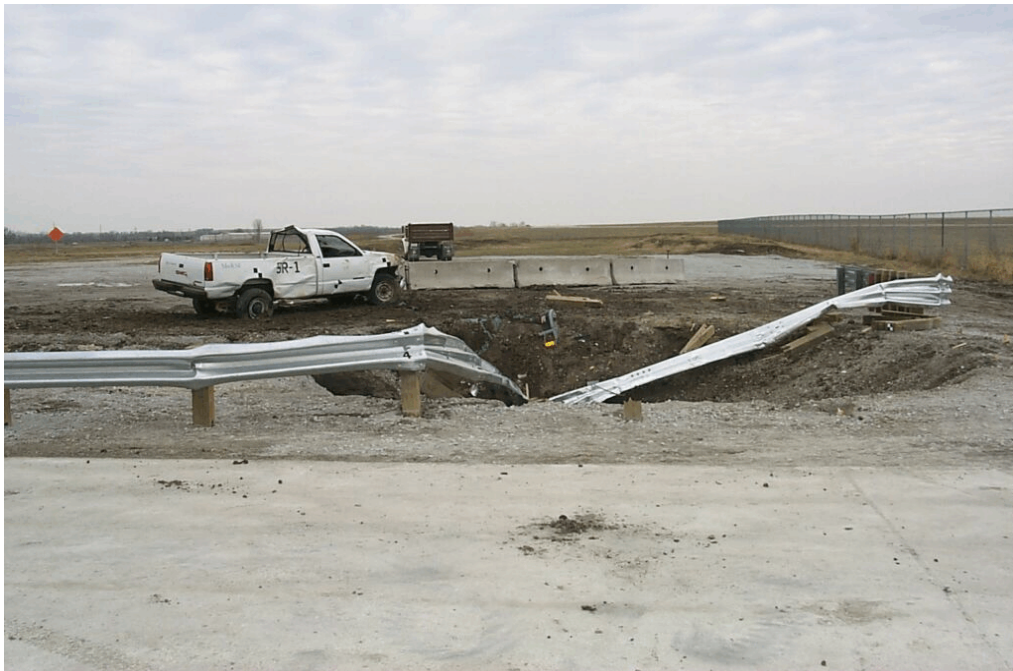
Figure 36. System Damage, Test SR-1

Damage to the short-radius system was extensive, as shown in Figures 36 through 39. Post nos. 1S and 3S on the secondary side were fractured and broken due to the guardrail on the secondary side being pulled towards the middle of the system. Post no. 4S displayed significant deflection but was not fractured. Rail section no. 2 on the secondary side of the system was bent around the post and blockout at post no. 4S. The curved radius, rail section no. 1, displayed completely torn slot tabs along the bottom set of slots in the rail, while only one slot tab was torn in the top set. In addition, the middle hump of the thrie beam was completely torn. The nose cables of the system remained attached to the guardrail by the anchor plates. On the primary side of the system, post nos. 1P through

8P were fractured, while post no. 9P was deflected in the soil. Rail section no. 2 on the primary side was bent around post no. 9P and was twisted as it was pushed into the moat.

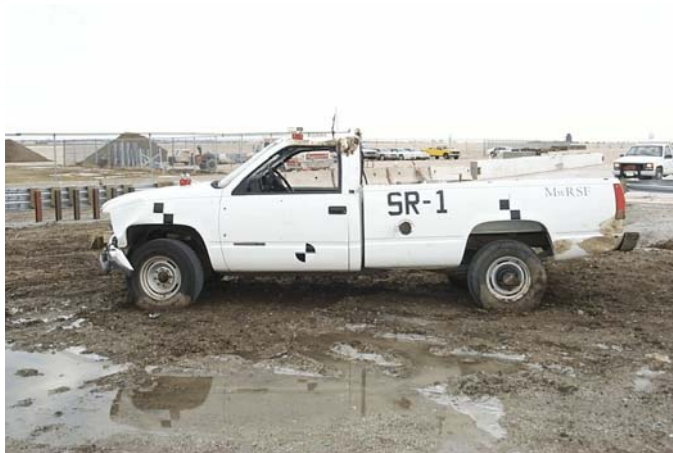
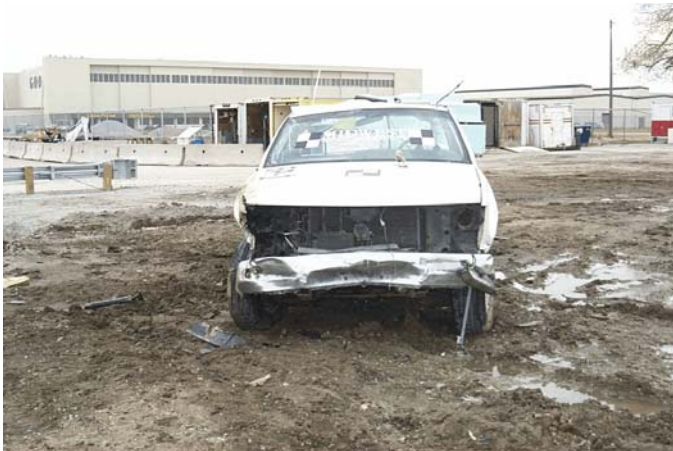
Figure 40. Vehicle Damage, Test SR-1

Vehicle damage was extensive, as shown in Figures 40 and 41. Damage due to the impact with the system was difficult to separate from damage due to rollover. The frontal area of the vehicle, including the bumper, radiator, and headlights, was crushed inward due to the impact with the system. The front grill was detached, and the front of the hood was bent slightly. The front fenders of the pickup truck displayed some deformation and crushing. Little or no damage was observed to the undercarriage of the vehicle. The right-rear tire of the pickup truck was knocked off the rim and was deflated. The right side of the box was crushed inward due to rollover, and the right side and rear window glass were broken as well. The bed of the pickup truck was severely deformed. Large dents and deformation were seen near the front of the bed on the right side and in between the wheel well and the end of the box on the left side.

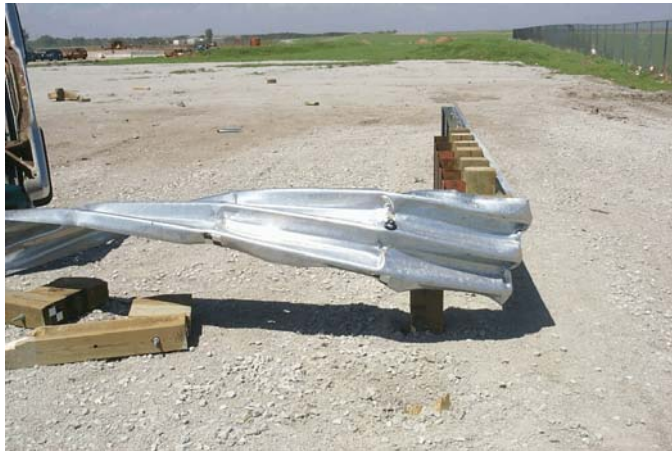
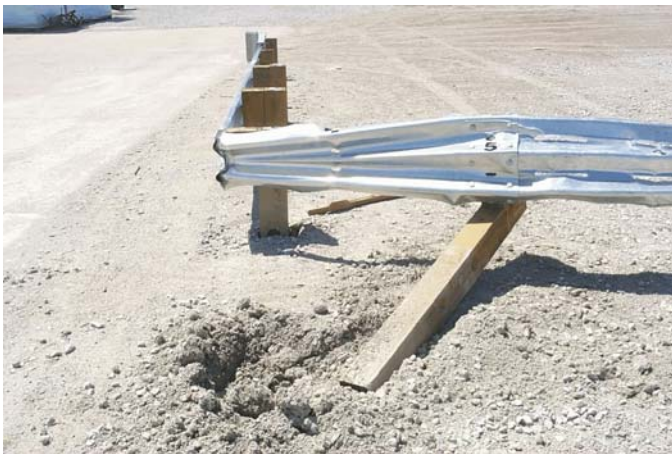
Figure 51. System Damage, Test SR-2

Damage to the short-radius system was extensive, as shown in Figures 51 through 55. Post nos. 1S and 4S on the secondary side were fractured due to the guardrail on the secondary side being pulled towards the middle of the system. Post no. 5S pulled out of the ground but was not fractured. Rail section no. 2 on the secondary side of the system was bent around the post and blockout at post no. 6S. The nose section of guardrail, rail section no. 1, displayed completely torn slot tabs along the bottom set of slots in the rail. In addition, the top and middle humps of the thrie beam were completely torn near the start of the secondary side of the system. The nose cables of the system remained attached to the guardrail by the anchor plates. On the primary side of the system, post nos. 1P through 8P were fractured, while post no. 9P was deflected in the soil. Rail section no. 2 on the primary side was bent around post no. 9P and twisted due to the vehicle rolling over it.

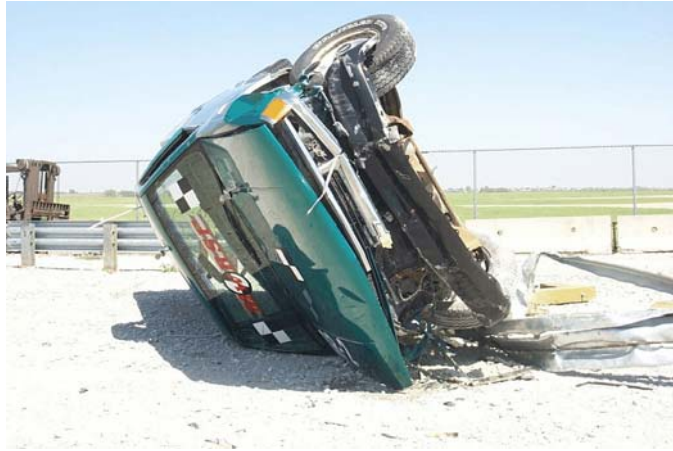
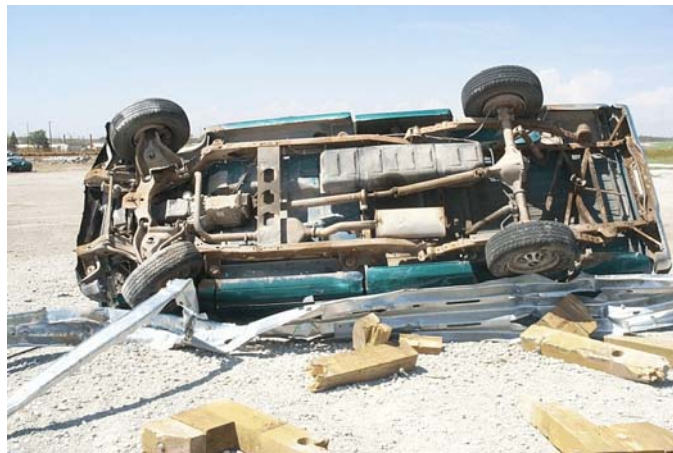
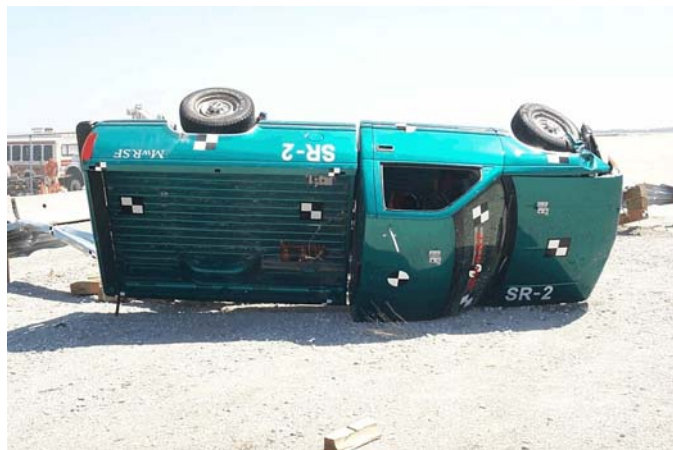
Figure 56. Vehicle Damage, Test SR-2

Vehicle damage was extensive, as shown in Figure 56. Damage due to the impact with the system was difficult to separate from damage due to rollover. The frontal area of the vehicle, including the bumper, radiator, and headlights, was crushed inward due to the impact with the system. The front grill was detached, and the front of the hood was bent. The front fenders of the pickup truck displayed some deformation and crushing. Little or no damage was observed to the undercarriage of the vehicle. A slight bend in the frame rail was observed behind the right-front wheel. The right side of the box of the pickup truck was crushed inward due to rollover. The right-front tire of the pickup truck was cut and deflated.

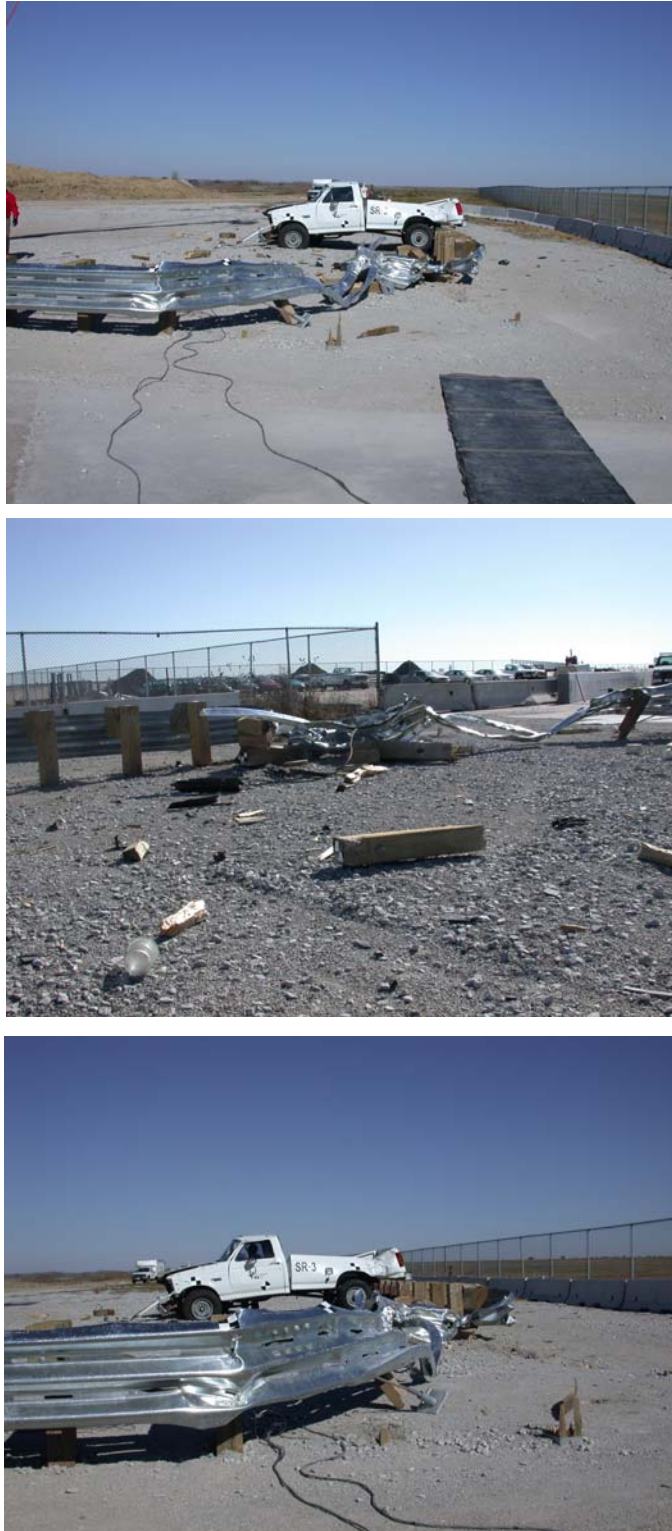
Figure 64. System Damage, Test SR-3

Damage to the short-radius guardrail system was extensive, as shown in Figures 64 through 66. Post nos. 1S and 2S on the secondary side were fractured due to the guardrail on the secondary side being pulled towards the middle of the system. Post nos. 3S and 4S displayed significant deflection but were not fractured. Rail section no. 2 on the secondary side of the system was bent around the post and blockout at post no. 3S. Damage was more severe to both the nose section and the primary side of the system. The curved radius, rail section no. 1, displayed torn slot tabs along both the top and bottom set of slots in the rail. The top hump of the section was completely ruptured 864-mm downstream of post no. 1S. Other minor tearing of rail section no. 1 was observed near the guardrail splice at post no. 1P. The top nose cable of the system detached on the secondary side by pulling the button ferrule through the cable anchor plate. On the primary side of the system, post nos. 1P through 5P were fractured, while post no. 6P was partially fractured. Rail section no. 2 on the primary side was severely buckled and crushed. The crushing of rail section no. 2 was evident from the beginning of the section to approximately post no. 6P. Post no. 9P displayed damage to the top of the post and minor deflection due to the pickup truck landing on it as it rolled.

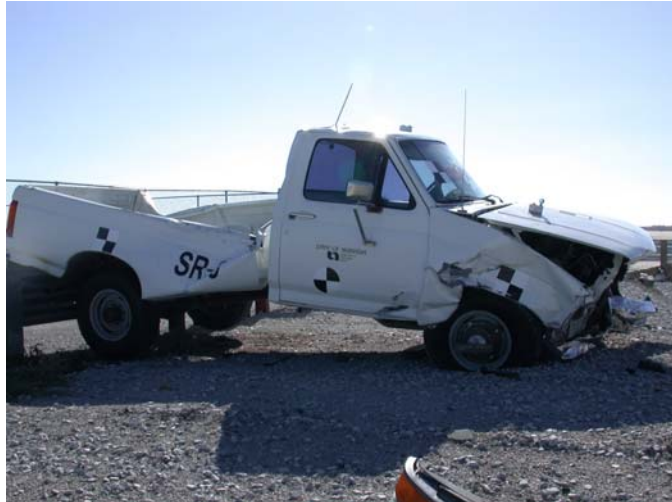
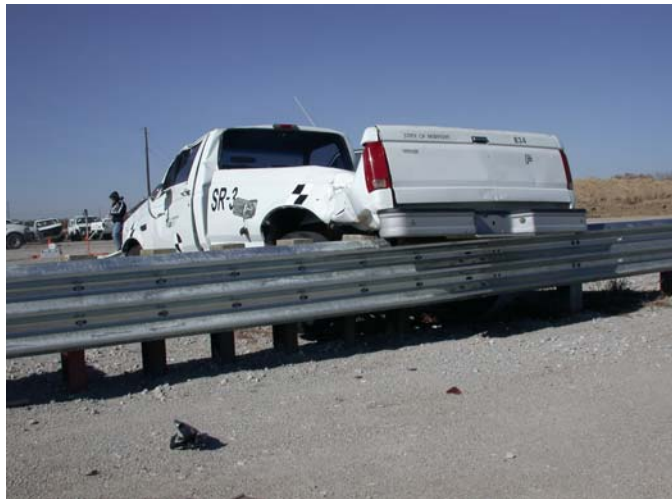
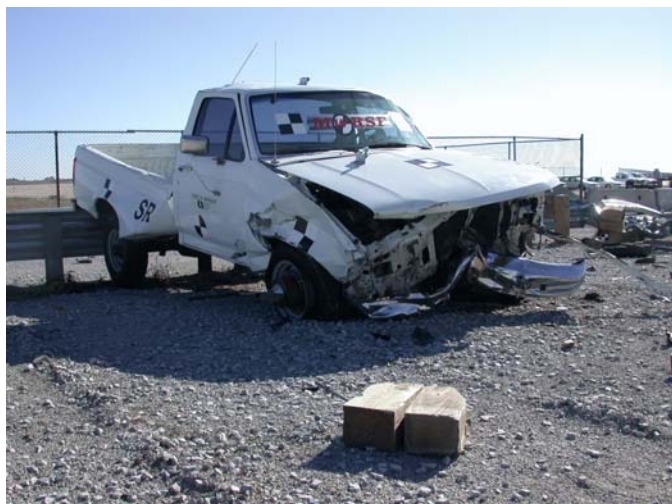
Figure 67. Vehicle Damage, Test SR-3

Vehicle damage was extensive, as shown in Figures 67 and 68. Damage due to the impact with the system was difficult to separate from damage due to rollover. The frontal area of the vehicle, including the bumper, radiator, and headlights, was crushed inward due to the impact with

the system. The majority of this frontal crush damage was due to the impact with the posts along the centerline of the vehicle and crushing of the guardrail along the primary side of the system. The front grill was detached, and the front of the hood was bent slightly. The front fenders of the pickup truck were deformed and dented. The front suspension on the right side of the vehicle was damaged due to the disengagement of the tie rod. The left-front tire of the pickup truck was knocked off the rim, and both of the front tires were deflated. The left-front corner of the cab of the pickup truck was crushed inward due to the rollover, and the windshield glass was broken in that area as well. The bed of the pickup truck was severely deformed. Large dents and deformation were seen near the front of the bed on the right side and in between the wheel well and the end of the truck box on the left side.
