Performance Level 2 Tests on a 29-in. Open Concrete Bridge Rail

Midwest Roadside Safety Facility (MwRSF) Center for Infrastructure Research

Transportation Research Report TRP-03-51-95

June 1996

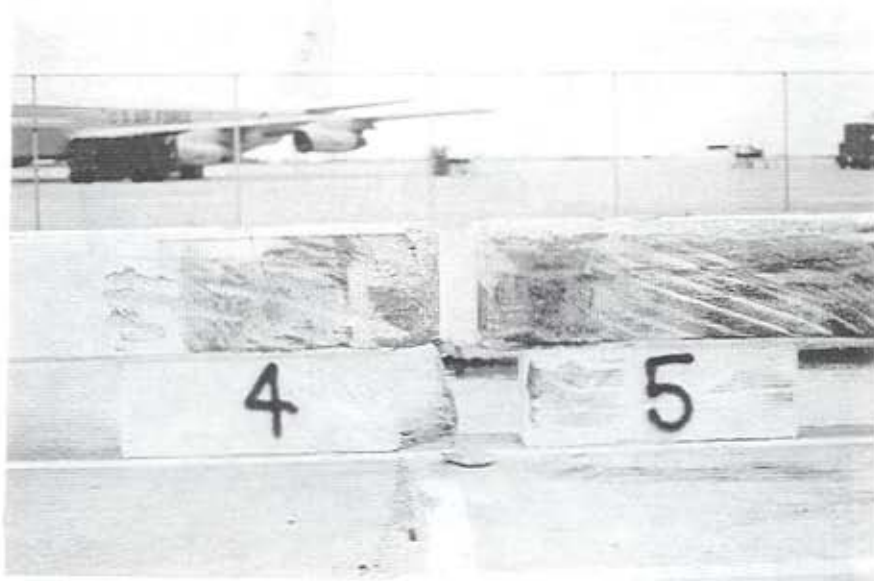
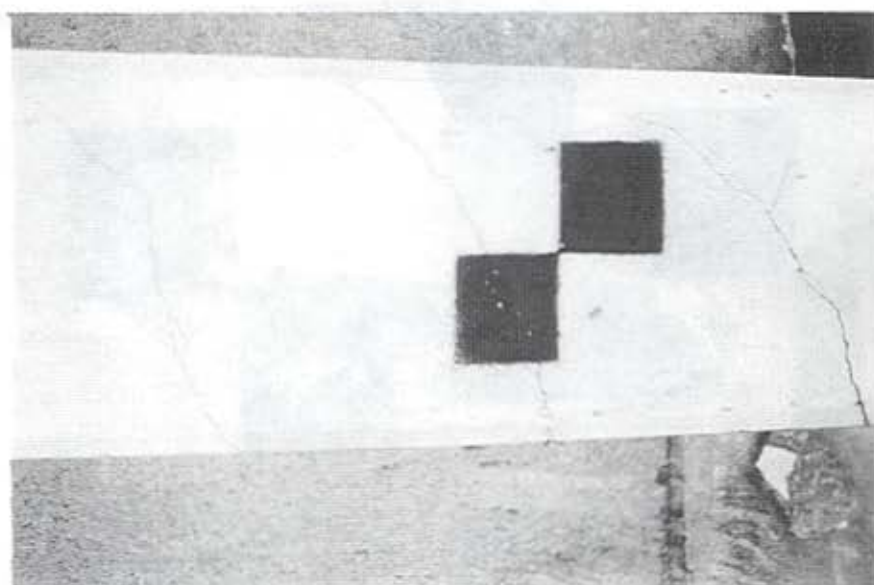
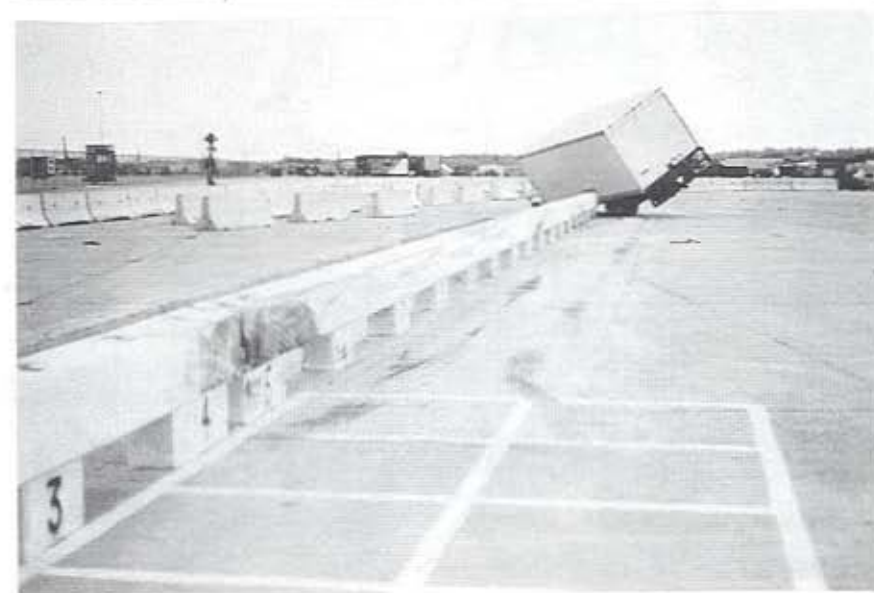
FIGURE 21. Bridge Rail Damage, Test NEOCR-3

Bridge rail damage is shown in Figure 21. Bridge rail damage at the 11.4-cm (4 ½-in.) gap is shown in Figure 22. The majority of the damage was upstream of the 11.4-cm (4 ½-in) gap. Two major diagonal cracks existed on front face and top at Post.

No. 4 as well as extensive concrete spalling at the end of the first section. Tire marks on the face of the rail were visible from the upstream edge of Post No. 4 to Post No. 11, from Post No. 12 to Post No. 14, and from Post No. 16 to Post No. 19. Gouging also occurred on the front face of the rail near Post No. 8 and a diagonal crack was observed on the face and top of the rail at Post No. 3. The maximum permanent set deflection was .95-cm (3/8-in.) at the downstream end of the 11.4-cm (4 ½-in.) gap.

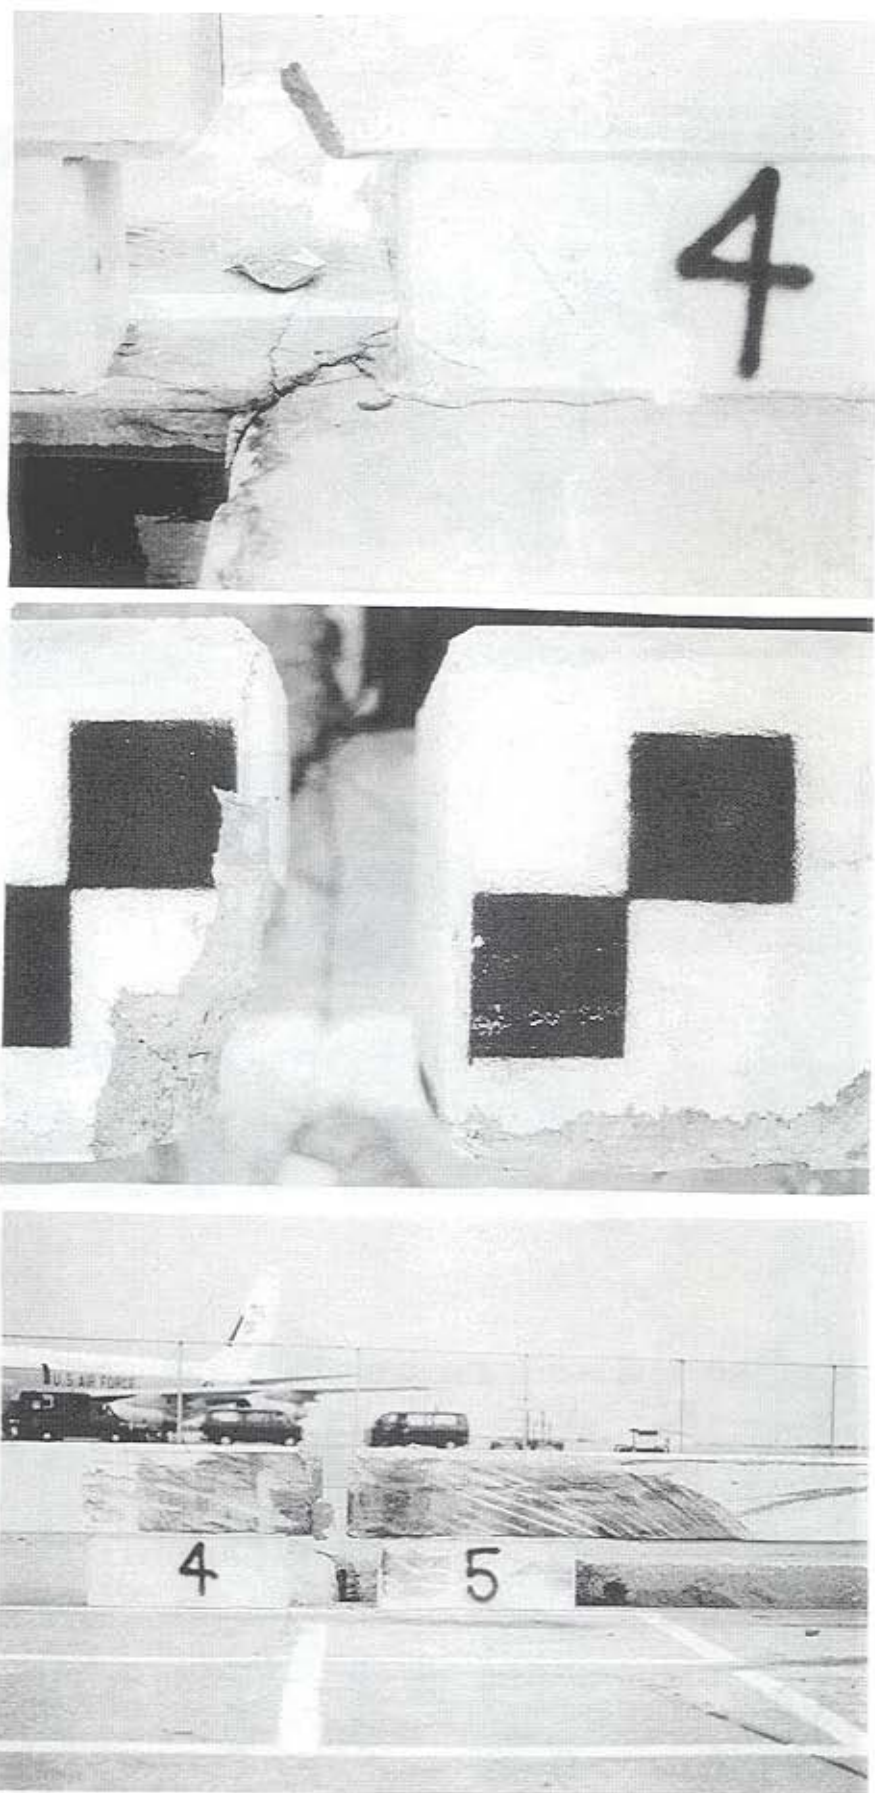
FIGURE 22. Bridge Rail Damage at the 11.4-cm (4 ½-in.) Expansion Gap, Test NEOCR-3

Although Test NEOCR-3 caused significant bridge rail and post damage near the gap location, the structural adequacy was maintained. As mentioned previously, most of this damage occurred when the rear wheel assembly contacted the gap location. Further, both test vehicles were smoothly redirected without exhibiting any tendency to roll over and performed exceptionally well based on redirection capacity with the single-unit truck test.

It was determined for testing purposes that the damage sustained at the gap location following this test was significant enough to repair before conducting the pickup test (Test NEOCR-6) upstream of the gap. The retrofit process involved saw cutting the rail just downstream of Post No. 2 and breaking out the concrete around the dowelled vertical reinforcement in Post Nos. 3 and 4, reforming the rail and posts and casting new concrete with a cold joint near Post No. 2. The retrofit process performed well during the test and offered insight to NDOR on the effects of a cold joint repair near the critical gap location.

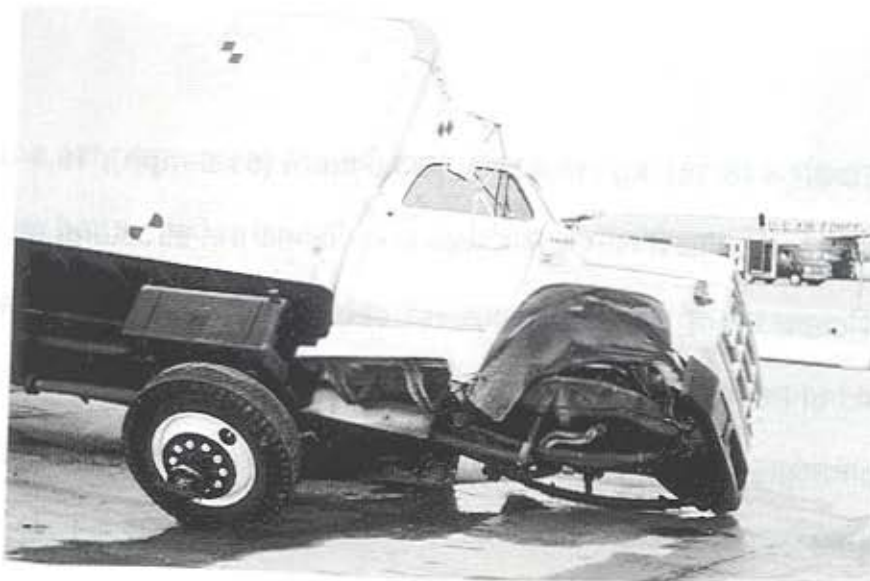
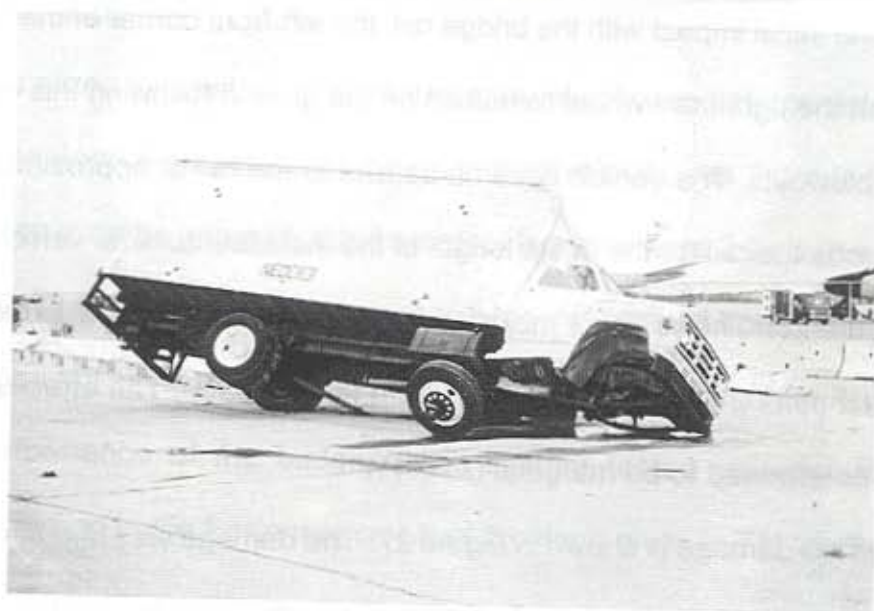
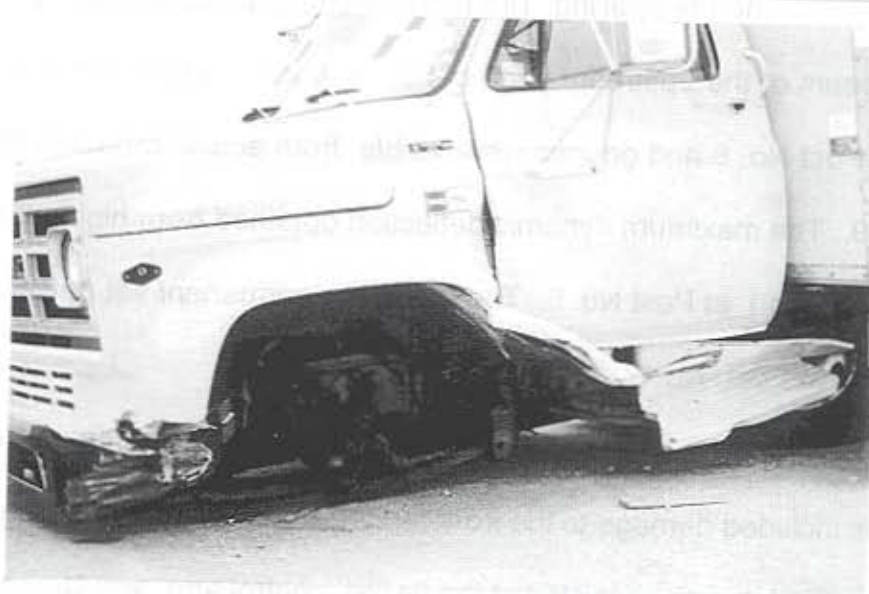
FIGURE 23. Test Vehicle Damage, Test NEOCR-3

Vehicle damage is shown in Figure 23. Most of the vehicle damage occurred near the left-front corner of the vehicle, consisting primarily of damage to the fender, hood, and bumper. This damage also included major undercarriage damage, disengagement of the front axle, and a severed brake line. Both the left rear wheel and left rear leaf spring were also damaged. There was no deformation to the exterior or interior of the box, as most damage occurred under the height of the box. There was no intrusion nor deformation of the occupant compartment. The vehicle remained upright both during and after the collision. The vehicle damage was assessed by the traffic accident scale (TAD) (8) and the vehicle damage index (VDI) (9), as shown in Figure 17.

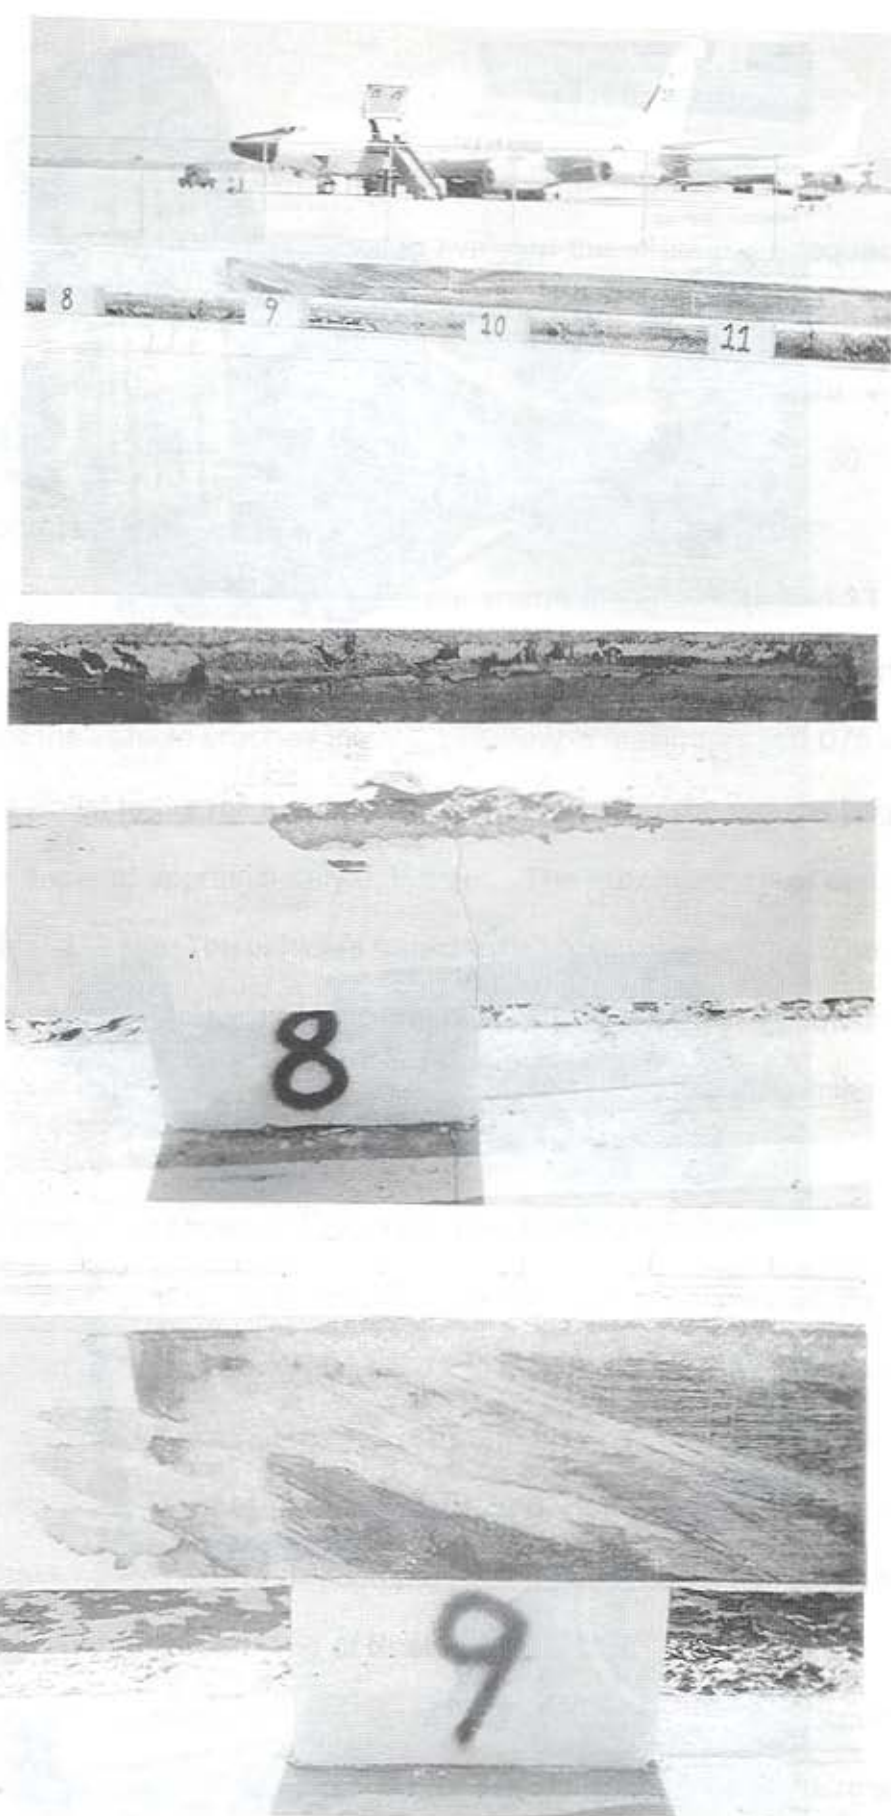
FIGURE 27. Bridge Rail Damage, Test NEOCR-4

Bridge rail damage is shown in Figure 27. The damage was minor, consisting of tire marks and minor concrete spalling. Tire marks indicated that actual impact was 35.6-cm (14-in.) upstream of the upstream edge of Post No. 9. Concrete spalling occurred at the top of rail at Post No. 8 and gouges were visible from actual impact to downstream end of Post. No. 9. The maximum dynamic deflection obtained from high speed film analysis was 2.9 cm (1.13 in.) at Post No. 9. The maximum permanent set deflection was 1.1 cm (7/16 in.), also at Post. No. 9.

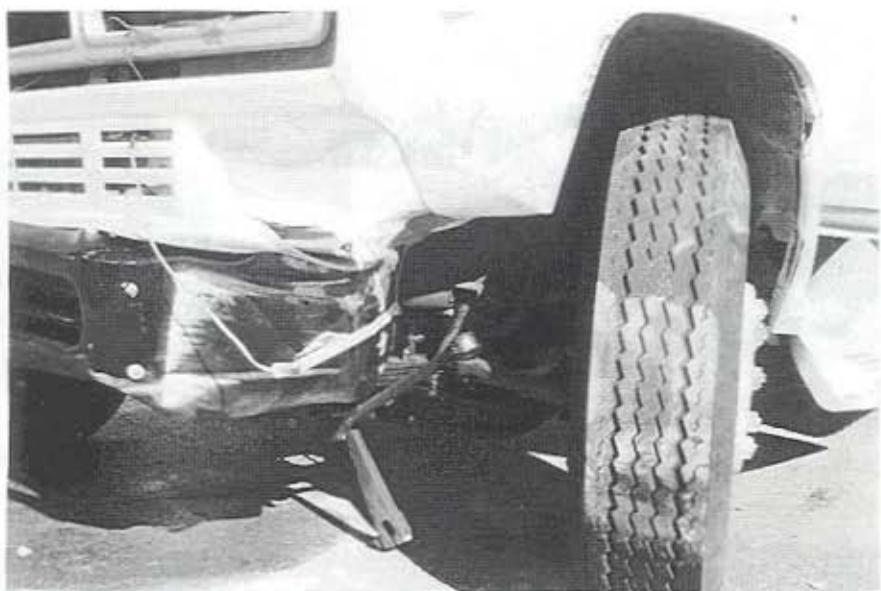
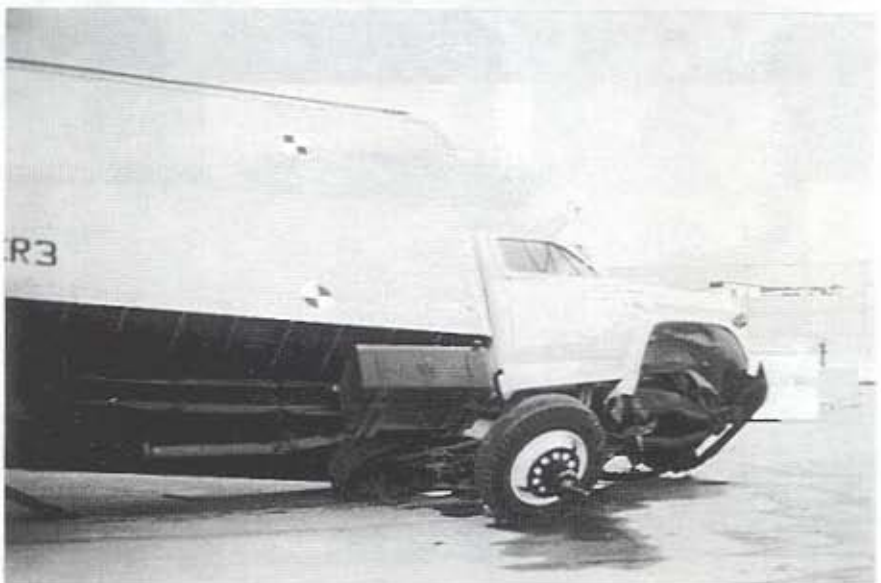
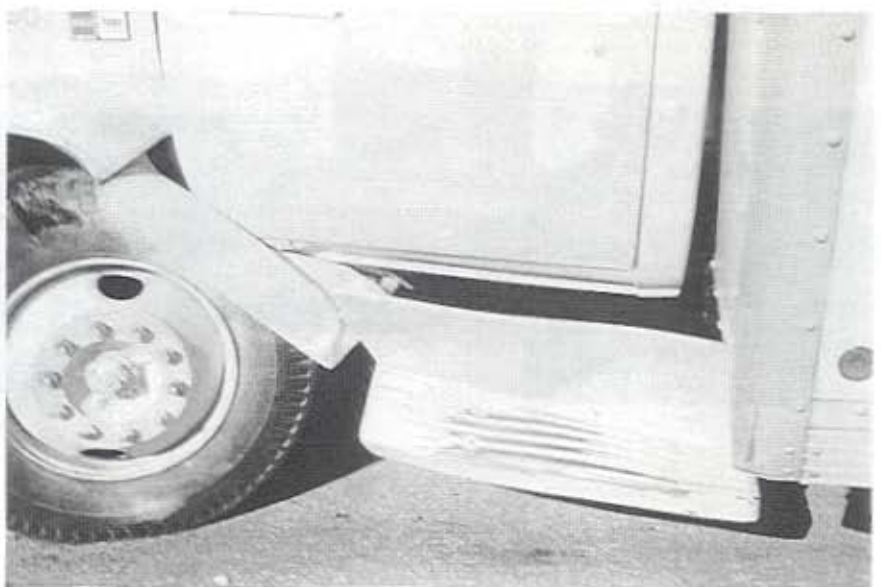
FIGURE 28. Vehicle Damage, Test NEOCR-4

Vehicle damage is shown in Figure 28. All of the vehicle damage occurred on the left-side. This included damage to the front fender, door, and running boards. Damage to the wheels on the left side consisted of the tie rod, control arm, and U-bolt on the left front

being broken, the only damage to the left rear was a bent rim. All tires were still inflated. During impact the box shifted to the left causing bolts connecting the box to be bent on the left side and some broke on the right side. There was also some damage to the left front corner of the box. There was no intrusion nor deformation of the occupant compartment. The vehicle remained upright both during and after the impact. The vehicle damage was assessed by the traffic accident scale (TAD) (7) and the vehicle damage index (VDI) (8), as shown in Figure 25.

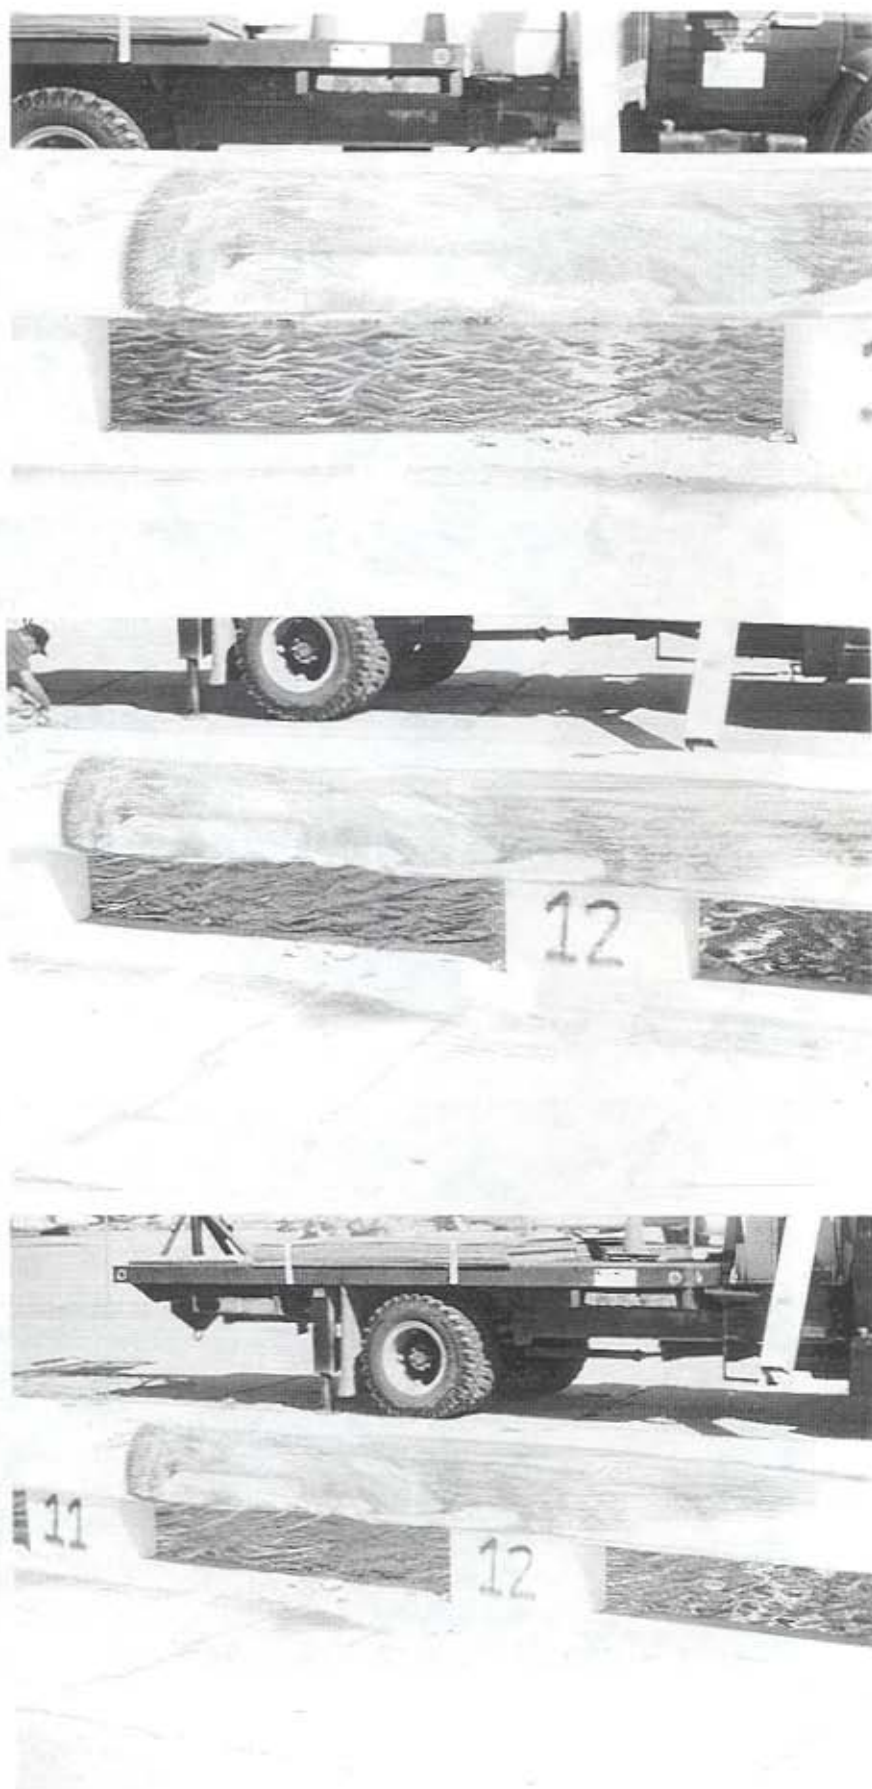
FIGURE 34. Bridge Rail Damage, Test NEOCR-5

Bridge rail damage is shown in Figure 34. The damage was minor, consisting of tire marks, concrete spalling, and small cracks. Tire marks on the face of the rail were approximately 3.7-m (12-ft) long from Post No. 11 to Post No. 13. Major concrete spalling and scrapes occurred 81.3-cm (32-in) downstream from the downstream end of Post No. 11 for approximately 1.2-m (4-ft) along the bottom of the rail. One diagonal crack formed from the back of Post No. 11 through the deck and another small crack was visible at the back corner of the upstream end of Post No. 11.

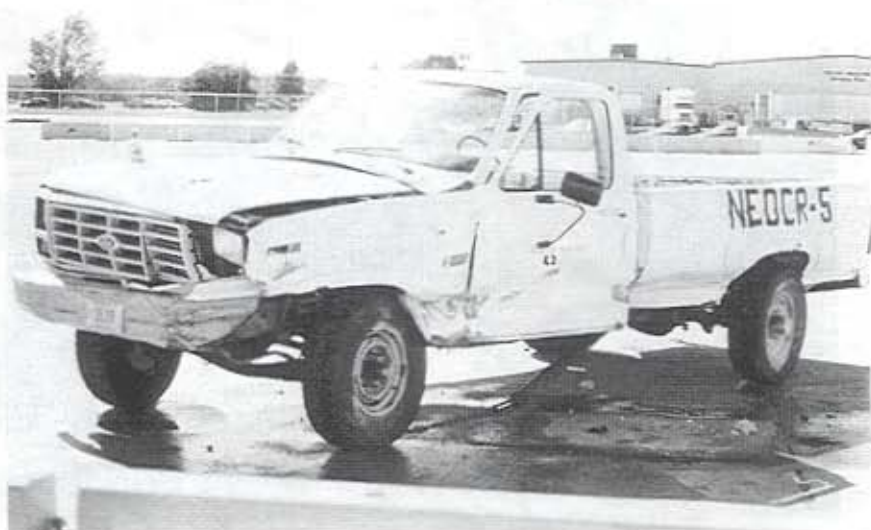
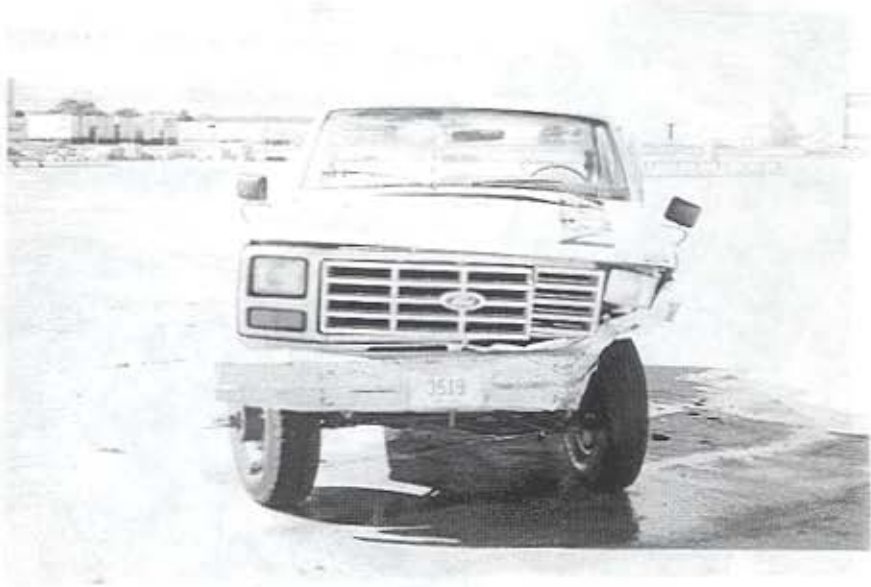
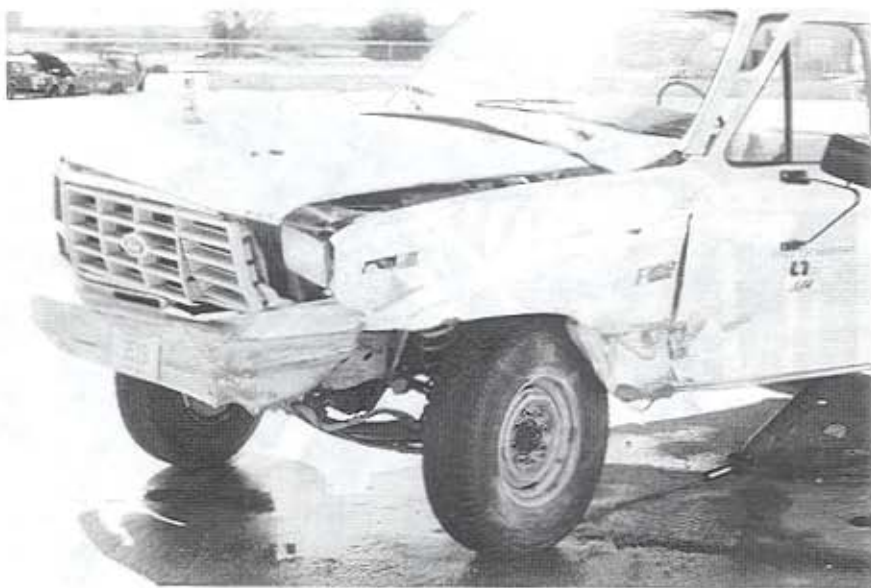
FIGURE 35. Vehicle Damage, Test NEOCR-5

Vehicle damage is shown in Figure 35. Most of the vehicle damage occurred on the left-side, consisting primarily of fender, bumper, and undercarriage deformation. The

undercarriage damage consisted of the left front wheel assembly being shoved inward, which caused damage to many key suspension members, including the buckling of the left control arm and the bending of the right control arm, which caused the frame to be twisted. Undercarriage damage is shown in Figure 36. Other damage included deformation inward of the door panel that caused the door to jar out at the top, a cracked windshield on the driver's side, and buckling of the rear bumper. Occupant compartment damage is shown in Figure 37. Damage included an inward crush of the rear of the cab, buckling of the dash, outward buckling of the floor at the driver's side seat location, and downward buckling at driver's side floorboard area. The maximum occupant compartment crush, near the center of the cab compartment floor pan, was approximately 13.3 cm (5 1/4-in.). The center of the dash buckled upward approximately 64 mm (2.5 in.) higher than its original orientation. These occupant compartment deformations were judged to be acceptable, based on the extent and location of the deformations, as discussed in Section 5. The vehicle remained upright both during and after the impact. The vehicle damage was assessed by the traffic accident scale (TAD) (7) and the vehicle damage index (VDI) (8), as shown in Figure 30.

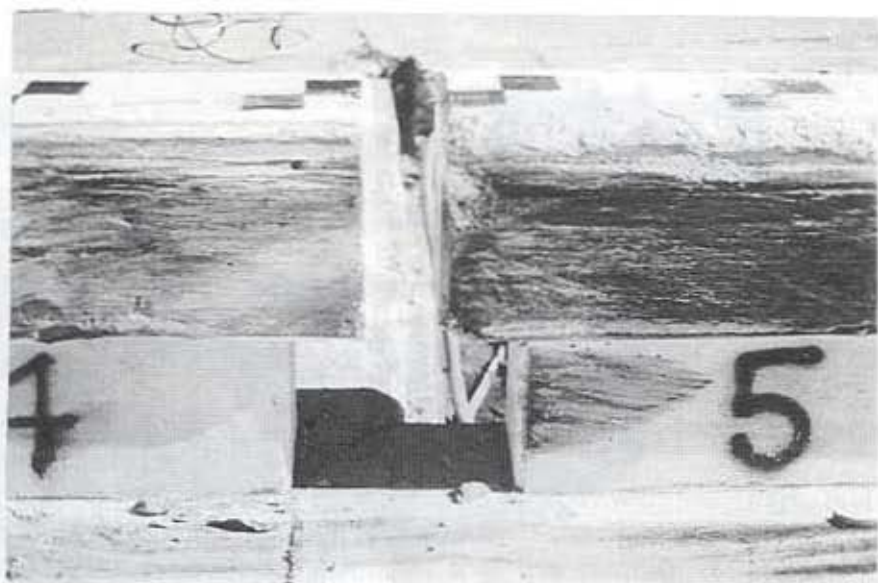
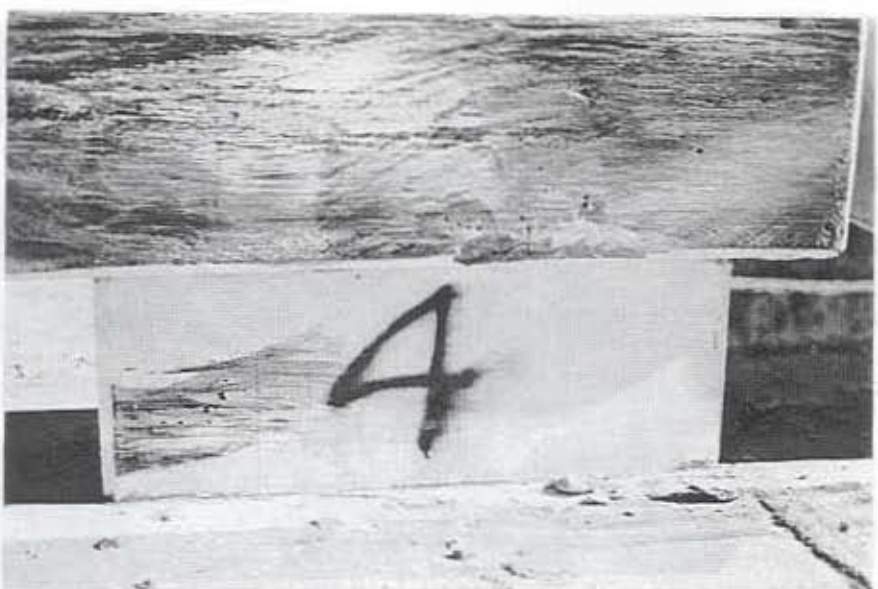
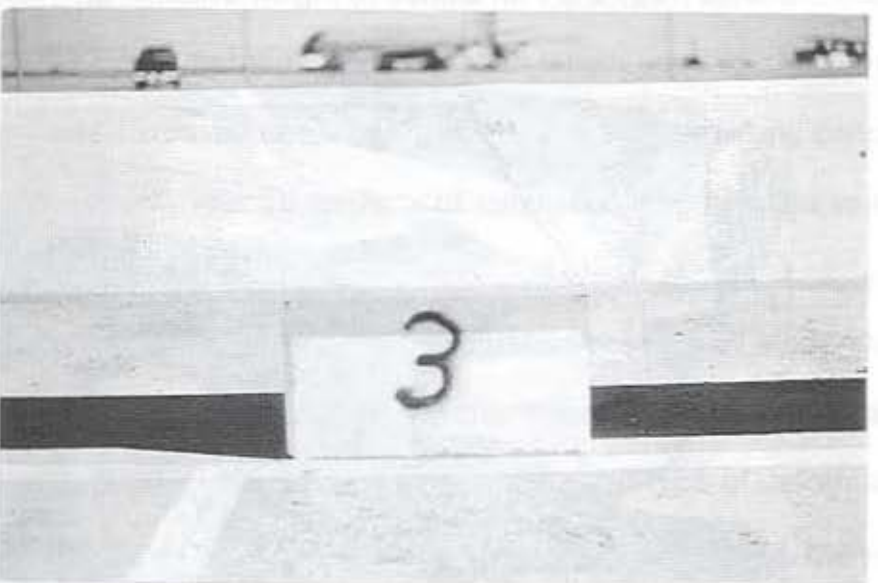
FIGURE 43. Bridge Rail Damage, Test NEOCK-6

Bridge rail damage is shown in Figure 43. The damage was minor, consisting of tire marks, light concrete spalling from rim contact, and small cracks. Tire marks on the face of the rail ran from approximately 1.8-m (6-ft) upstream of the gap to 16.5-cm (6 ½-in) downstream of the gap and from the centerline of Post No. 19 to the downstream edge of the installation. Minor concrete spalling occurred at Post Nos. 4 and 5. One diagonal

crack formed in the rail near the downstream end of Post No. 3. There was no sign of snag at the 11.4-cm (4 ½-in.) gap.

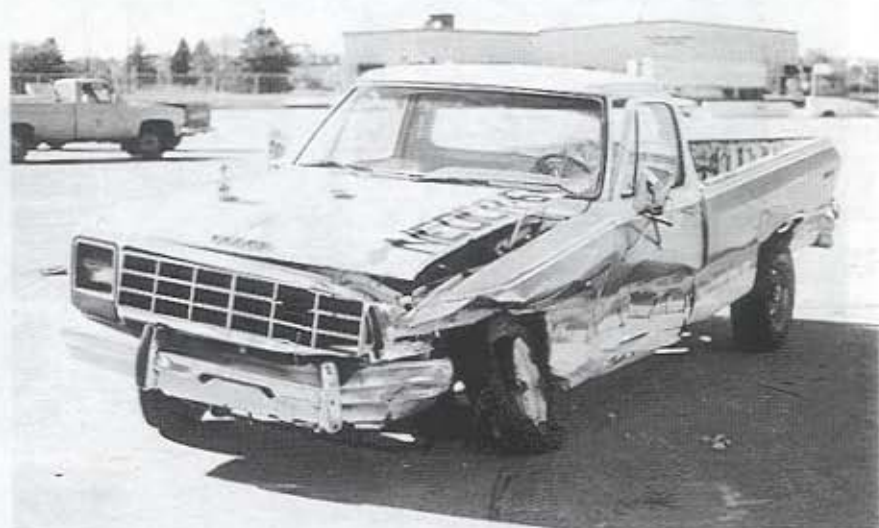
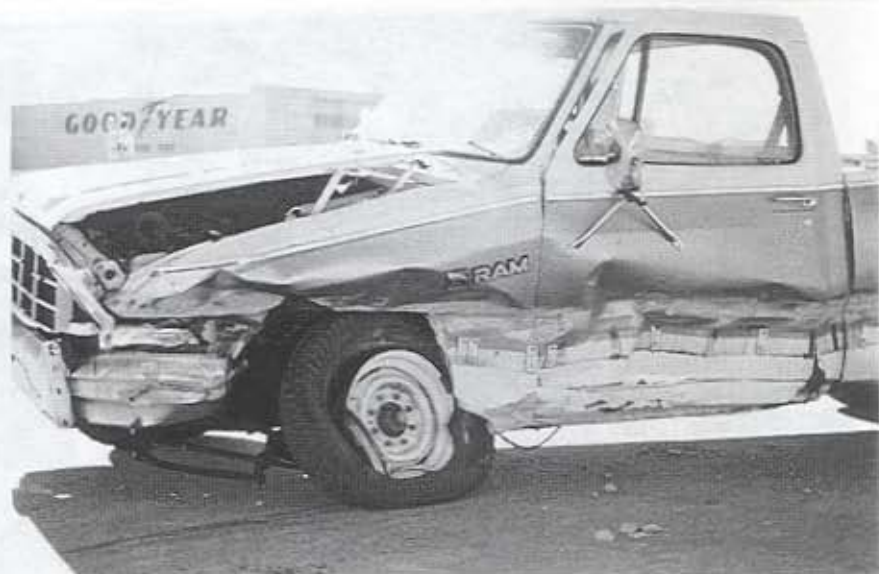
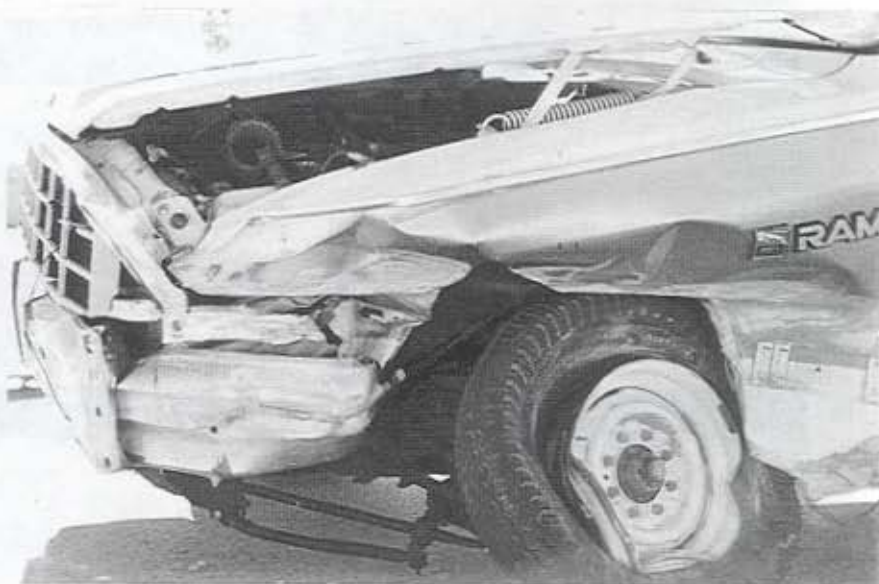
FIGURE 44. Vehicle Damage, Test NEOCR-6

Vehicle damage is shown in Figure 44. The majority of the vehicle damage occurred on the left-side, consisting primarily of fender, bumper, and undercarriage deformation. The fender was crushed inward approximately two feet. Other damage included deformation inward of the door panel which caused the door to separate from the cab at the top, a cracked windshield, and major deformation to the left front wheel. Occupant compartment damage included crush upward and toward the passenger of the driver's side floorboard and some deformation along the transmission well. The maximum occupant compartment crush, located on the left floor pan area was approximately 89 mm (3 ½-in). These occupant compartment deformations were judged to be acceptable, based on the extent and location of the deformations, as discussed in Section 5. There was no roof, passenger side, or dash board deformation. The vehicle remained upright both during and after the impact. The vehicle damage was assessed by the traffic accident scale (TAD) (7) and the vehicle damage index (VDI) (8), as shown in Figure 39.
