DEVELOPMENT OF A 7.62-m LONG SPAN GUARDRAIL SYSTEM – PHASE II

MIDWEST ROADSIDE SAFETY FACILITY

MwRSF Research Report No. TRP-03-88-99

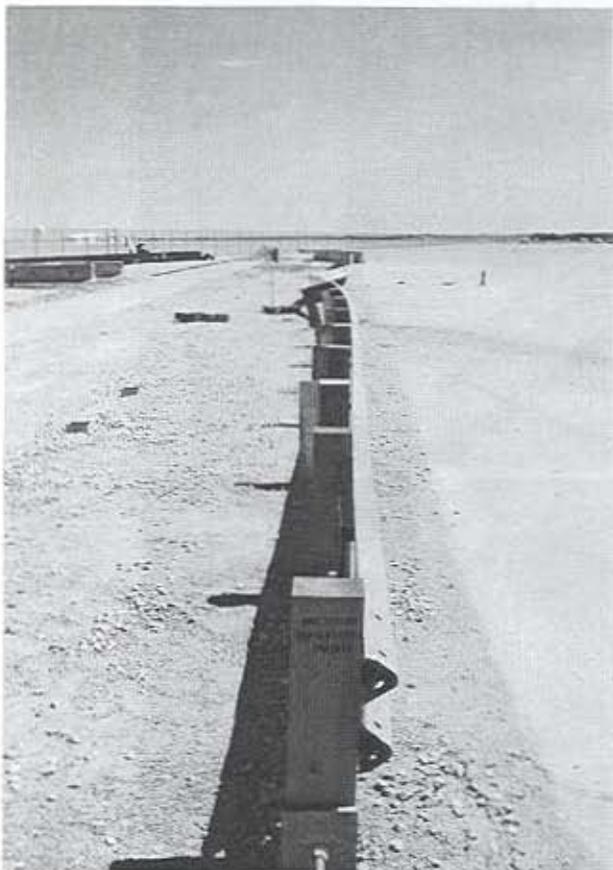
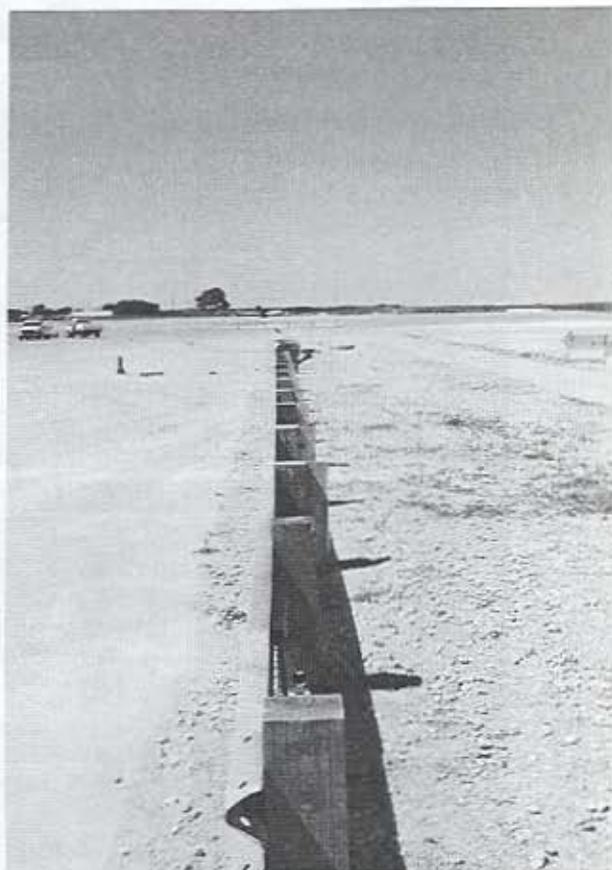
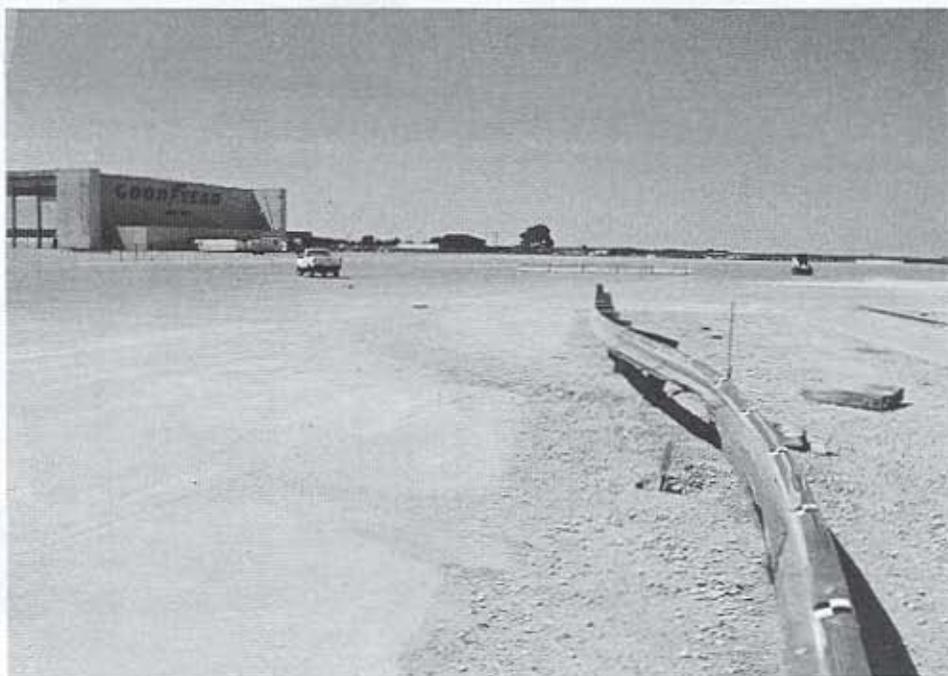
Figure 14. Long-Span Guardrail System Damage, Test OLS-3 (Design No. 3)

Damage to the barrier was moderate, as shown in Figures 14 through 18. Barrier damage consisted mostly of deformed W-beam, contact marks on a guardrail section, and deformed and fractured guardrail posts. The W-beam damage consisted of moderate deformation and flattening of the lower portion of the impacted section between post nos. 9 and 12. Contact marks were found on the guardrail between post nos. 9 and 12. The rail 533-mm downstream of post no. 11 had a major crease on the lower portion. The W-beam rail was pulled off of post nos. 3 and 4.

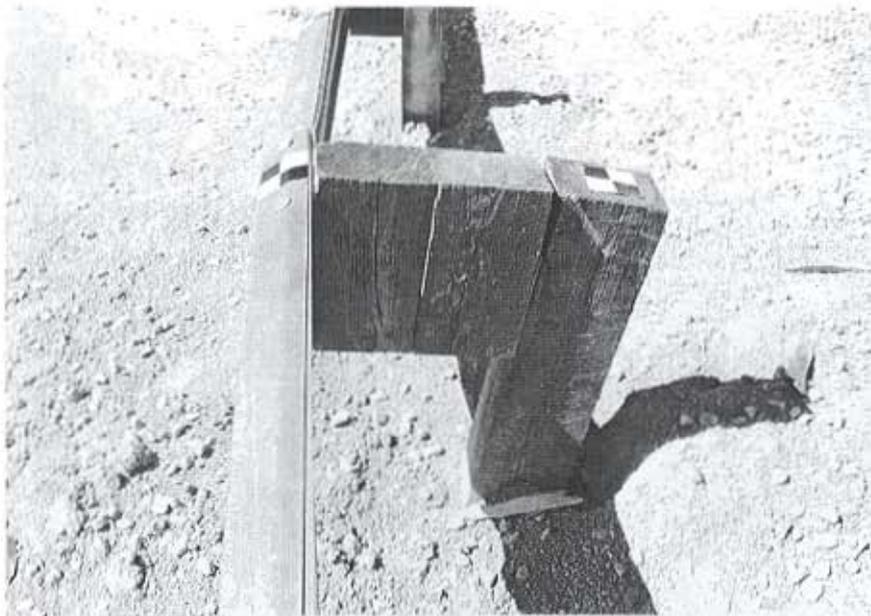
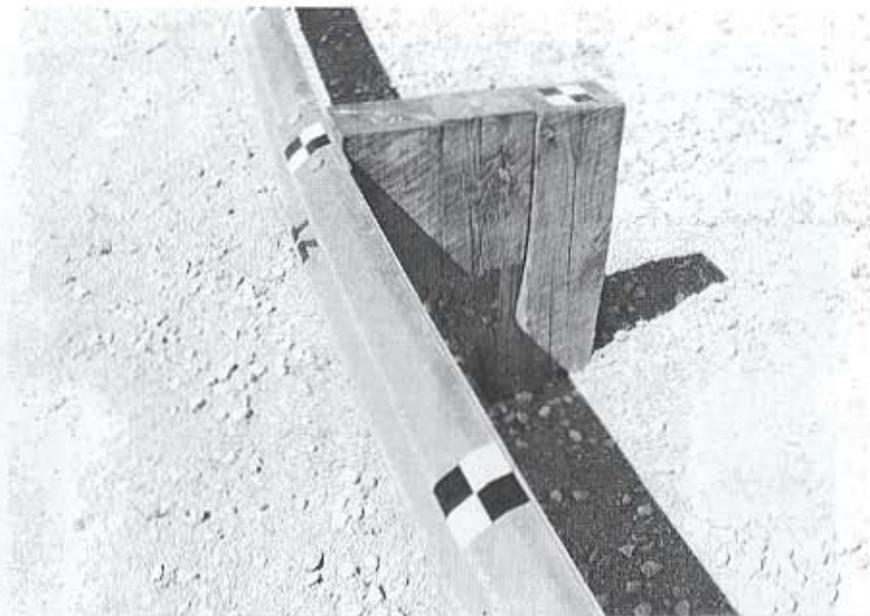
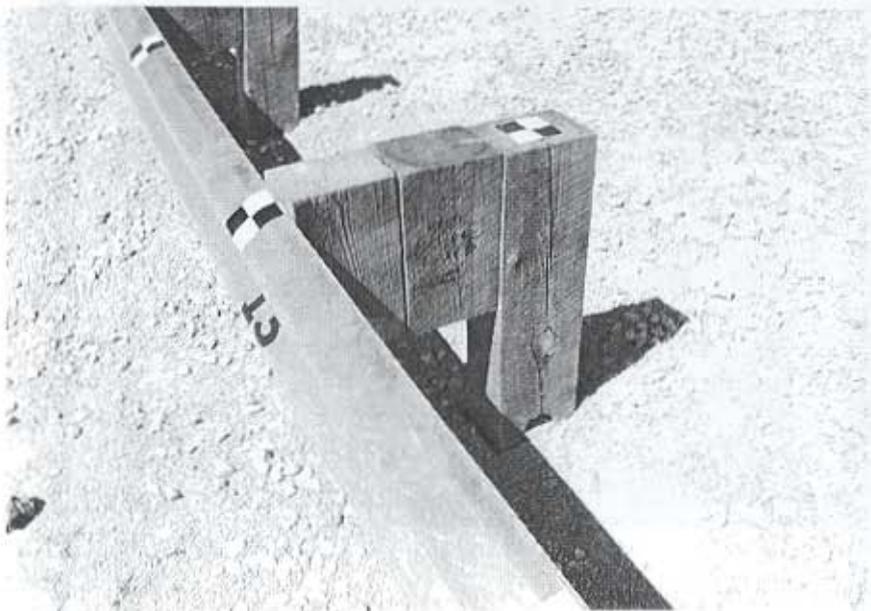
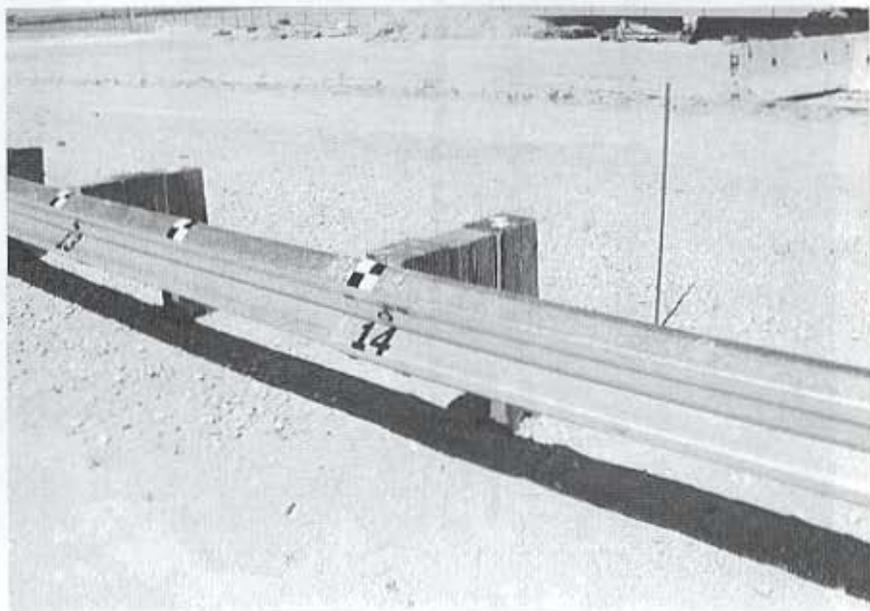
Figure 16. Final CRT Post Nos. 9, 12, 13, and 14 Positions, Test OLS-3 (Design No. 3)

Two CRT posts, post nos. 10 and 11, completely fractured while CRT post nos. 9 and 12 through 14 rotated backward, as shown in Figures 16 and 17. Steel post nos. 7 through 8 and 15 through 24 were twisted slightly and pushed backward. No significant post damage occurred to post nos. 3 through 6. No significant guardrail damage occurred upstream of post no. 14 nor downstream of post no. 9.

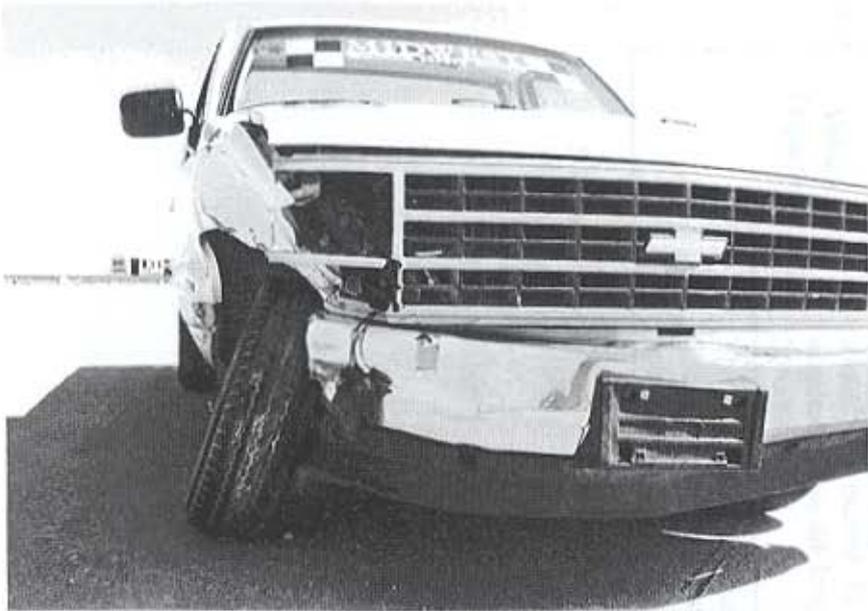
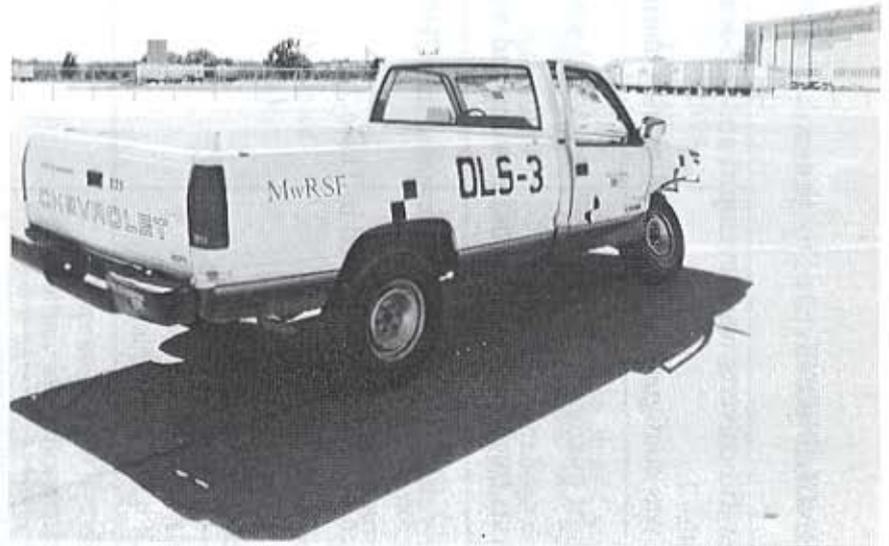
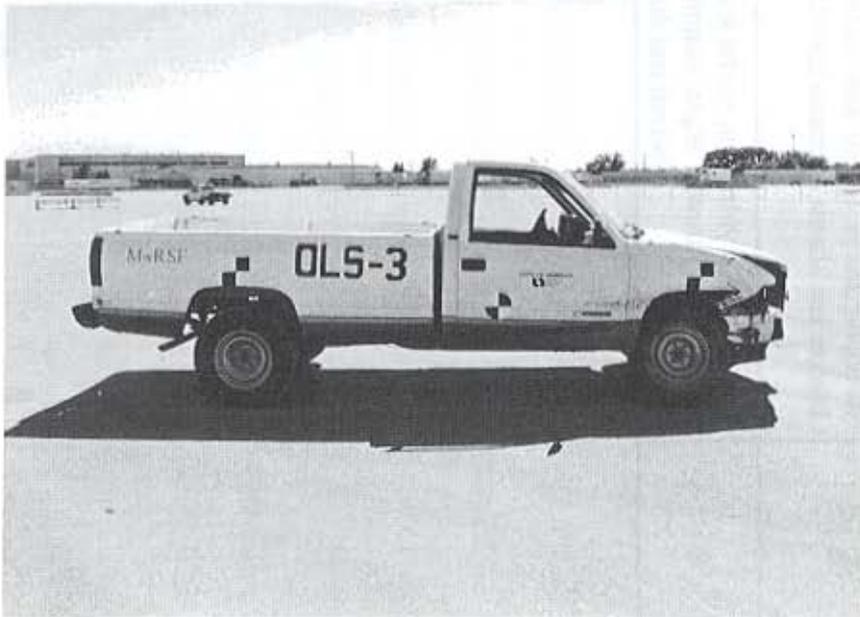
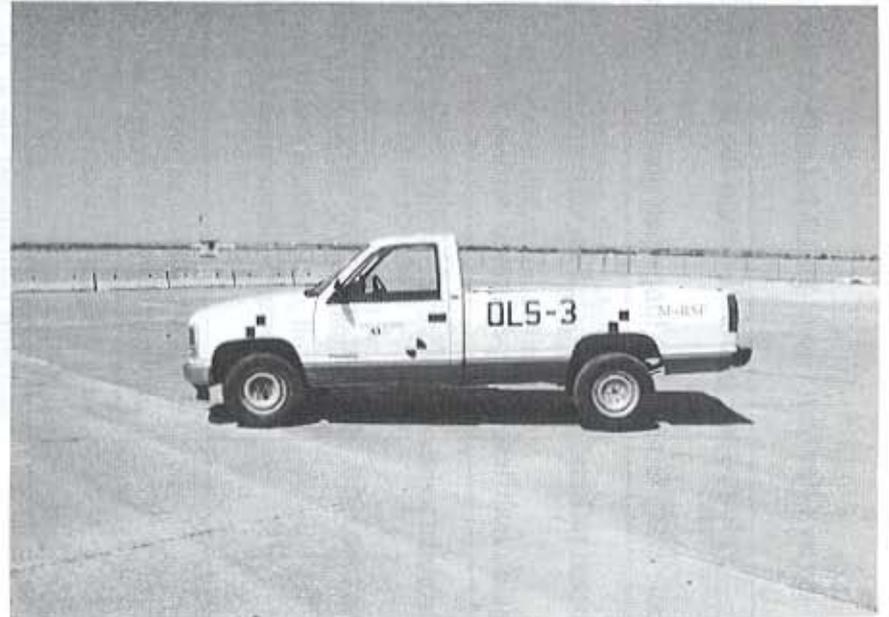
Figure 19. Vehicle Damage, Test OLS-3 (Design No. 3)

Exterior vehicle damage was minimal, as shown in Figure 19. Interior occupant compartment deformations were determined to be negligible. The right-front quarter panel was crushed inward, and the right side of the front bumper was also bent back toward the engine compartment. The right-front wheel assembly was deformed slightly, including contact marks on the rim. Small contact marks were found on the lower right side of the rear fender, the right-rear bumper, the lower right side of the truck box, and the right-side door. The right side of the box shifted downward and was twisted. No other damage to the vehicle was observed.
