TESTING CERT # 2937.01

NDOR Sponsoring Agency Contract No. DPU-STWD (94)

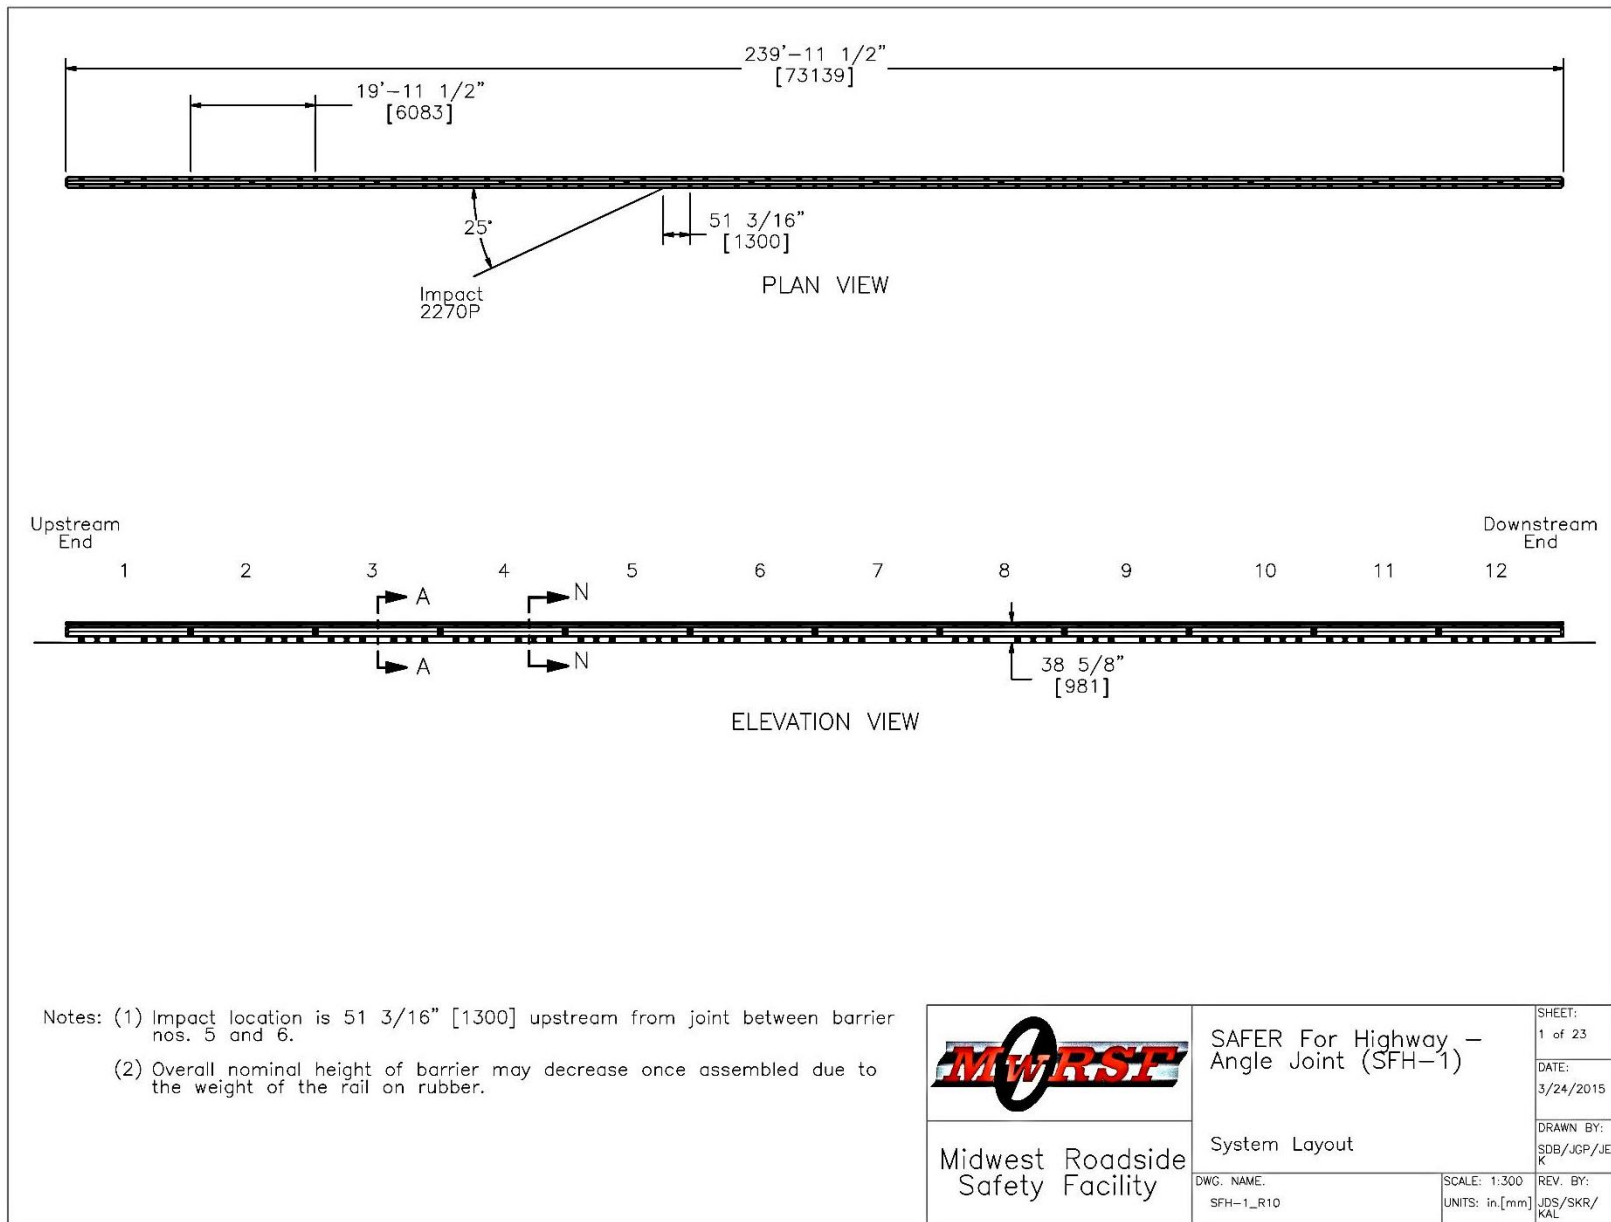
Figure 2. Test Installation Layout, Test No. SFH-1

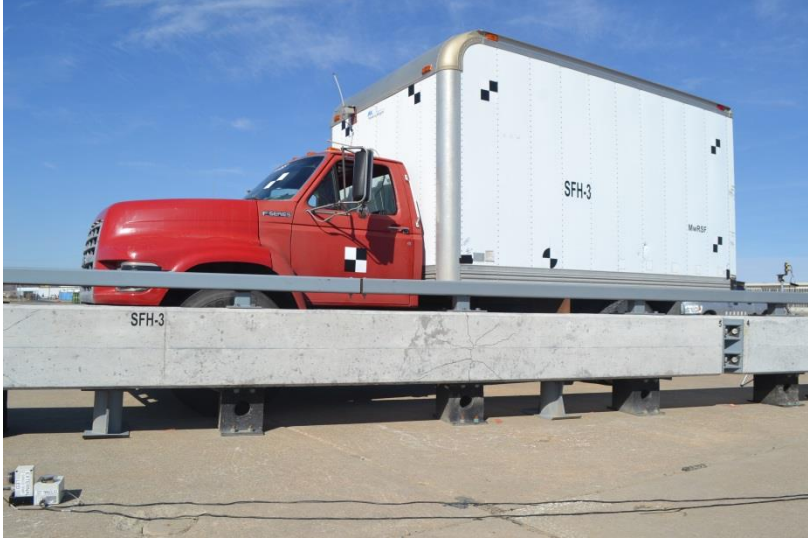
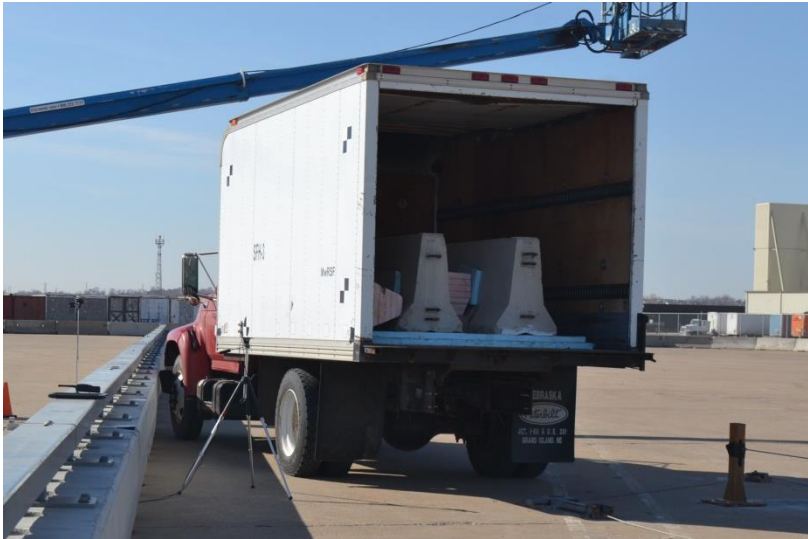
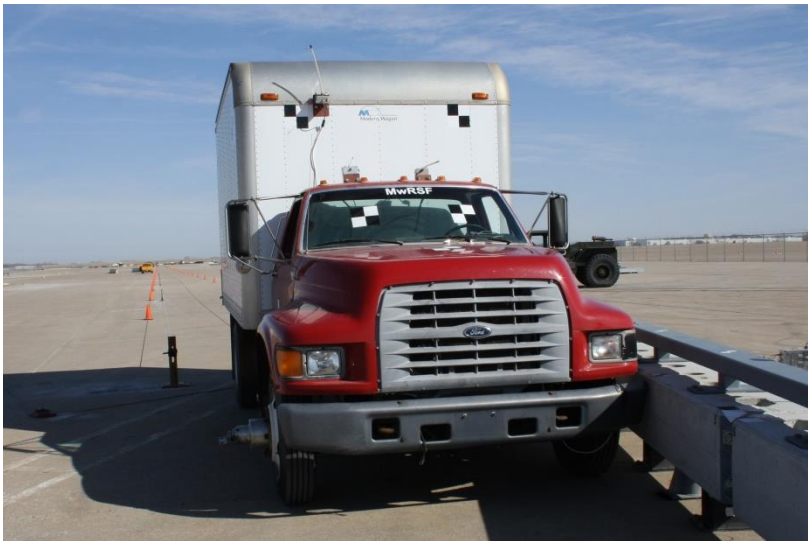
Figure 33. Test Vehicle, Test No. SFH-3

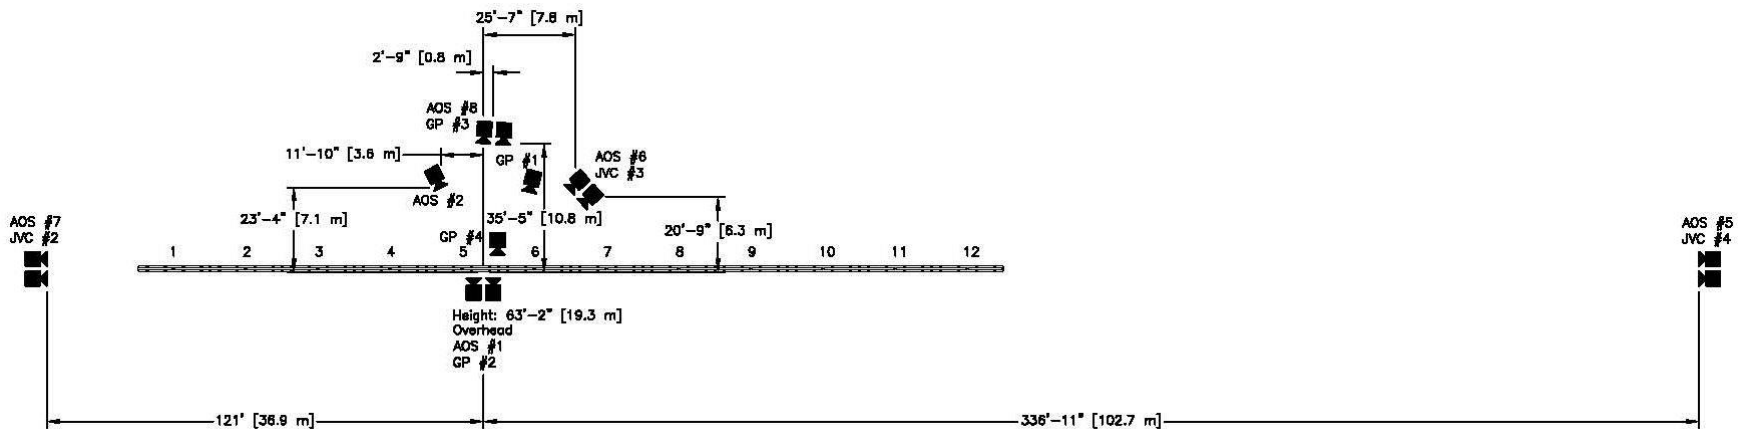
The high-speed videos were analyzed using ImageExpress MotionPlus and RedLake MotionScope software programs. Actual camera speed and camera divergence factors were considered in the analysis of the high-speed videos. A Nikon D50 digital still camera was used to document pre- and post-test conditions for all tests.

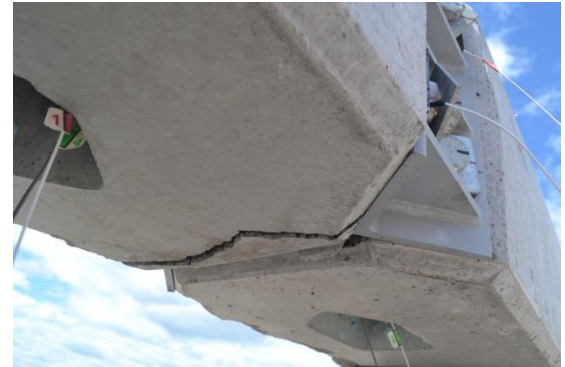
Back Face Underneath

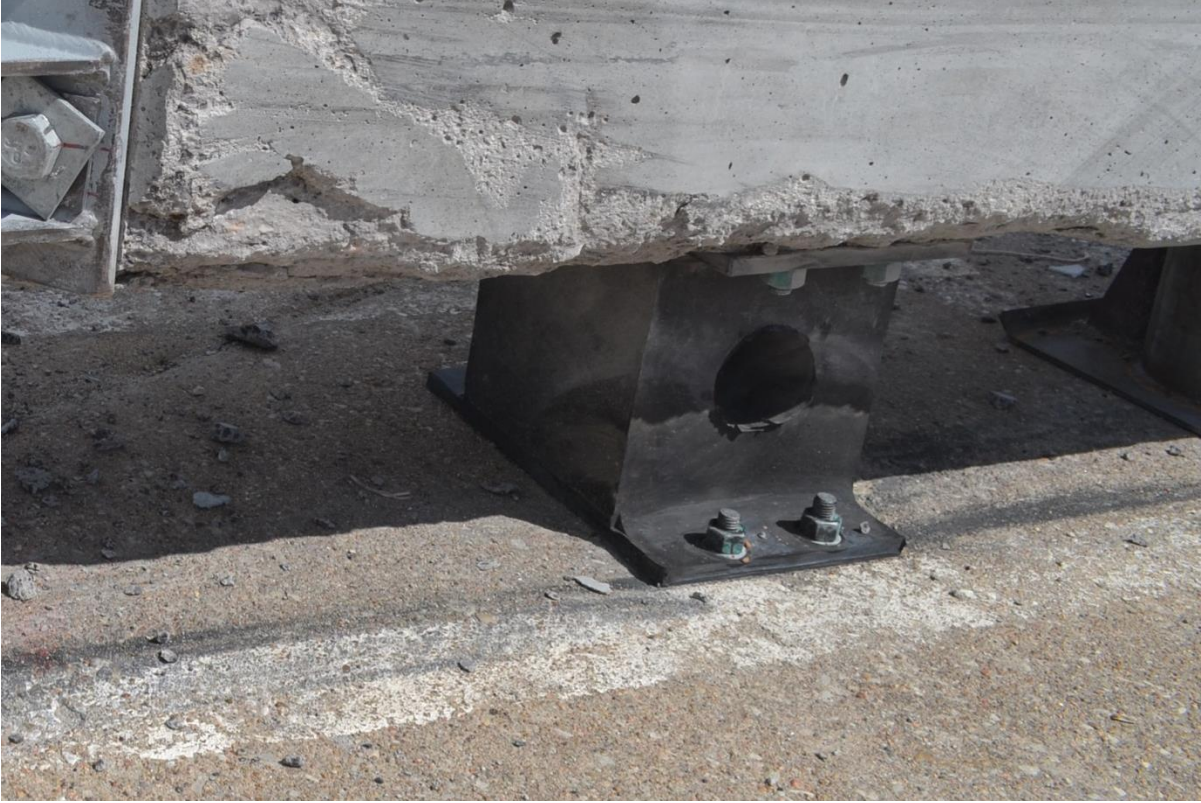
First Post Downstream from Barrier Nos. 5 and 6 Joint

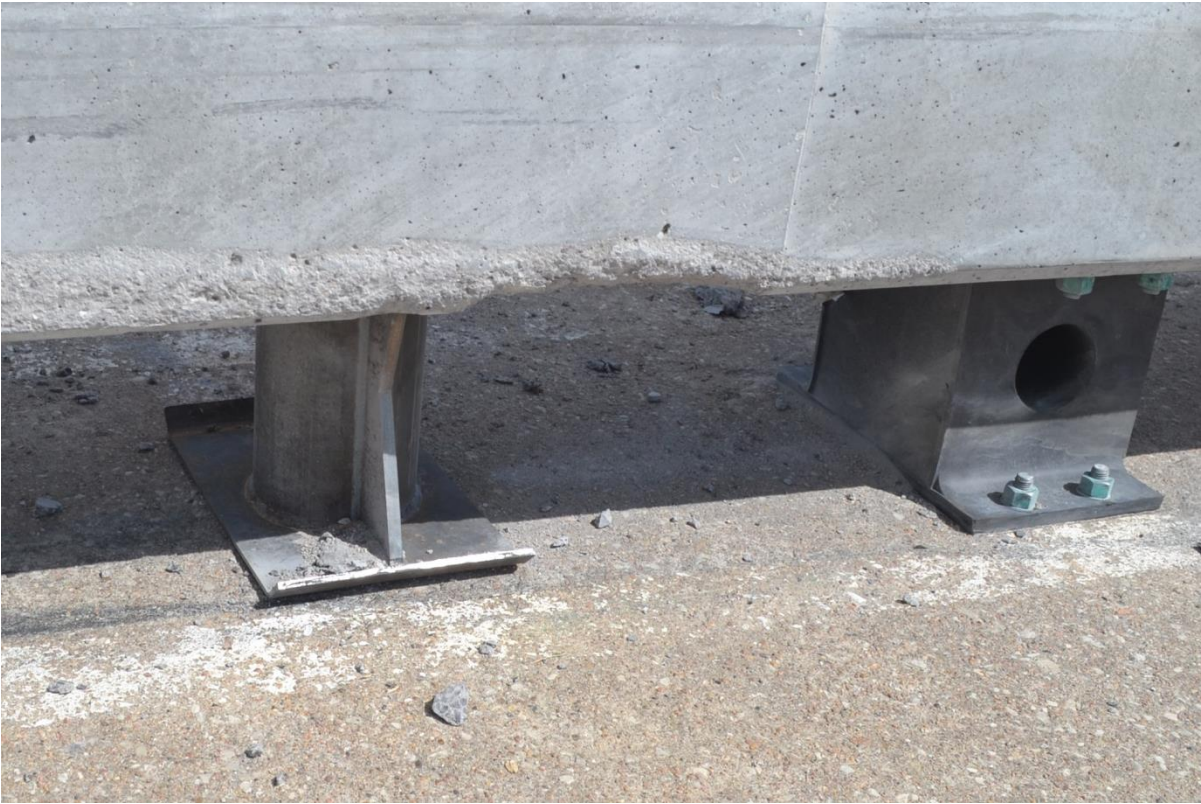
First Skid and Second Post Downstream from Barrier Nos. 5 and 6 Joint

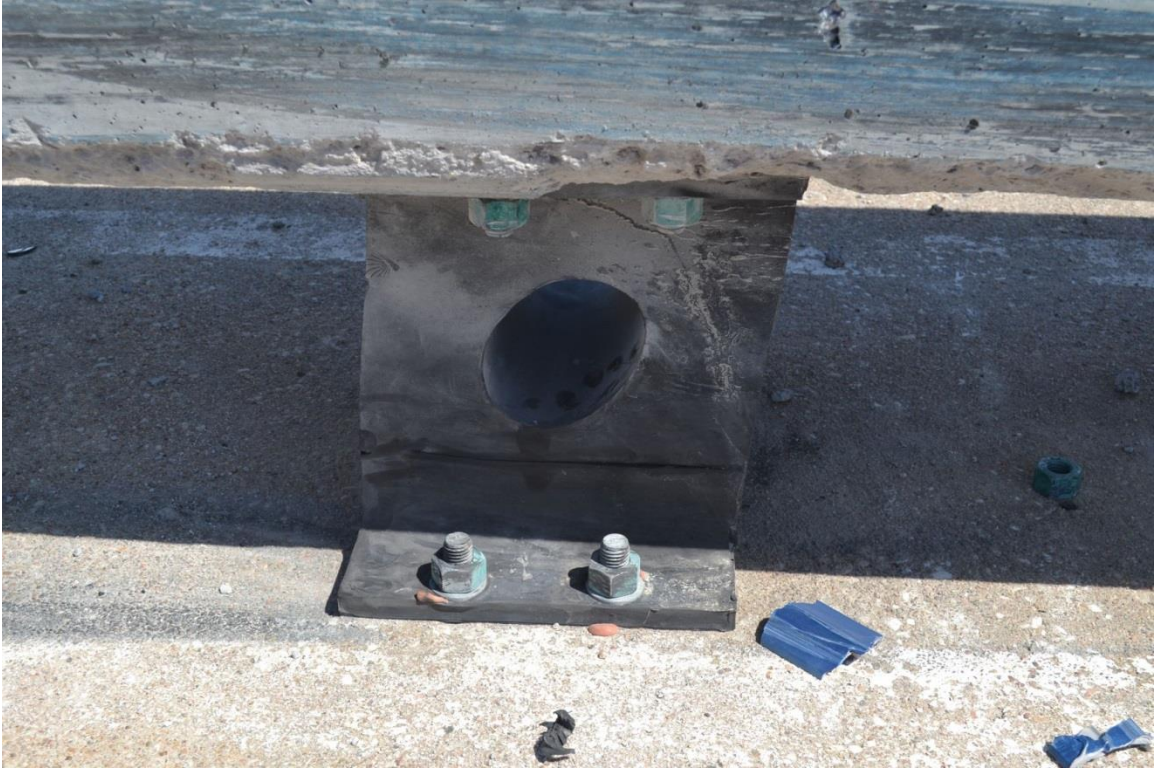
a) First Post Downstream from Joint between Barrier Nos. 7 and 8

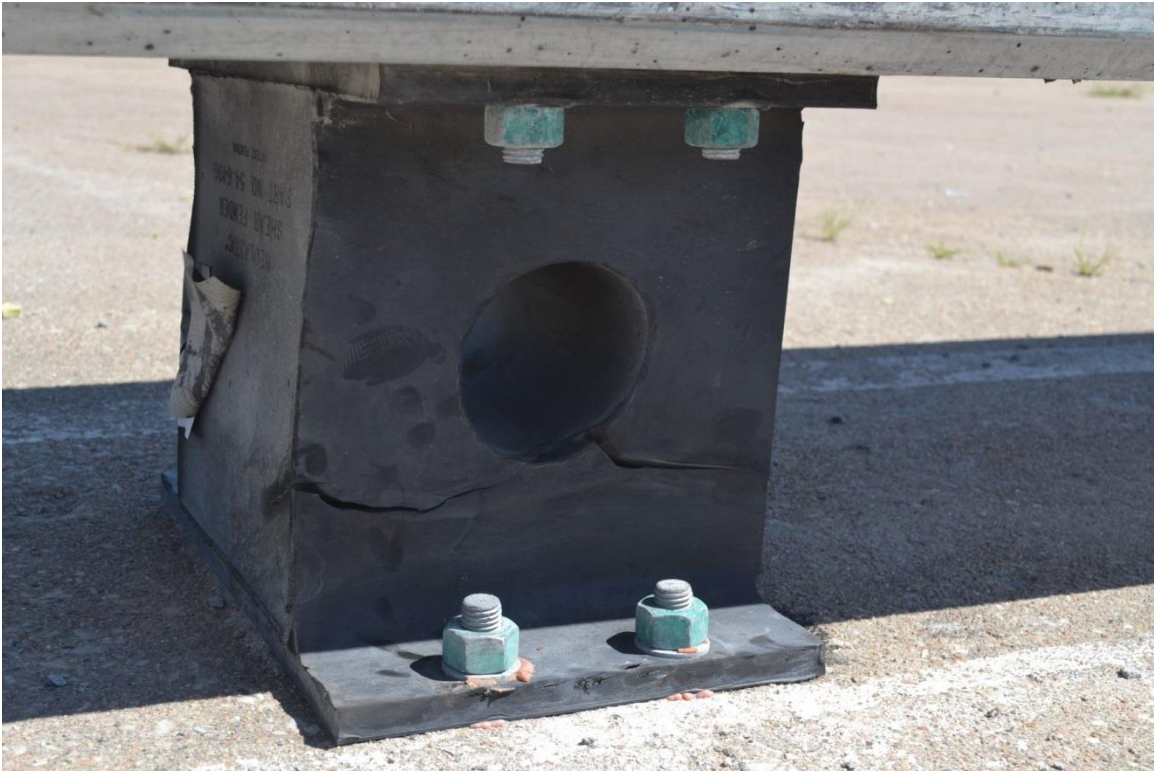
b) Second Post Downstream from Joint between Barrier Nos. 7 and 8

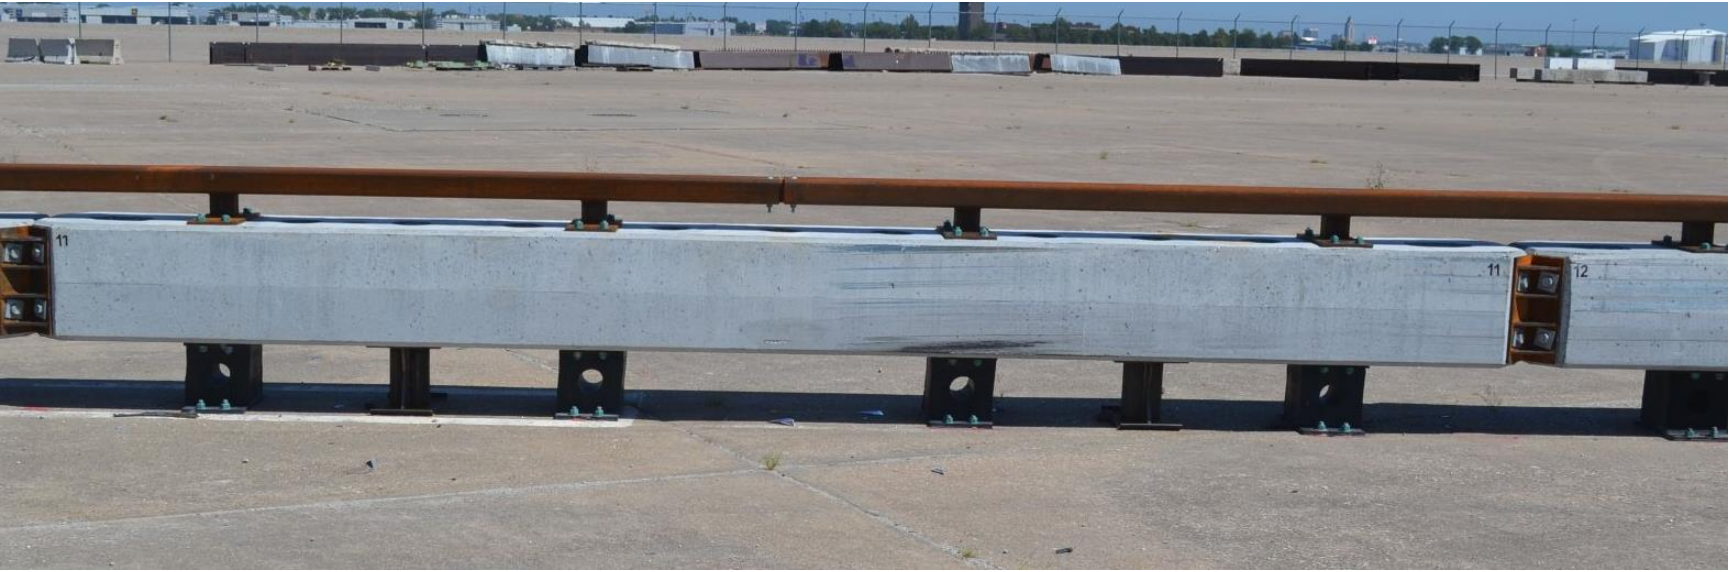
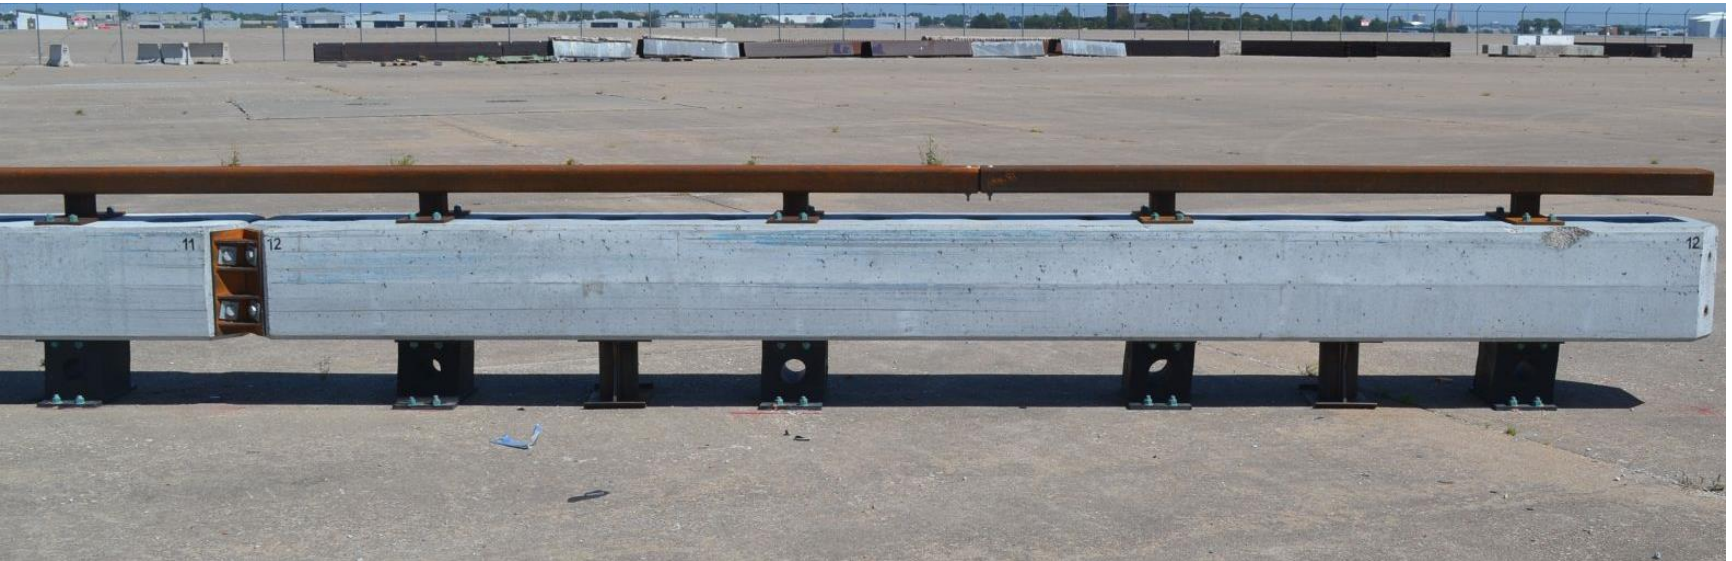
Figure 72. System Damage, Barrier Nos. 11 and 12, Test No. SFH-2

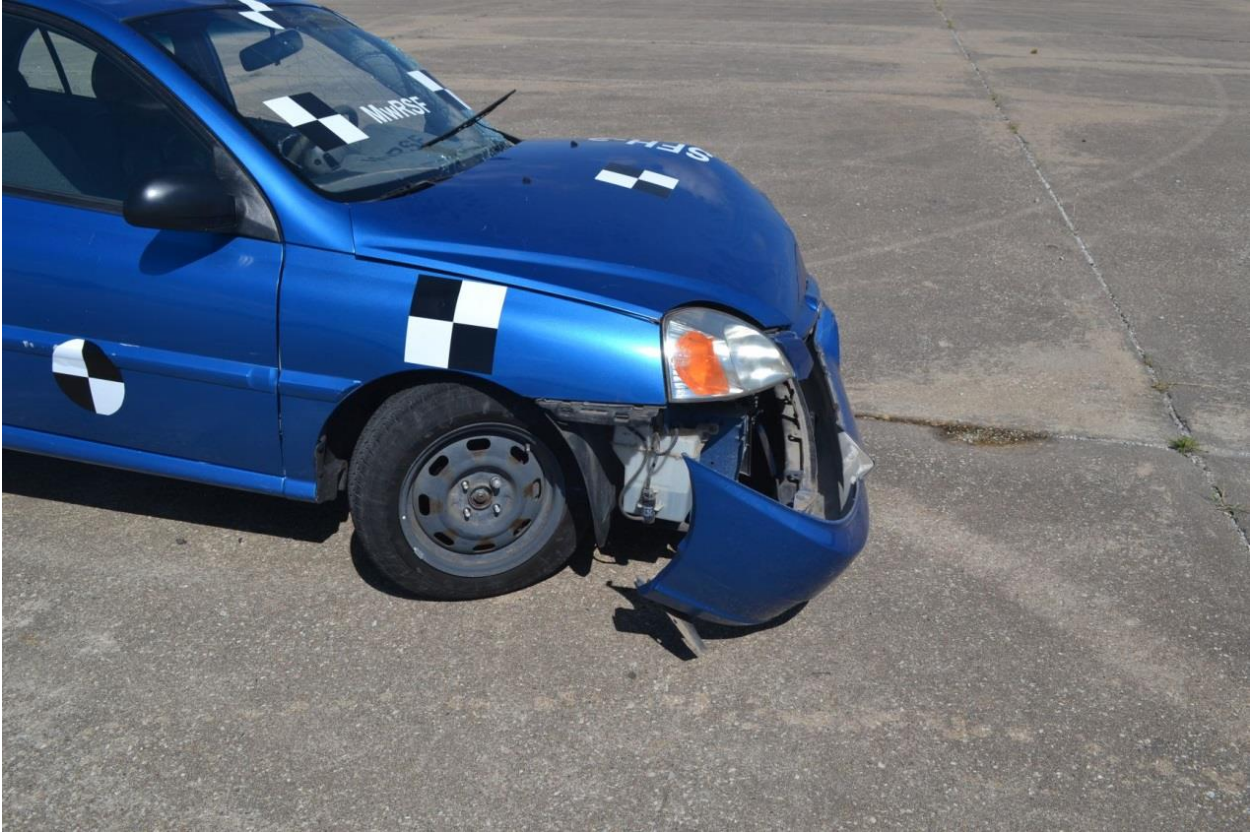
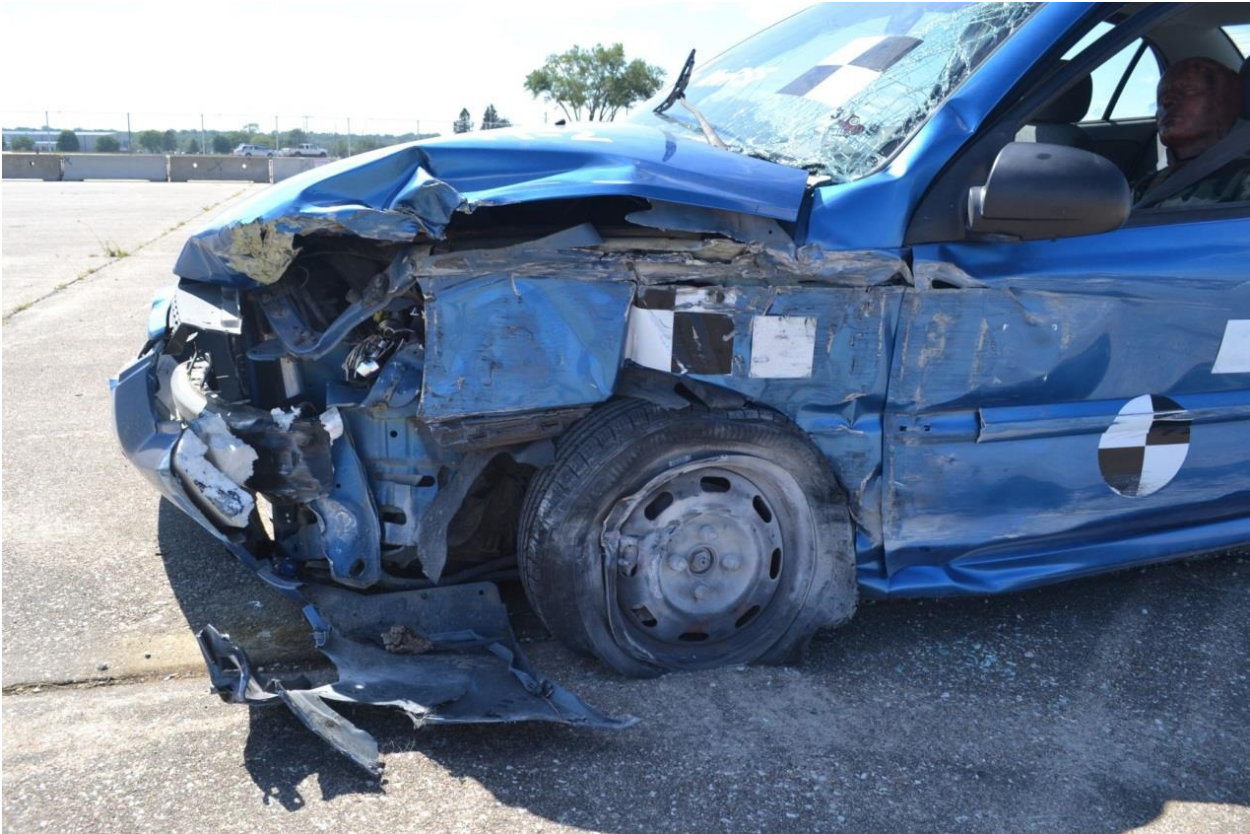
Figure 74. Vehicle Damage, Test No. SFH-2

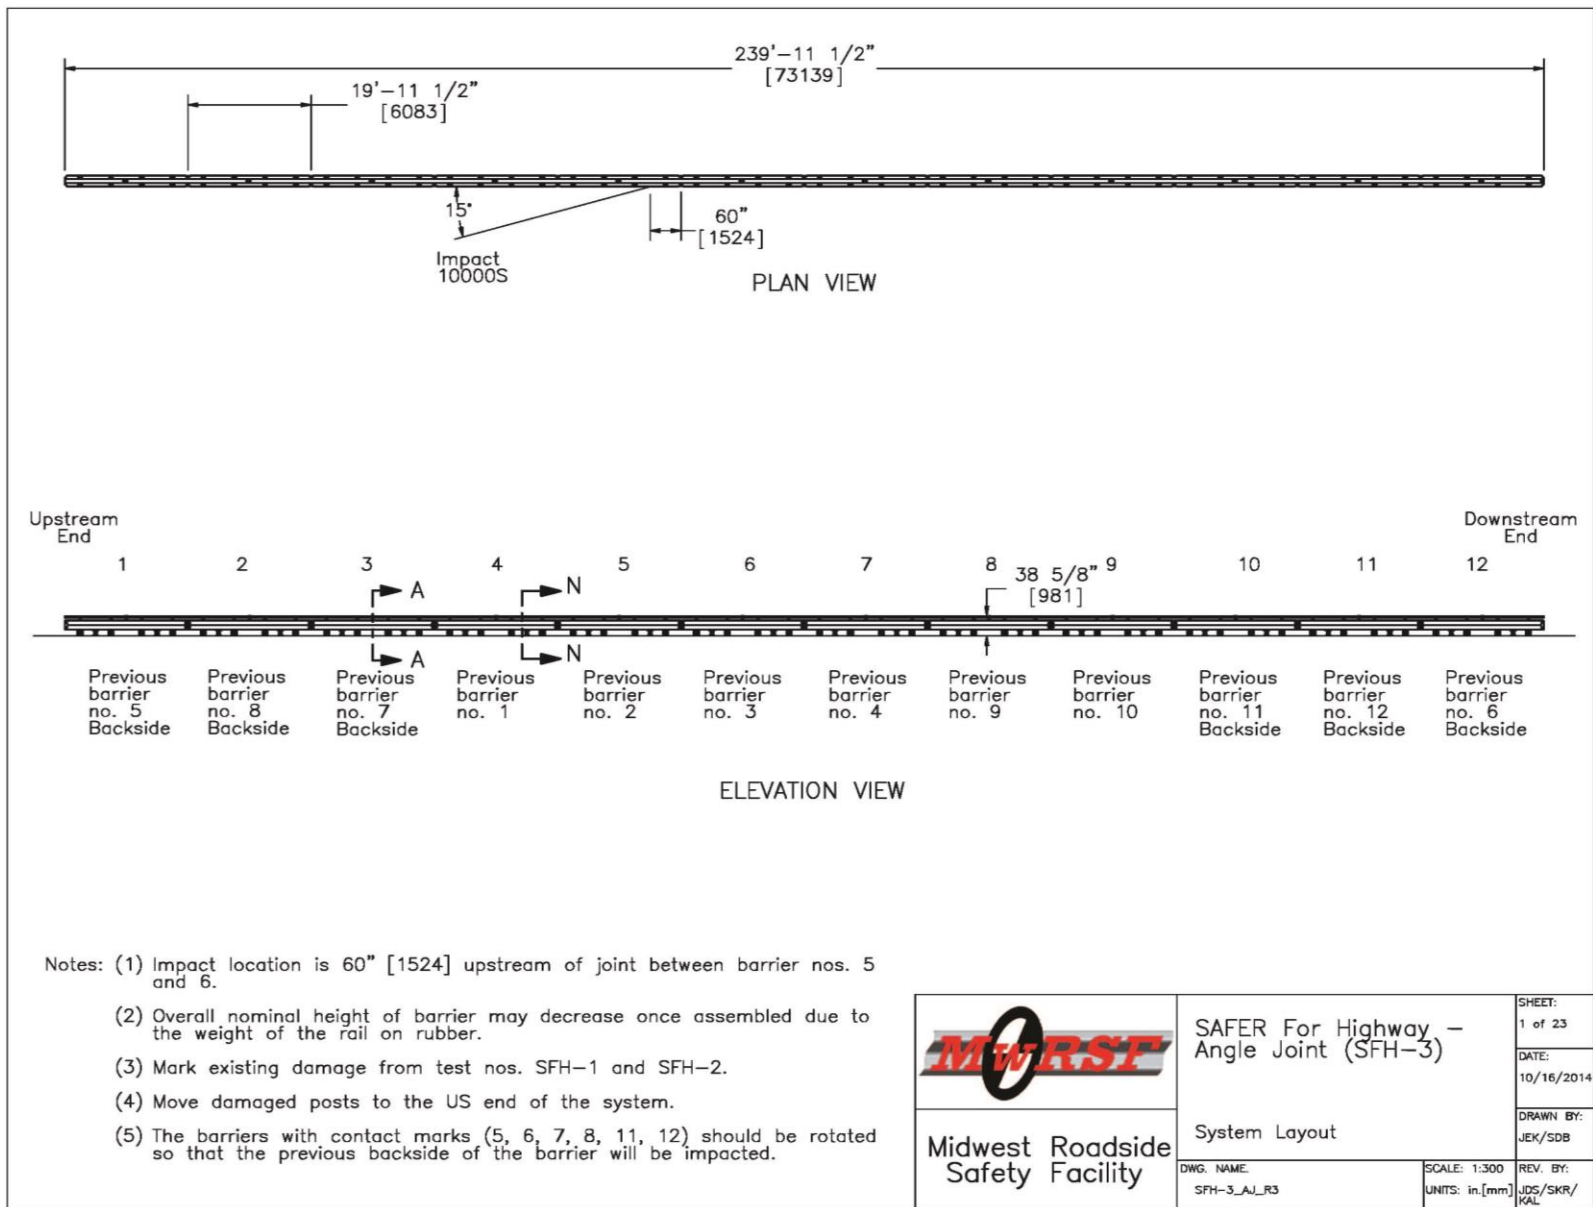
Figure 79. System Layout, Test No. SFH-3

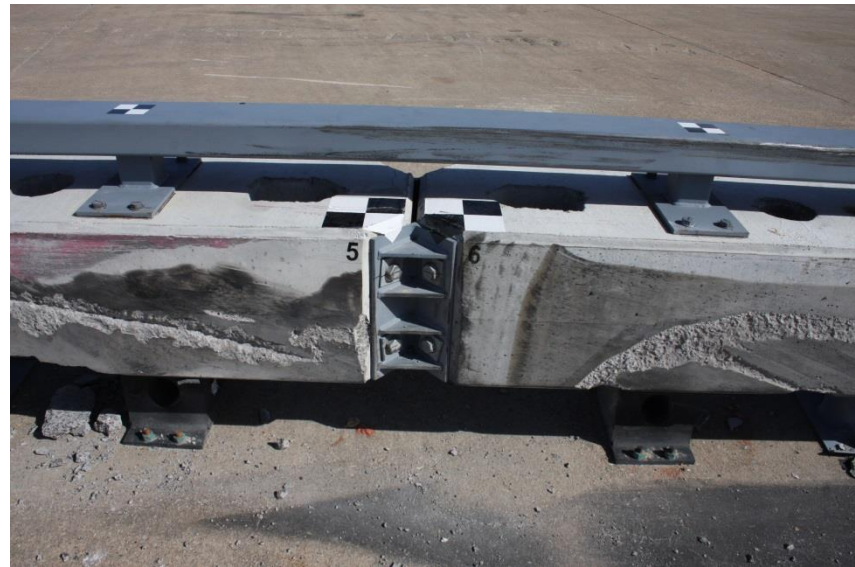
Figure 111. System Damage, Barrier No. 5 and Joint Between Barrier Nos. 5 and 6, Test No. SFH-3

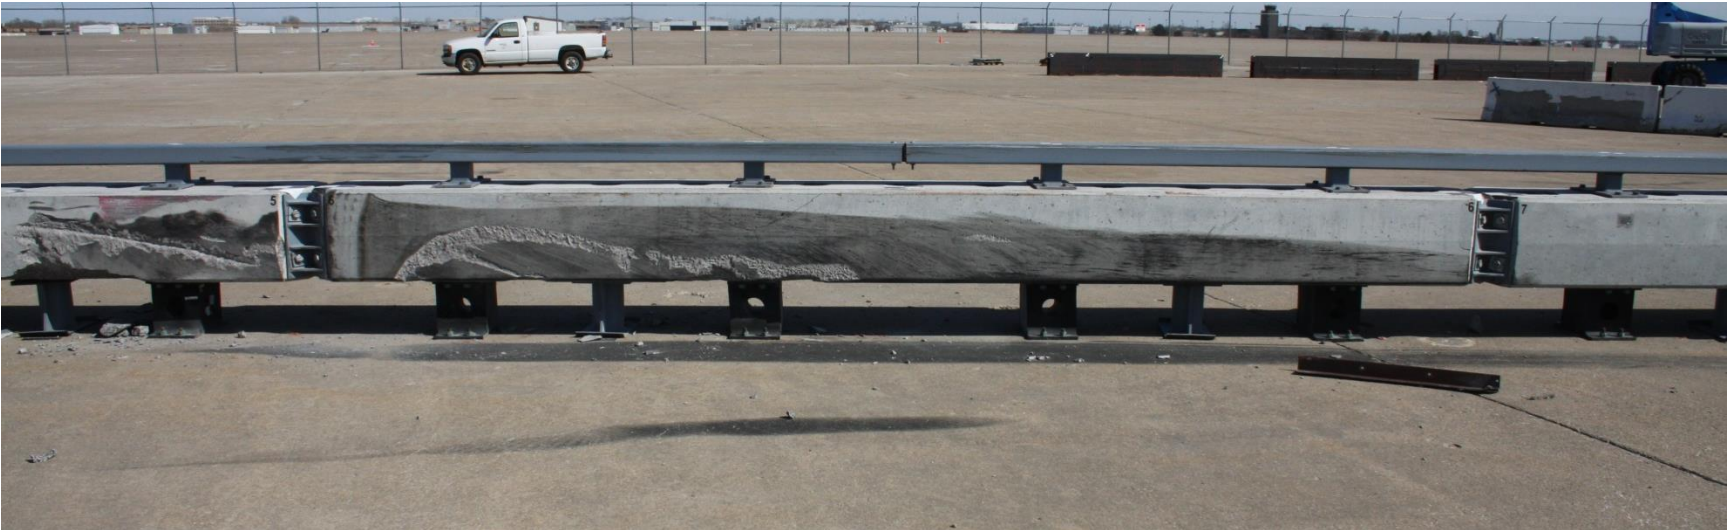
Figure 113. System Damage, Barrier No. 6, Test No. SFH-3

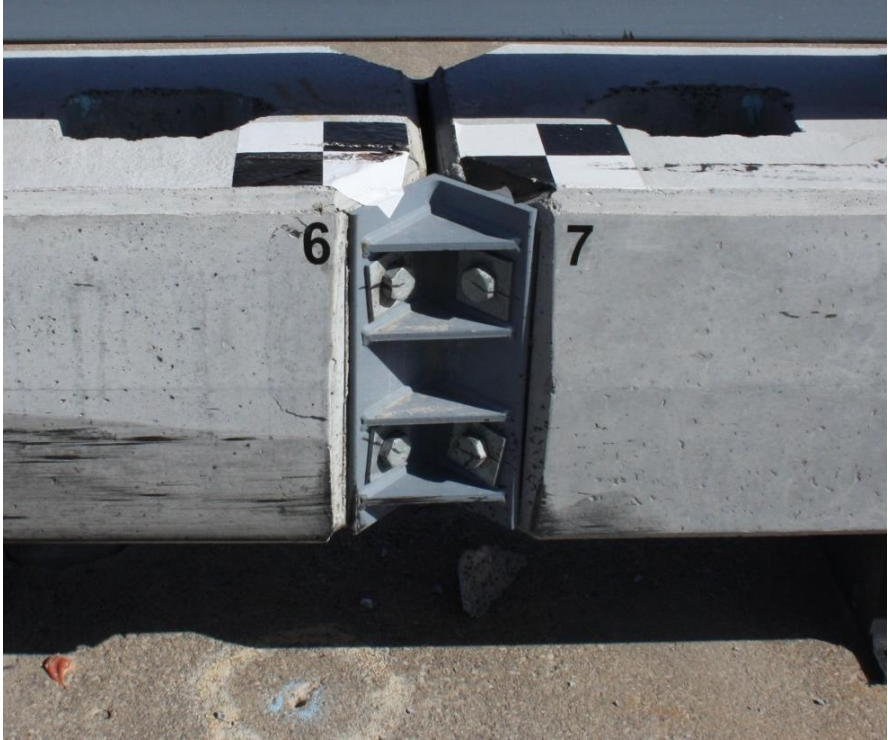
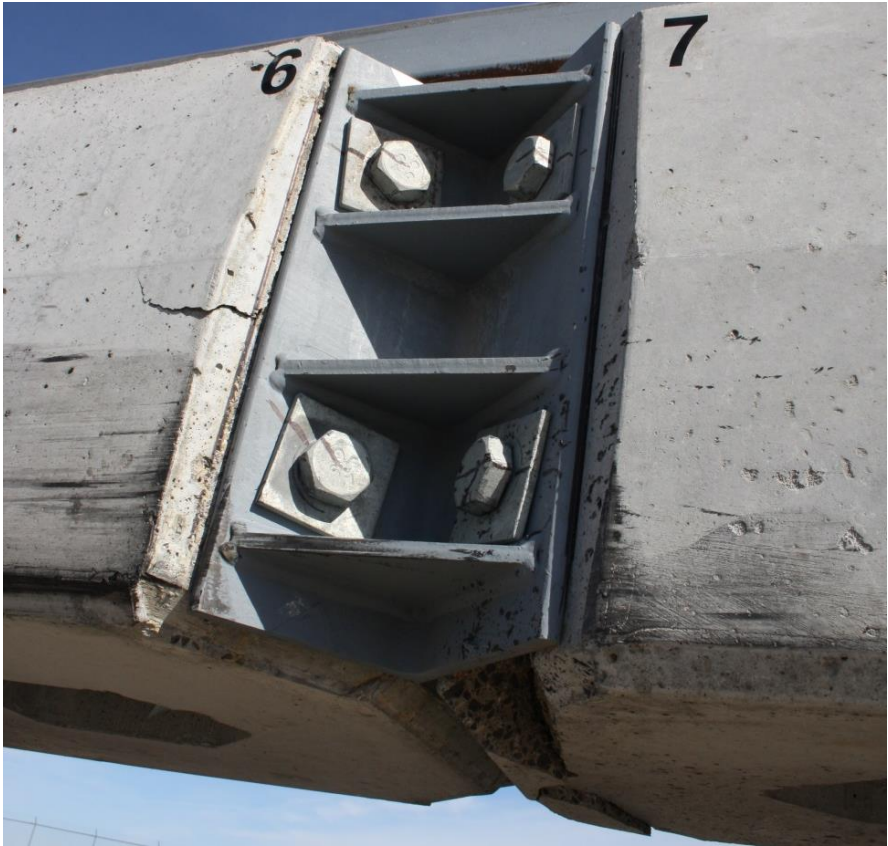
Figure 114. System Damage, Joint between Barrier Nos. 6 and 7, Test No. SFH-3

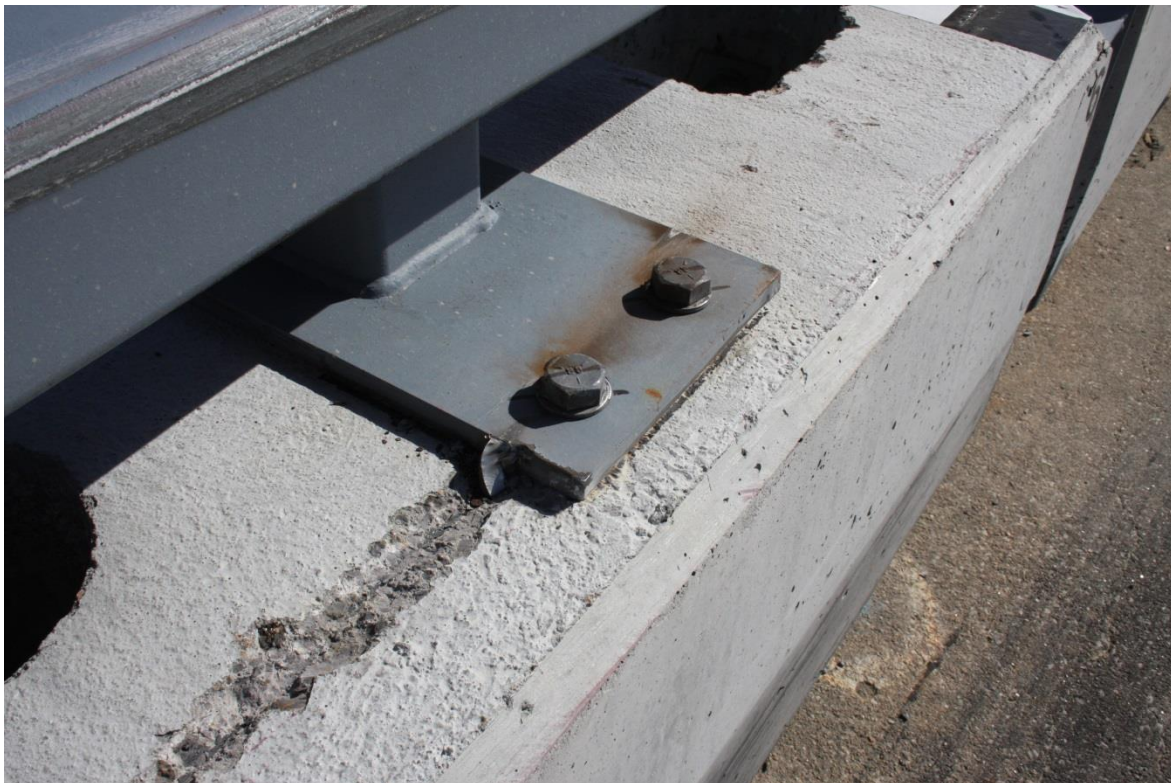
Figure 115. System Damage, First Upper Tube Assembly Connection Upstream from Joint between Barrier Nos. 6 and 7, Test No. SFH-3

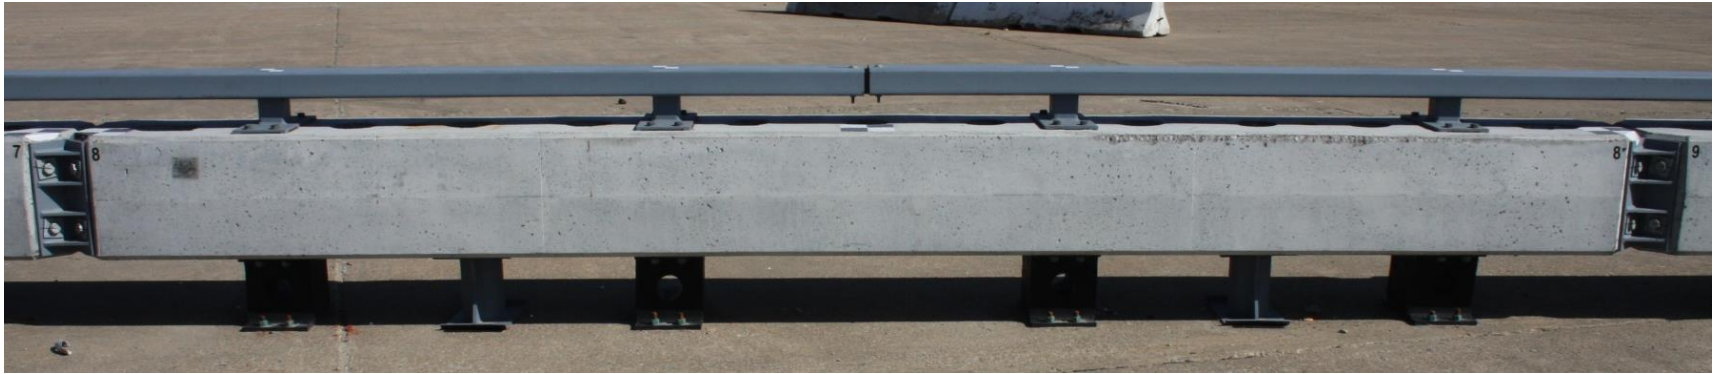
Figure 117. System Damage, Barrier No. 8, Test No. SFH-3

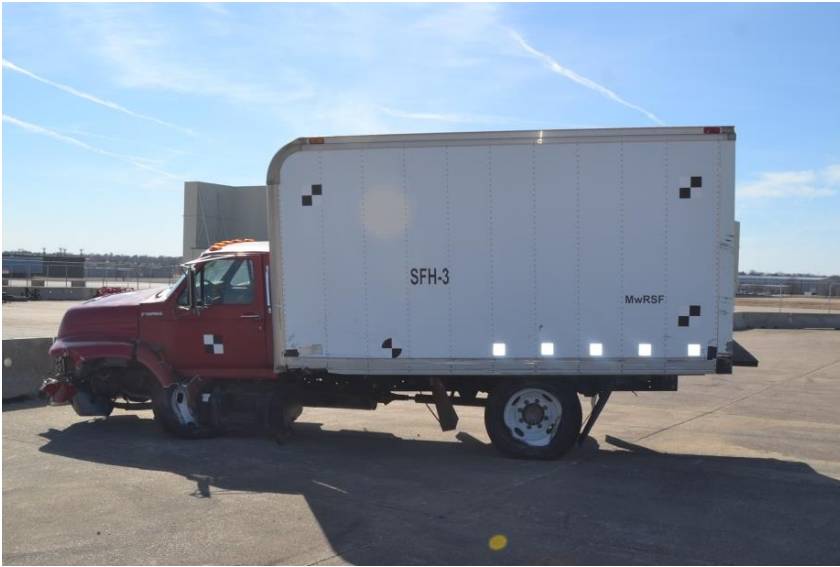
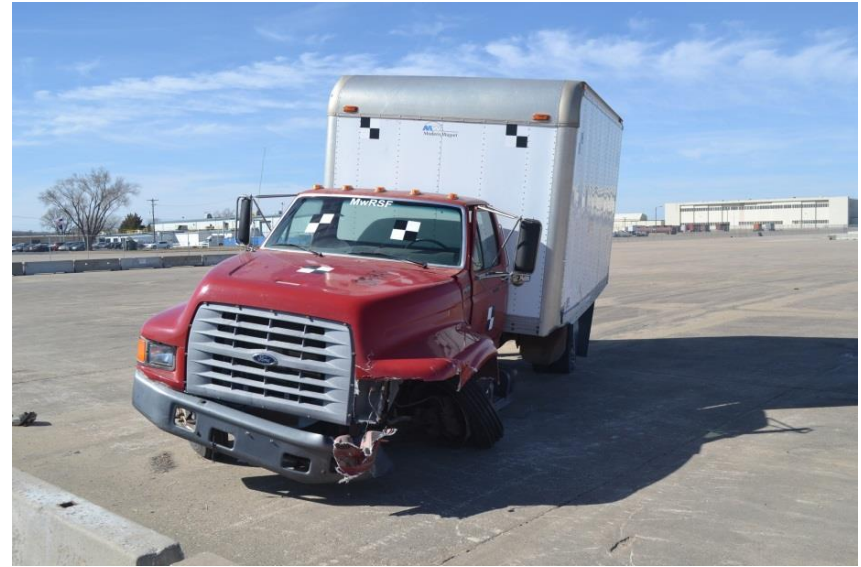
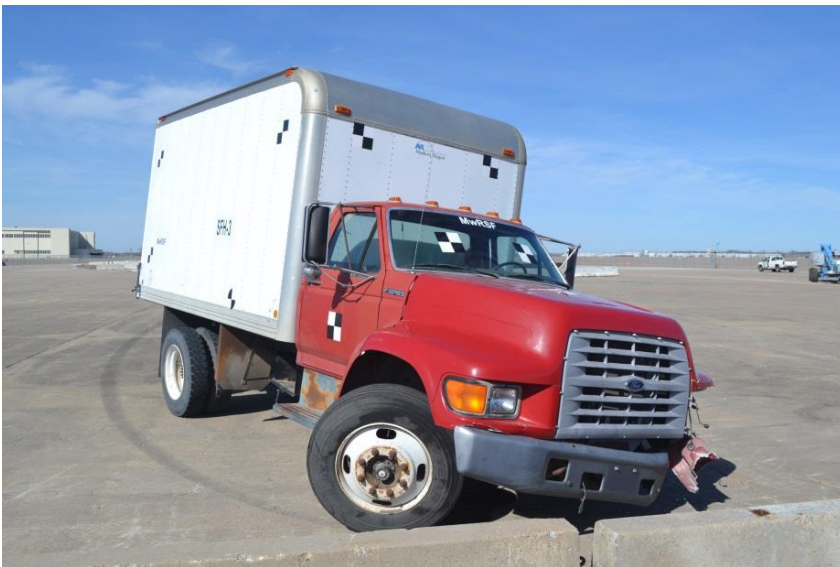
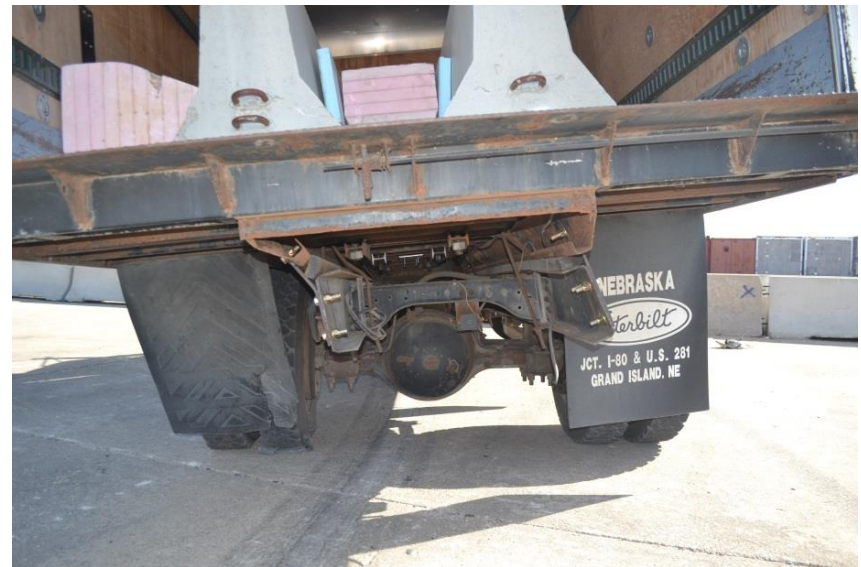
Figure 121. Vehicle Damage, Test No. SFH-3

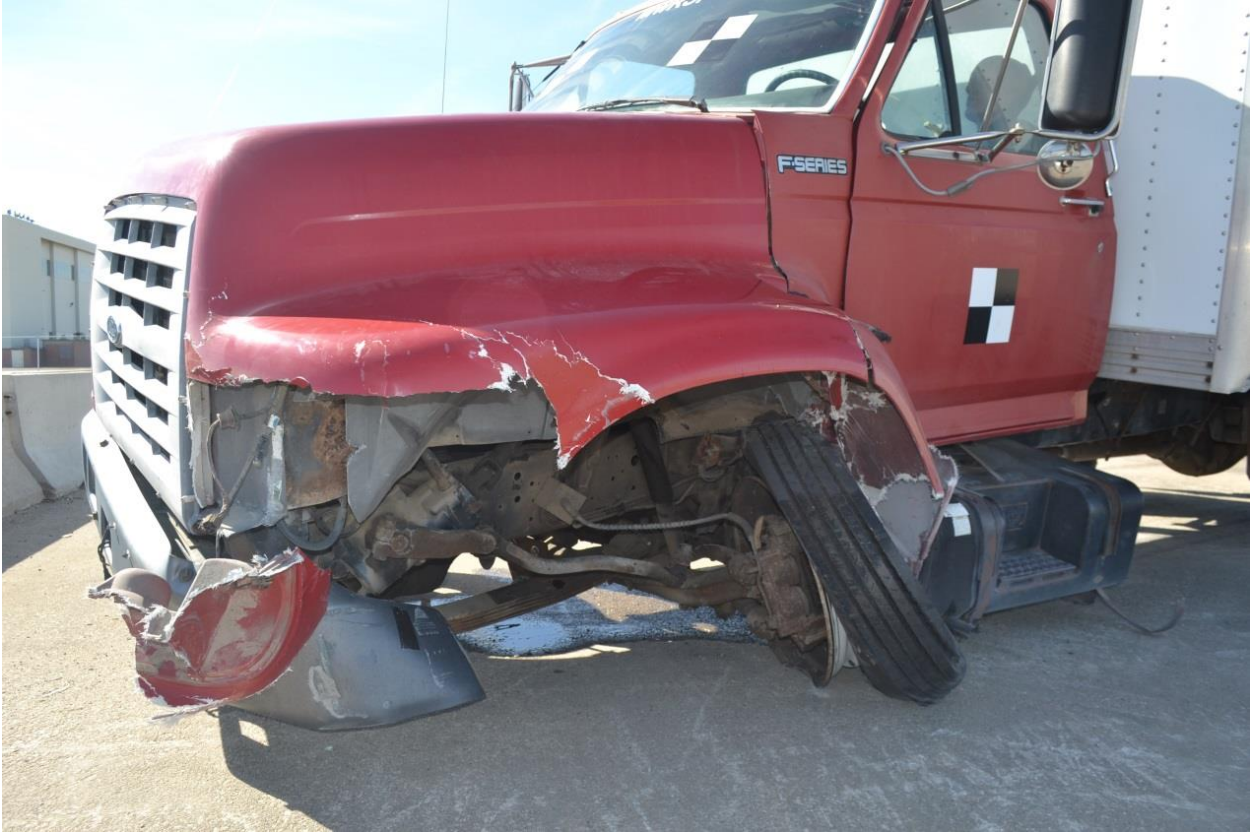
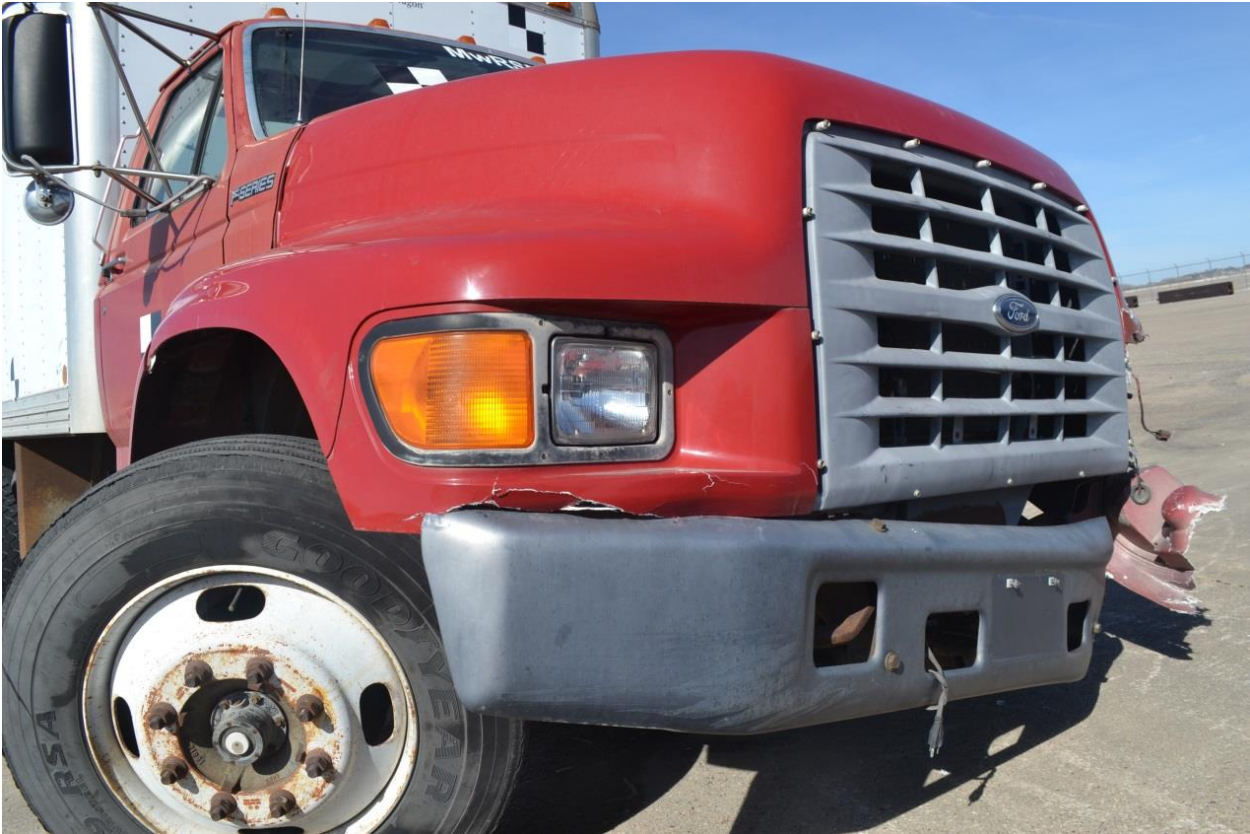
Figure 123. Vehicle Damage, Test No. SFH-3
