TESTING CERT # 2937.01

NDOR Sponsoring Agency Contract No. DPU-STWD (94)

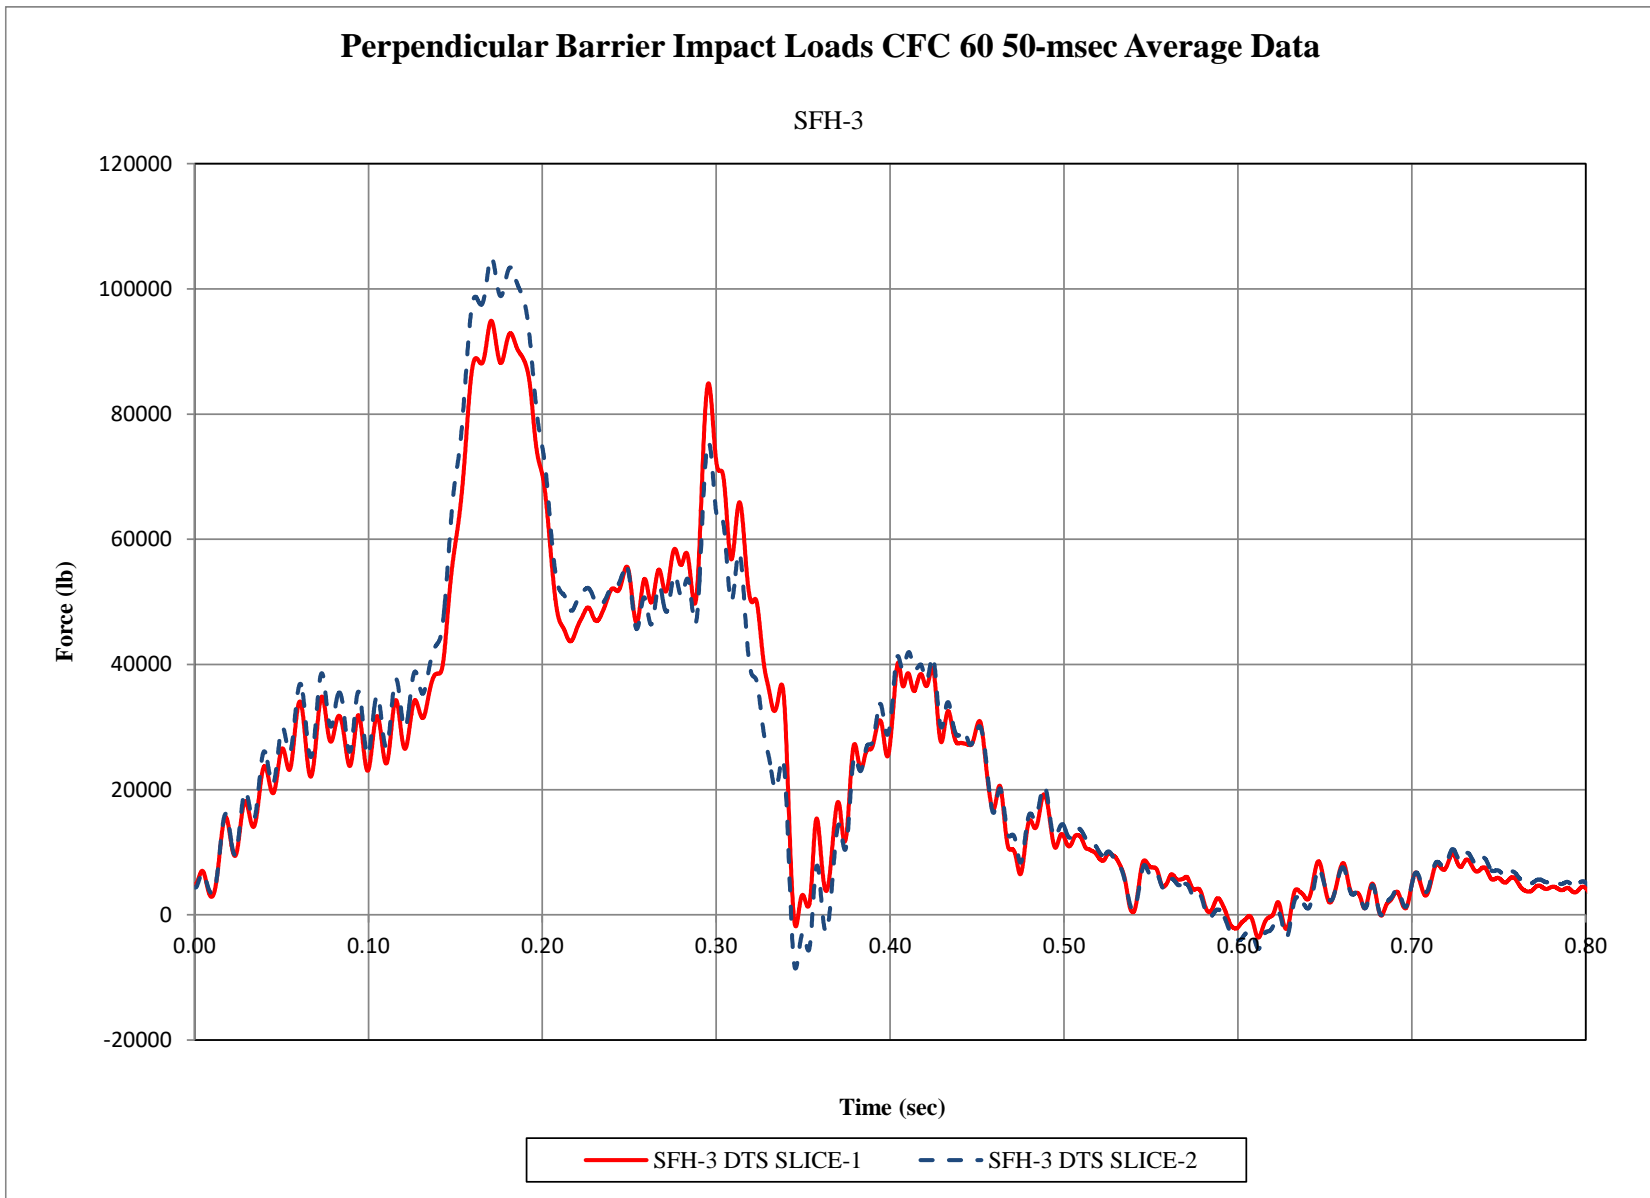
Figure 124. Perpendicular Forces Imparted to the Barrier System, Test No. SFH-3

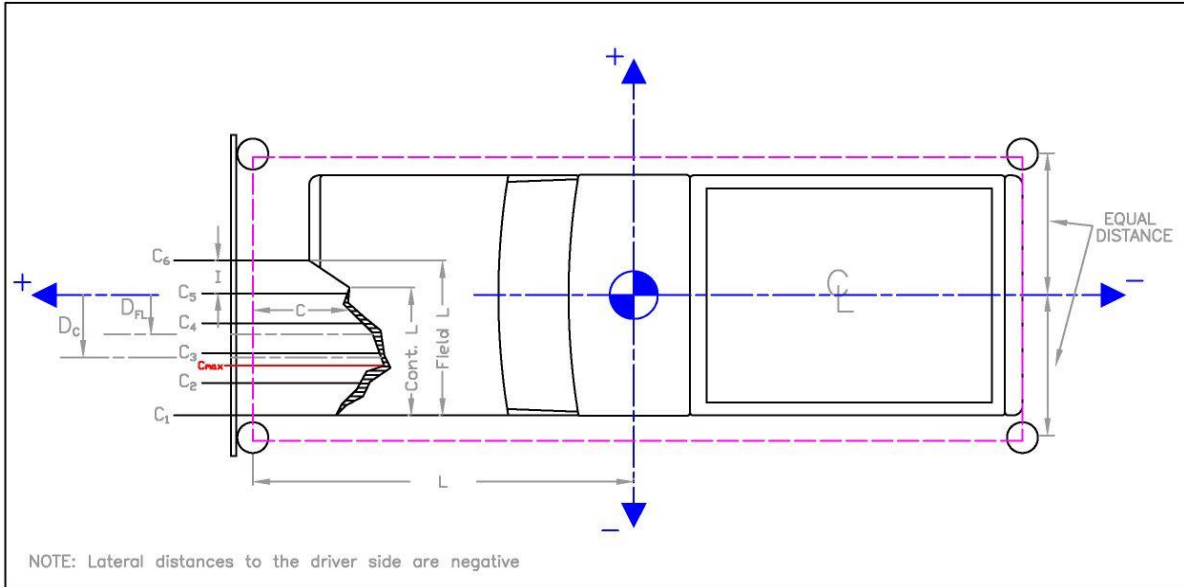
in.	(mm)
Distance from C.G. to reference line - L _{REF} :	112	(2845)
Width of contact and induced crush - Field L:	39	(991)
Crush measurement spacing interval (L/5) - I:	7.8	(198)
Distance from center of vehicle to center of Field L - D _{FL} :	-19.5	-(495)
Width of Contact Damage:	21	(533)
Distance from center of vehicle to center of contact damage - D _C :	28 1/2	(724)

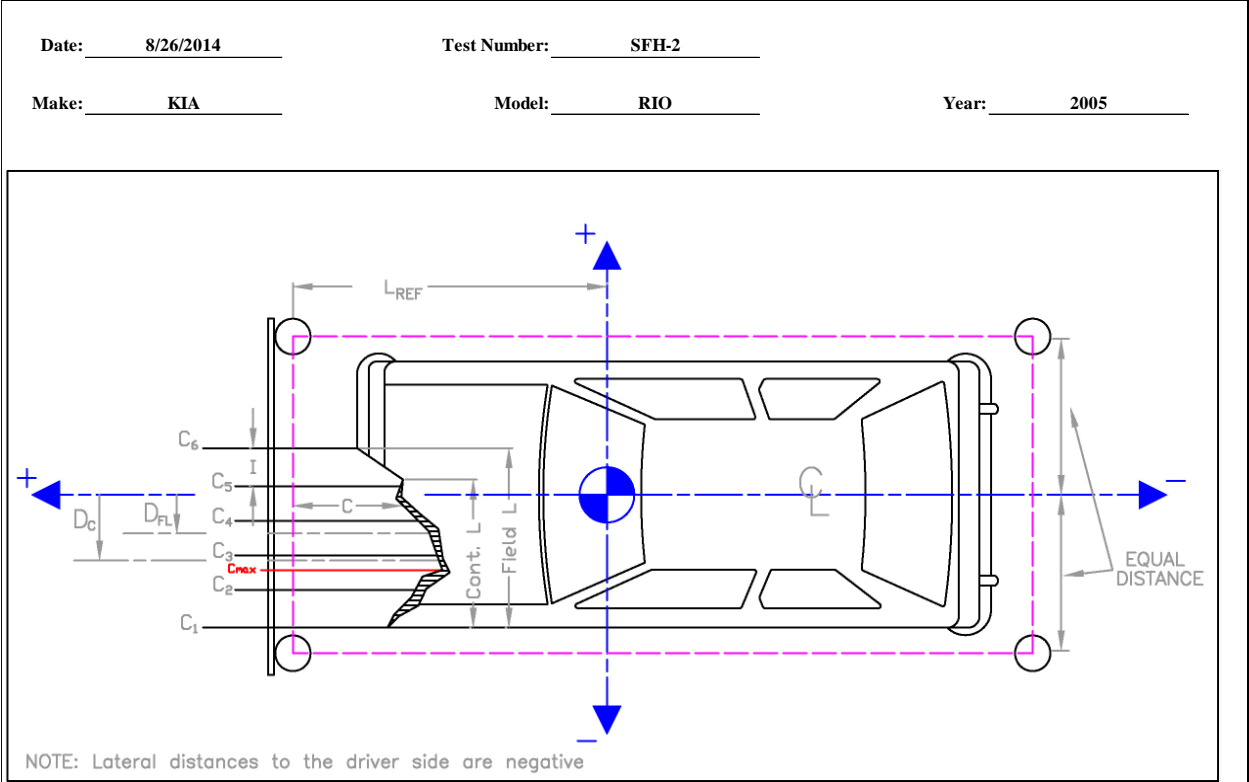
in.	(mm)
Distance from C.G. to reference line - L_{REF} :	<u>81 1/4</u>	<u>(2064)</u>
Width of contact and induced crush - Field L:	<u>65 1/2</u>	<u>(1664)</u>
Crush measurement spacing interval (L/5) - I:	<u>13</u>	<u>(333)</u>
Distance from center of vehicle to center of Field L - D_{FL} :	<u>0</u>	<u>(0)</u>
Width of Contact Damage:	<u>65 1/2</u>	<u>(1664)</u>
Distance from center of vehicle to center of contact damage - D_C :	<u>0</u>	<u>(0)</u>

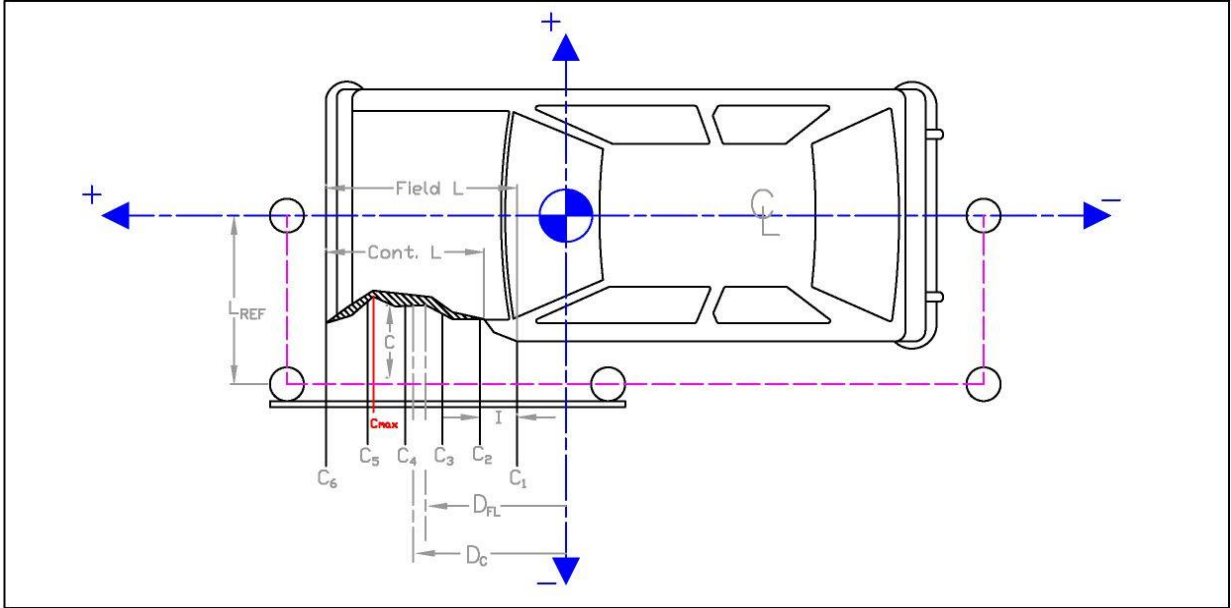
in.	(mm)
Distance from centerline to reference line - L _{REF} :	36	(914)
Width of contact and induced crush - Field L:	166.5	(4229)
Crush measurement spacing interval (L/5) - I:	33.3	(846)
Distance from vehicle c.g. to center of Field L - D _{FL} :	-13.75	-(349)
Width of Contact Damage:	166.5	(4229)
Distance from vehicle c.g. to center of contact damage - D _C :	13.75	(349)
