*Midwest Pooled Fund Research Program
Fiscal Years 2017-2019 (Years 27 through 29)
Research Project Number TPF-5(193) Supplement #105
NDOT Sponsoring Agency Code RPFP-17-MGS-1*

**ISO 17025 LABORATORY
TESTING CERT # 2937.01**

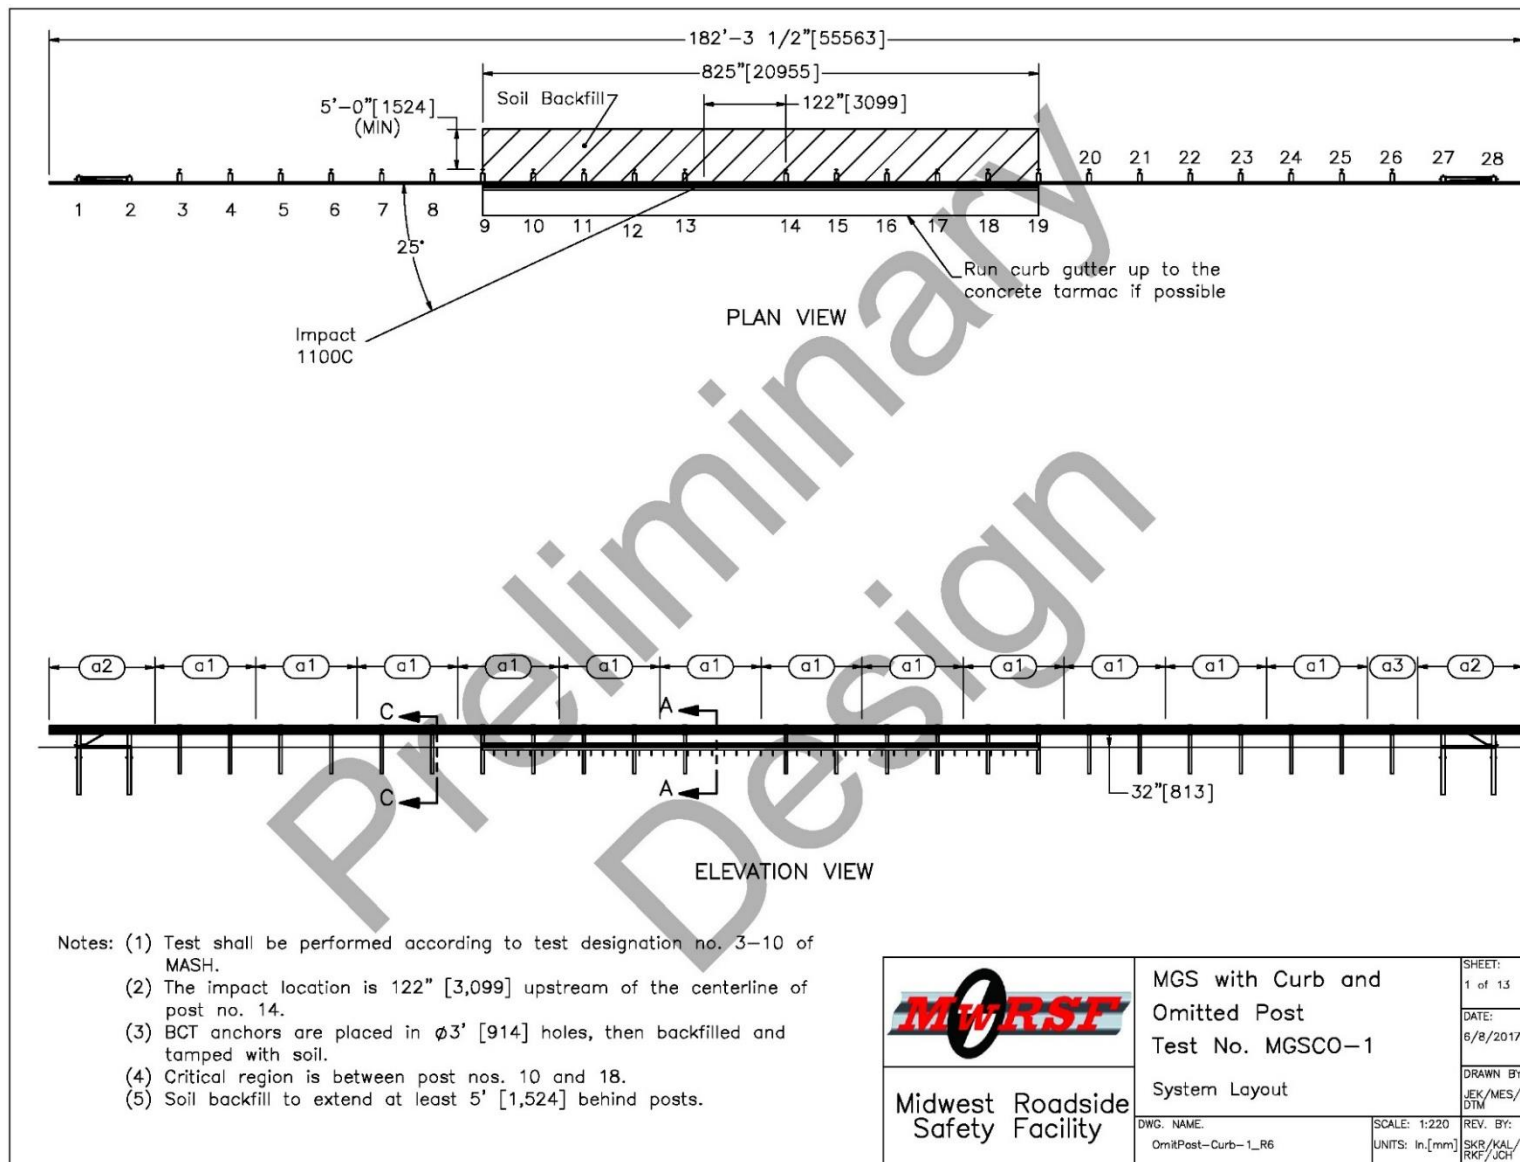
Figure 2. System Layout, Test No. MGSCO-1

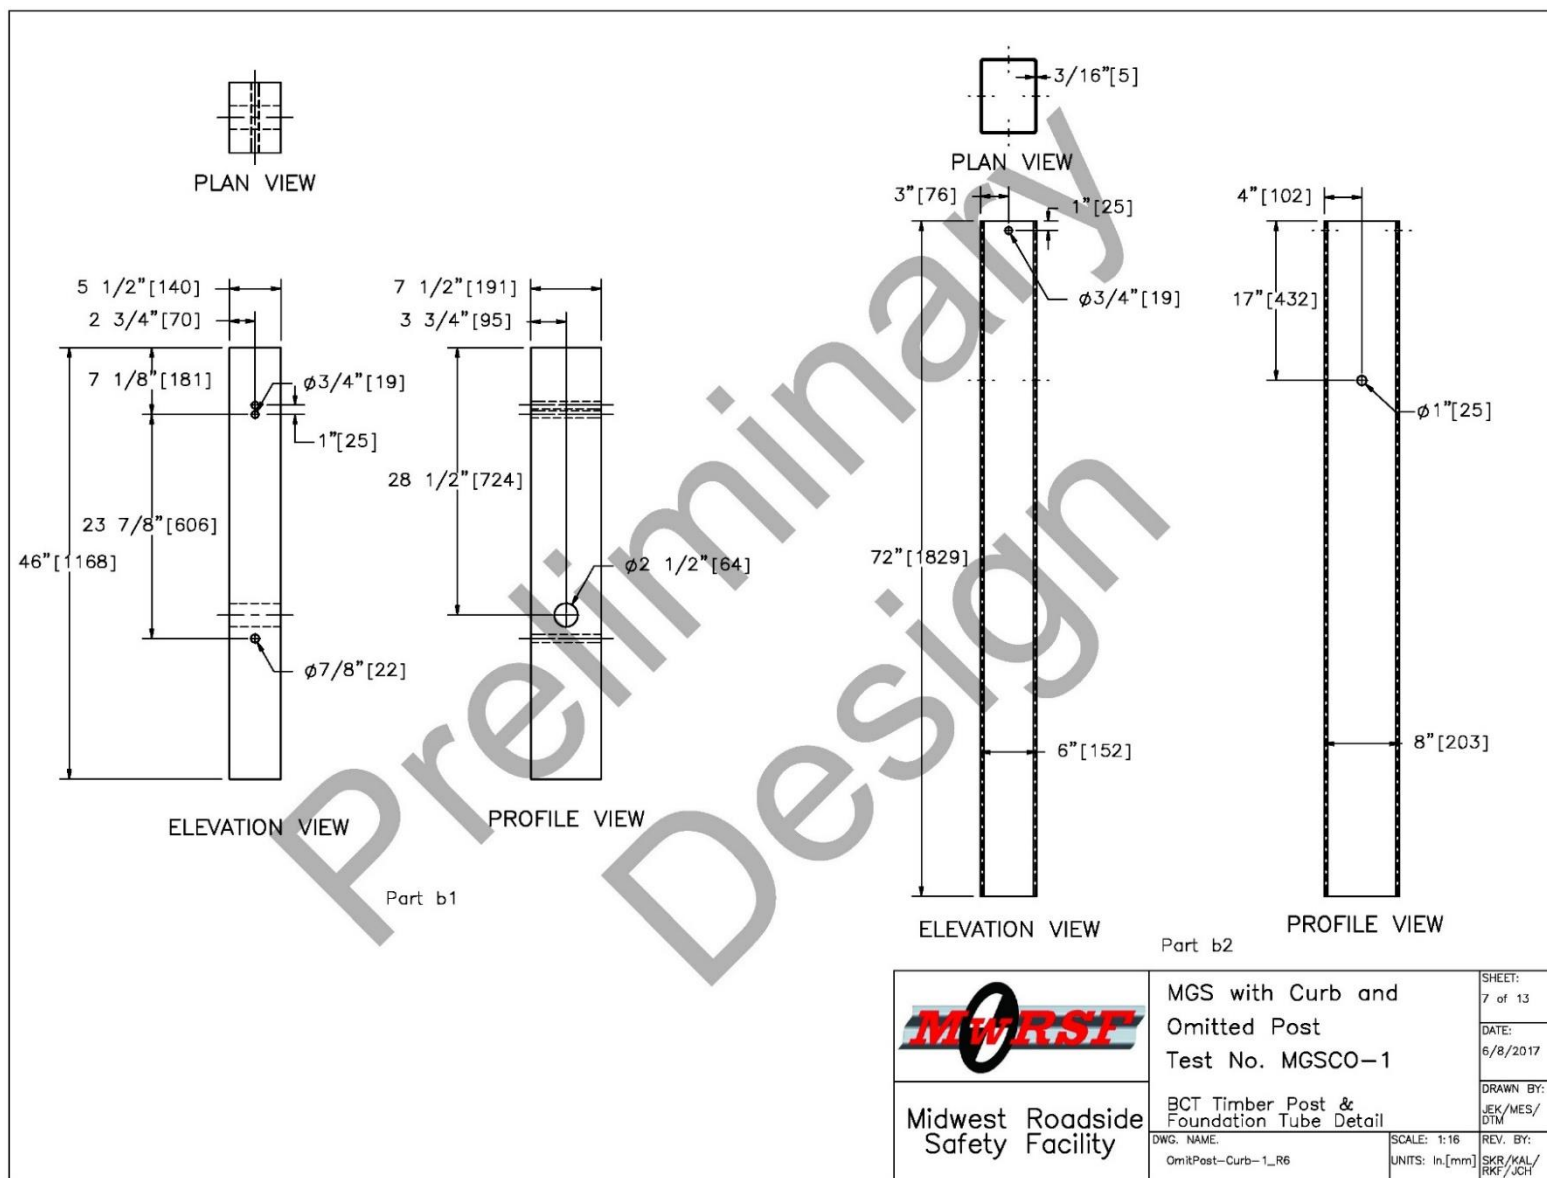
Figure 8. MGS BCT Timber Post and Foundation Tube Detail, Test No. MGSCO-1

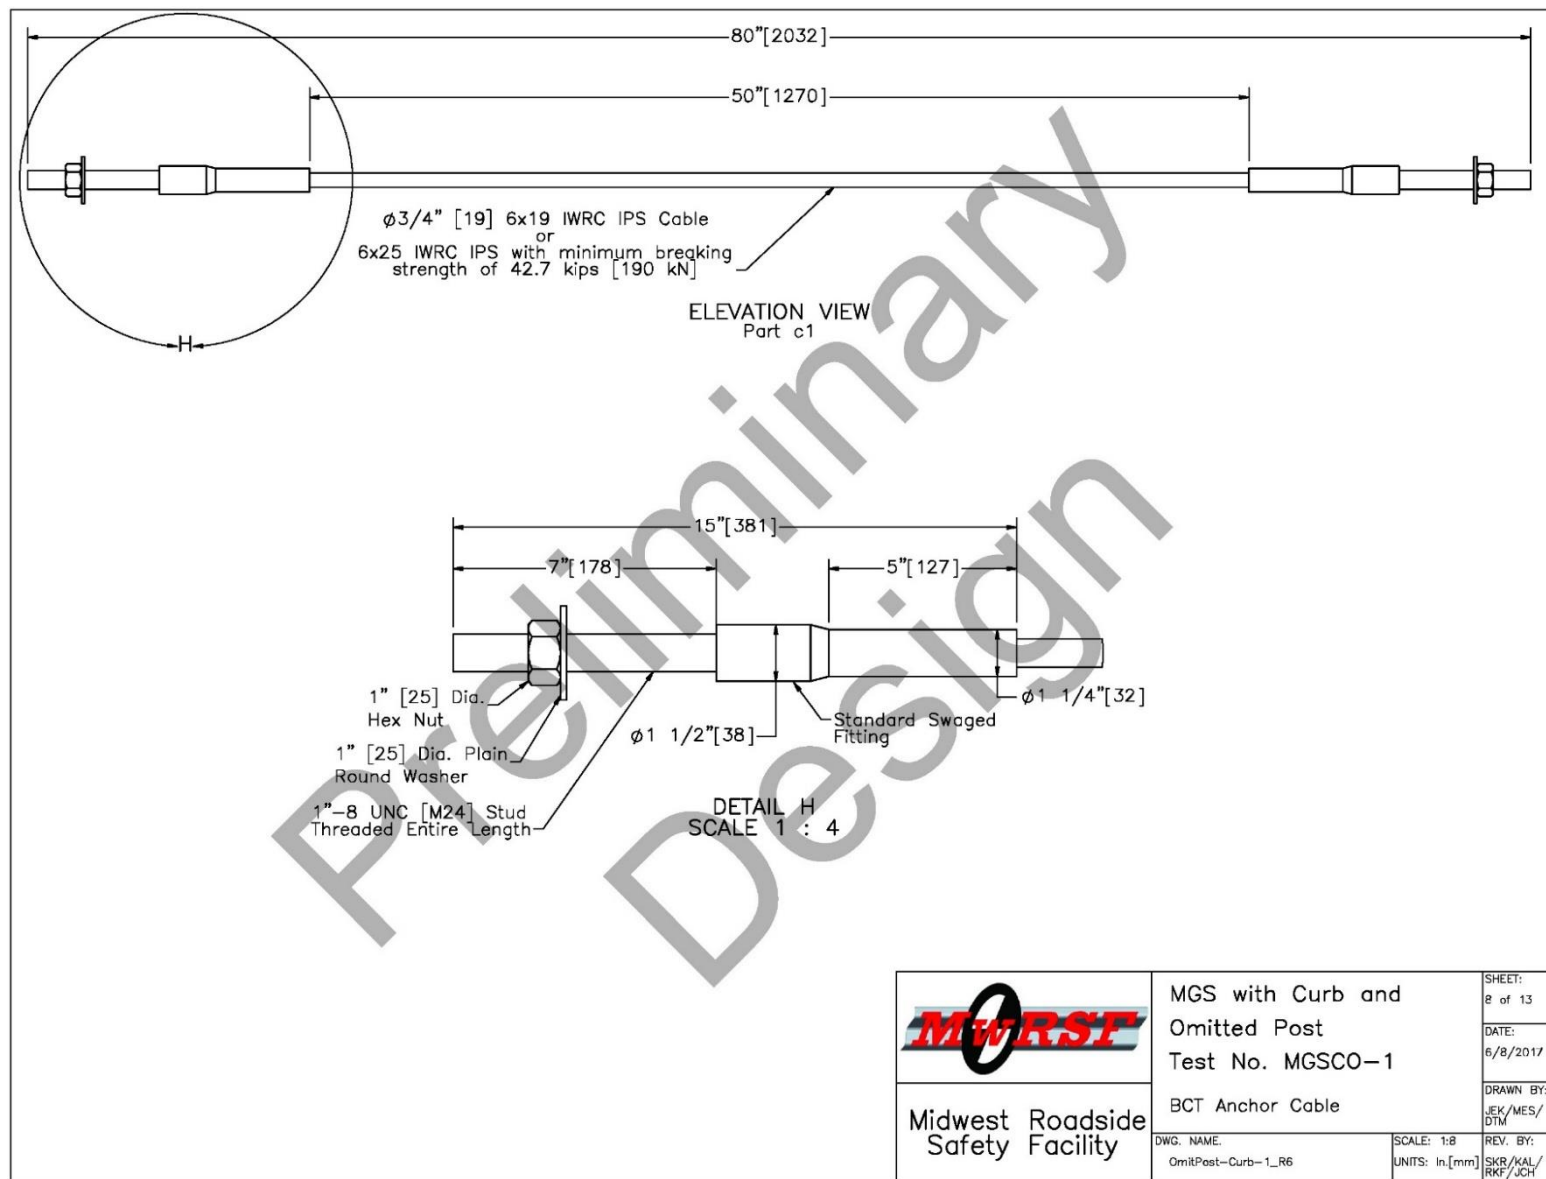
Figure 9. MGS BCT Anchor Cable, Test No. MGSCO-1

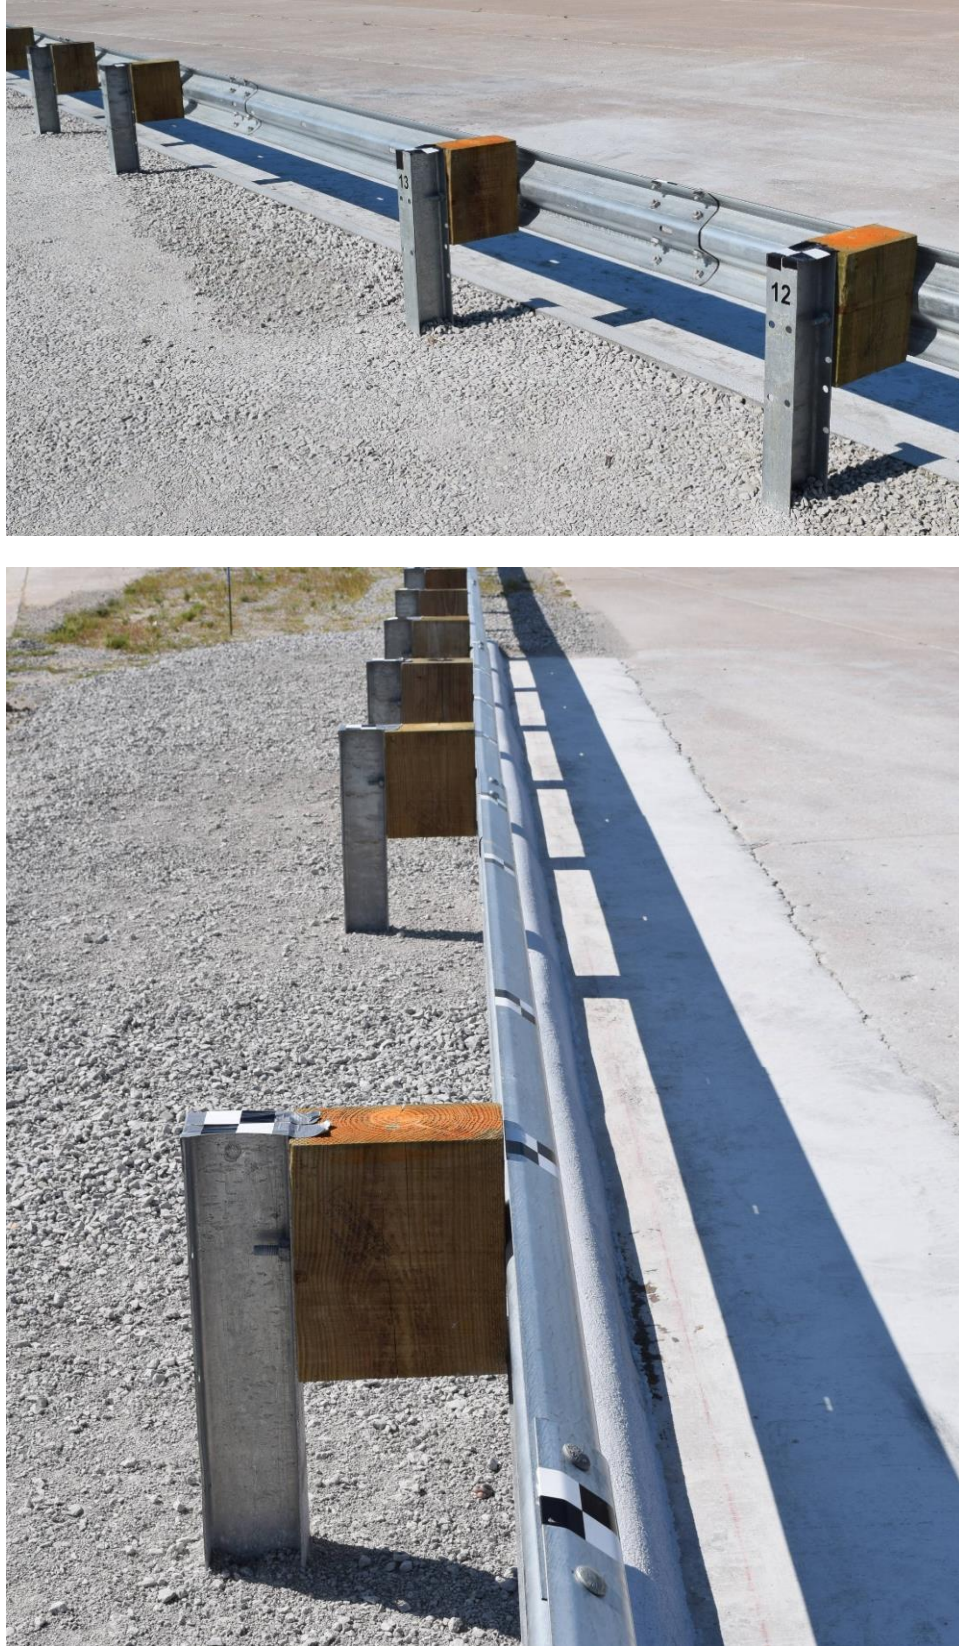
Figure 16. Test Installation Photographs, Test No. MGSCO-1

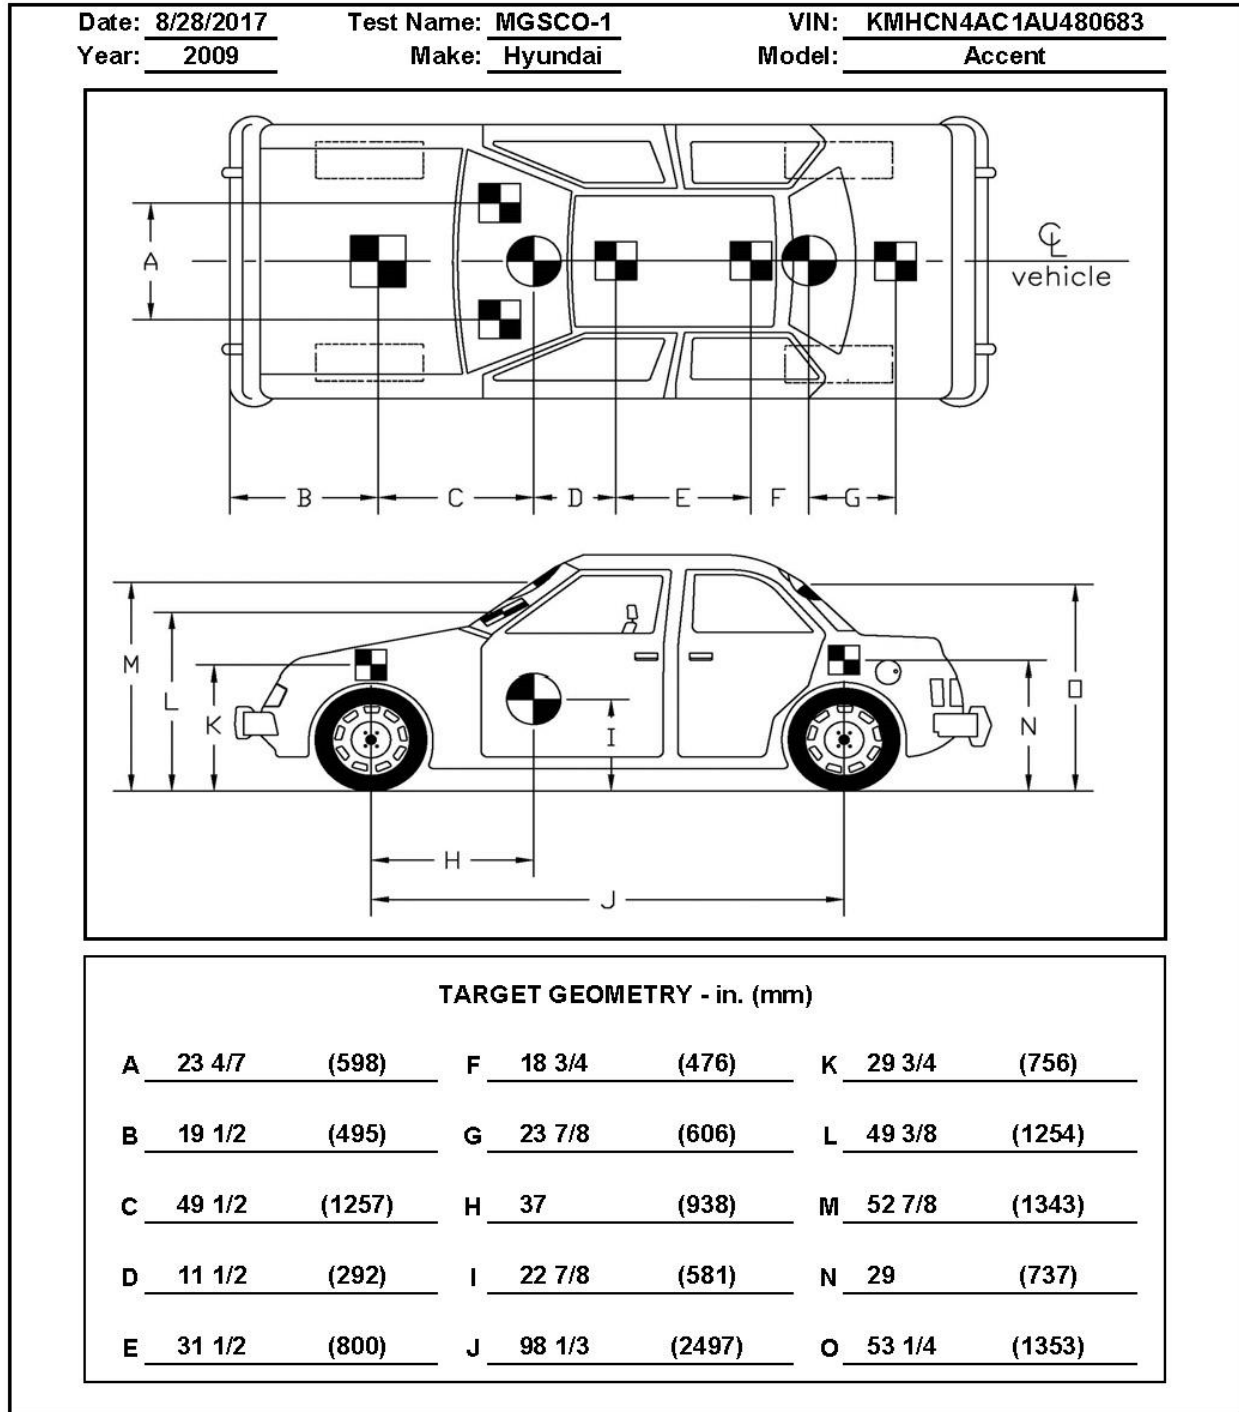
Figure 22. Target Geometry, Test No. MGSCO-1

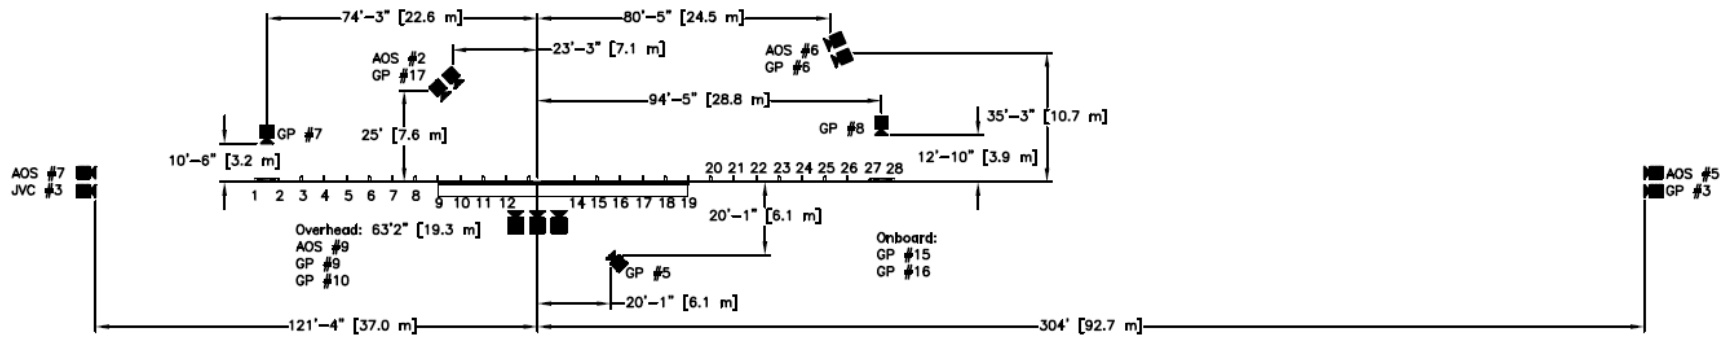
No.	Type	Operating Speed (frames/sec)	Lens
AOS-2	AOS Vitcam	500	KOWA 25 mm Fixed
AOS-5	AOS X-PRI	500	VIVITAR 135 mm Fixed
AOS-6	AOS X-PRI	500	FUJINON 35 mm Fixed
AOS-7	AOS X-PRI	500	FUJINON 50 mm Fixed
AOS-9	AOS TRI-VIT 2236	500	KOWA 12 mm Fixed
GP-3	GoPro Hero 3	60	
GP-5	GoPro Hero 3+	120	
GP-6	GoPro Hero 3+	120	
GP-7	GoPro Hero 4	240	
GP-8	GoPro Hero 4	240	
GP-9	GoPro Hero 4	120	
GP-10	GoPro Hero 4	240	
GP-15	GoPro Hero 4	120	
GP-16	GoPro Hero 4	120	
GP-17	GoPro Hero 4	240	
JVC-3	JVC – GZ-MG27u (Everio)	29.97

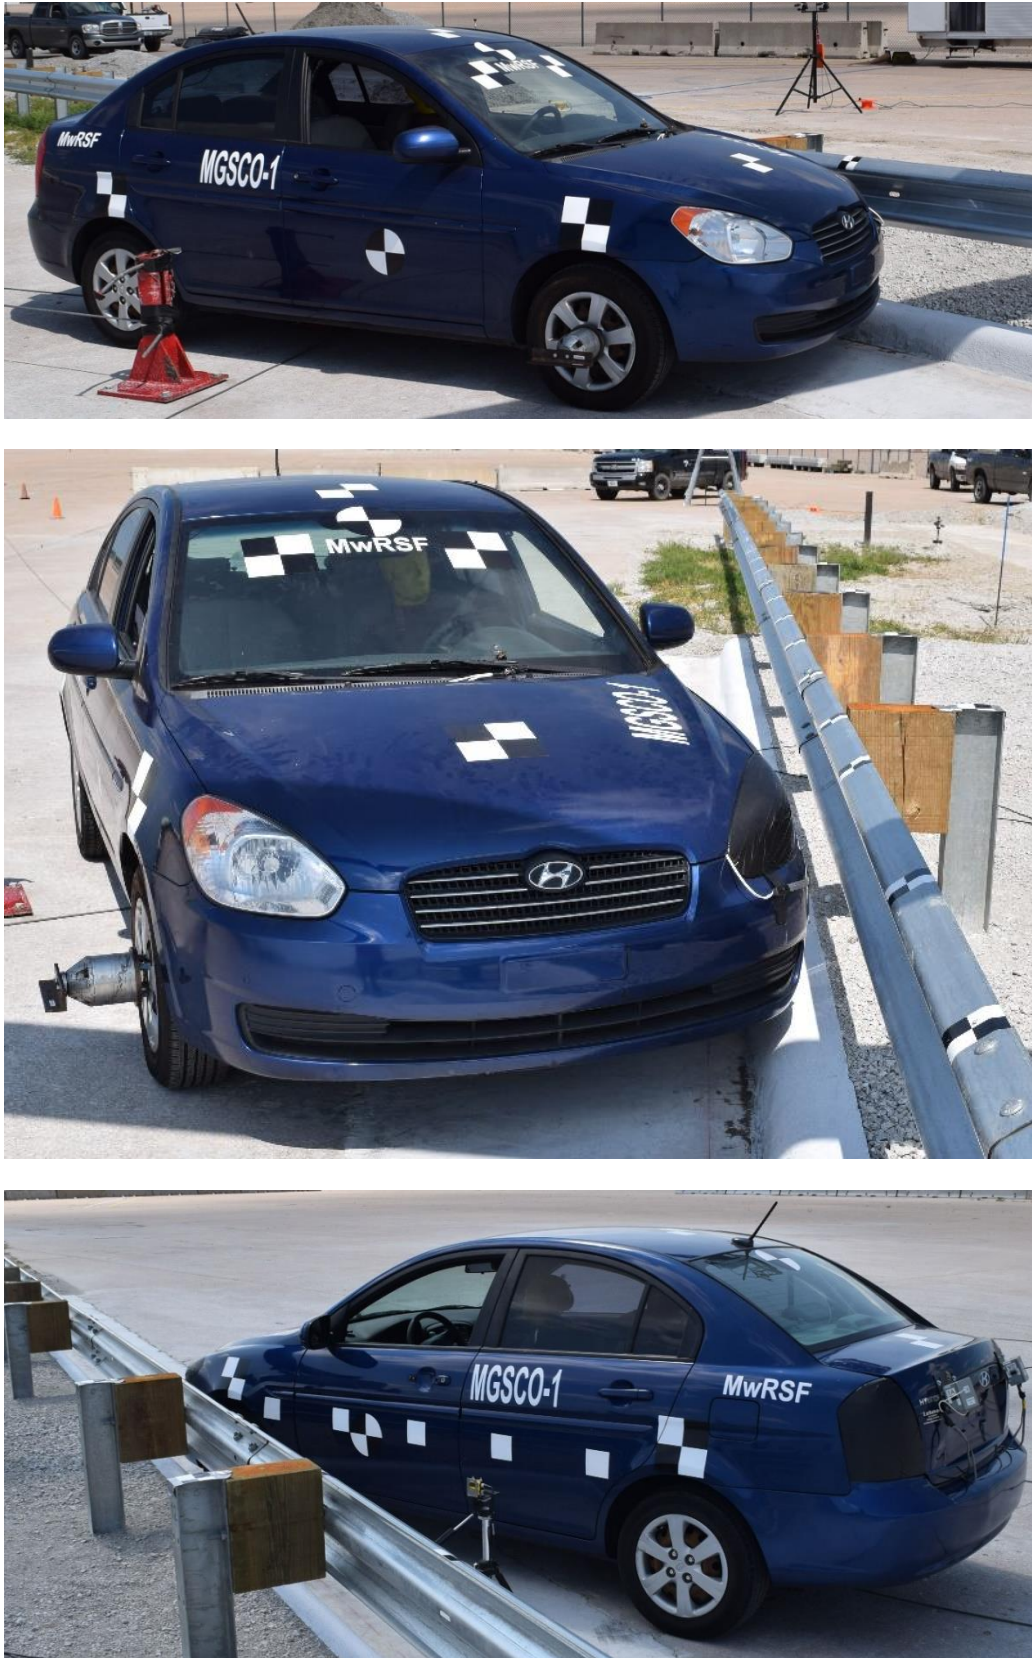
Figure 26. Impact Location, Test No. MGSCO-1

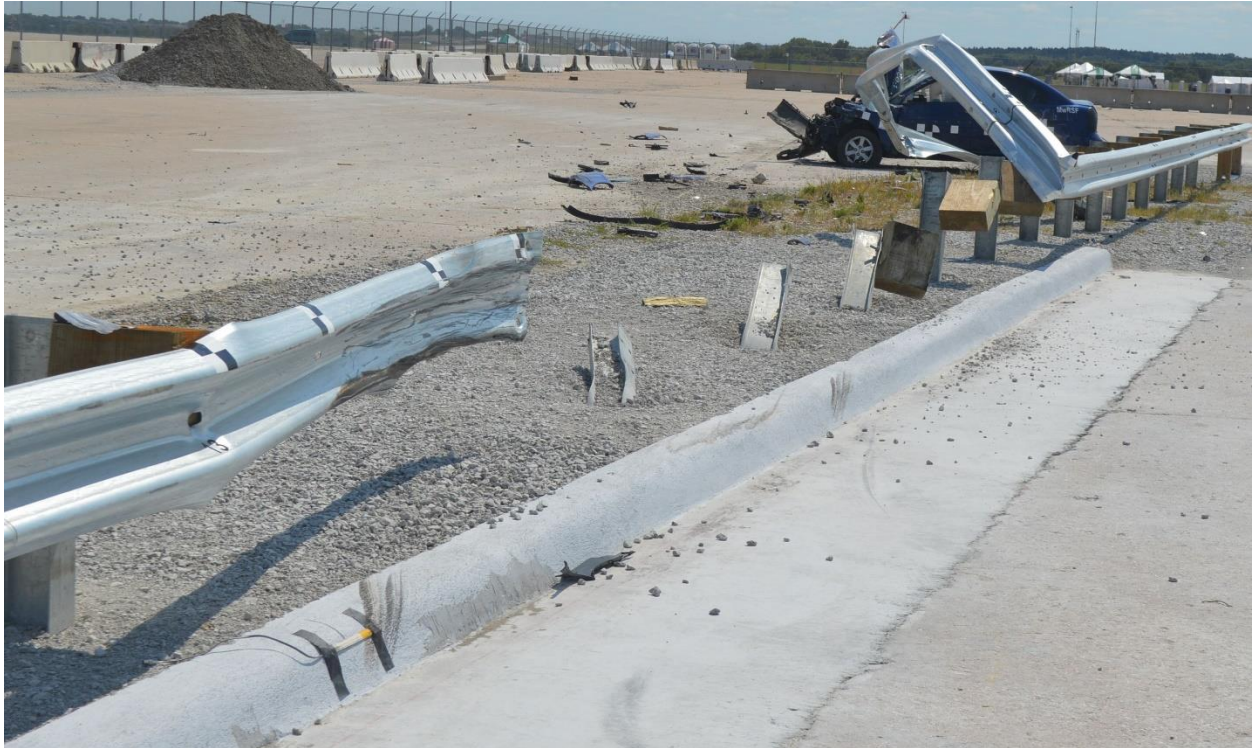
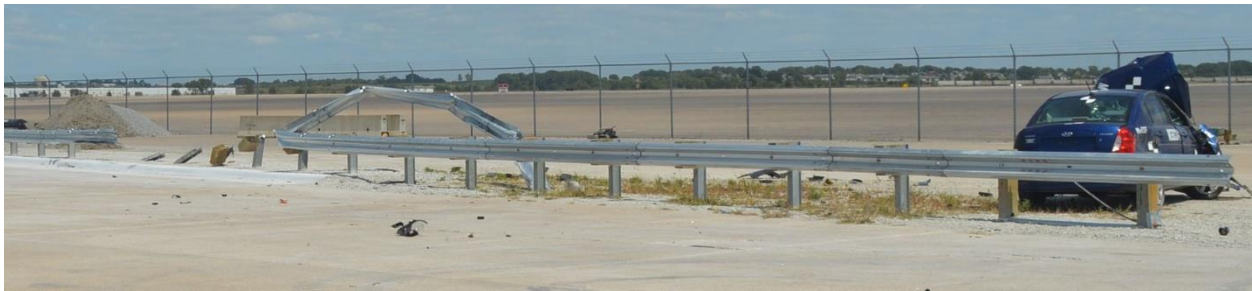
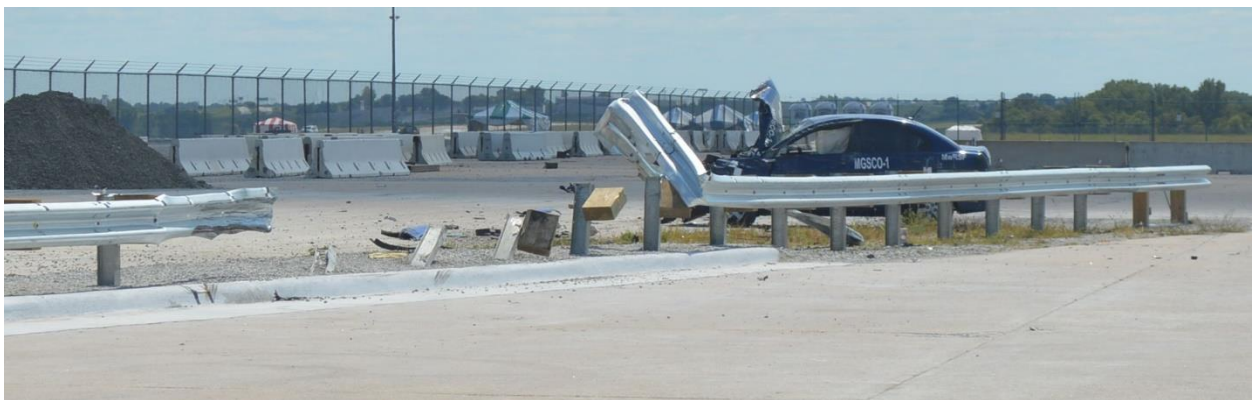
Figure 32. System Damage, Test No. MGSCO-1

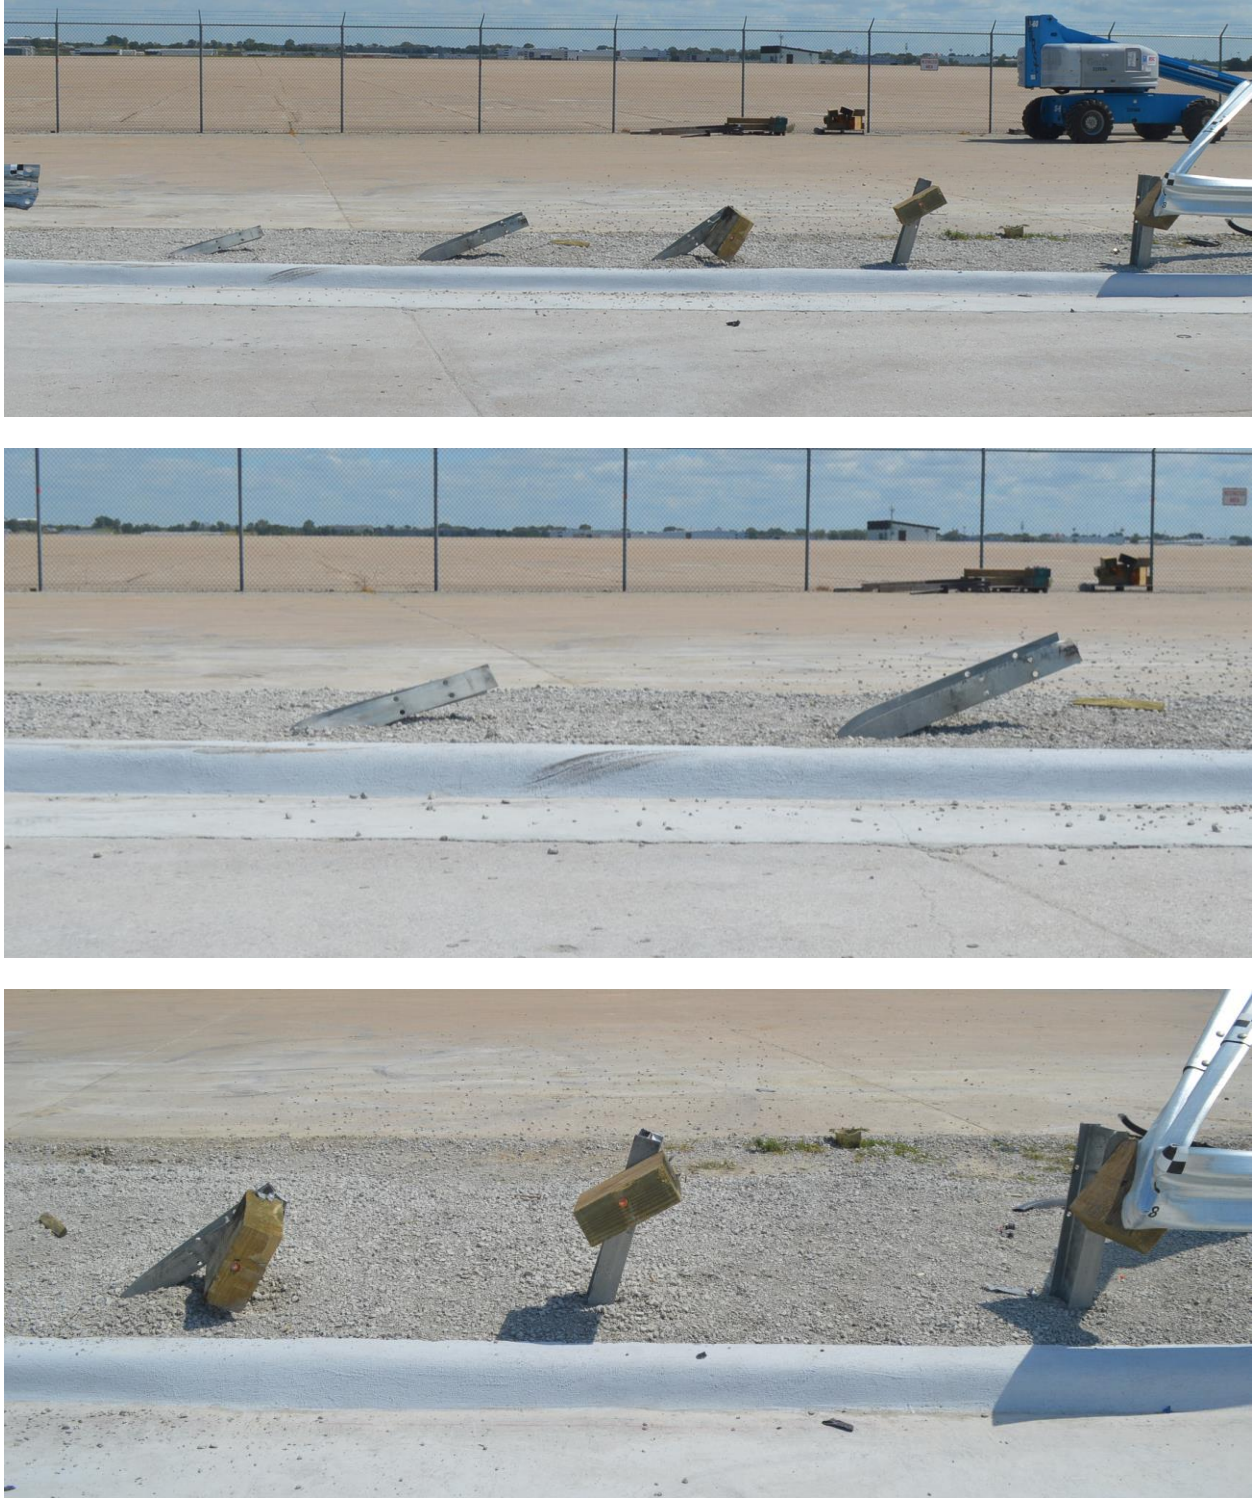
Figure 33. System Damage, Post Nos. 14 through 18, Test No. MGSCO-1

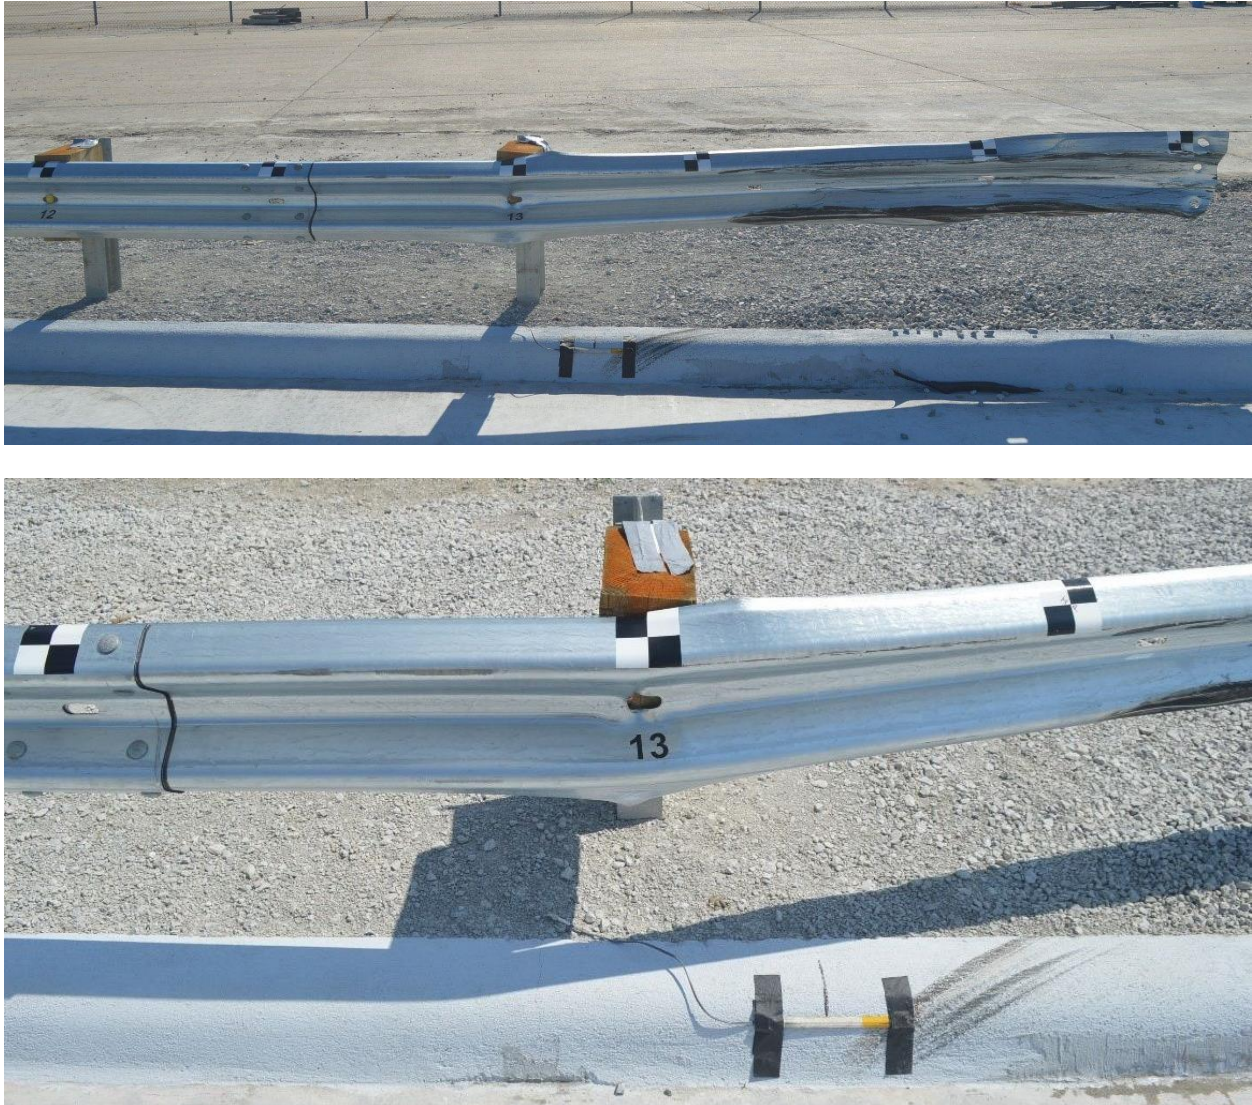
Figure 34. Rail Damage, Upstream from Rupture, Test No. MGSCO-1

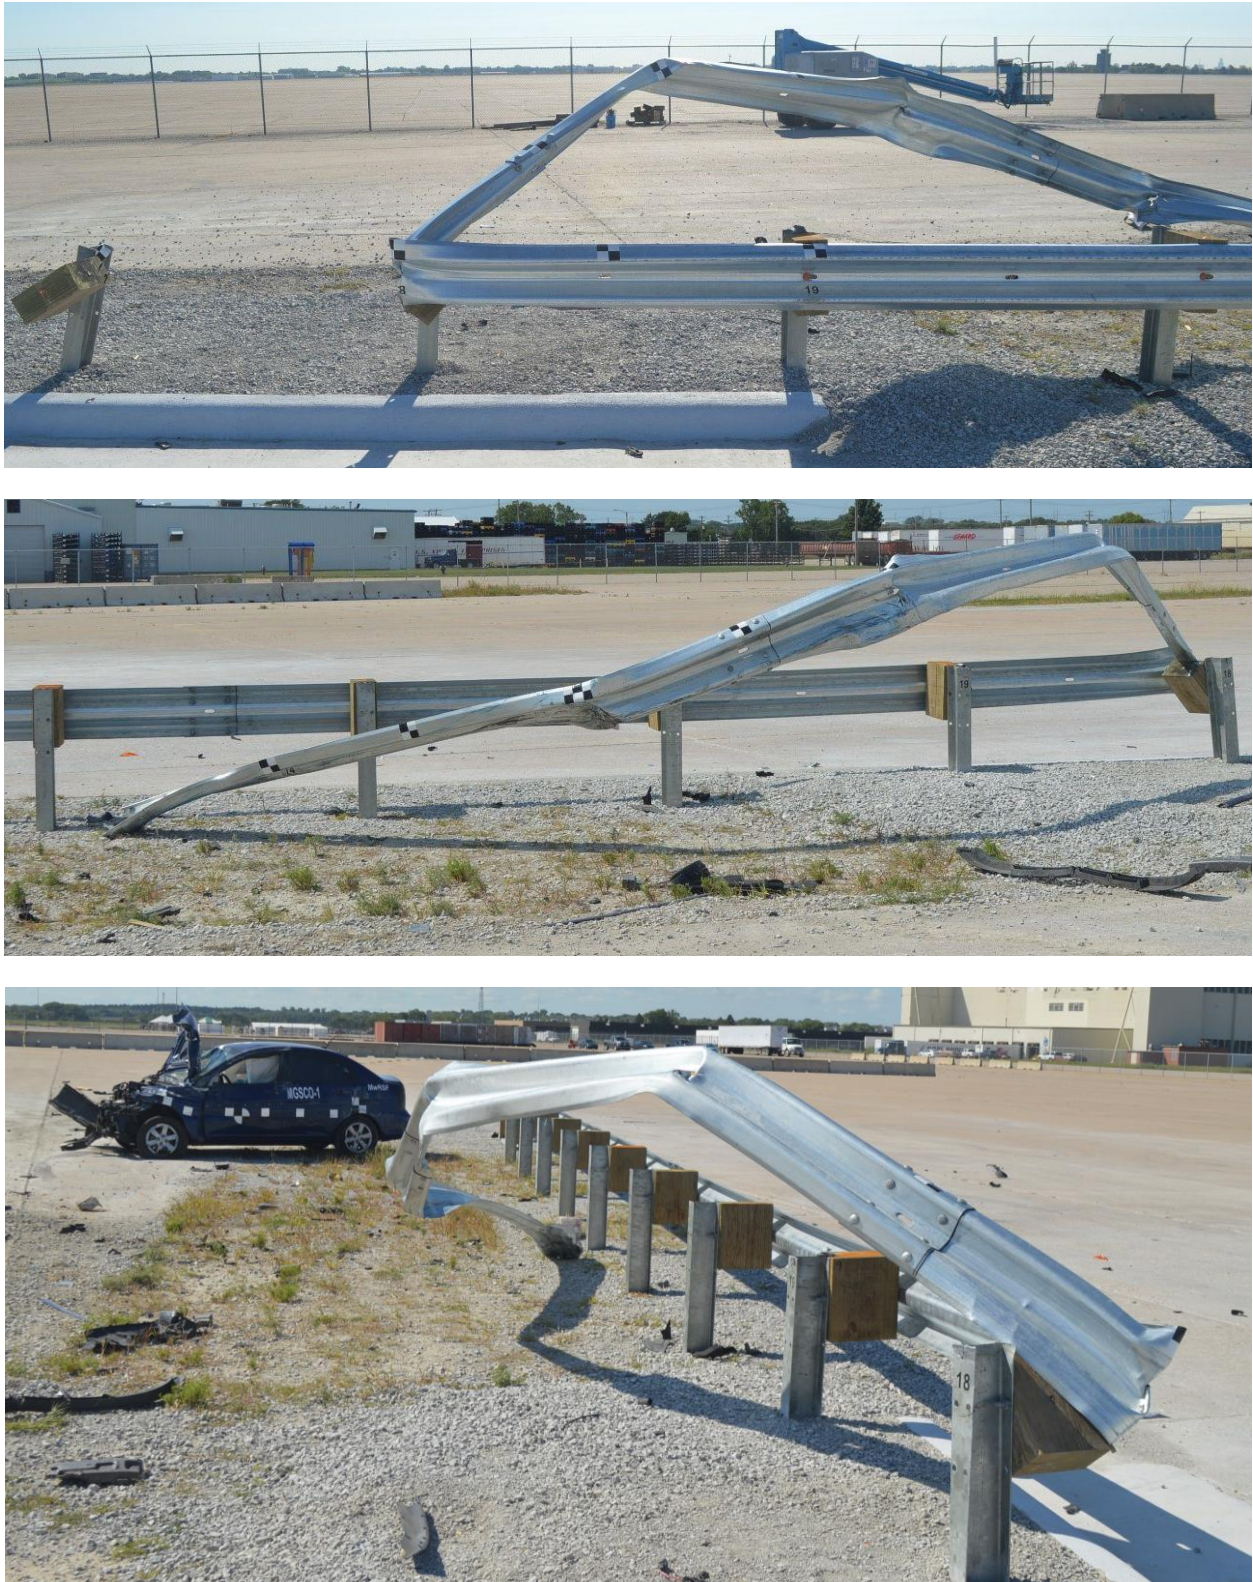
Figure 35. Rail Damage, Downstream from Rupture, Test No. MGSCO-1

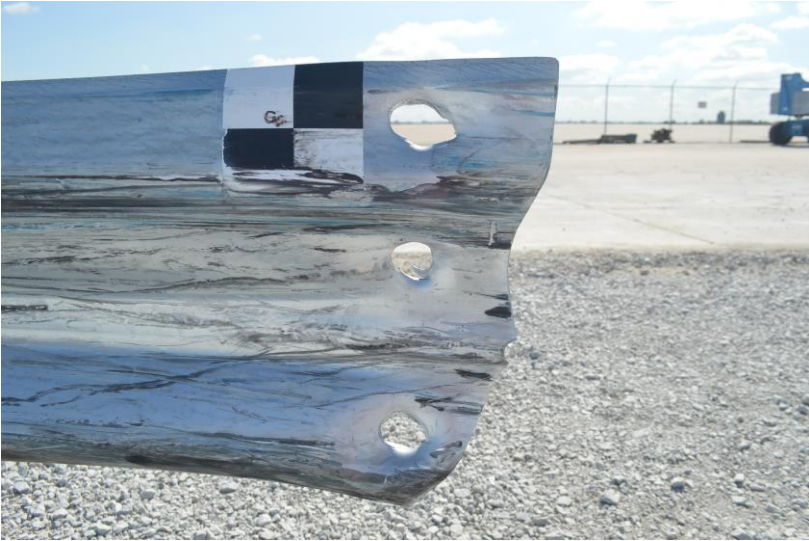
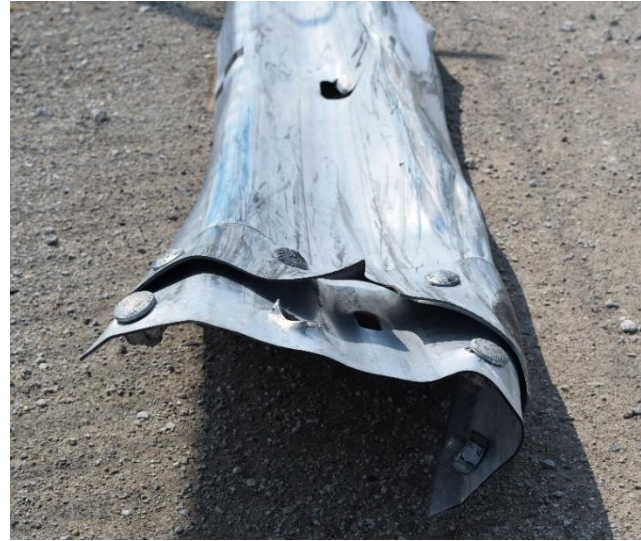
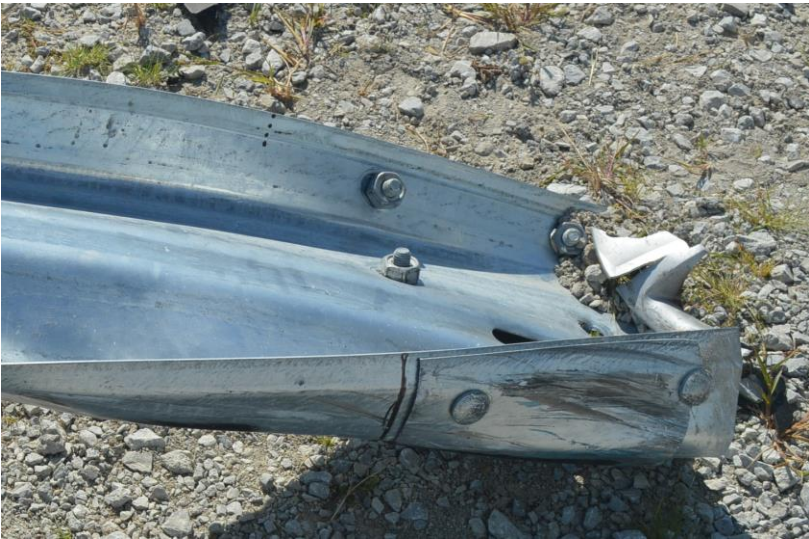
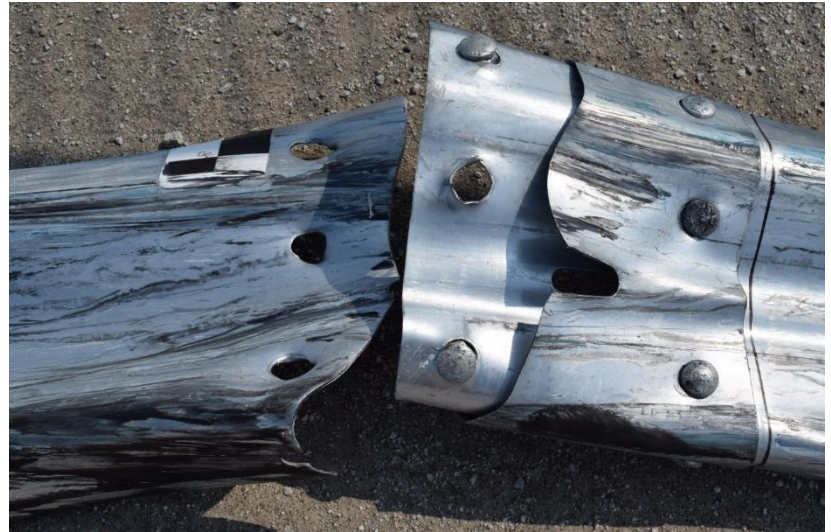
Figure 36. Rail Rupture at Splice, Test No. MGSCO-1

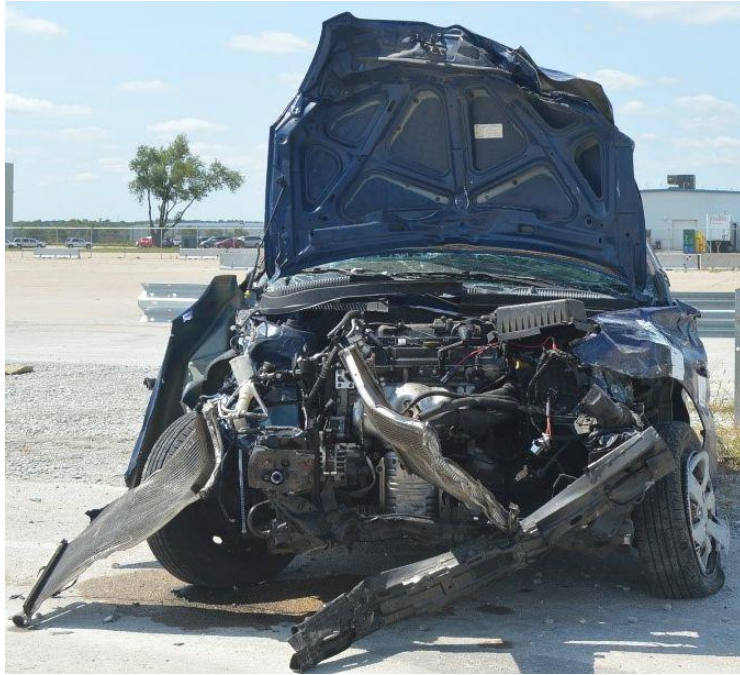
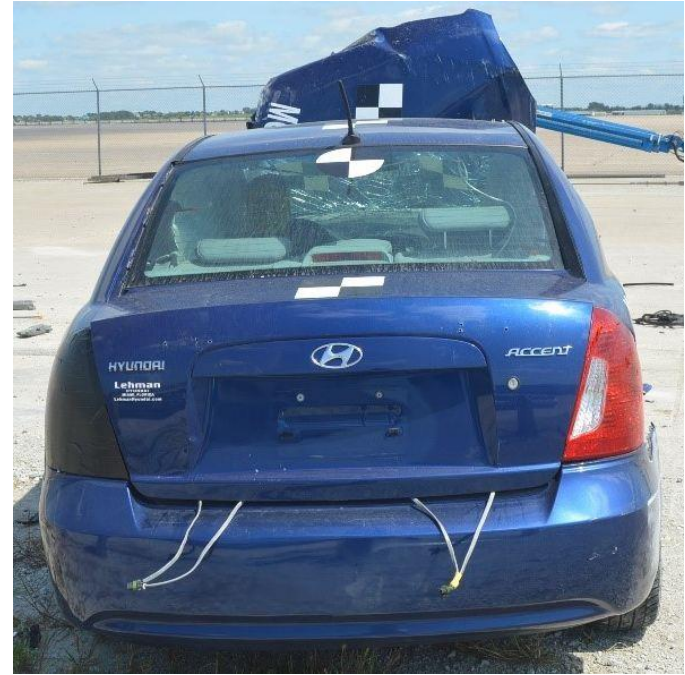
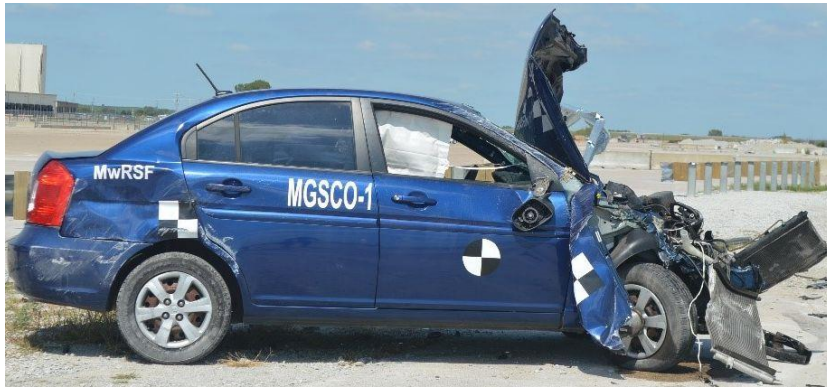
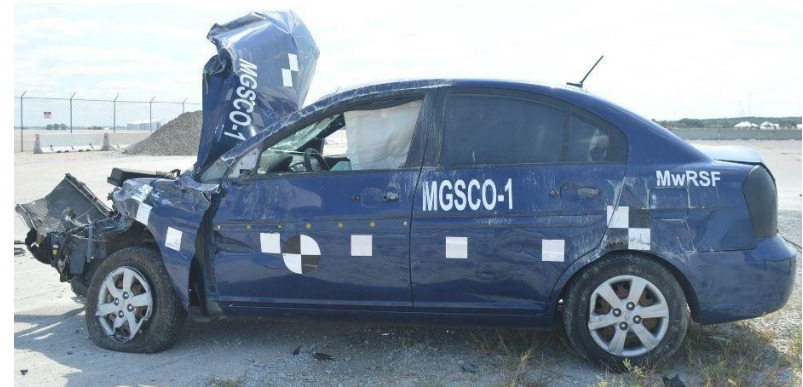
Figure 37. Vehicle Damage, Test No. MGSCO-1
