# **PERFORMANCE LIMITS FOR 6-IN. (152-MM) HIGH CURBS PLACED IN ADVANCE OF THE MGS USING MASH VEHICLES PART III: FULL-SCALE CRASH TESTING (TL-2)**

MwRSF Research Report No. TRP-03-237-10

November 24, 2010

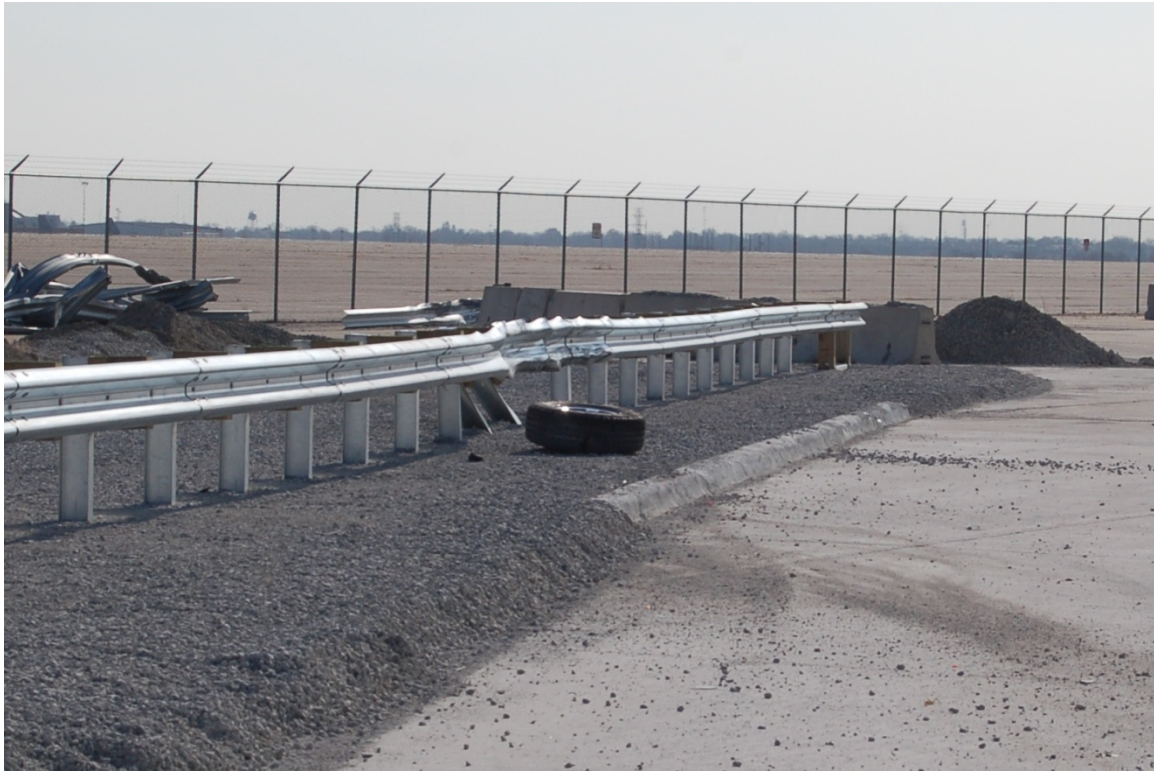
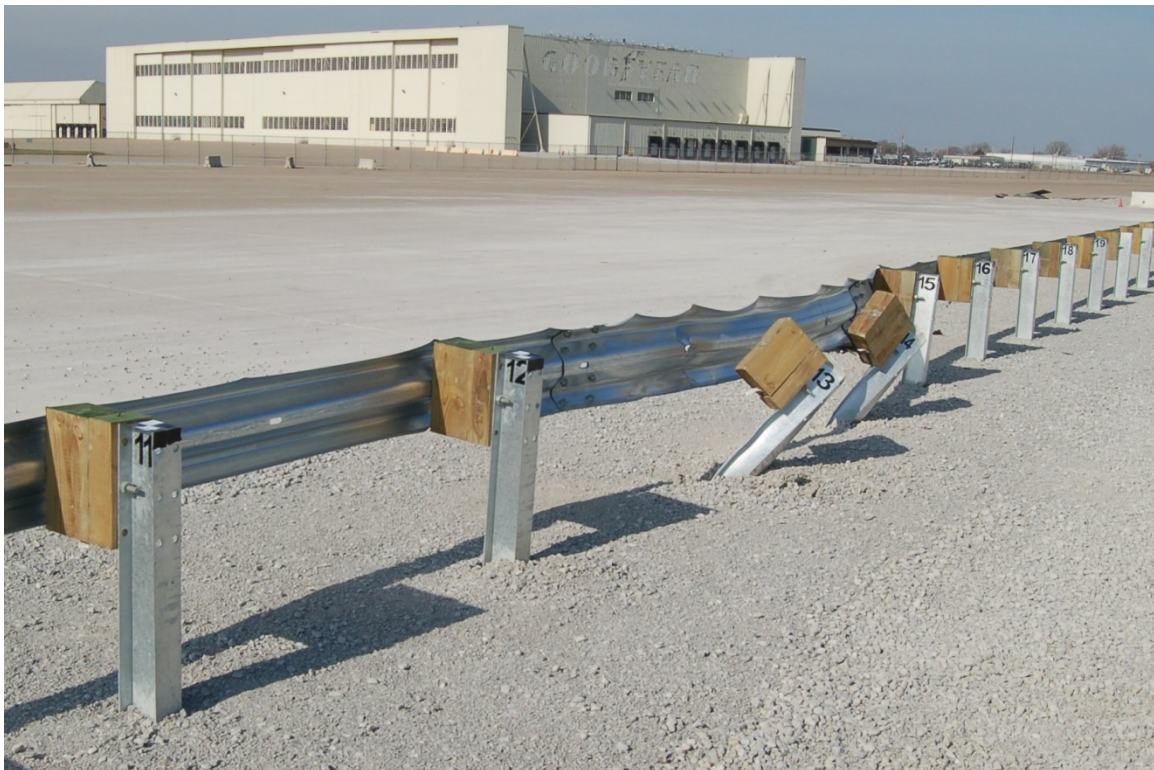
Figure 28. System Damage, Test No. MGSC-6

Damage to the barrier was moderate, as shown in Figures 28 through 33. Barrier damage consisted of contact marks and deformation of the W-beam rail, deformed guardrail posts, and disengaged post-to-rail connections. The length of vehicle contact along the barrier was approximately 19 ft - 5 in. (5.92 m) which spanned from 2 in. (51 mm) downstream of post no. 12 to 10 in. (254 mm) downstream of post no. 15.

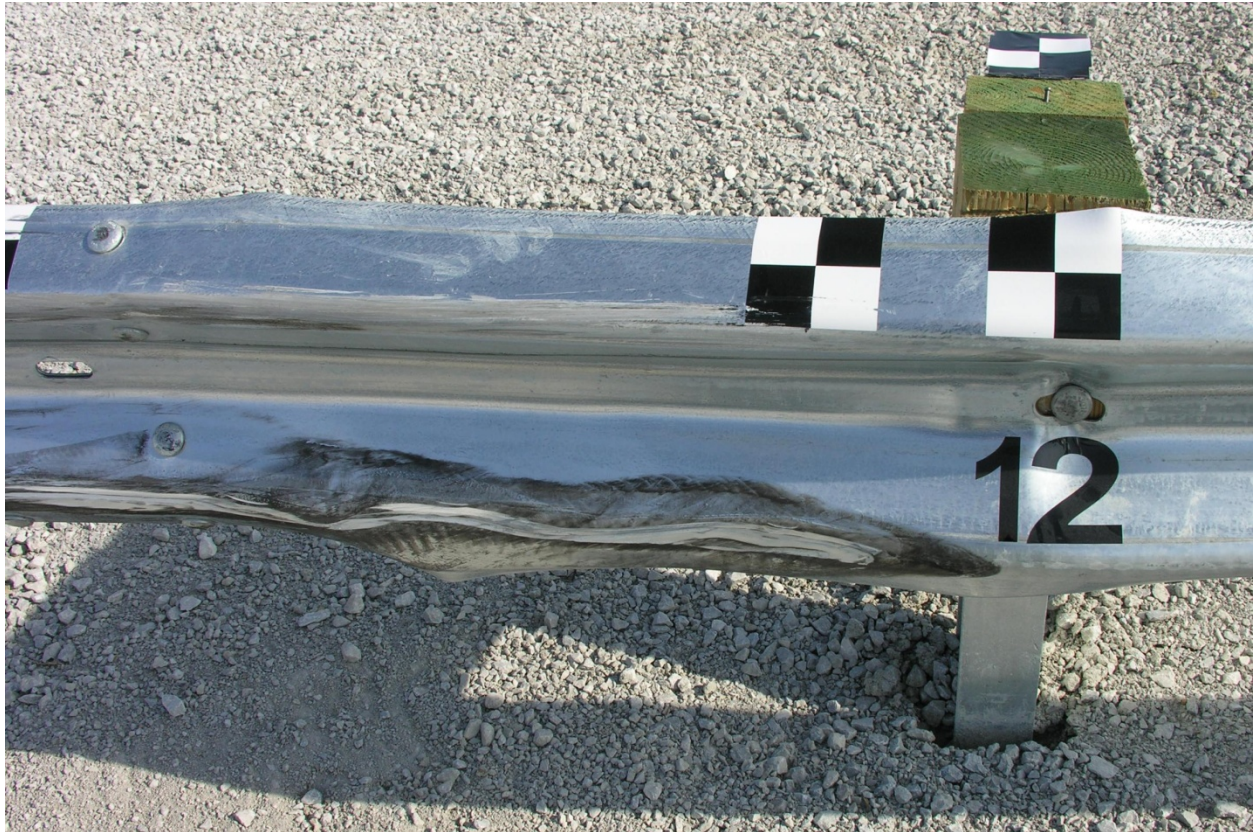
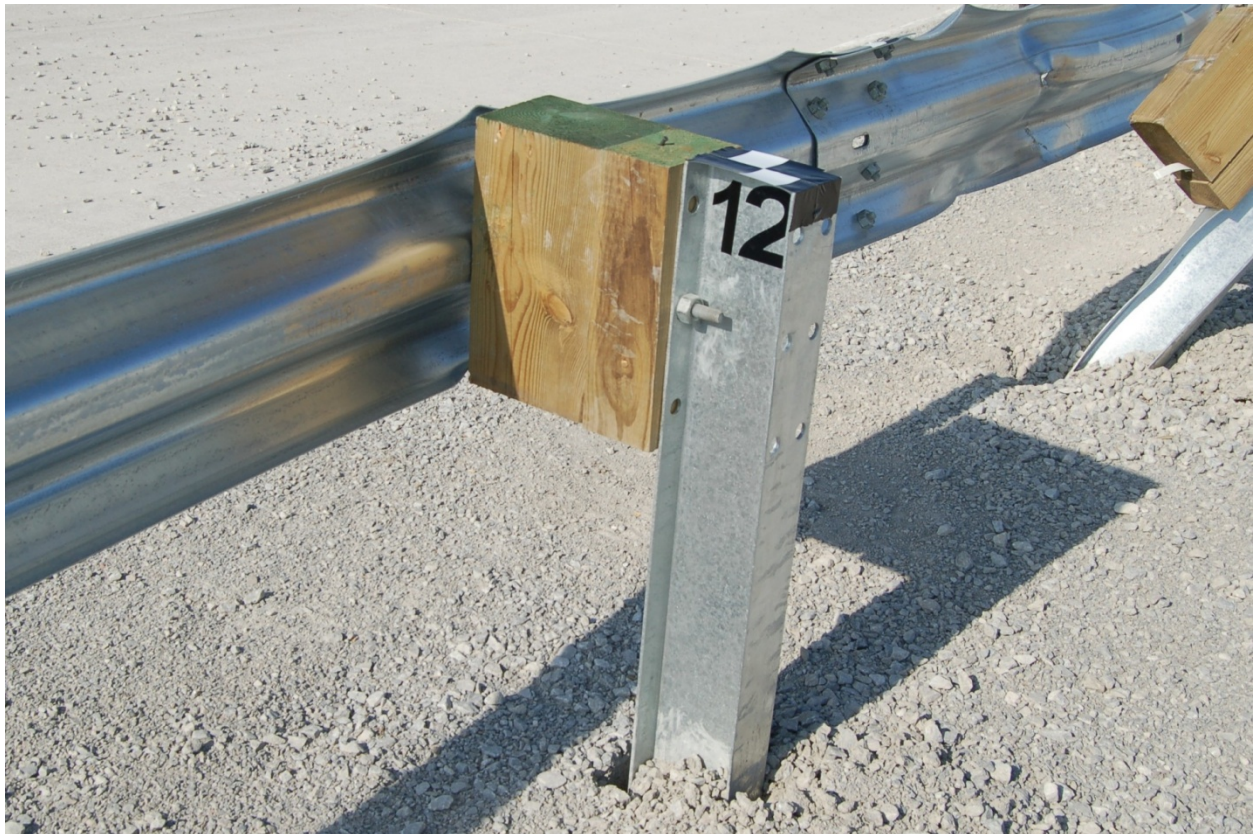
Figure 29. Post No. 12 Damage, Test No. MGSC-6

Post nos. 3 through 15 posts showed varying degrees of damage. Post nos. 3 through 11 twisted slightly downstream. Post nos. 12 and 15 rotated slightly backward and sustained minor twisting. Post nos. 13 and 14 sustained large downstream and backward rotations while twisting upstream. Tire marks were found on post no. 13.

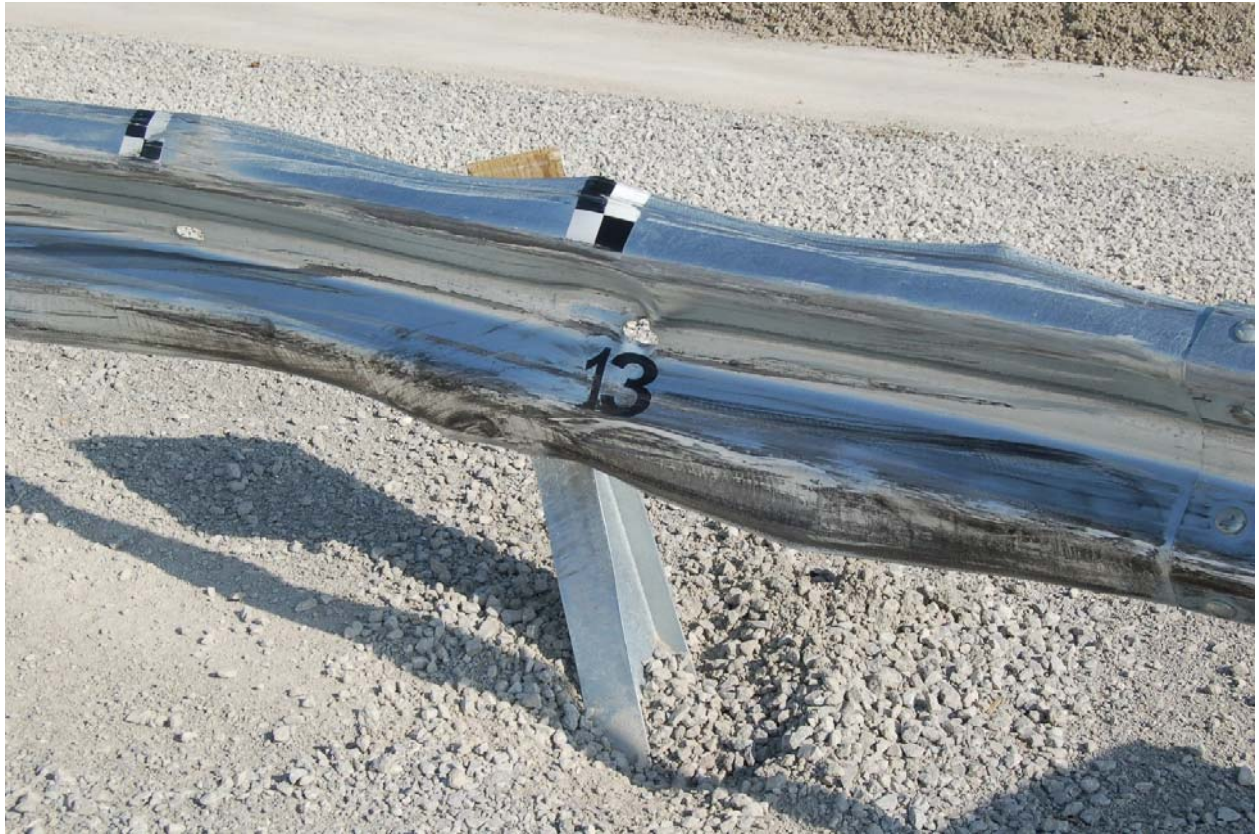
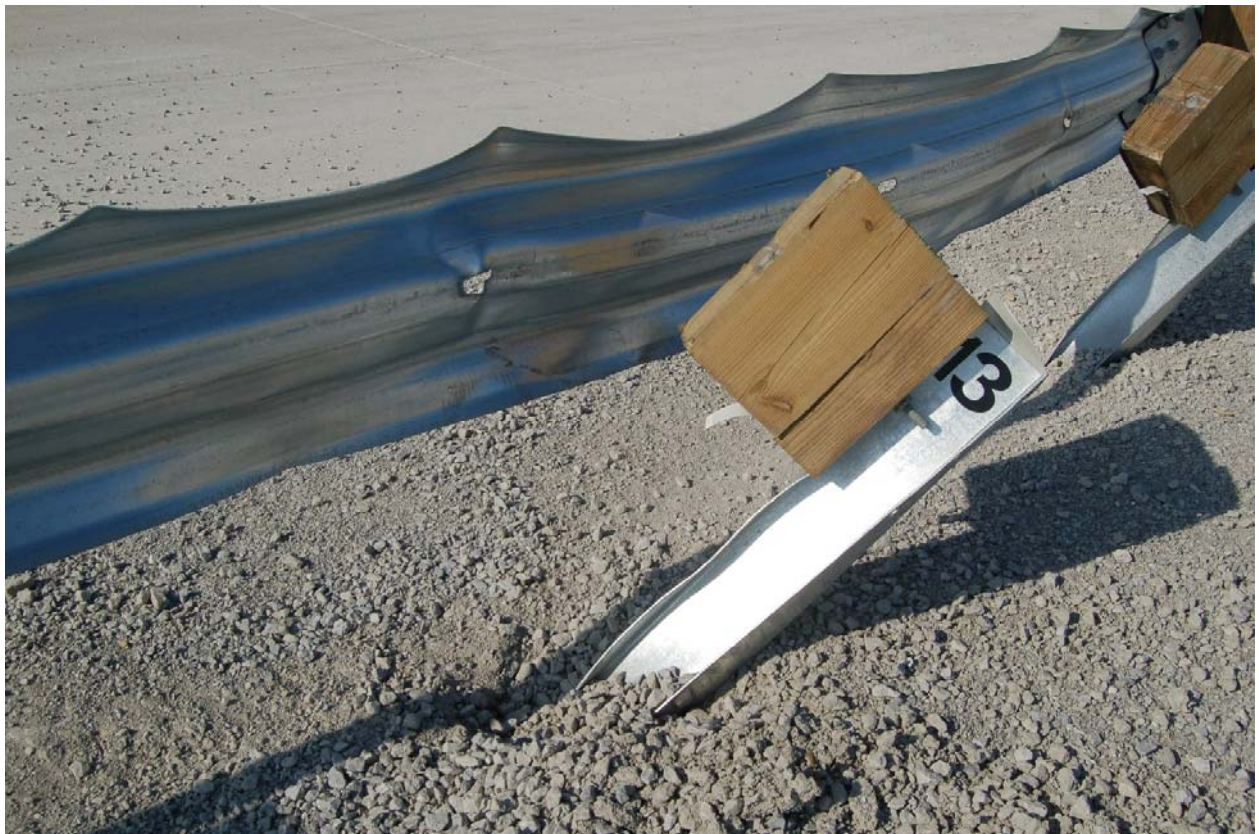
Figure 30. Post No. 13 Damage, Test No. MGSC-6

Post nos. 13 and 14 were disengaged from the rail due to pullout of the guardrail bolt and deformation of the guardrail slot. A small tear was found in the slot at post no. 13. Gaps of  $\frac{1}{8}$  in. (3 mm) were present at the splices located between post nos. 2 and 3, 10 and 11, and 12 and 13.

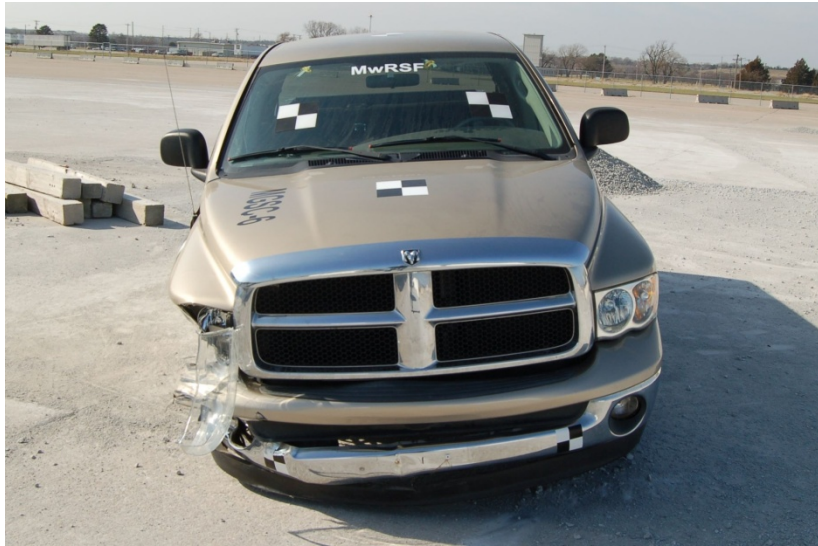
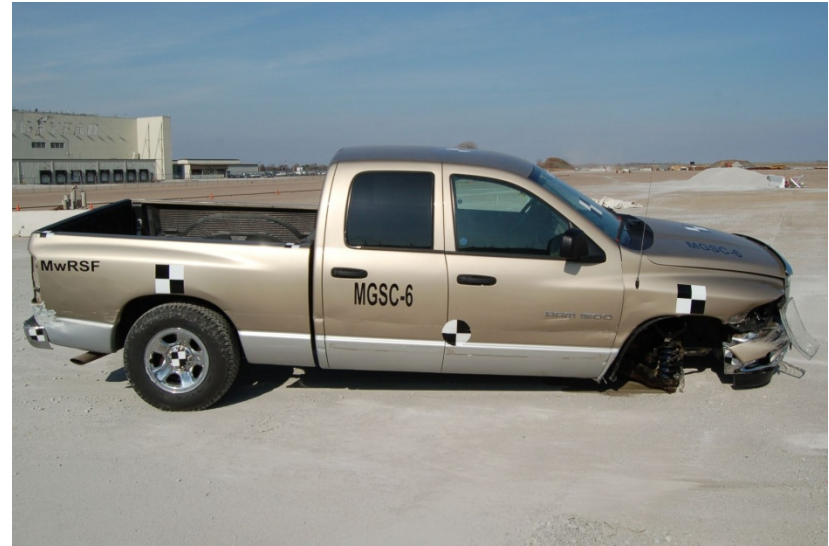
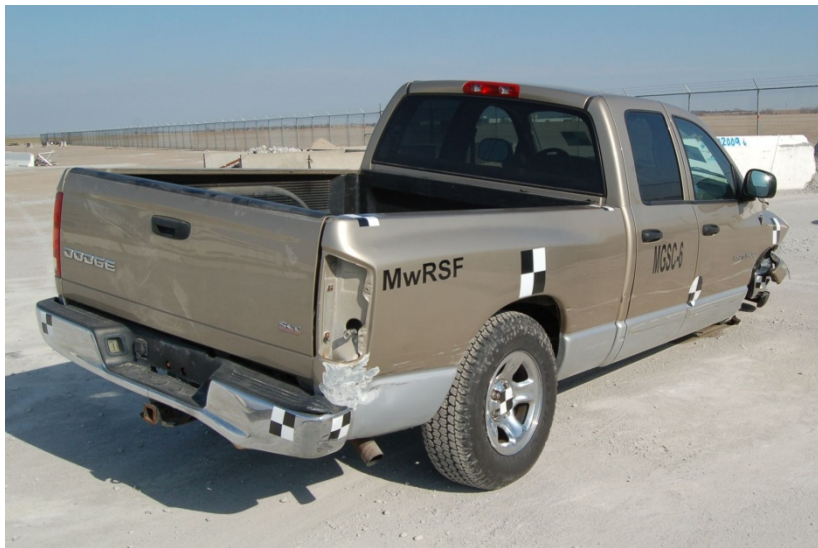
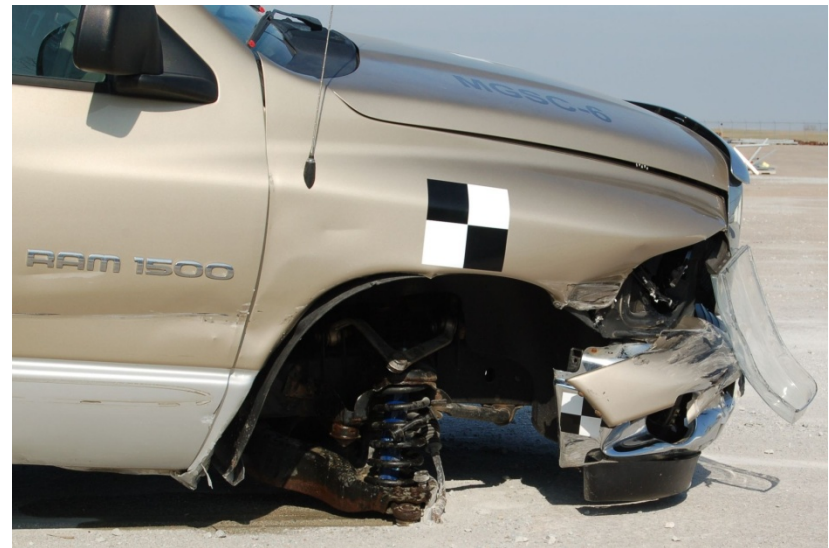
Figure 34. Vehicle Damage, Test No. MGSC-6

The majority of the damage was concentrated on the right-front corner and right side of the vehicle where the impact occurred. The right side of the front bumper was crushed inward and back. The right-front fender was dented and scraped. The right-front wheel was detached from the vehicle, and the right-front rim was scraped and deformed. The right-front brake lines were cut, and the right-upper control arm was bent inward. The right-side headlight and foglight

were disengaged from the vehicle. Denting and scraping were observed on the entire right side of the vehicle. The right-rear corner of the vehicle and right side of the rear bumper were slightly crushed inward. The right-side taillight was removed. The hood was ajar and slightly crushed inward. Slight deformation to the front of the vehicle frame was observed. The roof and all window glass remained undamaged.

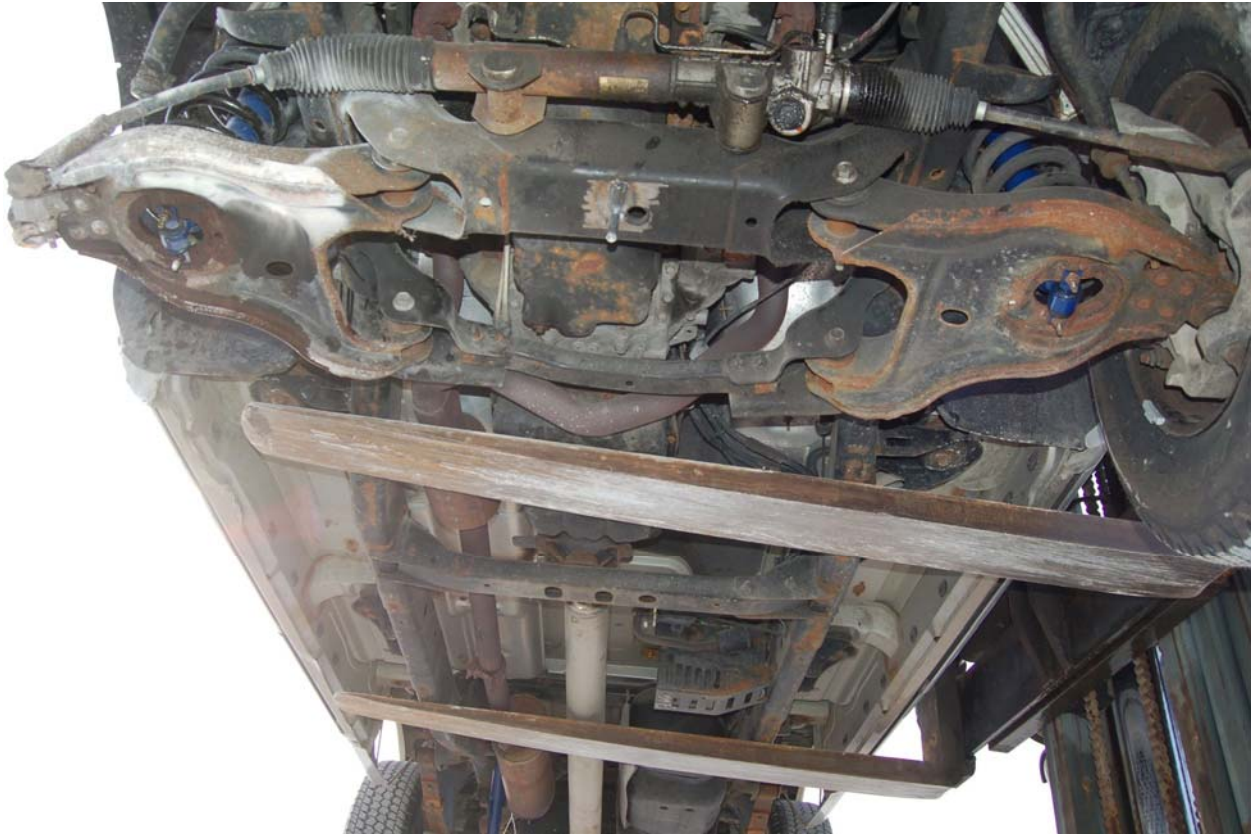
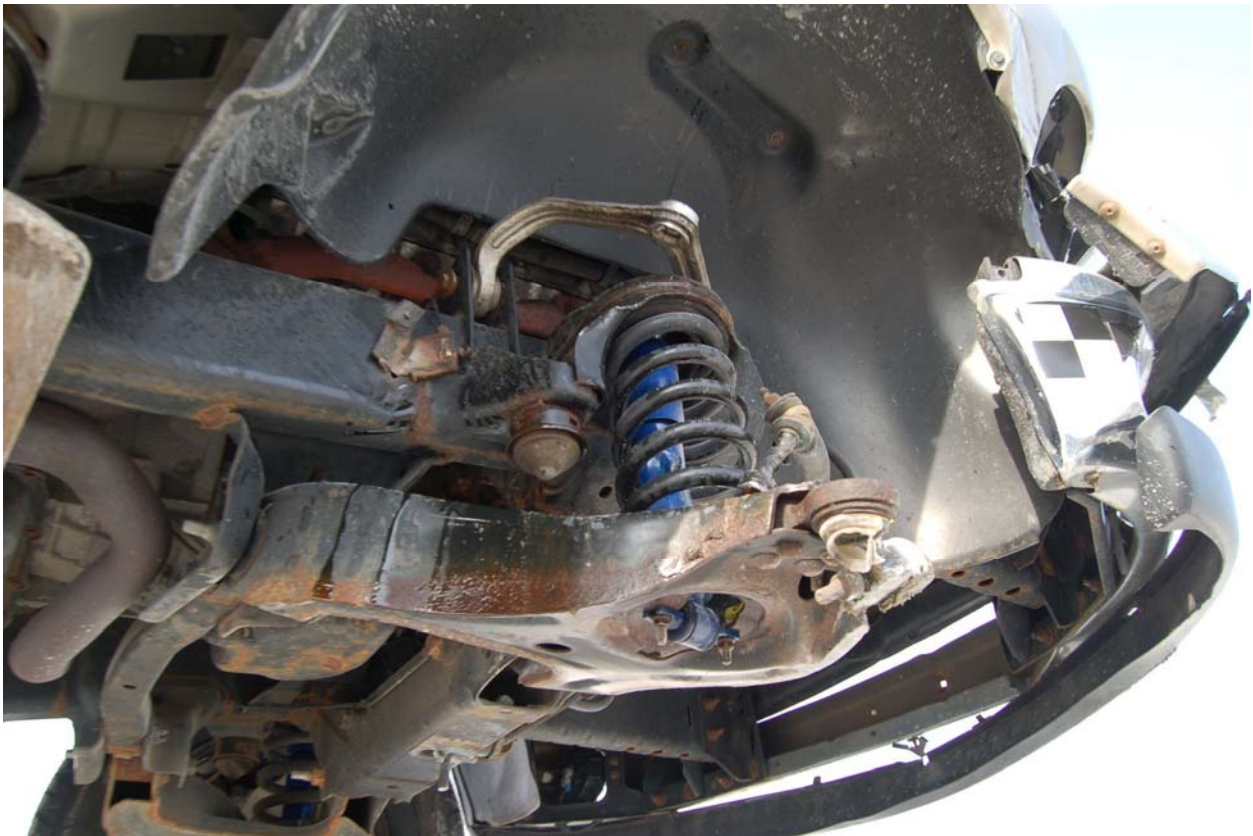
Figure 35. Undercarriage Damage, Test No. MGSC-6

The damage to the vehicle was moderate, as shown in Figures 34 and 35. The maximum occupant compartment deformations are listed in Table 5 along with the deformation limits established in MASH for various areas of the occupant compartment. It should be noted that none of the MASH established deformation limits were violated. Complete occupant compartment and vehicle deformations and the corresponding locations are provided in Appendix D.
