Research Project Number SPR-FY21(010)

CRASHWORTHY PERFORATED SQUARE STEEL TUBE (PSST) MAILBOX SUPPORT – PHASE I

MwRSF Research Report No. TRP-03-473-23

July 24, 2023

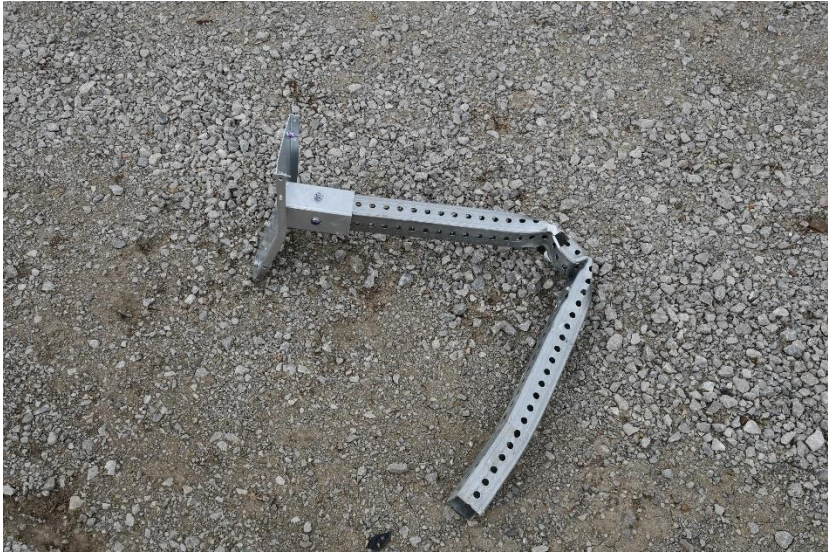
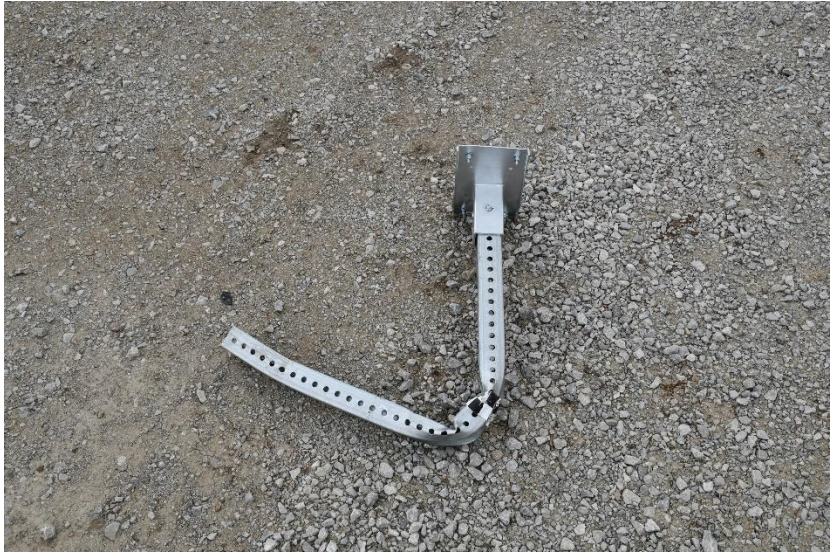
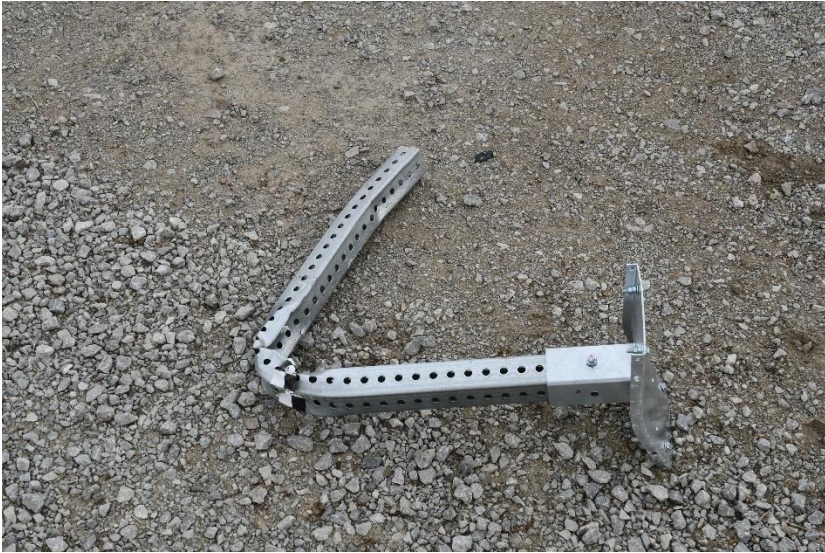
mailbox down toward the hood. The mailboxes impacted the upper third of the hood at 0.022 sec after initial impact. The PSST did not separate from the embedded stub in this impact, but partial fracture of the PSST post was noted near the stub socket. Without post release from the stub, the post was pulled down beneath the vehicle. This motion generated sufficient load to fracture the spade bolts connecting the TAPCO mounting assembly to the top of the PSST post. Fracture of the spade bolts released the mailboxes and TAPCO mounting bracket from the PSST at 0.040 sec after impact. After the mailboxes released, the mailbox and mounting bracket were propelled up and to the side of the 1100C vehicle with little to no relative velocity toward the windshield. The vehicle continued downstream and overrode the PSST support post and stub. No contact with the windshield or deformation or penetration of the occupant compartment were observed due to contact with the mailbox.

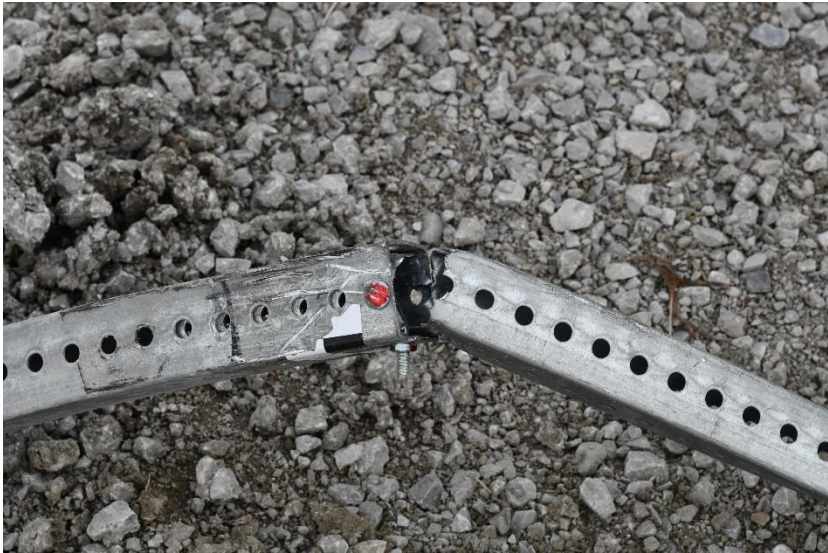
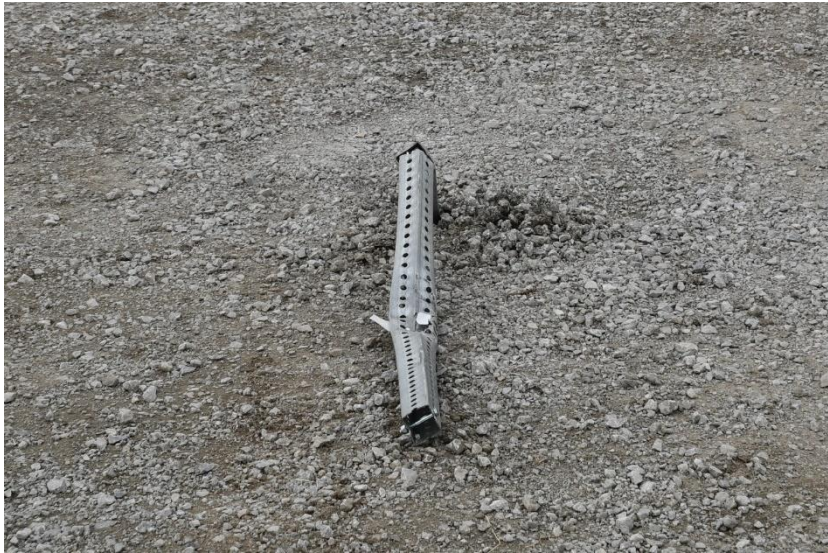
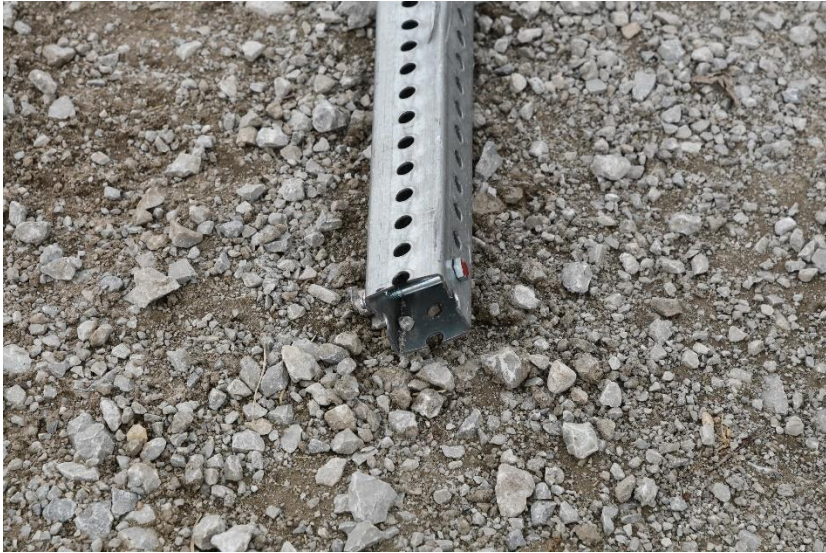
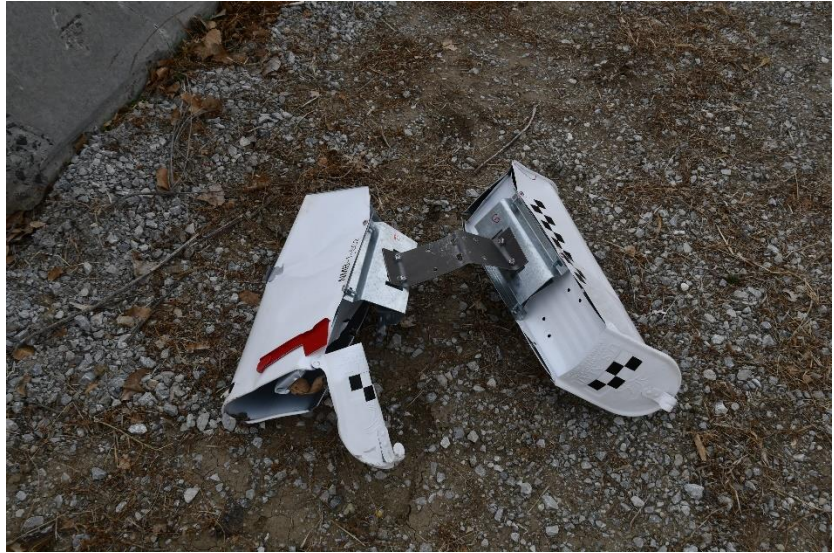
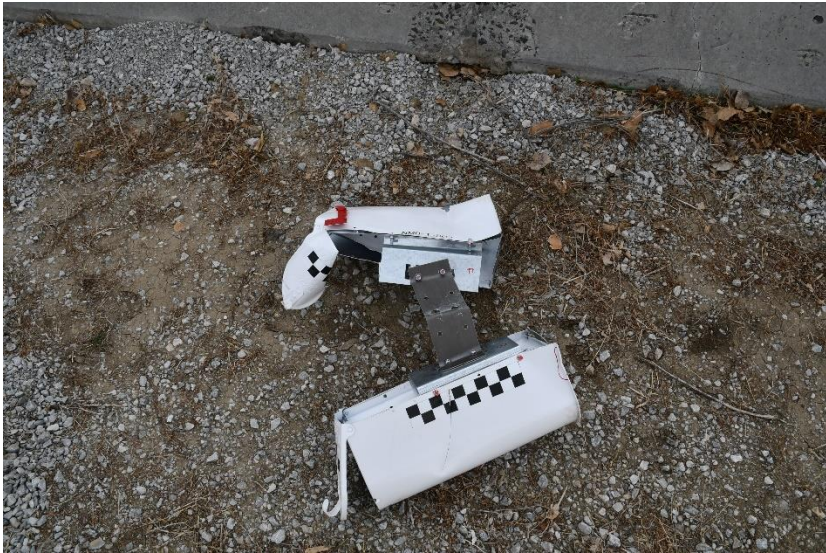
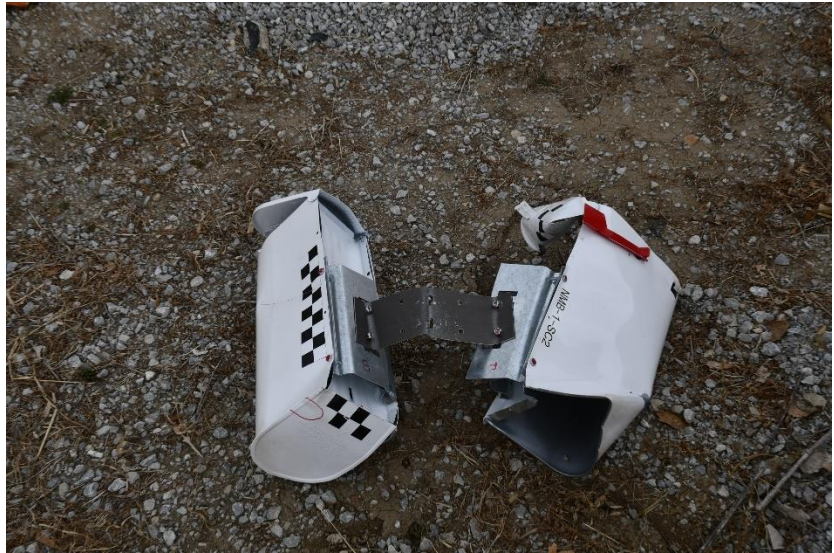
Damage to System B, the dual mailbox support, was extensive, as shown in Figures 54 and 55. The embedded stub of the mailbox support was displaced several inches through the soil and was bent near the groundline. The mailbox support post remained connected to the embedded stub and the corner bolt connecting the stub and support post remained intact. The mailbox support post was kinked and bent at a location midway along its length and was partially fractured where it was inserted into the stub. The dual mailboxes in System B were completely detached from the support post due to fracture of both spade bolts connecting the support post to the TAPCO mounting bracket. Both mailboxes remained attached to the TAPCO mounting bracket. The flat plate portion of the bracket and the adjustable brackets remained attached to each other and the mailboxes, but the mounting bracket hardware was deformed during impact. The mailbox nearest to the vehicle at impact was severely deformed. The rear mailbox was deformed as well, but the extent of the deformation was significantly less. All mailbox attachment bolts were intact and remained attached.

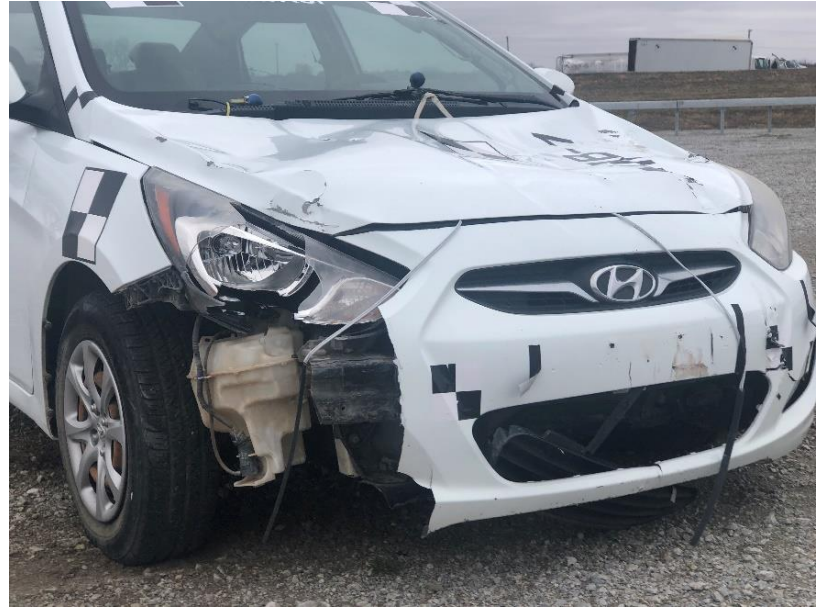
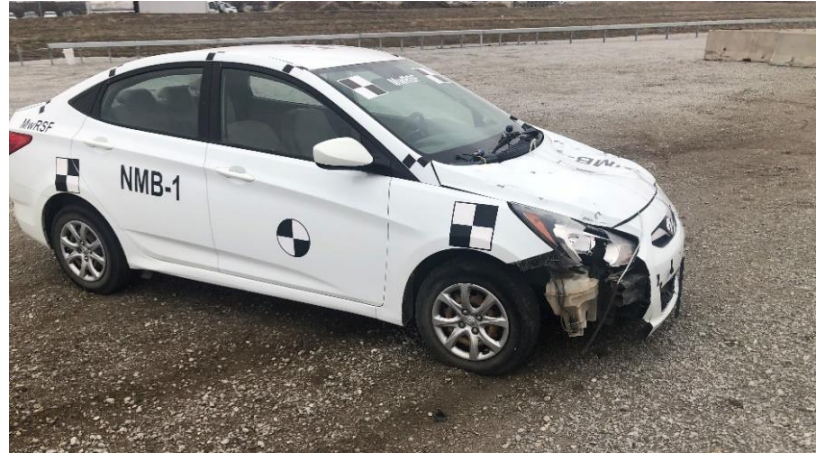
The surrogate, reusable, 1100C test vehicle sustained moderate damage, as shown in Figure 56. Damage consisted of minor deformation and contact marks at the left ¼ point of the front bumper where impact occurred. The right ¼ point of the front bumper sustained more damage as the right quarter of the bumper cover was disengaged, along with minor deformation of the bumper structure, and fracture of the right headlight cover. Indentation was visible on both sides of the vehicle hood due to contact with the mailboxes. No damage was observed to the windshield or roof of the vehicle. Occupant compartment deformations were not formally measured for this non-compliant test with a surrogate vehicle. While undercarriage contact with the System B mailbox support occurred, no visible occupant compartment deformations were observed.
