*Research Project Number TPF-5(193) Supplement #130*

# **EVALUATION OF THE NEW YORK LOW-TENSION THREE-CABLE BARRIER ON CURVED ALIGNMENT**

MwRSF Research Report No. TRP-03-263-12

February 19, 2013

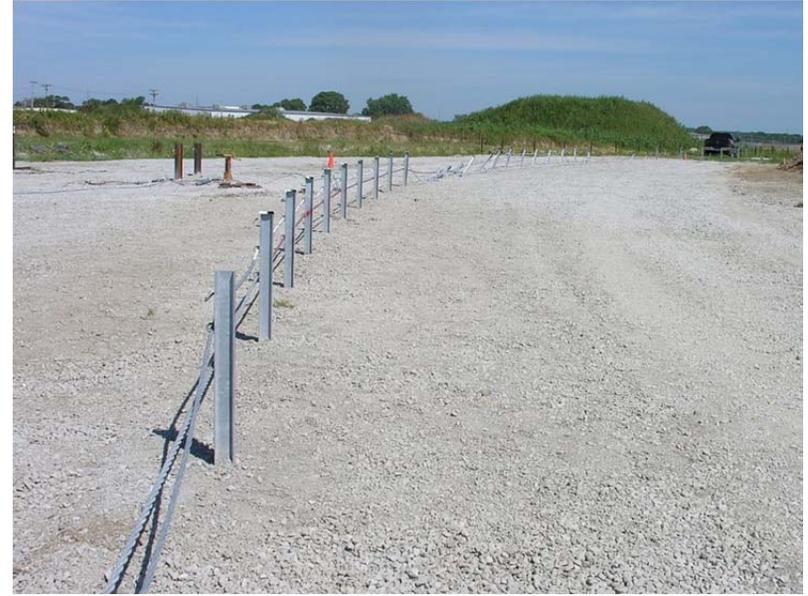
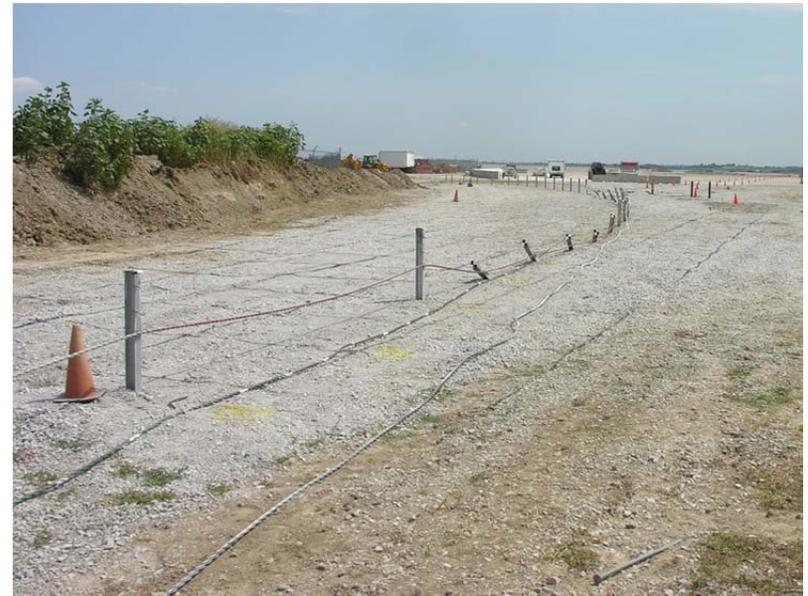
Figure 41. System Damage, Test No. NYCC-1

Damage to the barrier was extensive, as shown in Figures 41 through 55. Barrier damage consisted of bent posts, disengaged cables, weld failures, and anchor rod fractures. The length of vehicle contact along the barrier was approximately 130 ft (39.6 m), which spanned from 2 ft (0.6 m) upstream from post no. 17 through post no. 33.

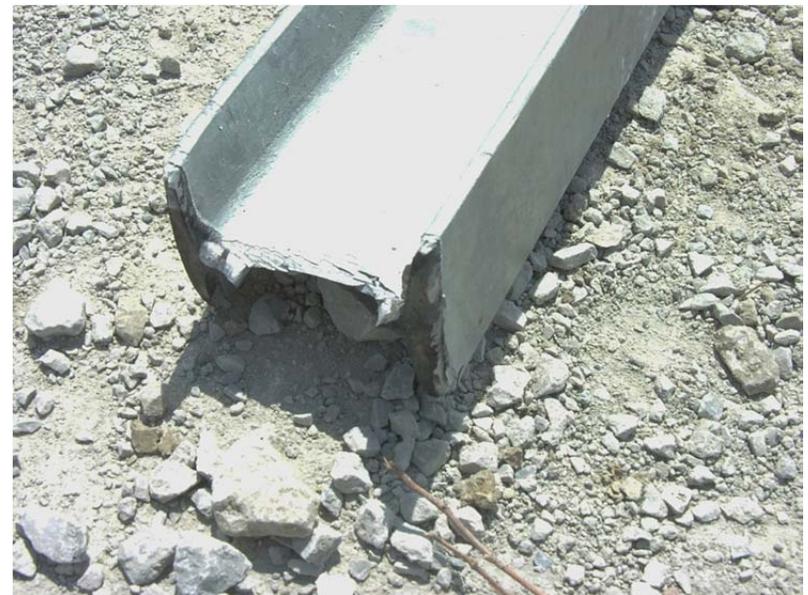
Figure 42. System Damage: Upstream Anchor and Post No. 1, Test No. NYCC-1

The upstream anchorage was moderately and unexpectedly damaged. The weld between post no. 1 and the slip base plate failed, as shown in Figure 42. Both the post and the plate were found adjacent to the slip base stub. All of the cables were disengaged from post no. 1. The top cable anchor rod fractured and the middle cable anchor rod bent, as shown in Figure 43. The upstream end of the top cable came to rest about 10 ft (3 m) in front of post no. 15. The brass keeper rod on the angled anchor plate was also bent.

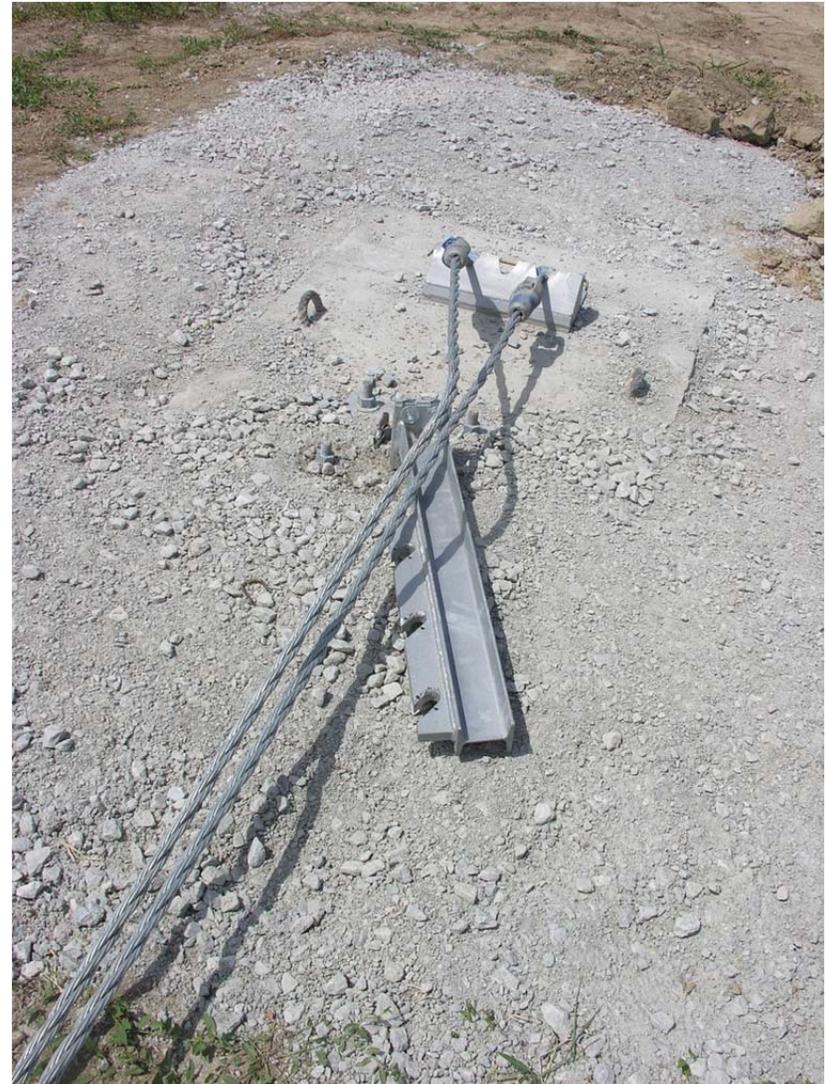
Figure 44. System Damage: Downstream Anchor and Post No. 40, Test No. NYCC-1

The downstream anchorage experienced similar damage. The weld between the bottom slip base plate and the post stub failed, as shown in Figure 44. The post came to rest adjacent to the stub with the slip base completely intact. All three cables were disengaged from the post. The middle cable anchor rod fractured, as shown in Figure 45, due to the cable being snagged on the vehicle. The downstream end of the middle cable came to rest behind the vehicle, about 6 ft (2 m) in front of post no. 38.

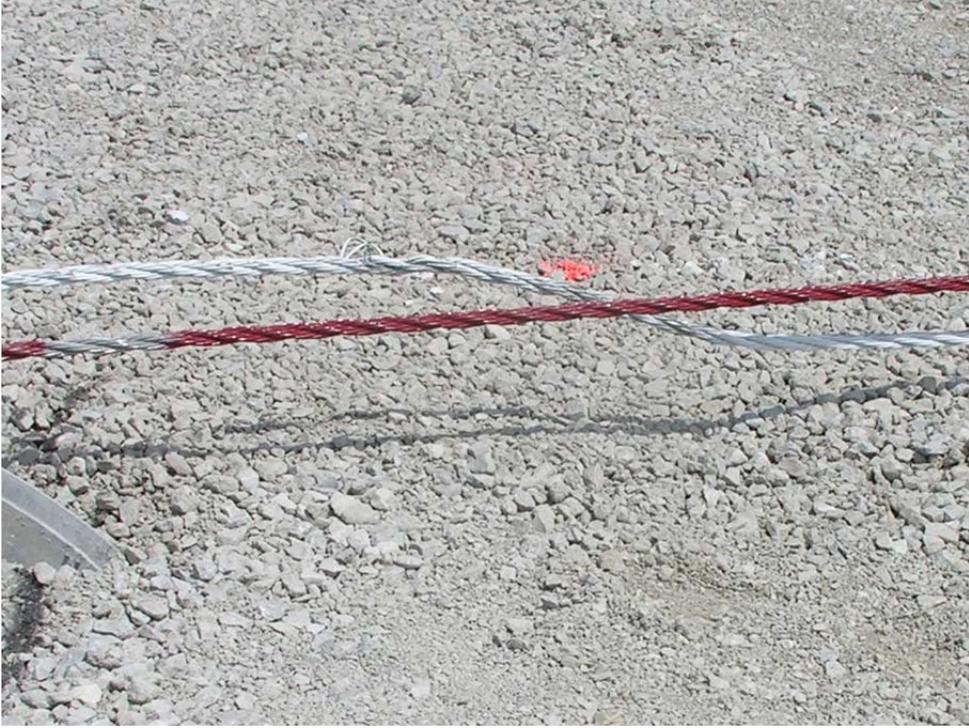
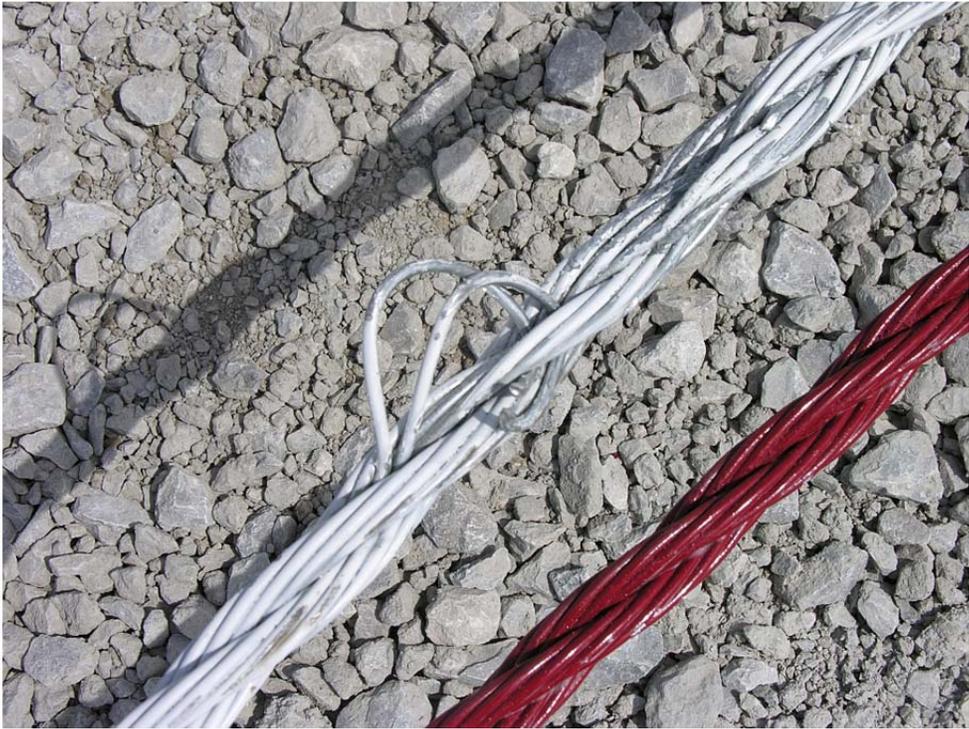
Figure 46. System Damage: Middle Cable between Post Nos. 17 and 18, Test No. NYCC-1

through 19, 30, and 33. The middle cable between post nos. 17 and 18 frayed. The fray consisted of two broken wire strands, as shown in Figure 46.

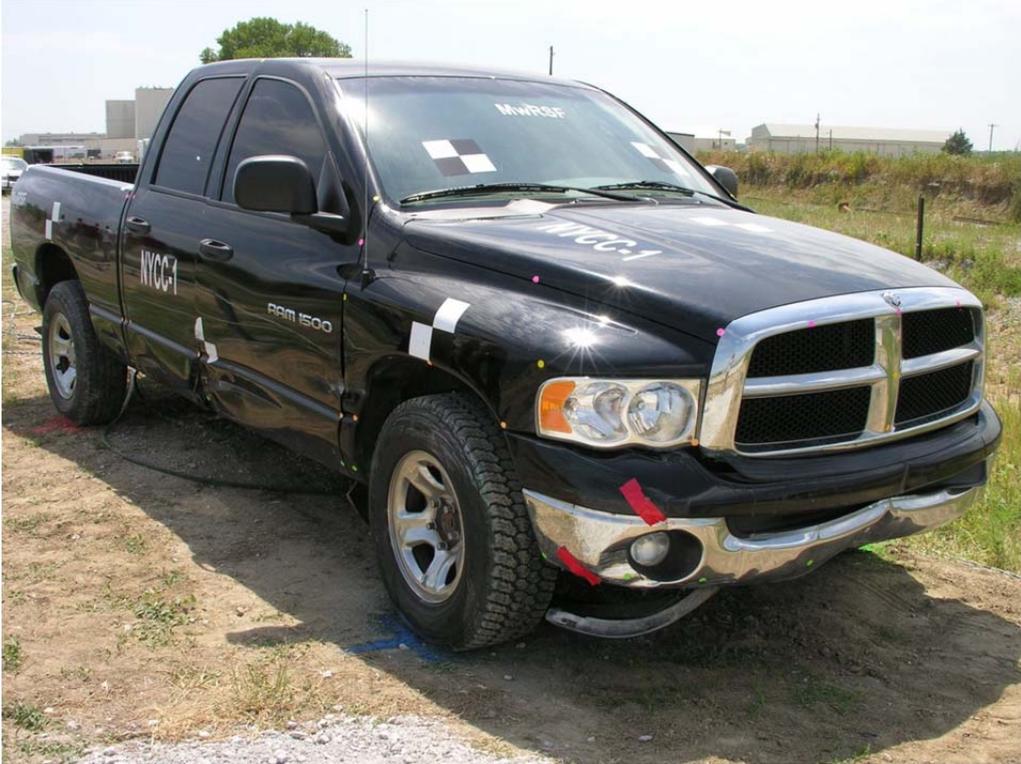
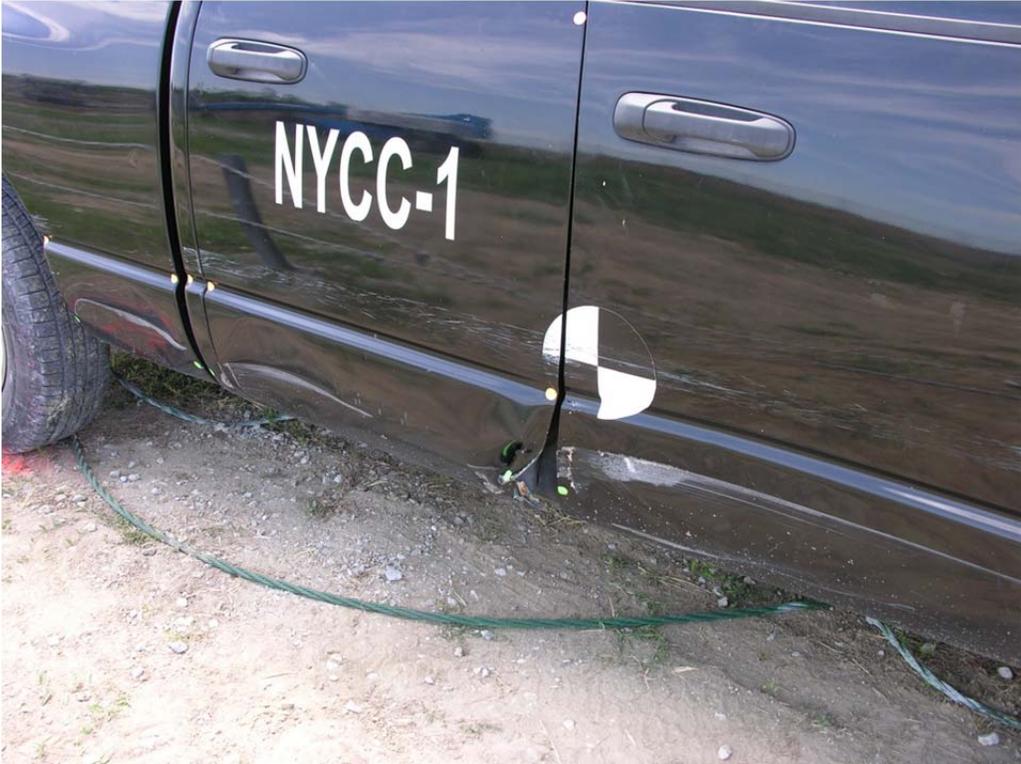
Figure 57. Vehicle Damage: Right Side, Test No. NYCC-1

The damage to the vehicle was minimal, as shown in Figures 57 and 58. The maximum occupant compartment deformations are listed in Table 5 along with the deformation limits established in MASH for various areas of the occupant compartment. Note that none of the MASH established deformation limits were violated. Complete occupant compartment and vehicle deformations and the corresponding locations are provided in Appendix D.

The majority of the damage was concentrated on the right-front corner and right side of the vehicle where the impact occurred. The lower front bumper trim was disengaged, and the front bumper was dented and bent inward near the vehicle centerline due to contact with posts. The right side of the front bumper had contact marks from the cables as well as denting and kinking due to contact with posts. The left side of the front bumper had dents and contact marks from the cables and posts. The right-front door experienced some gouging and denting. The right-rear door was dented and had a tear and fold at the front edge of the door, caused by the top cable contact. The right-rear quarter panel experienced gouging. The left-front wheel experienced gouging along the edge of the rim. The left-rear door was gouged along the bottom. The left-rear quarter panel had a small dent near the cab. Contact marks from the cables extended along the entire right side of the vehicle.

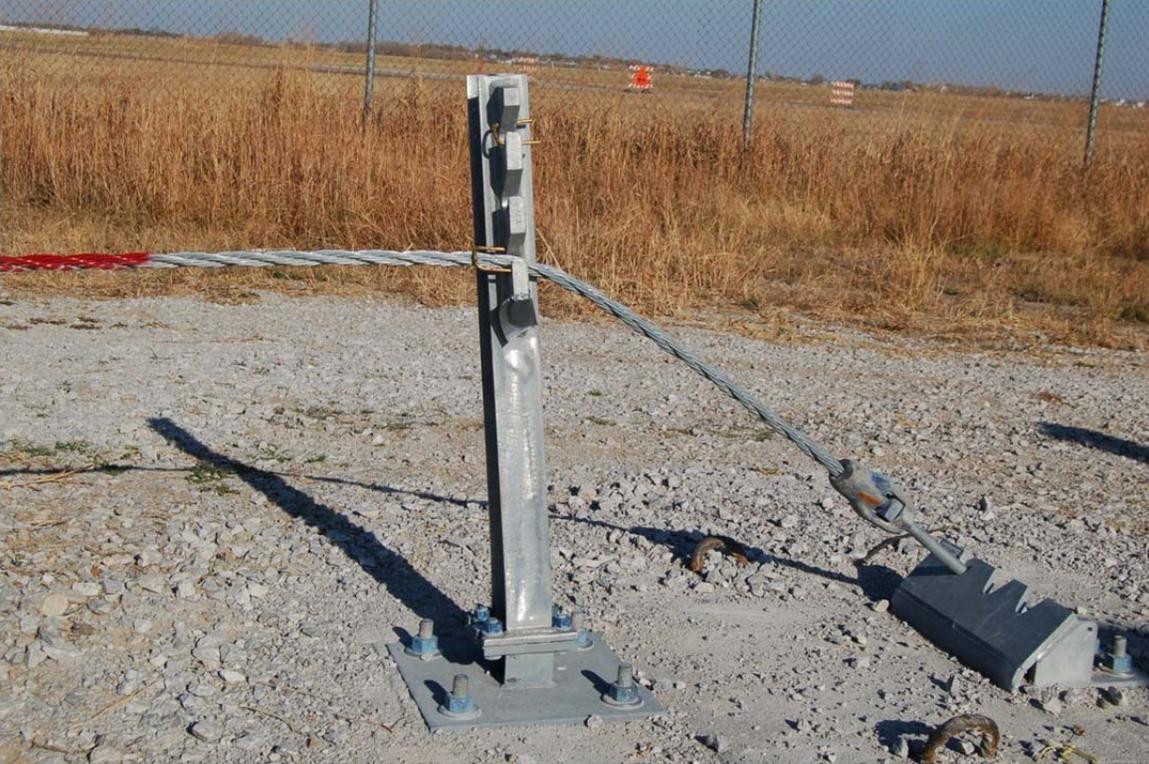
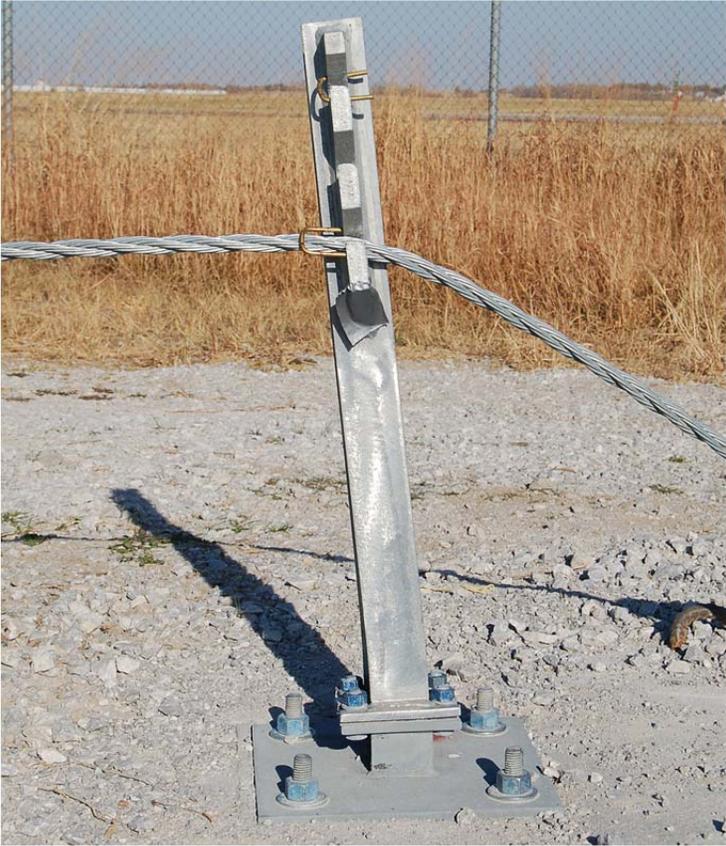
Figure 72. System Damage: Upstream Anchorage, Test No. NYCC-2

The upstream cable anchor assembly experienced minor damage. The top and middle cables had disengaged from both the angled anchor bracket and post no. 1. Post no. 1 was slightly bent downstream. Post nos. 17 through 19 were all bent backward and downstream.

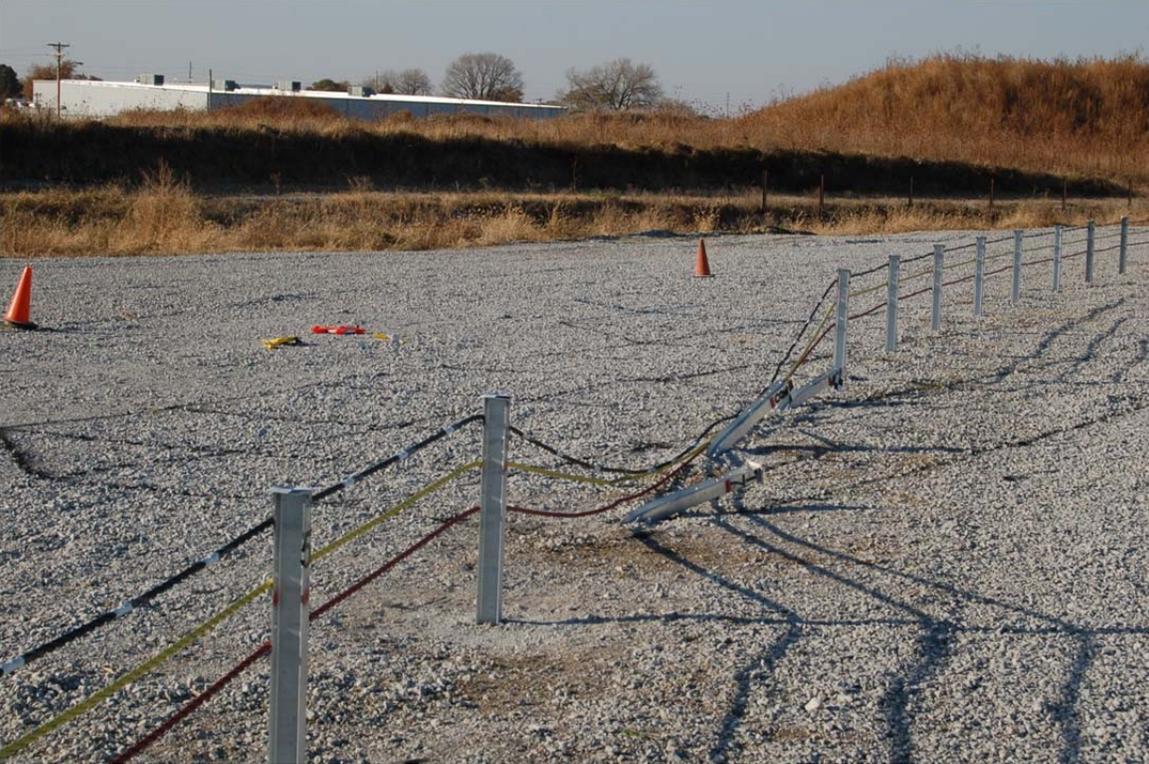
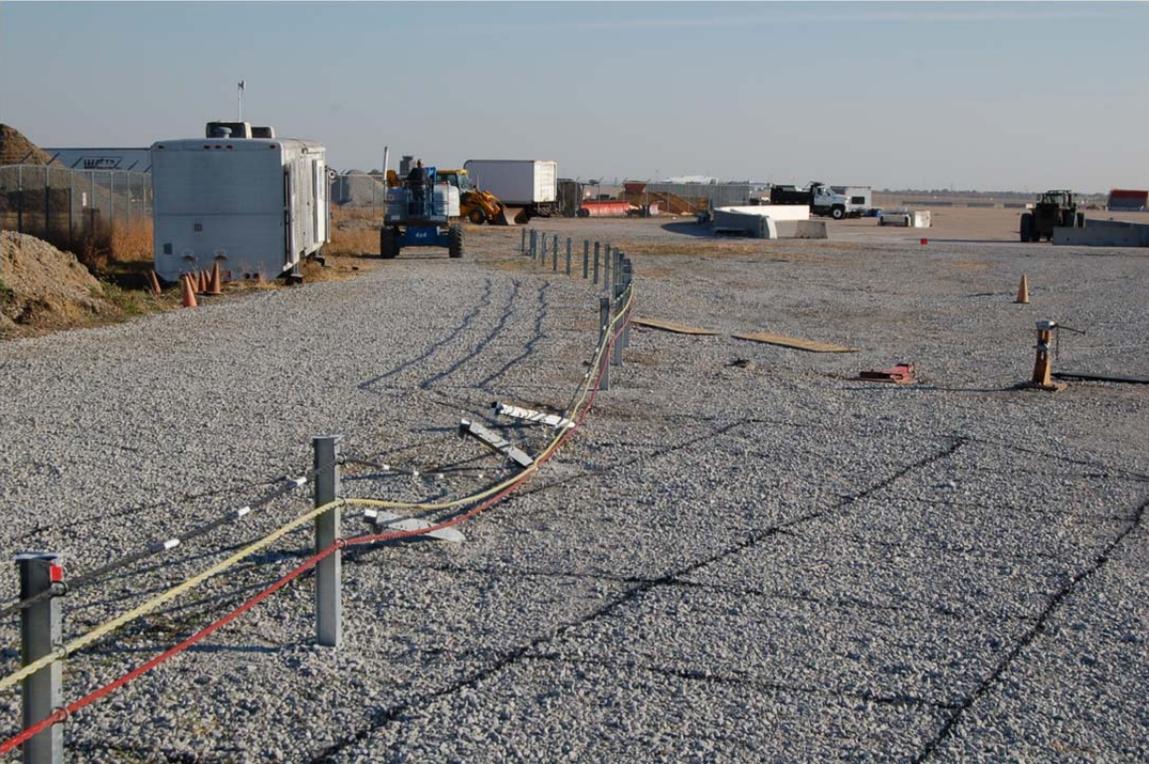
Figure 73. System Damage, Test No. NYCC-2

Damage to the barrier was minimal, as shown in Figures 71 through 74. Barrier damage consisted of bent posts and disengaged cables. The length of vehicle contact along the barrier was approximately 24 ft (7.32 m), which spanned from 2 ft (0.6 m) upstream from post 17 through 2 ft (0.6 m) upstream from post 20.

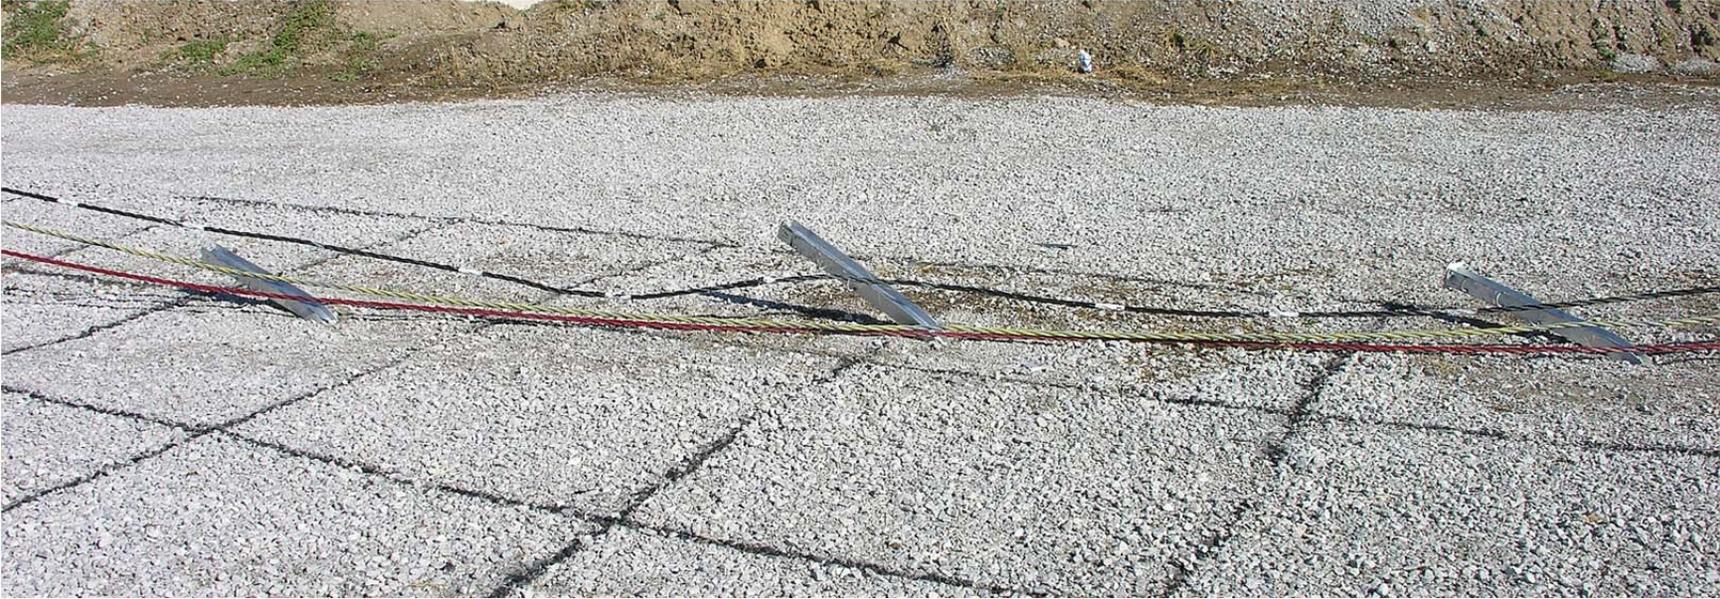
Figure 74. System Damage: Post Nos. 17 through 19, Test No. NYCC-2

The top, middle, and bottom cables disengaged from post nos. 17 through 19. All cable-to-post J-bolt attachments on post nos. 17 and 18 were bent. Additionally, the top and middle J-bolts on post nos. 17 and 18 were rotated upstream. The top and middle J-bolts on post no. 19 were fractured and the bottom J-bolt was bent and rotated upstream.

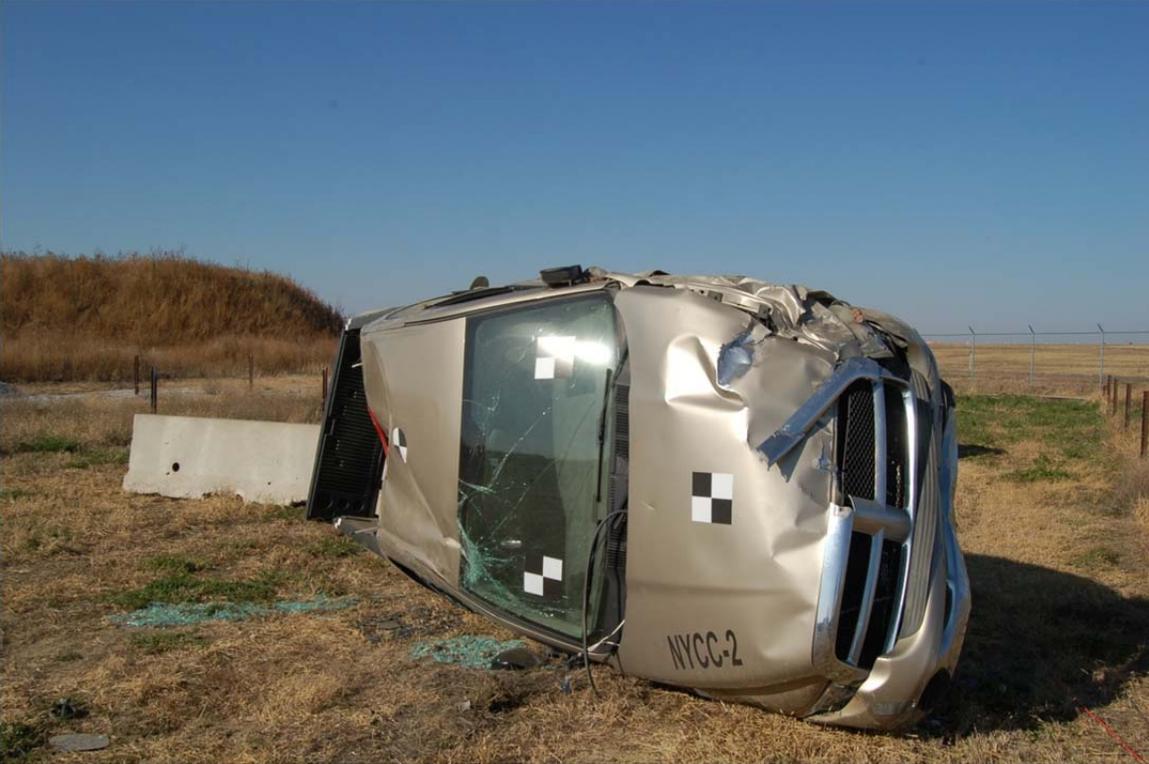
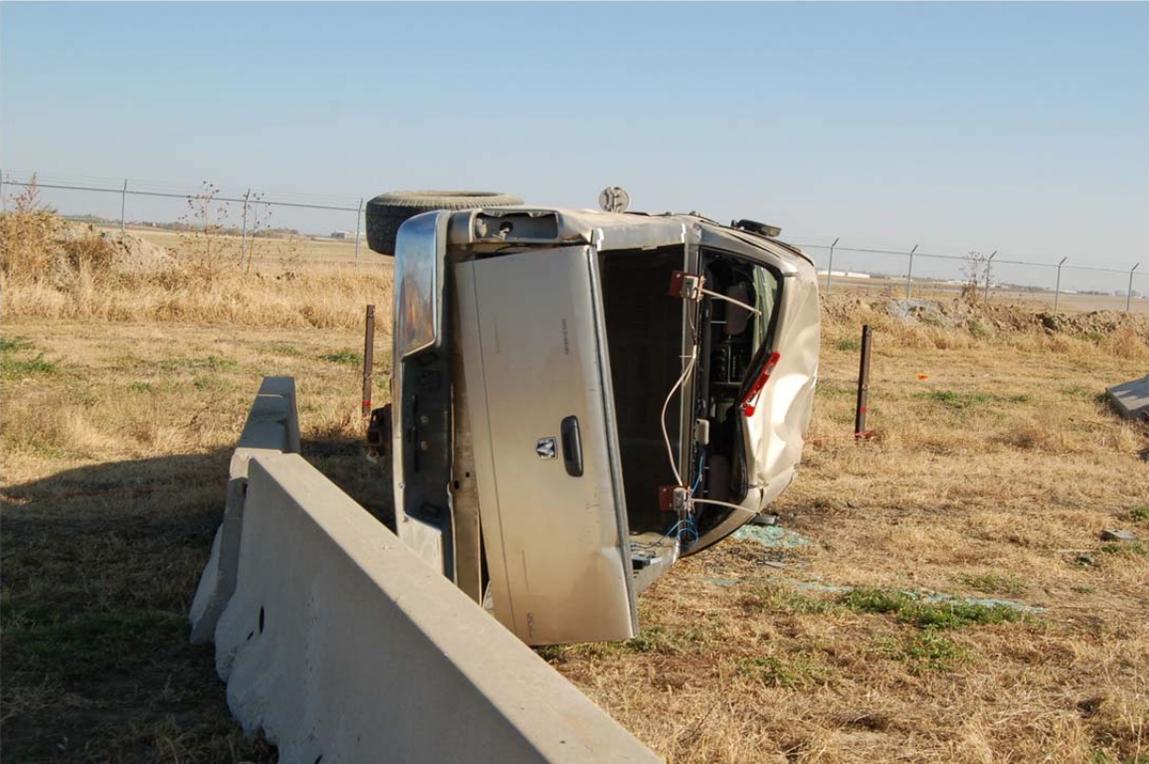
Figure 75. Vehicle Damage, Test No. NYCC-2

The damage to the vehicle was moderate, as shown in Figures 75 through 78. However, only minor vehicle damage resulted from the interaction with the barrier. The damage due to rollover was not attributable to the curved-cable system as the vehicle was stable and tracking before climbing the embankment. The maximum occupant compartment deformations are listed in Table 10 along with the deformation limits established in MASH for various areas of the occupant compartment. Note that the maximum permissible roof crush limits described in

The entire cab of the vehicle was dented due to rollover. The left-front bumper was crushed inward, and the hood was bent inward. A large indentation was present on the left side. The windshield experienced spider-web cracking, concentrated in the top right corner. The rear windshield was shattered. The roof of the cab was crushed downward about 8.5 in. (216 mm). Both of the rear tail lights were disengaged as well as the right side of the tailgate. The left-front wheel was disengaged, and the ball joint support was fractured. The left-front brake line was cut. The driveshaft was disengaged from the transmission. Cable contact marks were found on the underside of the gas tank. The passenger and driver side windows were fractured.
