TWO APPROACH GUARDRAIL TRANSITIONS FOR CONCRETE SAFETY SHAPE BARRIERS

MIDWEST ROADSIDE SAFETY FACILITY

MwRSF Research Report No. TRP-03-69-98

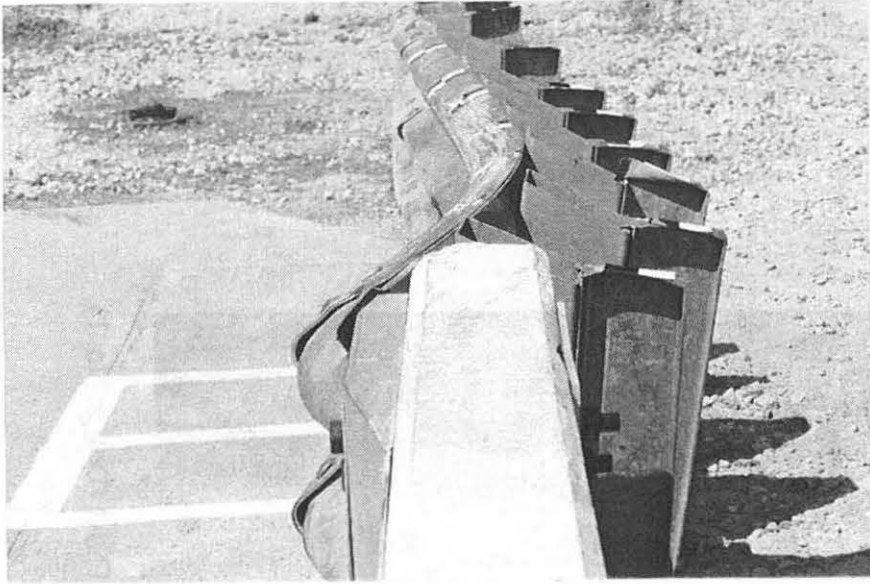
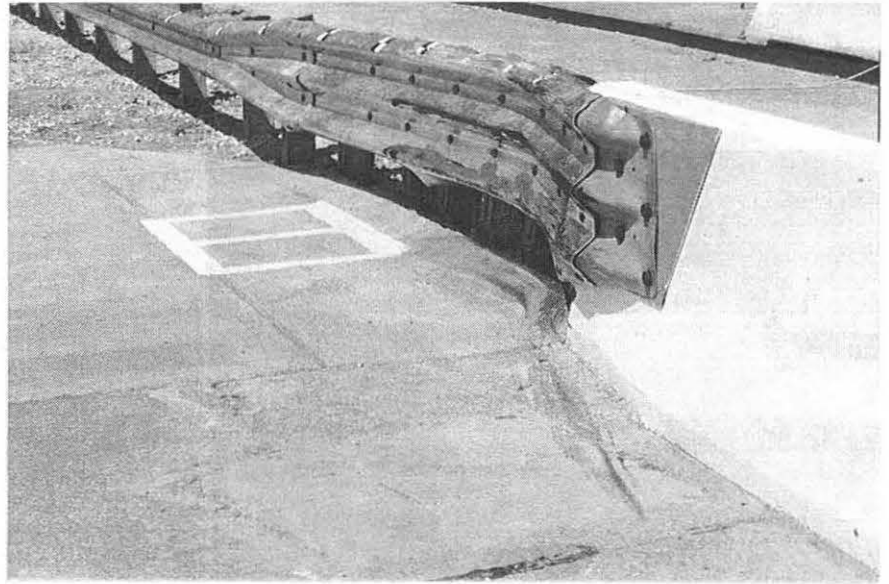
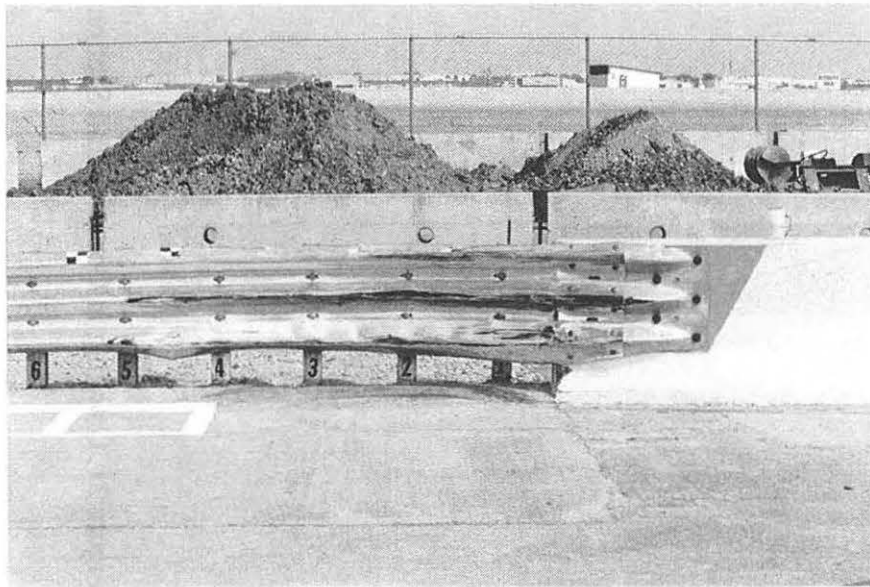
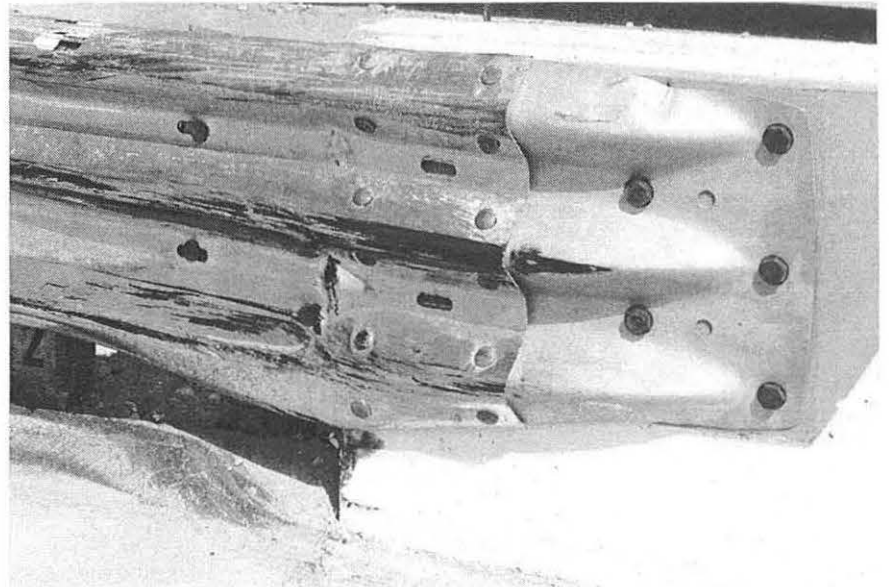
Figure 30. Barrier Damage, Test ITNJ-1 (Design No. 1)

Damage to the barrier was moderate, as shown in Figures 30 through 33. Barrier damage consisted mostly of deformed thrie beam, tire marks on the lower upstream face of the concrete end section, and cracking in the concrete end section. Concrete cracking and minor spalling was observed on the upstream end of the concrete end section, as shown in Figure 31. The permanent set of the guardrail and posts is shown in Figures 30 and 32 through 33. The maximum lateral permanent set deflection was approximately 241 mm at post no. 3, as measured in the field. The maximum lateral dynamic deflection was 349 mm at post no. 3, as determined from the high-speed film analysis.

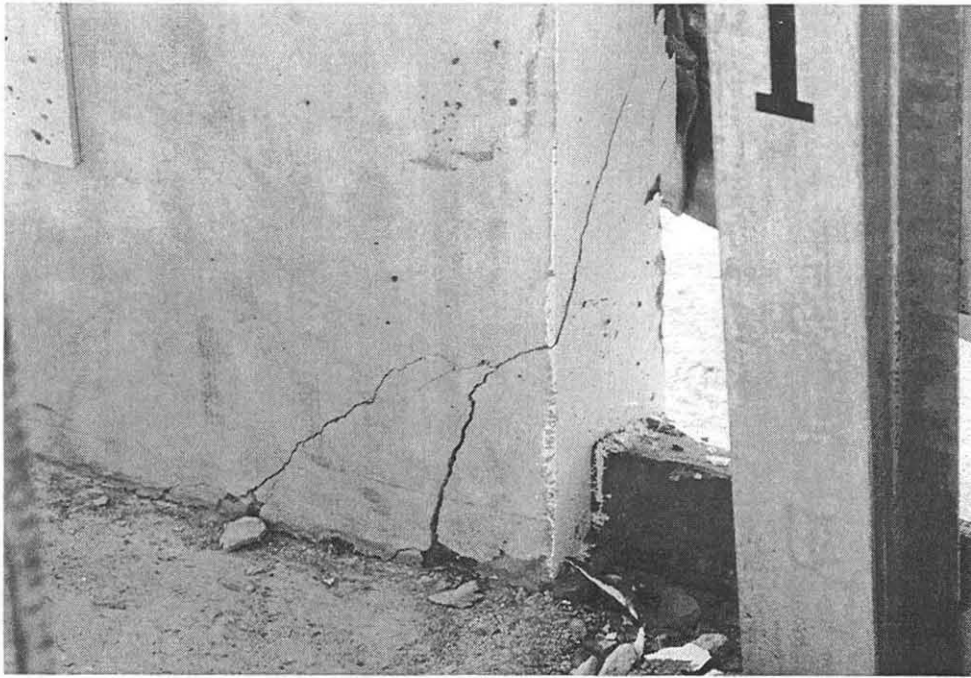
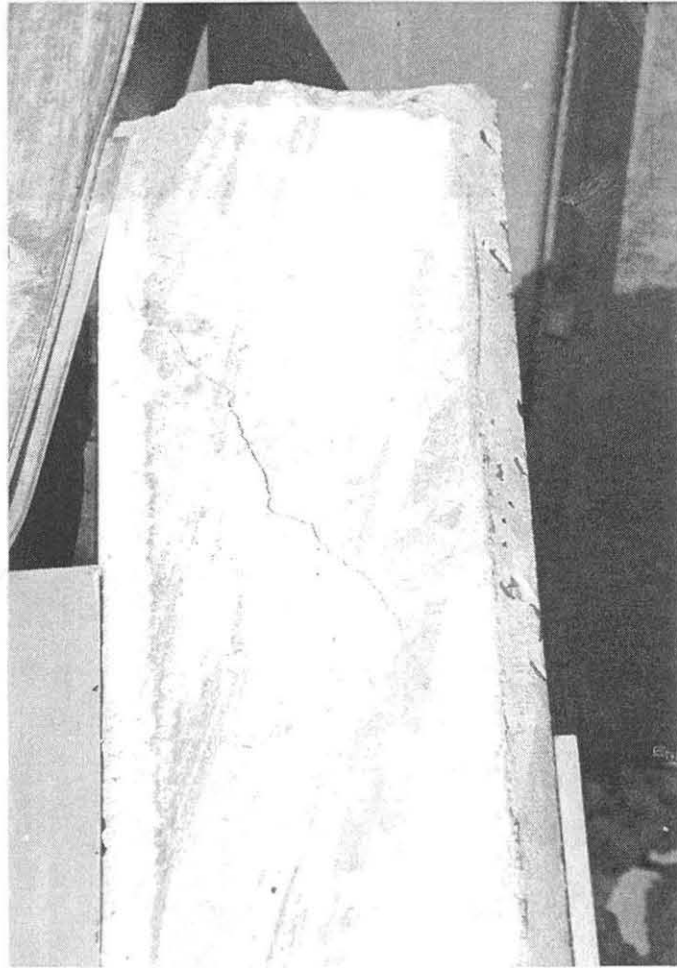
Figure 31. Cracking in Concrete End Section, Test ITNJ-1 (Design No. 1)

As a result of the extensive vehicle penetration into the barrier system, the pickup truck was redirected out of the barrier system at a higher than normal exit angle. Significant roll, pitch, and yaw angular motions were also produced, resulting in vehicle rollover. In addition, the increased vehicle penetration and minor pocketing led to higher than expected impact forces being applied to the concrete end section, resulting in cracking of the safety shape barrier.

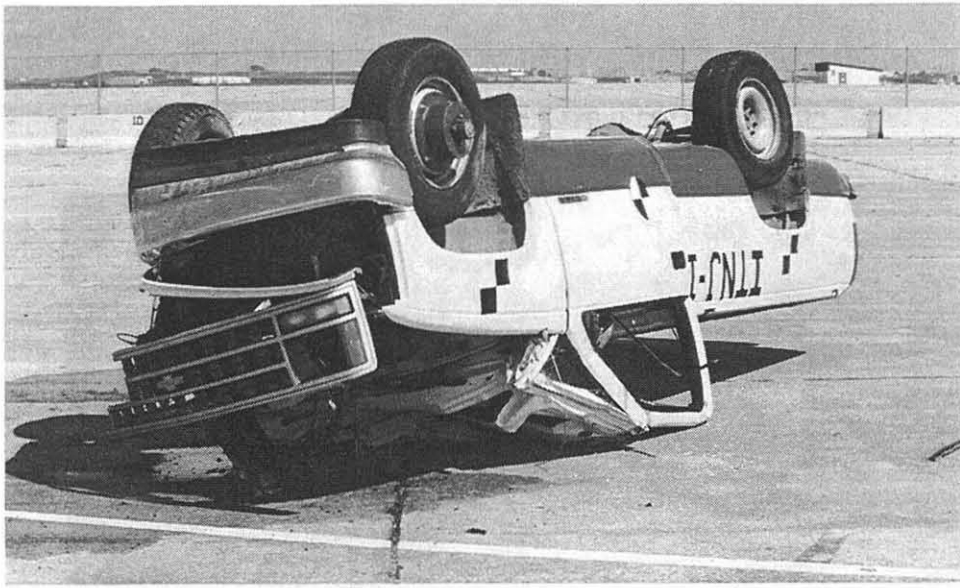
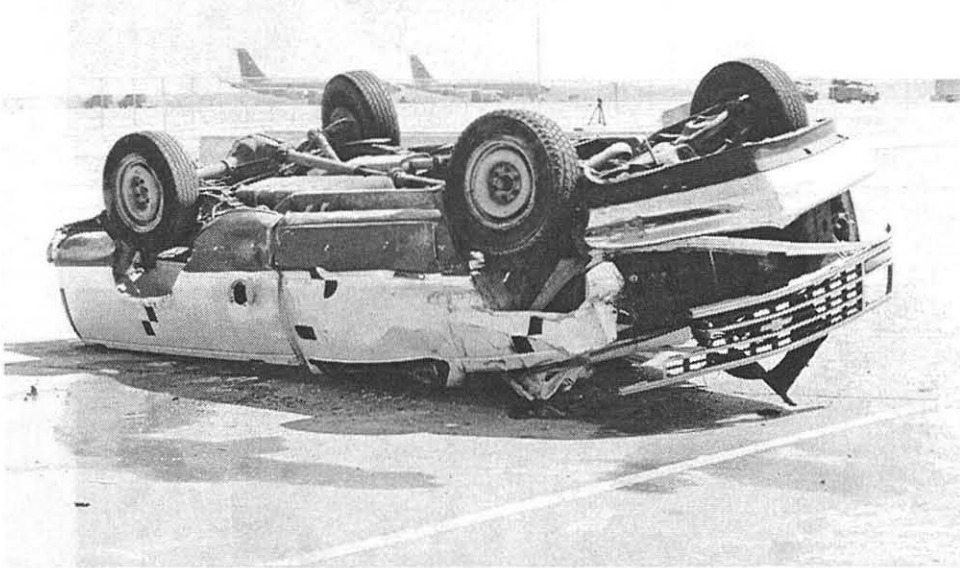
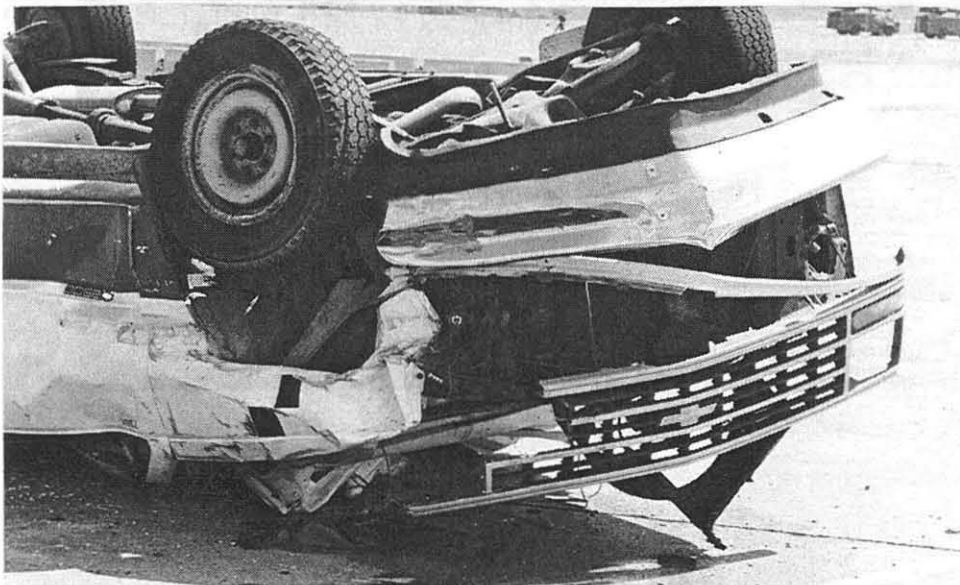
Figure 34. Vehicle Damage, Test ITNJ-1 (Design No. 1)

Exterior and interior vehicle damage was extensive and occurred at several body locations, as shown in Figures 34 and 35. The left-front quarter panel was crushed inward, and the left-side of the front bumper was bent back toward the engine compartment. The engine hood, roof, truck cab, and window glass were severely crushed during the vehicle rollovers. The floorboard of the occupant compartment also sustained significant plastic deformations due to the severe impact with the barrier as well as from vehicle rollover.

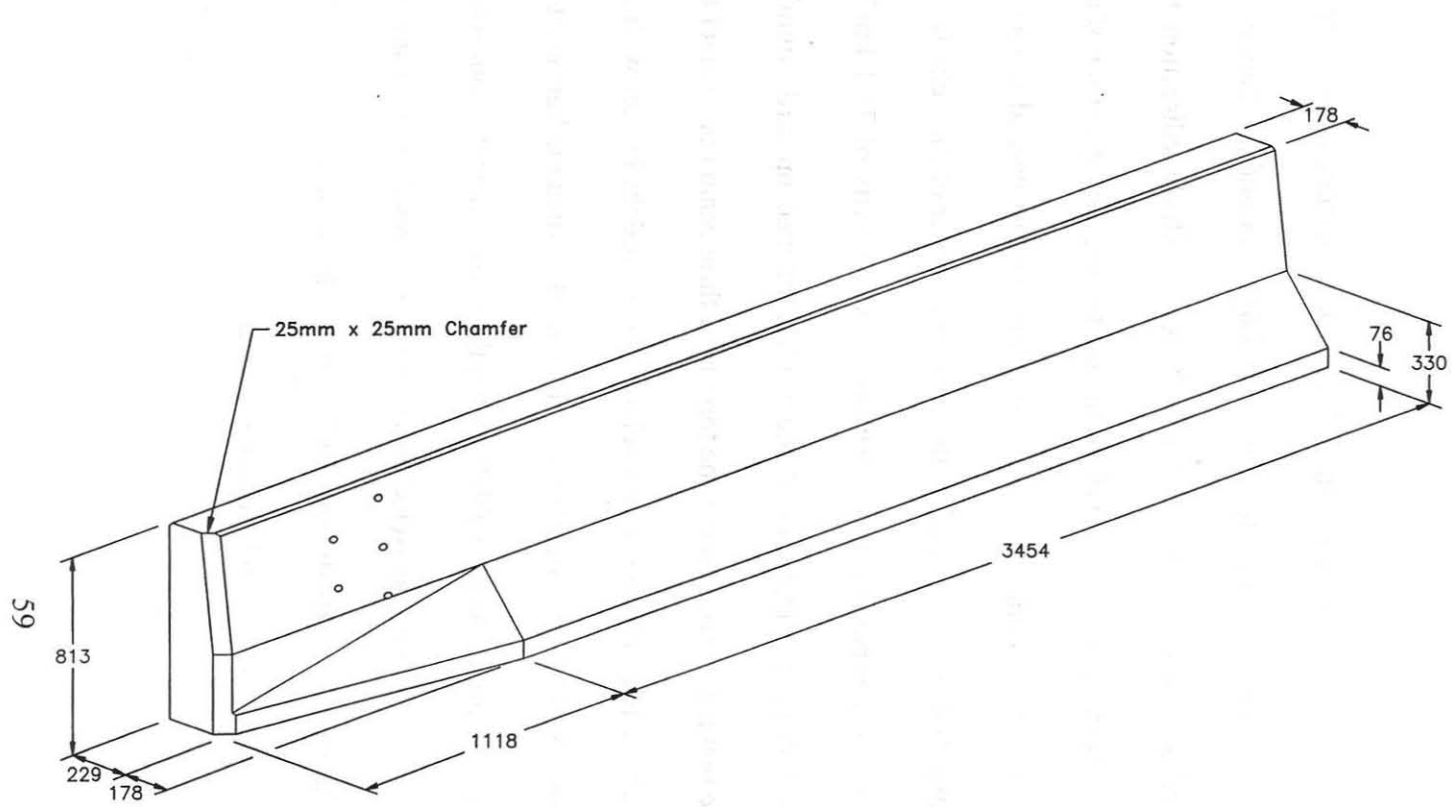
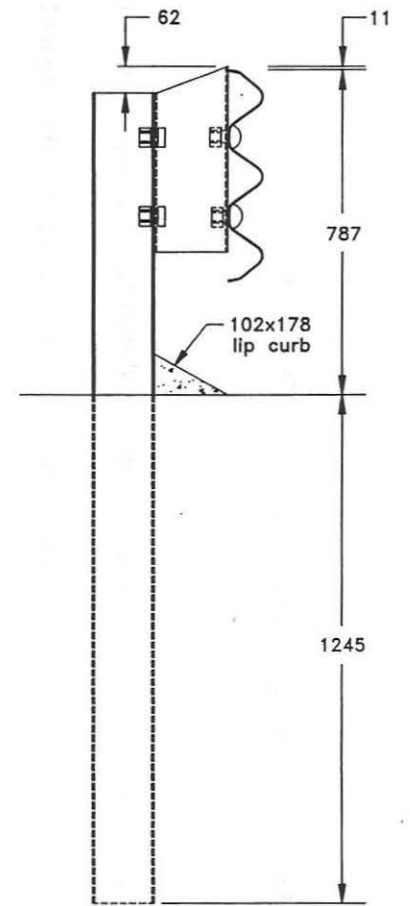
Figure 36. Barrier and Post Modifications, Design No. 2

Following the unsuccessful crash test of Design No. 1, it was necessary to determine the cause of the poor barrier performance and subsequent vehicle rollover so that design modifications could be made to the system. A careful examination of the damaged barrier system and an analysis of the test results revealed that the dynamic and permanent set barrier deflections were greater than those predicted. It is believed that these excessive barrier deflections occurred due to post-soil forces being significantly lower than expected. These lower post-soil forces may be attributed to the use of a relatively poorly-graded, coarse crushed limestone material meeting NCHRP Report 350 specifications.

modifications were made to the approach guardrail transition system. The embedment depth of post nos. 1 through 7 were increased by 152 mm, resulting in a total embedment depth of 1,245 mm. The relatively poorly-graded aggregate material used in Design No. 1 was replaced with a crushed limestone material more consistent with the AASHTO specification. In addition, a 25-mm chamfer was placed on the front vertical edge of the concrete safety shape's upstream end. These modifications, incorporated in Design No. 2, are shown in Figure 36.

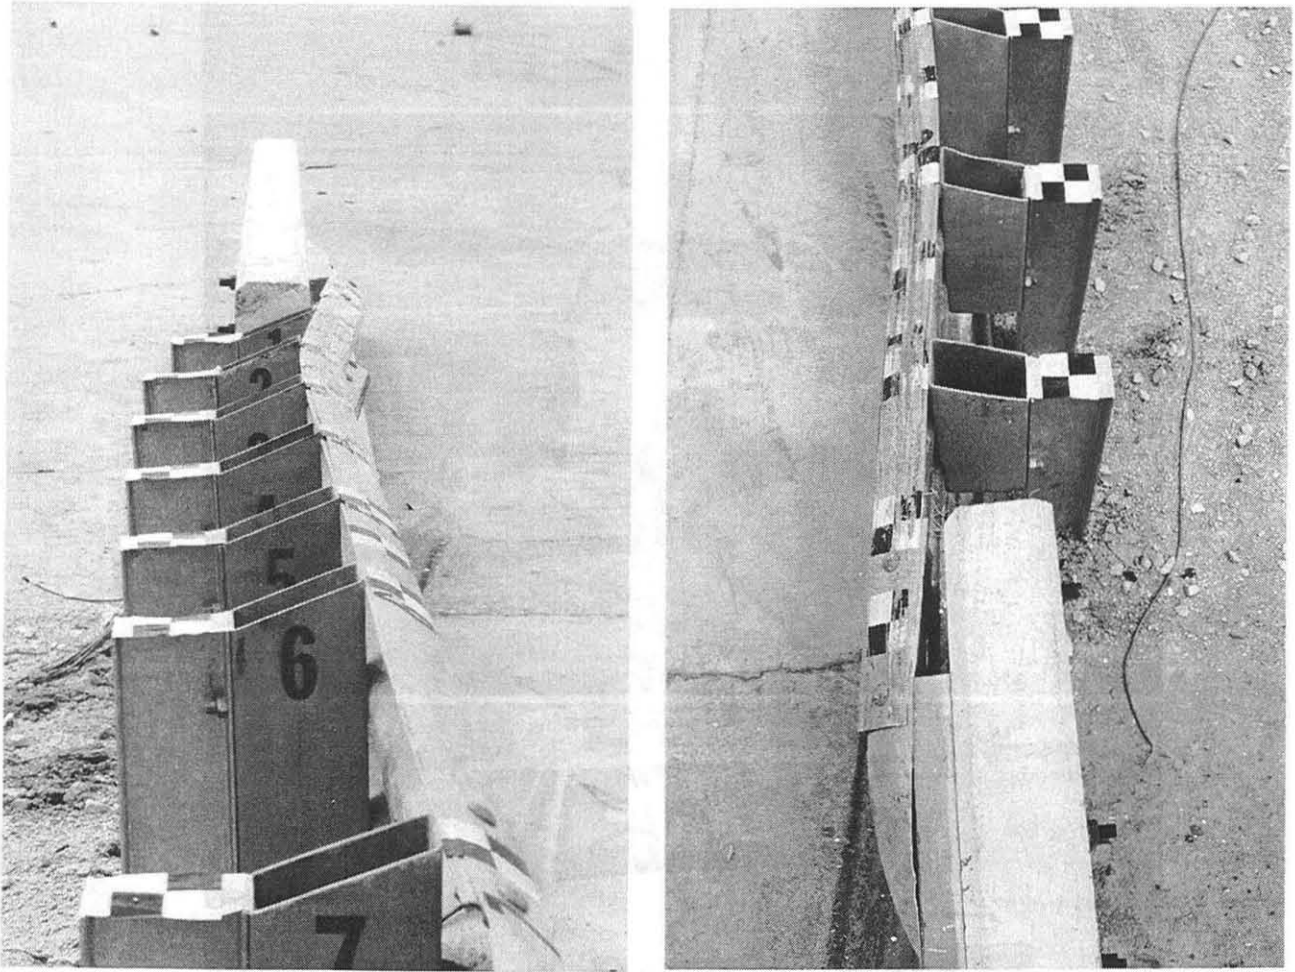
Figure 42. Barrier Damage, Test ITNJ-2 (Design No. 2)

Damage to the barrier was moderate, as shown in Figures 42 through 45. Barrier damage consisted mostly of deformed thrie beam and tire marks on the lower upstream face of the concrete end section. No cracking was observed in the concrete end section. The permanent set of the guardrail and posts is shown in Figures 42 and 44 through 45. The maximum lateral permanent set deflection was approximately 92 mm at post no. 2 and the midspan between post nos. 2 and 3, as measured in the field. The maximum lateral dynamic deflection was 133 mm at post no. 3, as determined from the high-speed film analysis. It is noted that some dynamic deflection measurements were not available for viewing from the overhead camera due to the vehicle extending over the barrier.

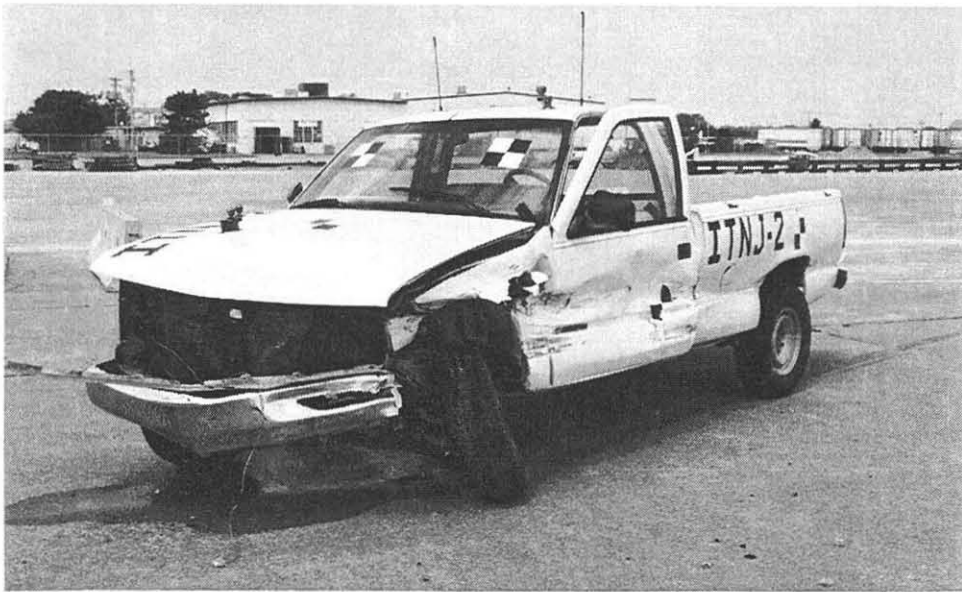
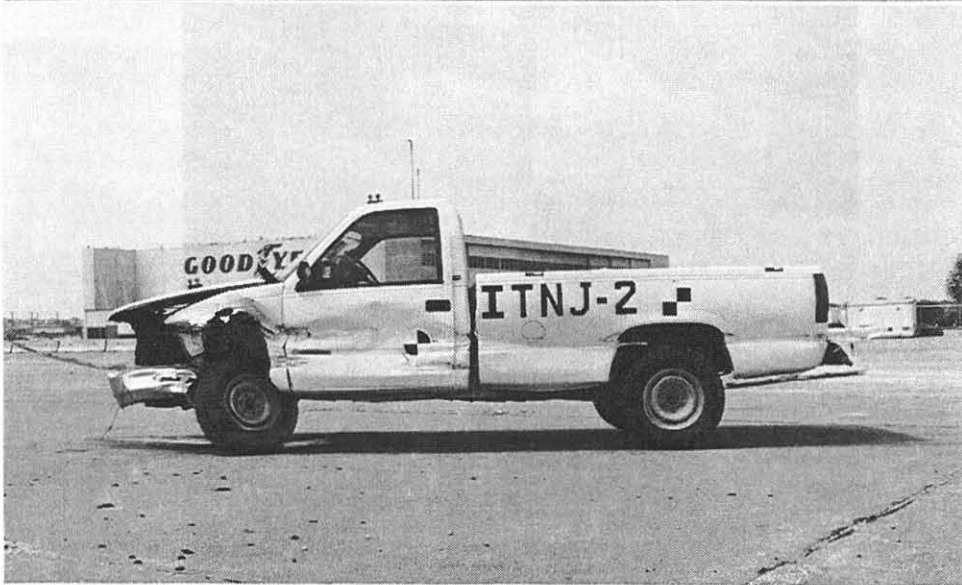
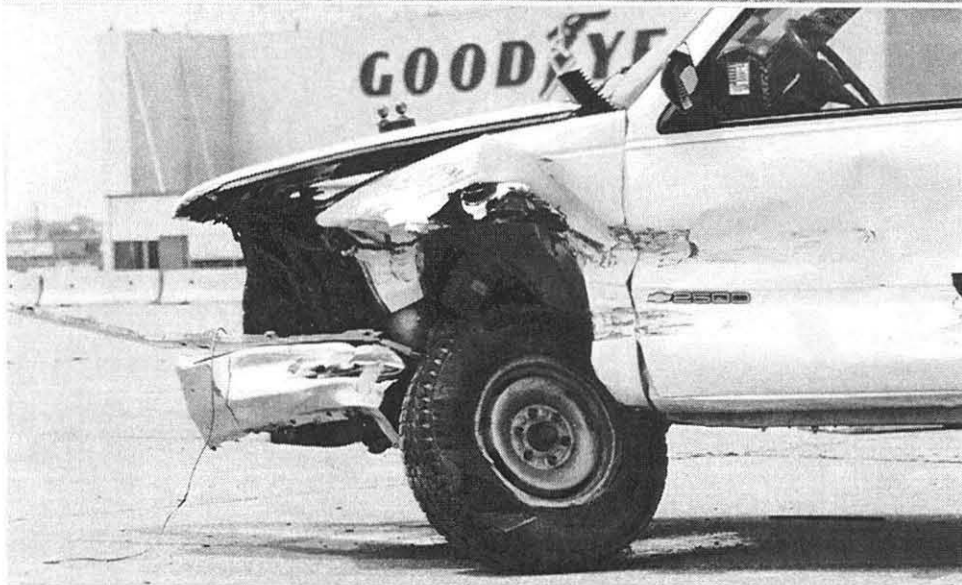
Figure 46. Vehicle Damage, Test ITNJ-2 (Design No. 2)

Vehicle damage was moderate, as shown in Figure 46. The left-front quarter panel was crushed inward, and the left-side of the front bumper was also bent back toward the engine compartment. The left-front wheel assembly was deformed and pushed backward into the firewall. Longitudinal deformations, due to vehicle-rail interlock, were observed along the entire left-side of the vehicle. Maximum occupant compartment deformations to the floorboard and/or firewall in the lateral, longitudinal, and vertical directions were 95 mm, 83 mm, and 83 mm, respectively, as shown in Figure 47.

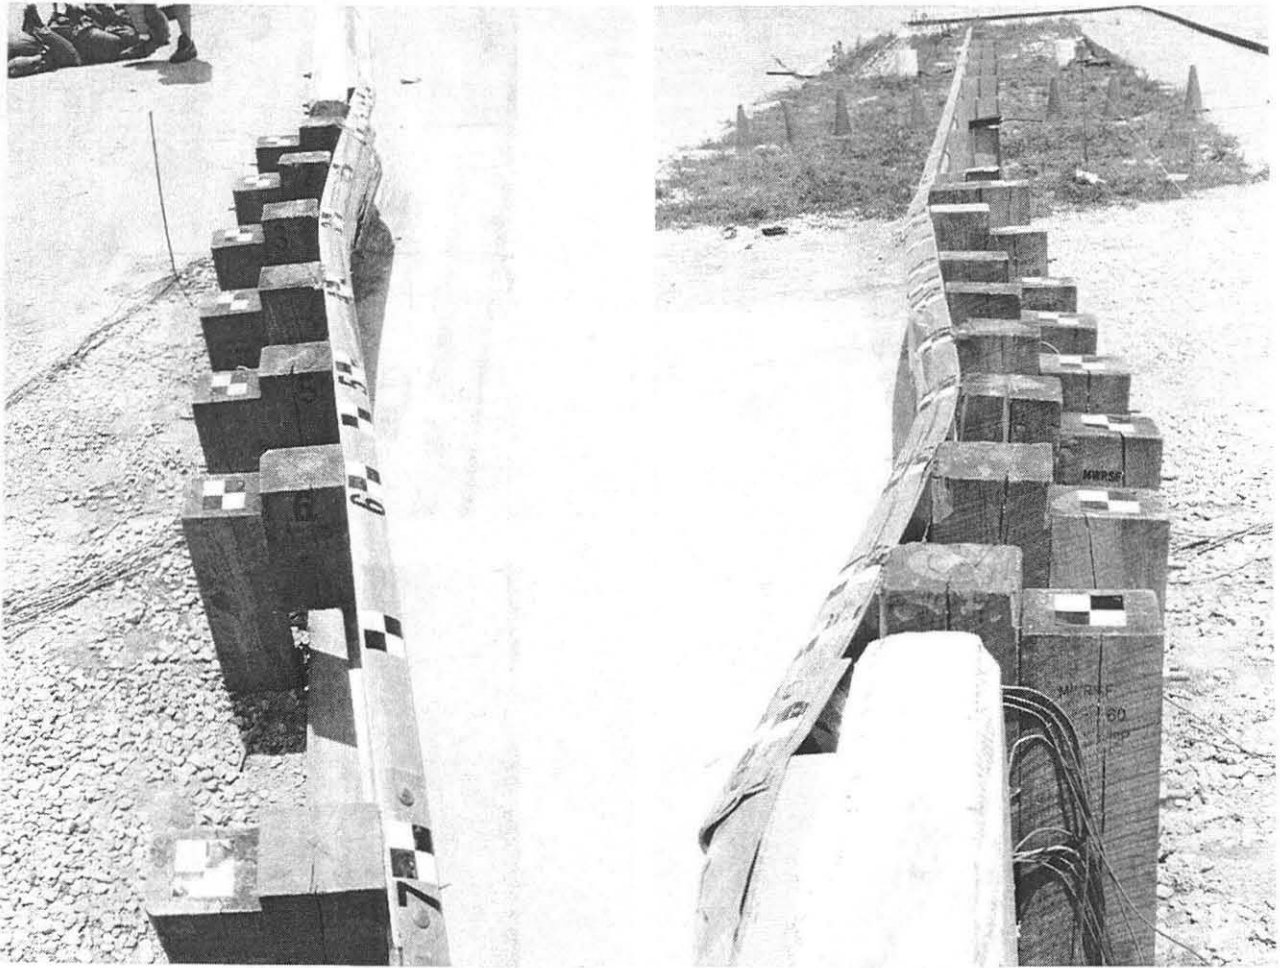
Figure 56. Barrier Damage, Test ITNJ-3 (Design No. 3)

Damage to the barrier was moderate, as shown in Figures 56 through 59. Barrier damage consisted mostly of deformed thrie beam, tire marks on the lower upstream face of the concrete end section, and cracking in the concrete end section. Concrete cracking and minor spalling was observed on the upstream end of the concrete end section. The permanent set of the guardrail and posts is shown in Figures 51 and 56 through 59. The maximum lateral permanent set deflection was approximately 171 mm at post no. 3, as measured in the field. The maximum lateral dynamic deflection was 264 mm at post no. 3, as determined from the high-speed film analysis.
