DEVELOPMENT OF A TL-2 STEEL BRIDGE RAILING AND TRANSITION FOR USE ON TRANSVERSE, NAIL-LAMINATED, TIMBER BRIDGES

WEST VIRGINIA DEPARTMENT OF TRANSPORTATION

MwRSF Research Report No. TRP-03-212-09

August 13, 2009

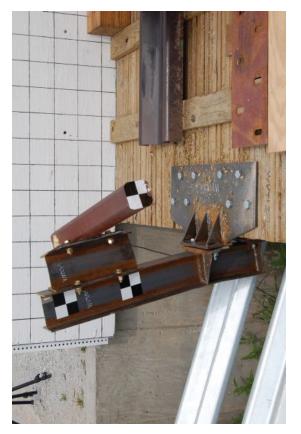
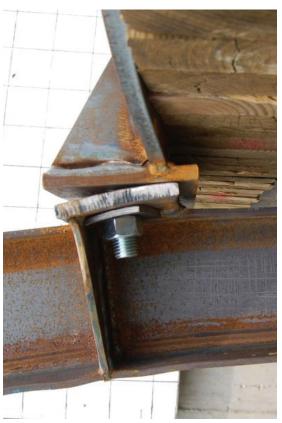
Figure 18. Post Assembly Damage, Test No. WVTL2-1

Damage to the post assembly included plastic bending and minor buckling, as shown in Figure 18. The top deck plate was bent downward near its attachment to the post. The post had minor buckling along its compression flange, and a gap had opened between the post plate and the top end plate. Also, the web of the post blockout was bent, resulting in the impact tube rotating approximately 20 degrees. Damage to the timber bridge deck consisted of only minor bearing deformations to the bolt holes, as shown in Figure 19.

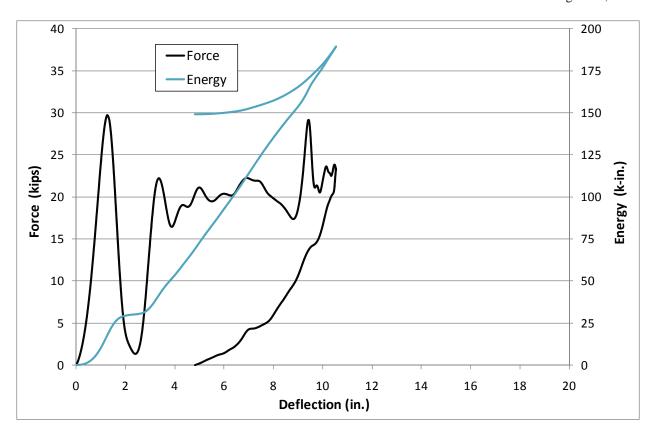
Figure 20. Force vs. Deflection and Energy vs. Deflection, Test No. WVTL2-1

Force versus deflection and energy versus deflection curves are shown in Figure 20. Initially, a high peak force of 29.7 kips (132.1 kN) was observed at 1.3 in. (33 mm), likely resulting from the inertial effects. The inertial spike dropped off to 1.4 kips (6.2 kN) at 2.4 in. (61 mm). The force level climbed and spiked again at 3.4 in. (86 mm) with a magnitude of 22.2 kips (98.8 kN). From 3.2 in. (81 mm) to 9.1 in. (231 mm), the post's average resistive force was approximately 20 kips (89 kN). Subsequently, the force level increased to 29.1 kips (129.4 kN) at 9.4 in. (239 mm). At a maximum deflection of 10.5 in. (267 mm), the post assembly had absorbed 189.2 kip-in. (21.4 kJ) of energy. For comparison purposes, the energy dissipated at 5 in. (127 mm) and 10 in. (254 mm) was 73.2 kip-in. (8.3 kJ) and 176.8 kip-in (20.0 kJ), respectively.

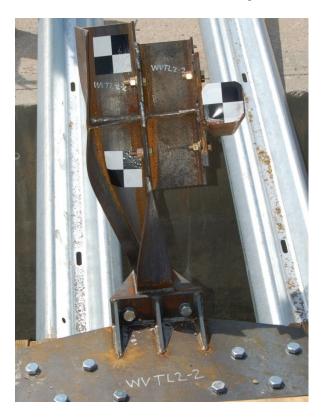
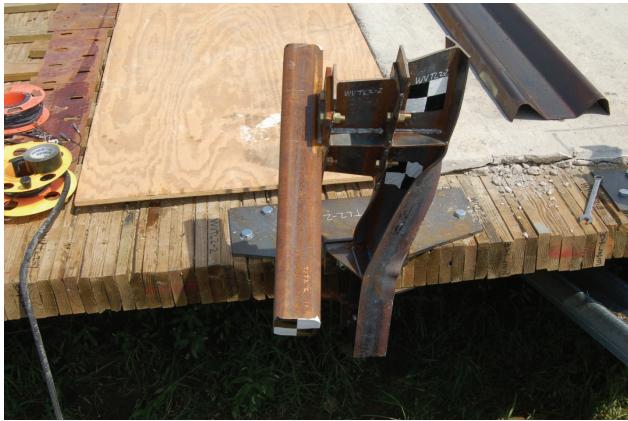
Figure 22. Post Assembly Damage, Test No. WVTL2-2

The post experienced severe plastic deformations, resulting from twisting and bending of the post, as shown in Figure 22. The post was bent backward and twisted nearly 90 degrees about its vertical axis. Localized buckling was found on the rear post flange, just above the connection to the deck plates. Also, the top deck plate was bent downward off of the edge of the timber bridge deck. The upper post region (portion above the bottom end of the blockout) and the blockout sustained limited deformation due to the additional gussets placed in these regions to prevent premature collapse or failure under eccentric loading. The timber bridge deck sustained only minor bearing deformations to the bolt holes, as shown in Figure 23.

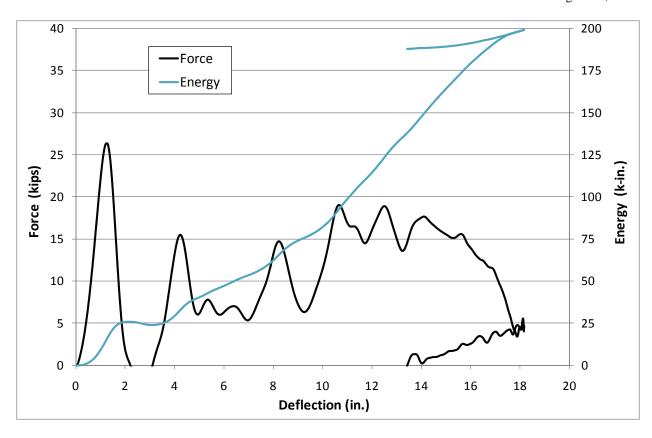
Figure 24. Force vs. Deflection and Energy vs. Deflection, Test No. WVTL2-2

Force versus deflection and energy versus deflection curves are shown in Figure 24. At the beginning of the impact event, a large peak load of 26.3 kips (117.0 kN) was recorded at 1.3 in. (33 mm), likely resulting from the inertial effects. The inertial spike dropped to zero at 2.2 in. (56 mm). Subsequently, the force climbed and spiked again at 4.3 in. (109 mm) with a magnitude of 15.4 kips (68.5 kN). From 3.8 in. (97 mm) to 8.8 in. (224 mm), the post's average resistive force was under 10 kips (44.5 kN). Later, the average resistive force increased to an approximate level of 16 kips (71.4 kN) between of 10 in. (254 mm) and 15 in. (381 mm). The post resistance then decreased until the bogie vehicle reached its maximum deflection of 18.2 in. (462 mm). The post absorbed 199.0 kip-in. (22.5 kJ) of energy at the maximum deflection of 18.2 in. (462 mm). For comparison purposes, the energy dissipated at 5 in. (127 mm), 10 in. (254 mm), and 15 in. (381 mm) was 40.6 kip-in. (4.6 kJ), 82.3 kip-in. (9.3 kJ), and 164.3 kip-in. (18.6 kJ), respectively. It should be noted that the displacements noted above pertain to the longitudinal movement of the rigid bogie vehicle.

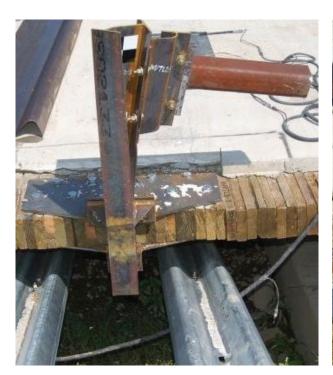
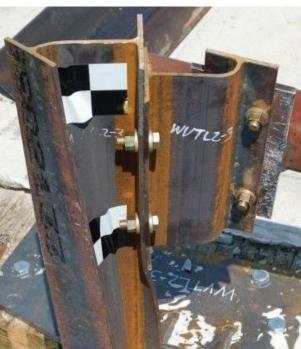
Figure 26. Post Assembly Damage, Test No. WVTL2-3

Damage to the bridge post assembly consisted of plastic bending, twisting, and localized buckling, as shown in Figure 26. The post was bent backward, and a gap had opened between the post plate and the top end plate. The post was also twisted clockwise resulting in localized flange buckling and bending of the web. The web of the post blockout was bent in the opposite direction as the web of the post, which resulted in the horizontal impact tube remaining normal to the path of the bogie. The deck plates and the timber bridge deck sustained no visual damage, as shown in Figures 26 and 27.

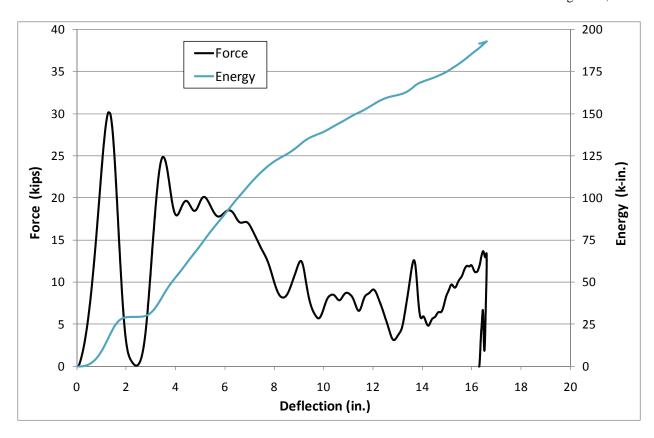
Figure 28. Force vs. Deflection and Energy vs. Deflection, Test No. WVTL2-3

Force versus deflection and energy versus deflection curves are shown in Figure 28. Initially, a high peak force of 30.1 kips (133.9 kN) was observed at 1.3 in. (33 mm), likely resulting from the inertial effects. The inertial spike dropped off to zero at 2.4 in. (61 mm). The force level climbed and spiked again at 3.4 in. (86 mm) with a magnitude of 24.8 kips (110.3 kN). From 3.1 in. (79 mm) to 6.1 in. (155 mm), the post's average resistive force was approximately 19 kips (84.5 kN). Subsequently, the force level began to significantly drop off when the impact head began to slide down the horizontal impact tube, thus causing the assembly to twist. At a maximum deflection of 16.6 in. (422 mm), the post assembly had absorbed 192.9 kip-in. (21.7 kJ) of energy. For comparison purposes, the energy dissipated at 5 in. (127 mm), 10 in. (254 mm), and 15 in. (381 mm) was 72.4 kip-in. (8.2 kJ), 139.2 kip-in. (15.7 kJ), and 175.0 kip-in (19.8 kJ), respectively.

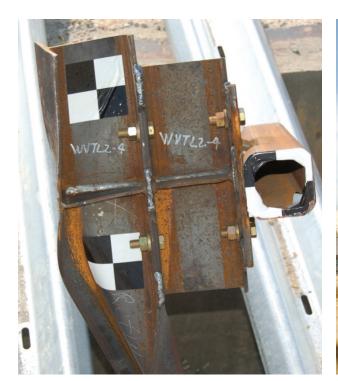
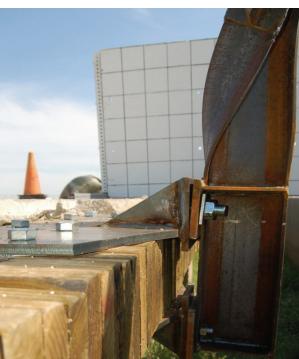
Figure 30. Post Assembly Damage, Test No. WVTL2-4

Damage to the post assembly included plastic bending and twisting, as shown in Figure 30. The post was twisted nearly 90 degrees between the deck connection and the impact height. Flange and web buckling were evident throughout this region of the post. A small gap had opened between the post plate and the top end plate, but there did not appear to be any damage to the deck plates. The post blockout did not appear to be damaged or deformed. Also, the timber deck did not sustain any visual damage, as shown in Figure 31.

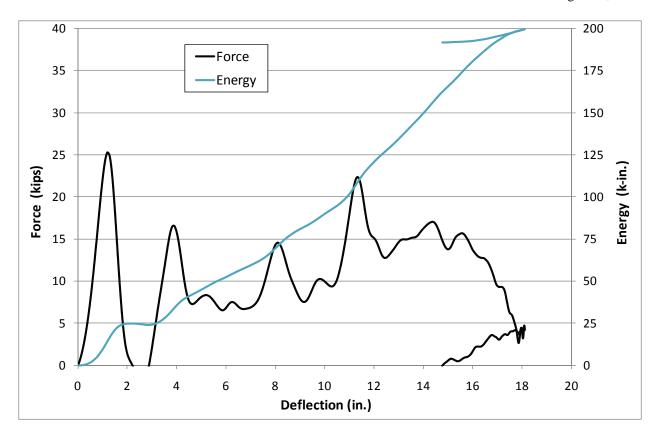
Figure 32. Force vs. Deflection and Energy vs. Deflection, Test No. WVTL2-4

Force versus deflection and energy versus deflection curves are shown in Figure 32. At the beginning of the impact event, a large peak load of 25.3 kips (112.5 kN) was recorded at 1.2 in. (31 mm), likely resulting from the inertial effects. The inertial spike dropped to zero at 2.3 in. (58 mm). Subsequently, the force climbed and spiked again at 3.9 in. (99 mm) with a magnitude of 16.5 kips (73.4 kN). From 3.4 in. (86 mm) to 8.7 in. (221 mm), the post's average resistive force was approximately 10 kips (44.5 kN). Later, the resistive force increased and spiked at 11.3 in. (287 mm) with a magnitude of 22.3 kips (99.2 kN). From 10.9 in. (277 mm) to 15.8 in. (401 mm), the post's average resistive force was in excess of 15 kips (66.7 kN). The post resistance then decreased until the bogic vehicle reached its maximum deflection of 18.1 in. (460 mm). The post absorbed 199.6 kip-in. (22.6 kJ) of energy at the maximum deflection of 18.1 in. (460 mm). For comparison purposes, the energy dissipated at 5 in. (127 mm), 10 in. (254 mm), and 15 in. (381 mm) was 45.1 kip-in. (5.1 kJ), 89.8 kip-in (10.1 kJ), and 165.5 kip-in. (18.7 kJ), respectively. It should be noted that the displacements noted above pertain to the longitudinal movement of the rigid bogic vehicle.

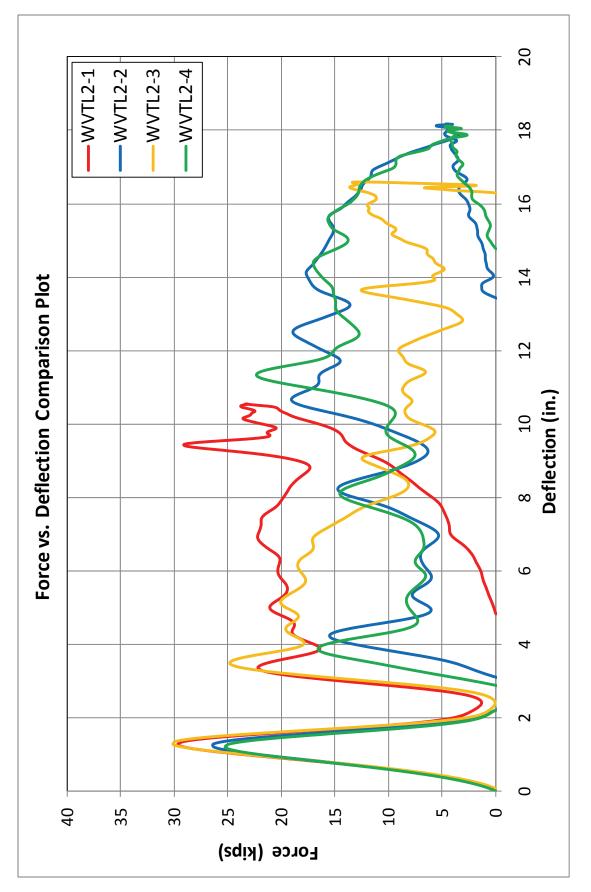
Figure 33. Force vs. Deflection - Test Nos. WVTL2-1 through WVTL2-4

For all four bogie tests, inertial effects were observed in the beginning of the impact events. As illustrated in Figure 33, the recorded data from each test showed a large force spike approximately over the first 2 in. (51 mm) of deflection. For the centerline impact events, the peak force of the inertial spoke ranged between 29.7 and 30.1 kips (132.1 and 133.9 kN). For the eccentric impact events, the peak force of the inertial spike ranged between 25.3 and 26.3 kips (112.5 and 117.0 kN). The displacements corresponding to the peak load values and to the zero, or nearly non-zero, force values after the peak load were nearly identical for the four bogie tests.
