Attachment A, TABLE II.2

BACKGROUND CRASH TEST INFORMATION FOR CATEGORY 2 DEVICES (Continued)

3.4 FIXED SIGN SUPPORT (Test No. 453360-3)

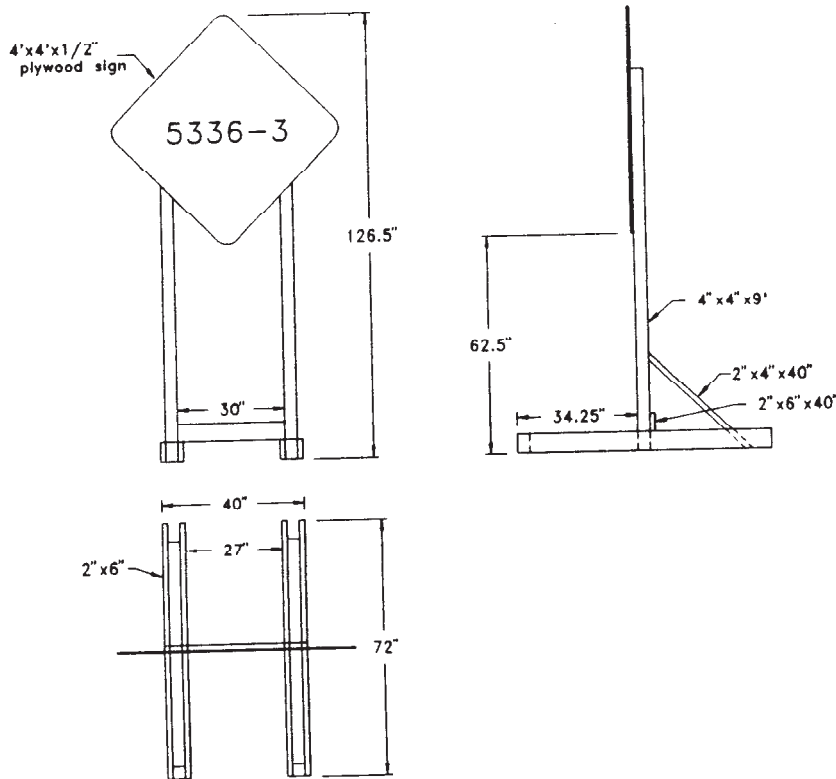
Figure 37. Schematic of Skid-Mounted Sign Support with Wooden Sign Panel (Test No. 453360-3)

A schematic of the skid-mounted sign support with a 1219 mm x 1219 mm (48 in x 48 in) wooden sign panel mounted at a height of 1.52 m (5 ft) is shown in Figure 37. The test vehicle was a 1984 Chevrolet pickup truck, as shown in Figure 38. Dimensions and information on the vehicle are given in Appendix Figure 95. The test vehicle impacted the skid mounted sign support head-on with the centerline of the vehicle aligned with the centerline of the sign support, traveling at a speed of 98.0 km/h (60.9 mi/h).
