1. Report No. TX-96/5388-1F		2. Government Accession No.		3. Recipient's Catalog No.	
4. Title and Subtitle EVALUATION OF WORK ZONE BARRICADES AND TEMPORARY SIGN SUPPORTS				5. Report Date February 1996

EVALUATION OF WORK ZONE BARRICADES AND TEMPORARY SIGN SUPPORTS

Report No. 5388-1F
Research Study No. 585xxA3014
Research Study Title: Development of New Designs for Barricades
and Sign Supports in Work Zones

February 1996

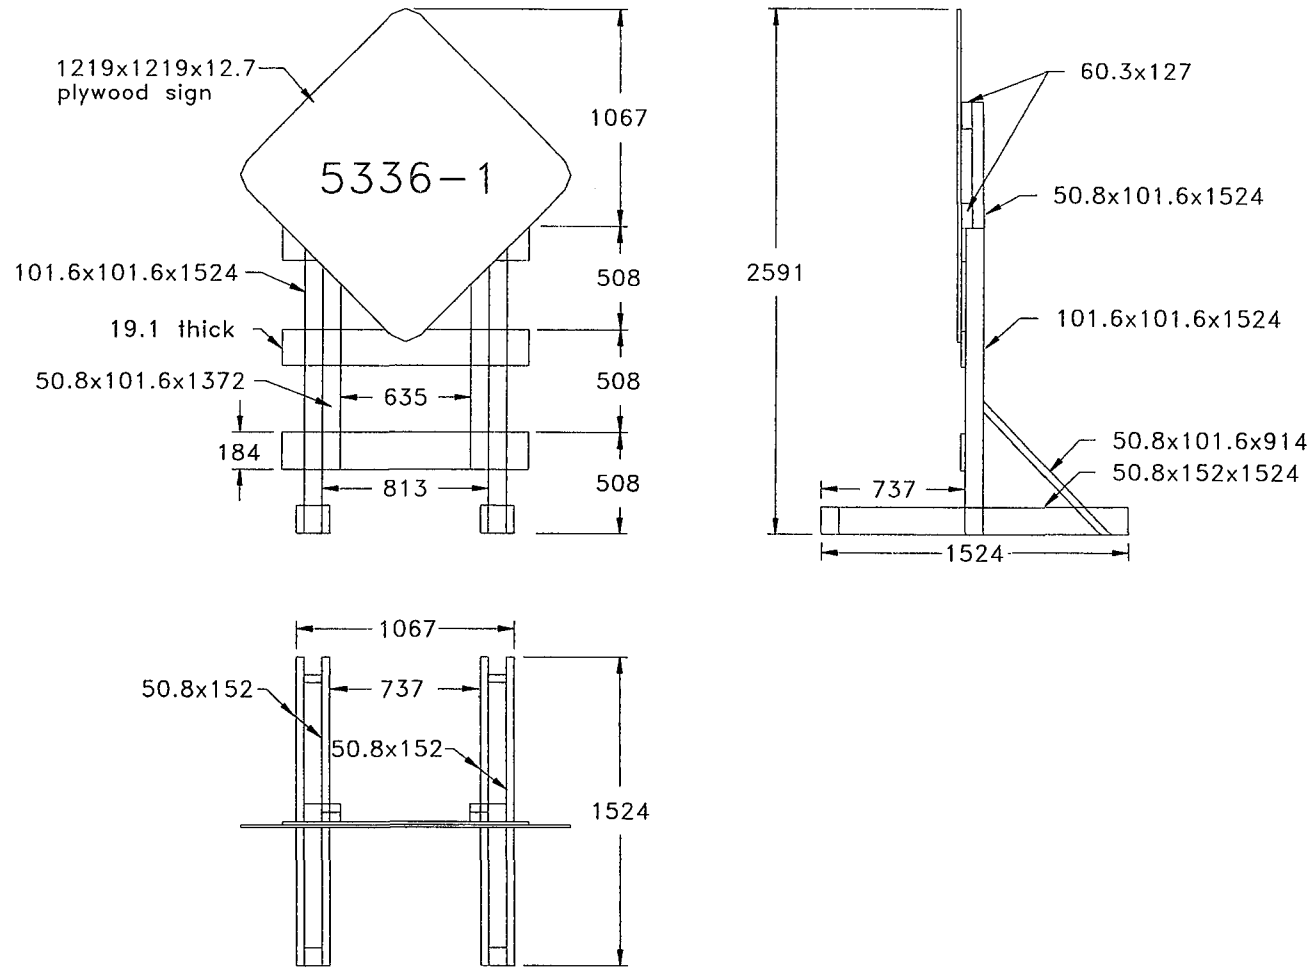
Figure 1. Schematic of Type III Wooden Barricade with Wooden Sign Panel (Test No. 453360-1)

In the first test with the Type III wooden barricade (test no. 453360-1), a 1219 mm x 1219 mm wooden sign panel was attached to the barricade at a mounting height of 914 mm from the ground to the bottom of the sign panel. The sign panel impacted the roof of the vehicle, and the fractured vertical supports impacted and penetrated the windshield. Therefore, the performance of the barricade with sign attachment was judged to be unsatisfactory. The test was then repeated without the sign attachment (test no. 453360-4). Again, the fractured vertical

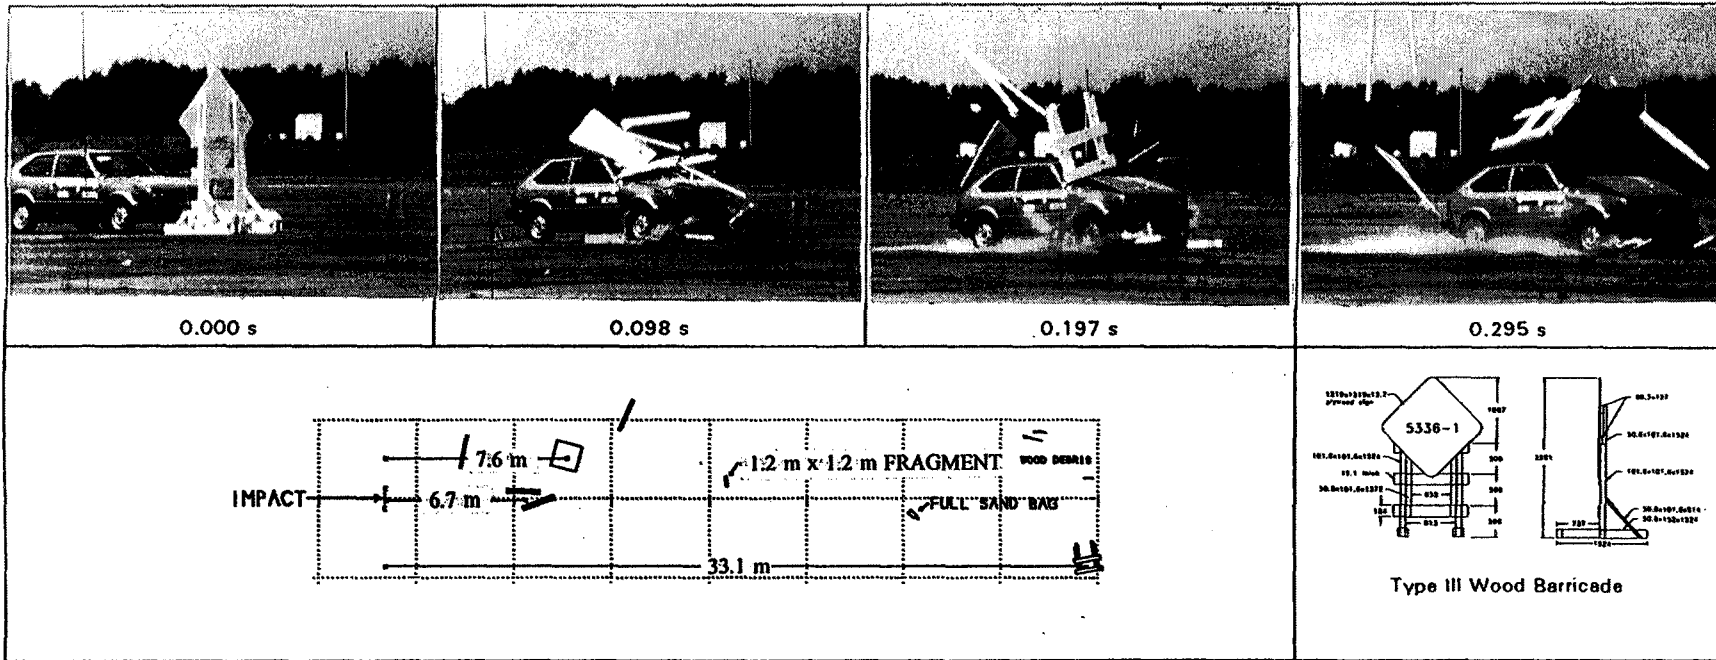
Figure 4. Summary of Results for Test No. 453360-1

Figure 4 presents a brief summary of the results of this test. The barricade shattered upon impact. The vertical supports broke from the bases and impacted and penetrated the windshield, resulting in broken glass entering the occupant compartment. The sign panel was detached from the barricade and impacted the roof of the vehicle. Debris from the barricade was thrown along an area 11 m wide by 37 m long. Some fragments were fairly large, which could pose potential hazard to oncoming traffic in adjacent lanes and to workers in the area. Sand was also scattered on the pavement, which could lead to loss of control of other vehicles. The vehicle sustained damage to the front bumper, hood, windshield and roof. There was no occupant contact during the test period. The maximum 50-msec average accelerations were -5.9 g in the longitudinal direction and 1.1 g in the lateral direction. The vehicle exited the immediate test site in a relatively smooth, stable manner and showed no potential for intrusion into adjacent traffic lanes.

In summary, the performance of the barricade was judged to be unsatisfactory due to penetration of the windshield and the occupant compartment by the fractured vertical supports of the barricade.

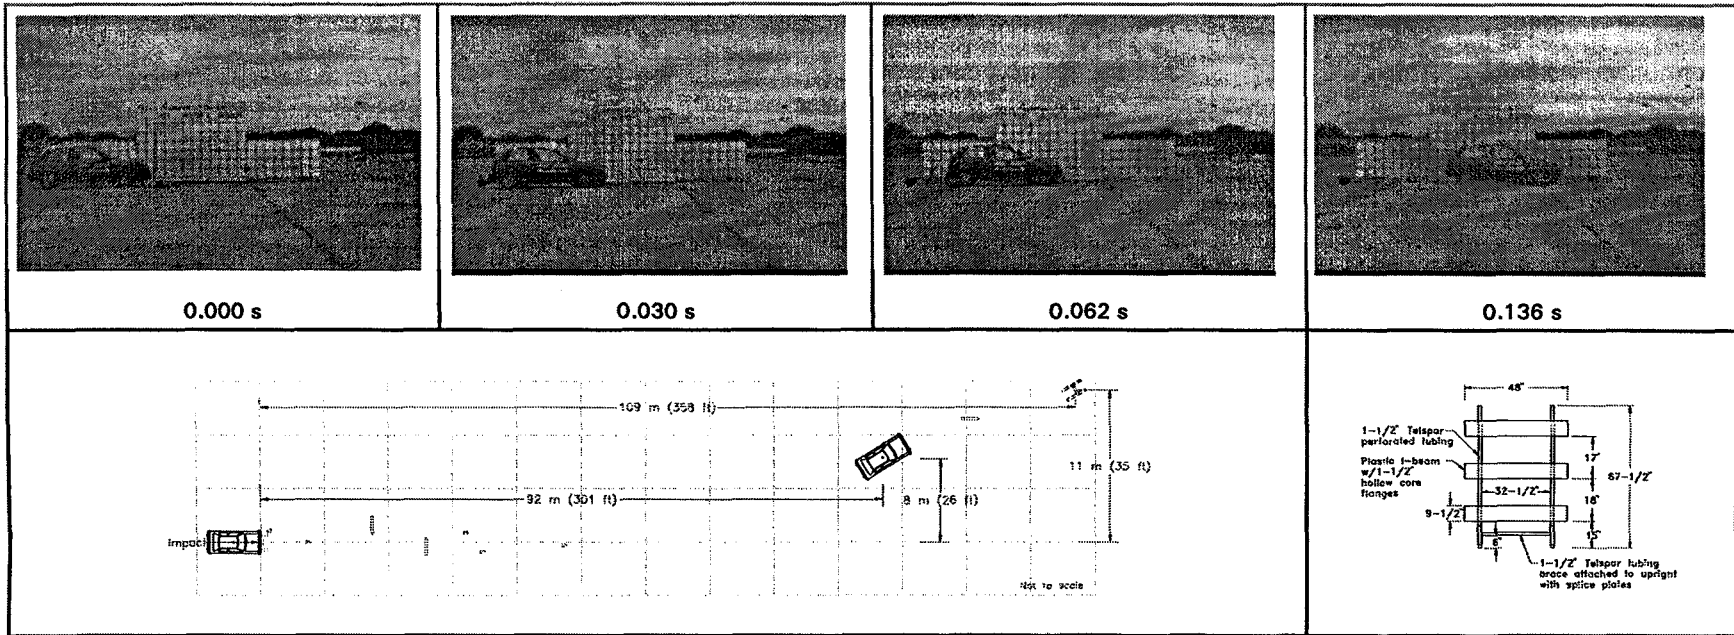
Figure 48. Summary of Results for Test No. 453790-3

Upon impact, the middle and top rail elements separated from the vertical supports while the vertical support uprights deformed and wrapped around the front of the vehicle. At 7 msec, the middle rail element contacted the hood of the vehicle. The vehicle lost contact with the left vertical support at 37 msec. The top rail element contacted the windshield at 47 msec, and the middle rail element contacted the windshield at 49 msec. However, the windshield remained intact. The vehicle lost contact with the right vertical support, which then rode underneath the vehicle, and the lower rail element rode along on the bumper. At 142 msec, the vehicle cleared

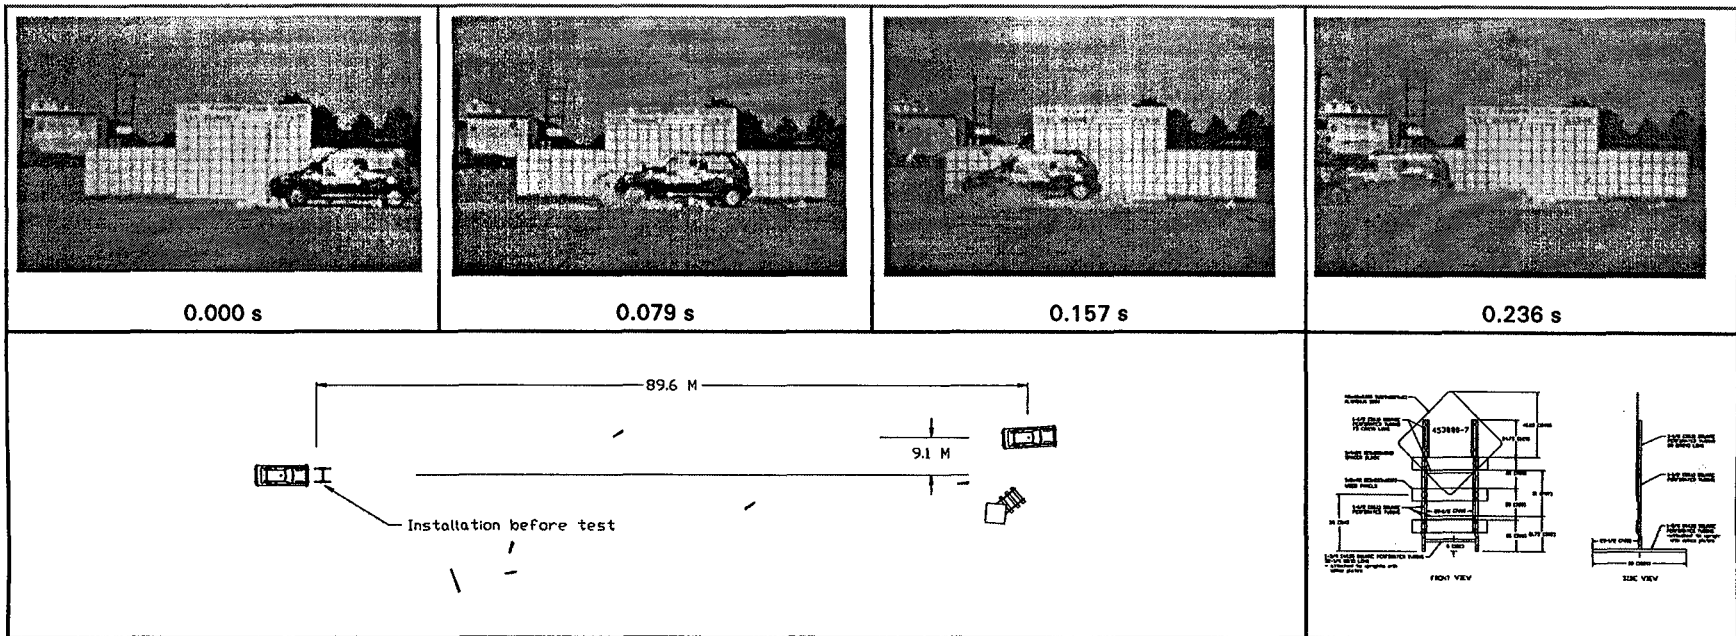
Figure 83. Summary of Results for Test No. 453880-7

The crash test with the second sign attachment alternative (test no. 453880-7) was successful. However, the fractured vertical supports, the rail elements and the sign panel stayed as a single unit and was thrown forward by the impacting vehicle, raising concern that this may pose a hazard to adjacent traffic and workers in the area. After consultation with TxDOT, it was decided that this sign attachment mechanism is not desirable and should not be considered for implementation.

As the vehicle impacted the barricade, the base began to separate from the vertical supports, and at 34 msec, the vertical supports slapped the hood. At 49 msec, the vertical supports began to pitch up, and at 89 msec, the sign panel contacted the windshield. The braces separated from the supports at 101 msec. At 126 msec, the sign panel contacted the roof, and the vertical supports for the sign panel separated from those for the barricade. The braces
