Design Problem No. 1

Dean L. Sicking, Ph.D., P.E.
2004 Roadside Safety Workshop
June 23-24, 2004

Treatment of Ponds Near Edge of Clear Zone

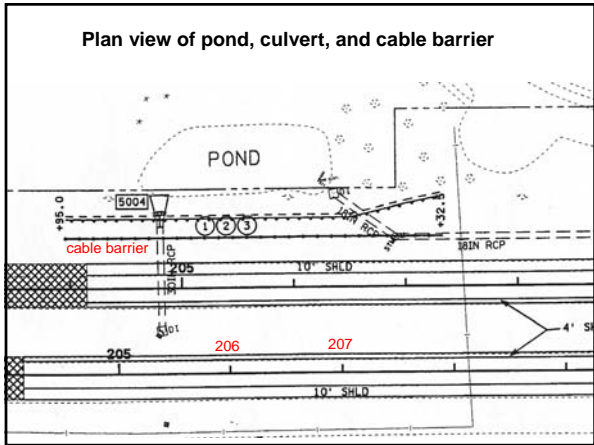
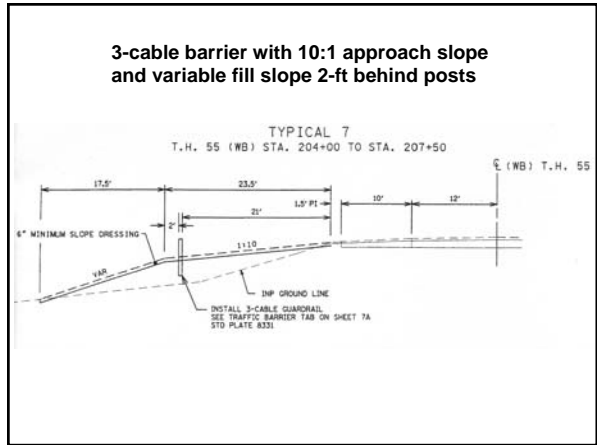
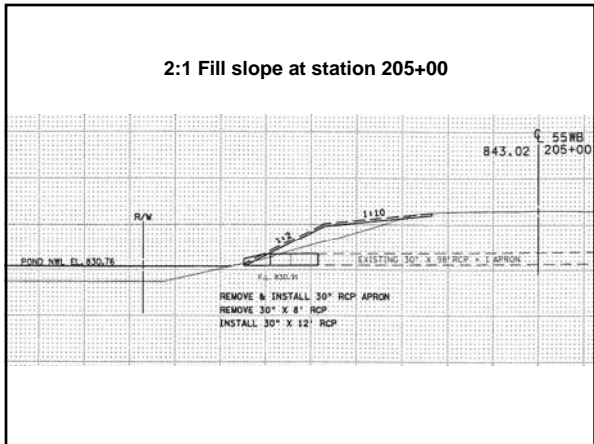
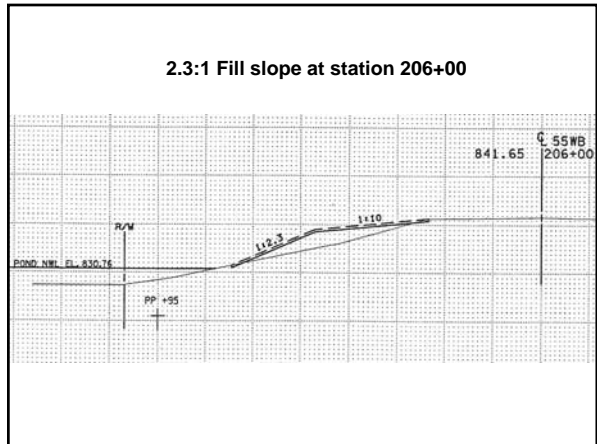
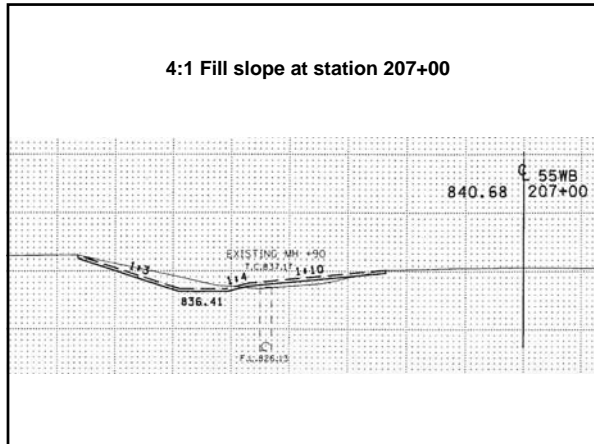
- Facts
 - 6-ft deep pond near and/or within clear zone
 - culvert at upstream end of pond
 - three cable barrier used to protect entire obstacle, including portions outside of clear zone
 - 10:1 approach slope to cable barrier
 - slope, varying from 2:1 to 5:1, begins 2-ft behind cable barrier posts
 - no accident history

- **Comments**
 - three cable barrier incapable of redirecting 2000P vehicle impacting at TL-3 condition of NCHRP 350 when installed adjacent to 1.5:1 slope
 - TL-3 approved, strong-post, W-beam design variations exist when placed near or directly on 2:1 fill slope

- **Conclusions**
 - could conduct benefit-cost analysis to determine whether entire hazard required protection
 - extending protection to include entire hazard is reasonable and appropriate due to small increase in guardrail length
 - if MnDOT treats hazards entirely outside of clear zone, agency wide policy should be adopted
 - potential tort risk associated with inconsistent application of clear zone principles

- Cable guardrail may function in this application, but research not yet complete
- Simulation study indicates cable barrier should provide acceptable performance when placed 3' in front of slope break point and post spacing reduced to 4'
- W-beam guardrail with 7' posts on 3'-1.5" centers placed at the slope break point is an NCHRP Report 350 approved alternative
