# **DEVELOPMENT OF THE MIDWEST GUARDRAIL SYSTEM (MGS) W-BEAM TO THREE BEAM TRANSITION ELEMENT**

## **MIDWEST ROADSIDE SAFETY FACILITY**

MwRSF Research Report No. TRP-03-167-07

November 26, 2007

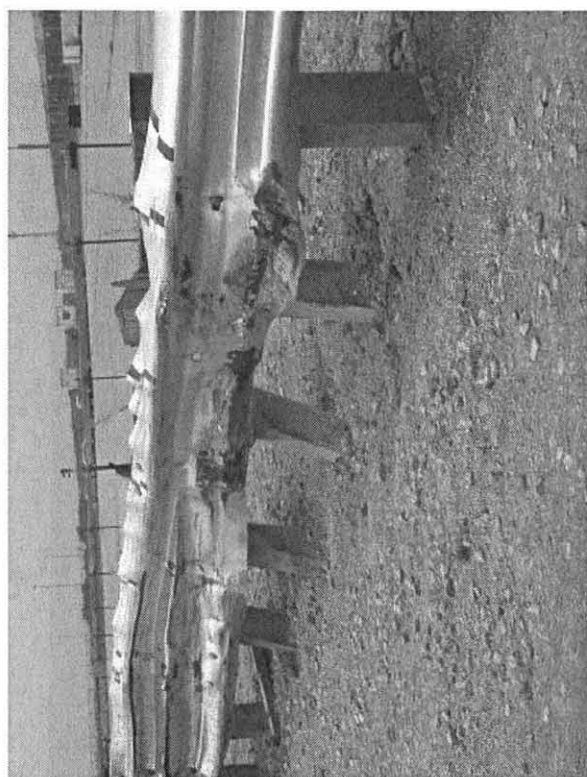
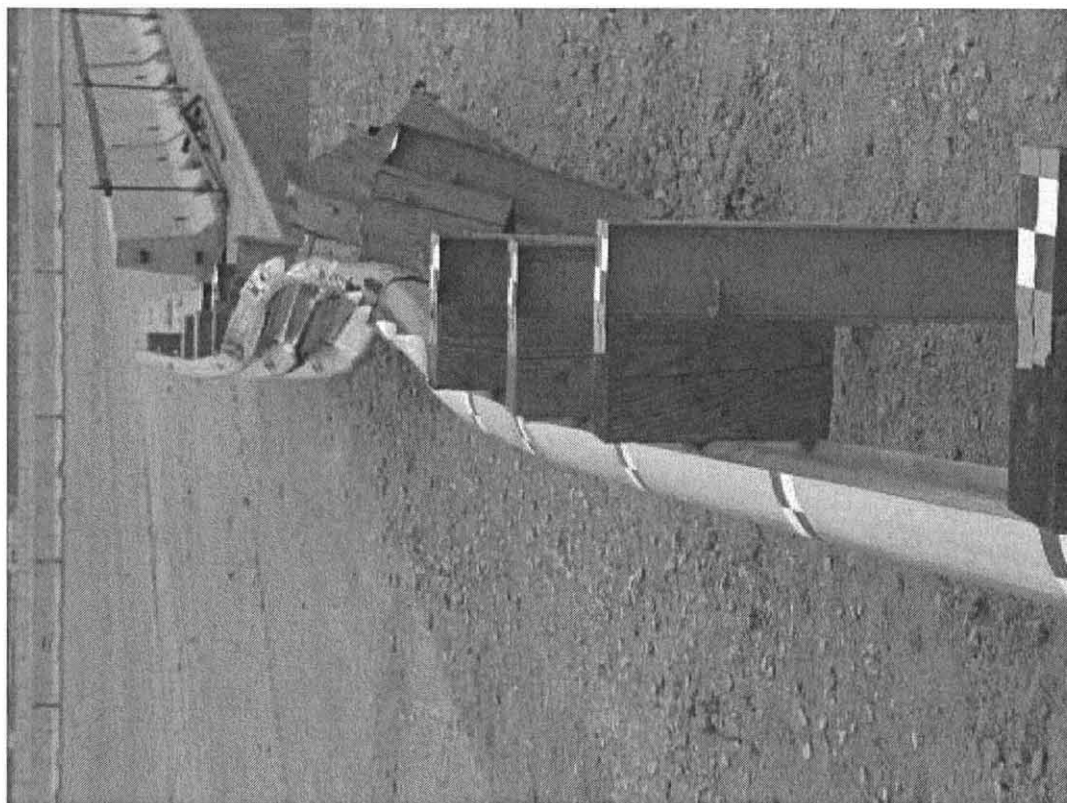
Figure 39. System Damage, Test MWT-3

Damage to the barrier was moderate, as shown in Figures 39 through 45. Barrier damage consisted of deformed guardrail and posts, contact marks on a guardrail section, and fractured wooden spacer blockouts. The length of vehicle contact along the approach guardrail system was approximately 5.7 m (18.75 ft), which spanned from 203 mm (8 in.) upstream from the centerline of post no. 9 through 203 mm (8 in.) upstream from the centerline of post no. 15.

Buckling in the upper and lower portions of the rail was found 102 mm (4 in.) upstream of post no. 8. Two buckle points were evident on the top portion of the rail at the leading edges of the blockouts at post nos. 16 and 17. Between post nos. 9 and 12, the bottom portion of the W-beam was

The permanent set of the barrier system is shown in Figure 39. The maximum lateral permanent set rail and post deflections were 389 mm (15.3 in.) at the centerline of post no. 12 and 556 mm (21.9 in.) at the centerline of post no. 11, respectively, as measured in the field. The maximum lateral dynamic rail and post deflections were 620 mm (24.4 in.) at the centerline of post no. 12 and 649 mm (25.5 in.) at the centerline of post no. 11, respectively, as determined from the high-speed film analysis. The working width of the system was found to be 785 mm (30.9 in.).

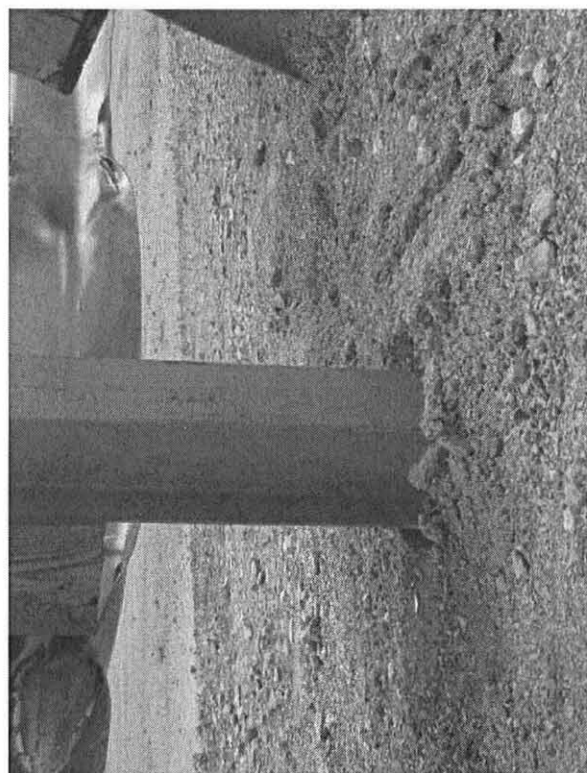
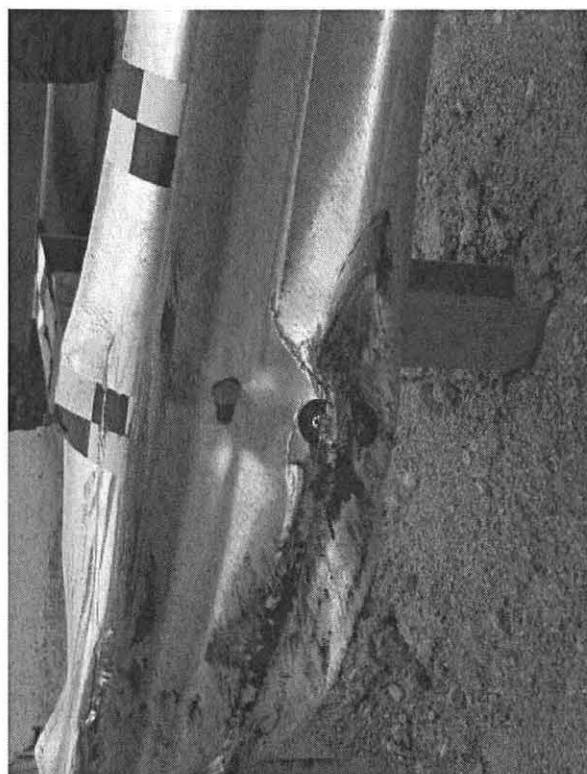
Figure 41. Anchorage Damage, Test MWT-3

Post nos. 1 and 2 deflected downstream slightly causing soil cracks to radiate from both soil foundation tubes. The soil became amassed on the upstream side of post no. 1. Soil gaps were visible on the upstream and downstream sides of post nos. 1 and 2. Post nos. 3 through 7 twisted approximately 25 mm (1 in.) at the back of the rail and were rotated downstream. Minor soil gaps occurred around post nos. 3 through 7. Post no. 8 remained undamaged with no major twisting nor deflection. Soil gaps of 3 mm (0.125 in) and 6 mm (0.25 in.) were evident on the traffic and back sides of post no. 8, respectively. Post no. 9 encountered 19 mm ( $\frac{3}{4}$  in.) of twist. Soil gaps of 25.4 mm (1 in.) were found on both the traffic and back sides of post no. 9. Post no. 10 encountered severe deflections backward and downstream. Post no. 10 also twisted approximately 30 degrees counter-clockwise. A tire mark was visible on post no. 10 beginning on the upstream corner 102 mm (4 in.)

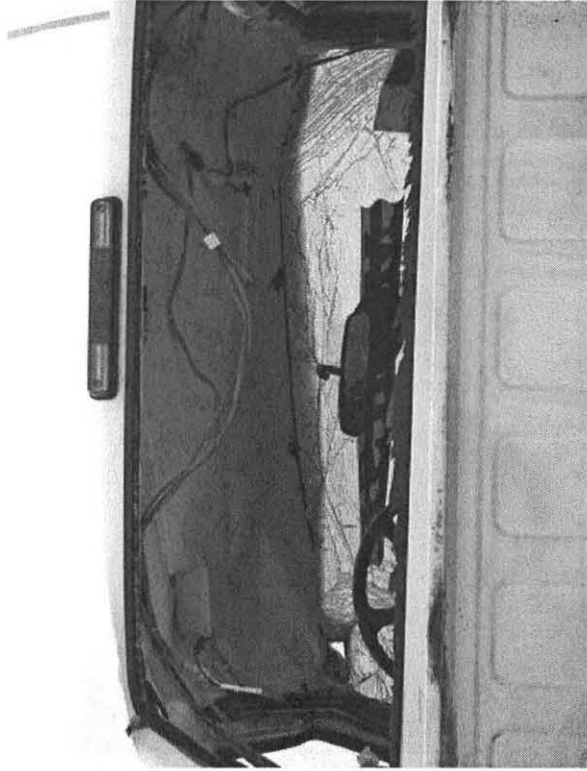
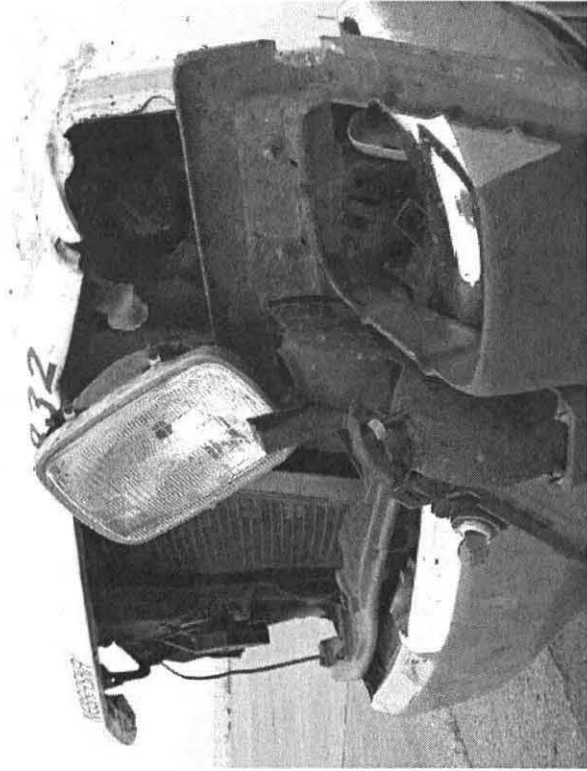
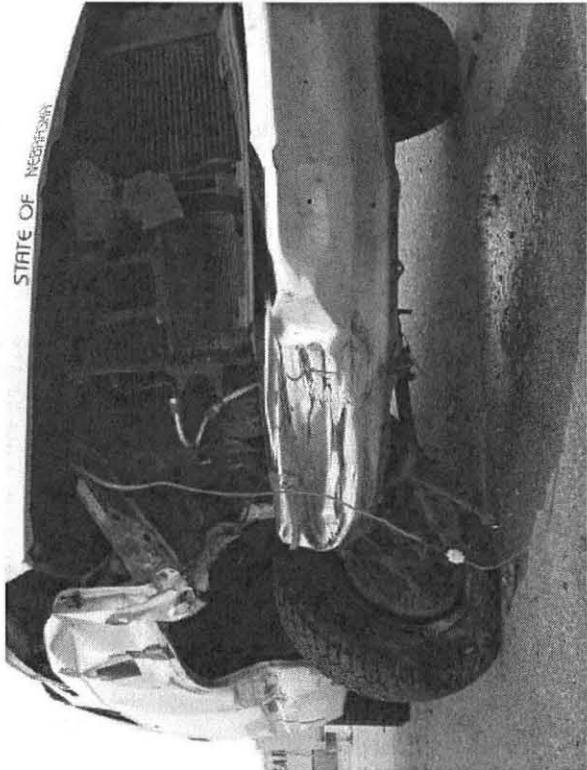
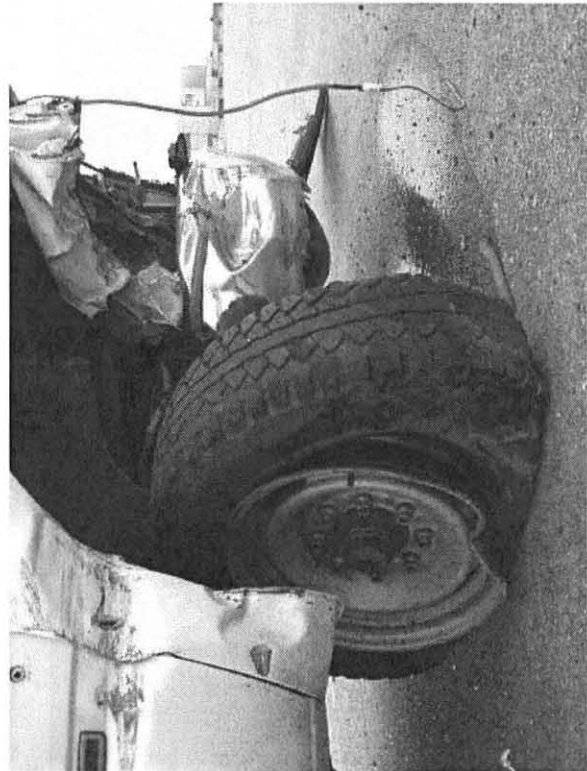
Figure 46. Vehicle Damage, Test MWT-3

Exterior and interior damage to the vehicle was extensive, as shown in Figures 46 through 49. Occupant compartment deformations to the roof were severe due to vehicle rollover. However, the floorboard and firewall deformations were minimal. Complete occupant compartment deformations and the corresponding locations are provided in Appendix C.

Most of the damage was concentrated on the front, both the left and right sides, and the roof of the vehicle due to rollover, as shown in Figure 46. The right-front corner of the vehicle was

crushed inward toward the engine with the bumper buckling near its center. The roof of the vehicle was crushed downwards due to vehicle roll. The right-front tire was deflated and removed from the steel rim, and the inside of the steel rim encountered deformations. The right-front outer tie rod was disengaged, while the ball joints, stabilizer bar, and shock mount remained intact. The right-side A-frame was deformed. The right-rear fender behind the tire, the right-side end of the rear bumper, and the tail pipe encountered significant damage.

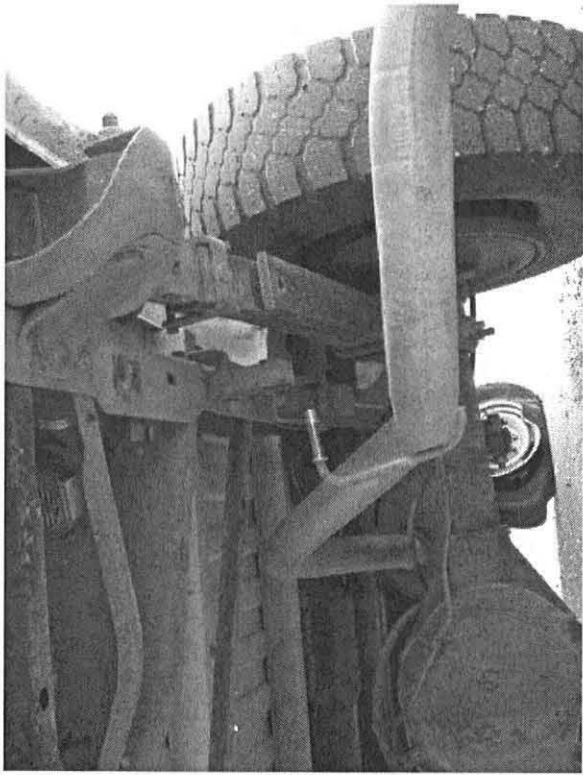
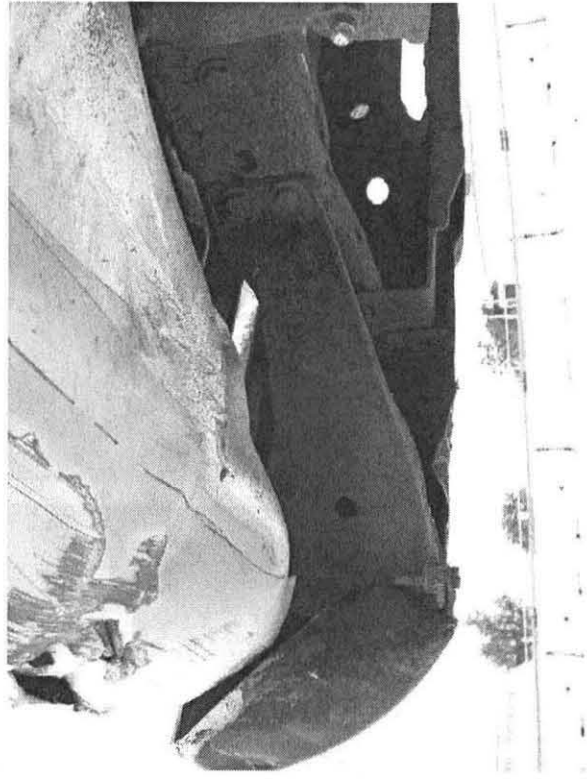
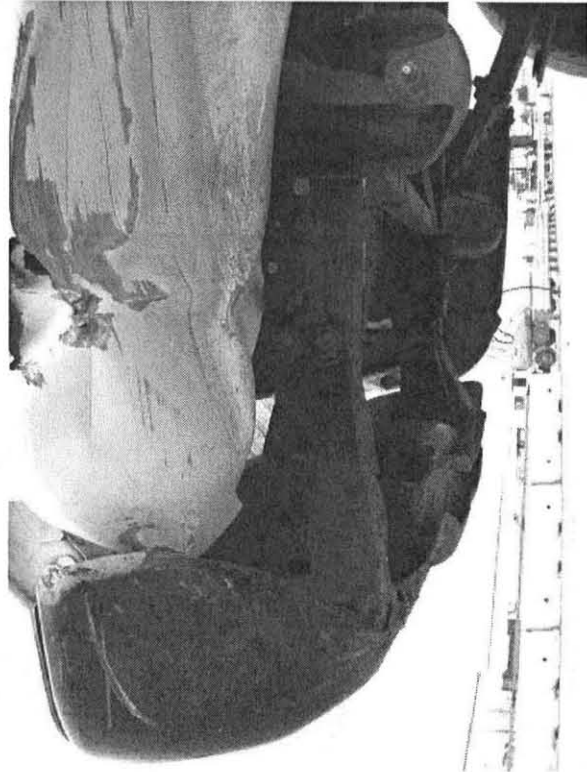
Figure 47. Vehicle Damage, Test MWT-3

The damage to the frame was minimal and focused mainly around the bumper bracket and frame horns. Deformations to the vehicle's body were evident on the right side in the shape of the guardrail. Left-side damage was limited to light scraping and box deformations due to rollover. The windshield was shattered but remained intact due to the safety layer, as shown in Figure 48. All other window glass shattered and was removed from the system.

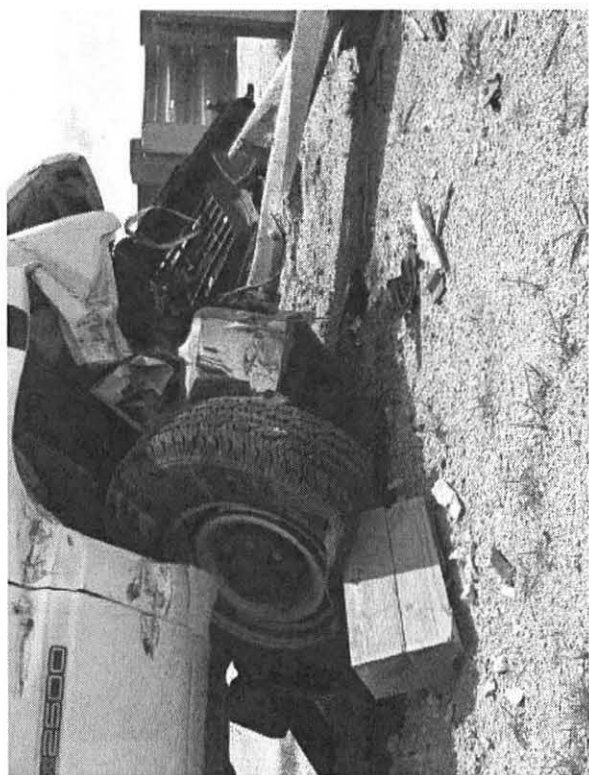
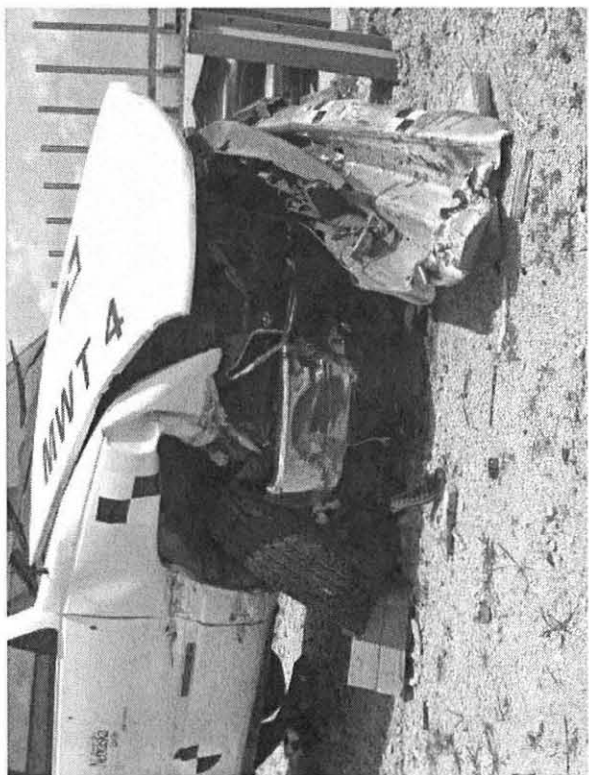
Figure 77. Vehicle Damage, Test MWT-4

Damage was concentrated on the front third of the vehicle. The front of the vehicle through the front quarter panels buckled inward. The right-front and left-front quarter panels and right-side door encountered significant contact and scratch marks along with buckling and numerous dents. The right-side frame rail buckled near the cab portion. The hood deformed downward and inward under itself. The front bumper encountered significant tears, dents, and buckling. The front grill was fractured and removed from the vehicle. The radiator encountered contact marks and was punctured. Contact marks were visible on the right side of the rear bumper. The right-front and left-front wheel wells sustained contact and scratch marks, and the right-front wheel well also encountered significant dents. Both of the front wheel assemblies were severely deformed and damaged.

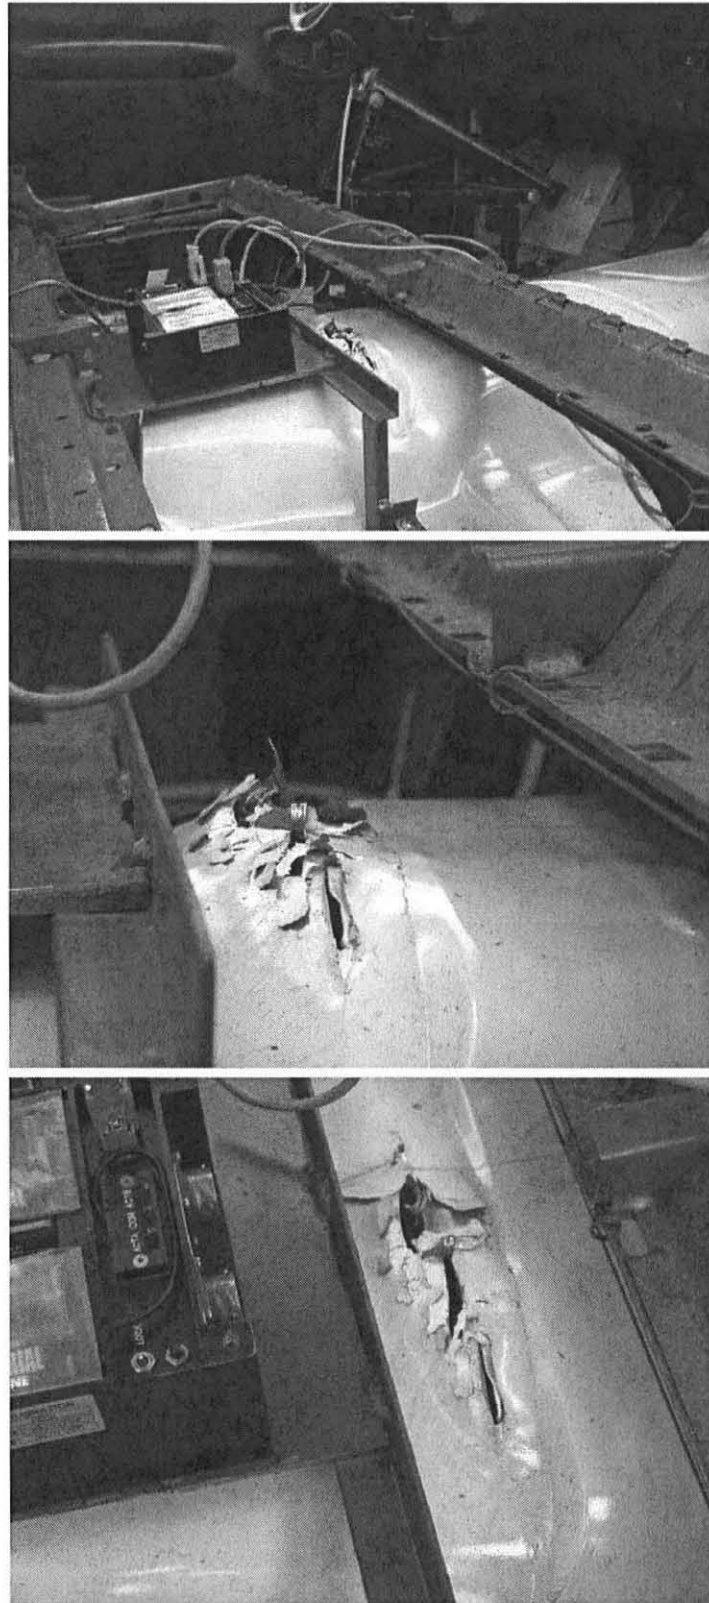
Figure 80. Occupant Compartment Damage, Test MWT-4

Exterior vehicle damage was moderate, as shown in Figures 77 and 80. Extensive occupant compartment deformations occurred with the penetration of the center of the floorboard, as shown in Figure 80. The drive shaft U-joint penetrated through and caused a 178-mm (7-in.) slice in the floorboard. A 64-mm (2.5-in.) dent was also found in the floorboard. Complete occupant compartment deformations and the corresponding locations are provided in Appendix C.
