PHASE III DEVELOPMENT OF A BULLNOSE GUARDRAIL SYSTEM FOR MEDIAN APPLICATIONS

MIDWEST ROADSIDE SAFETY FACILITY

MwRSF Research Report No. TRP-03-95-00

June 1, 2000

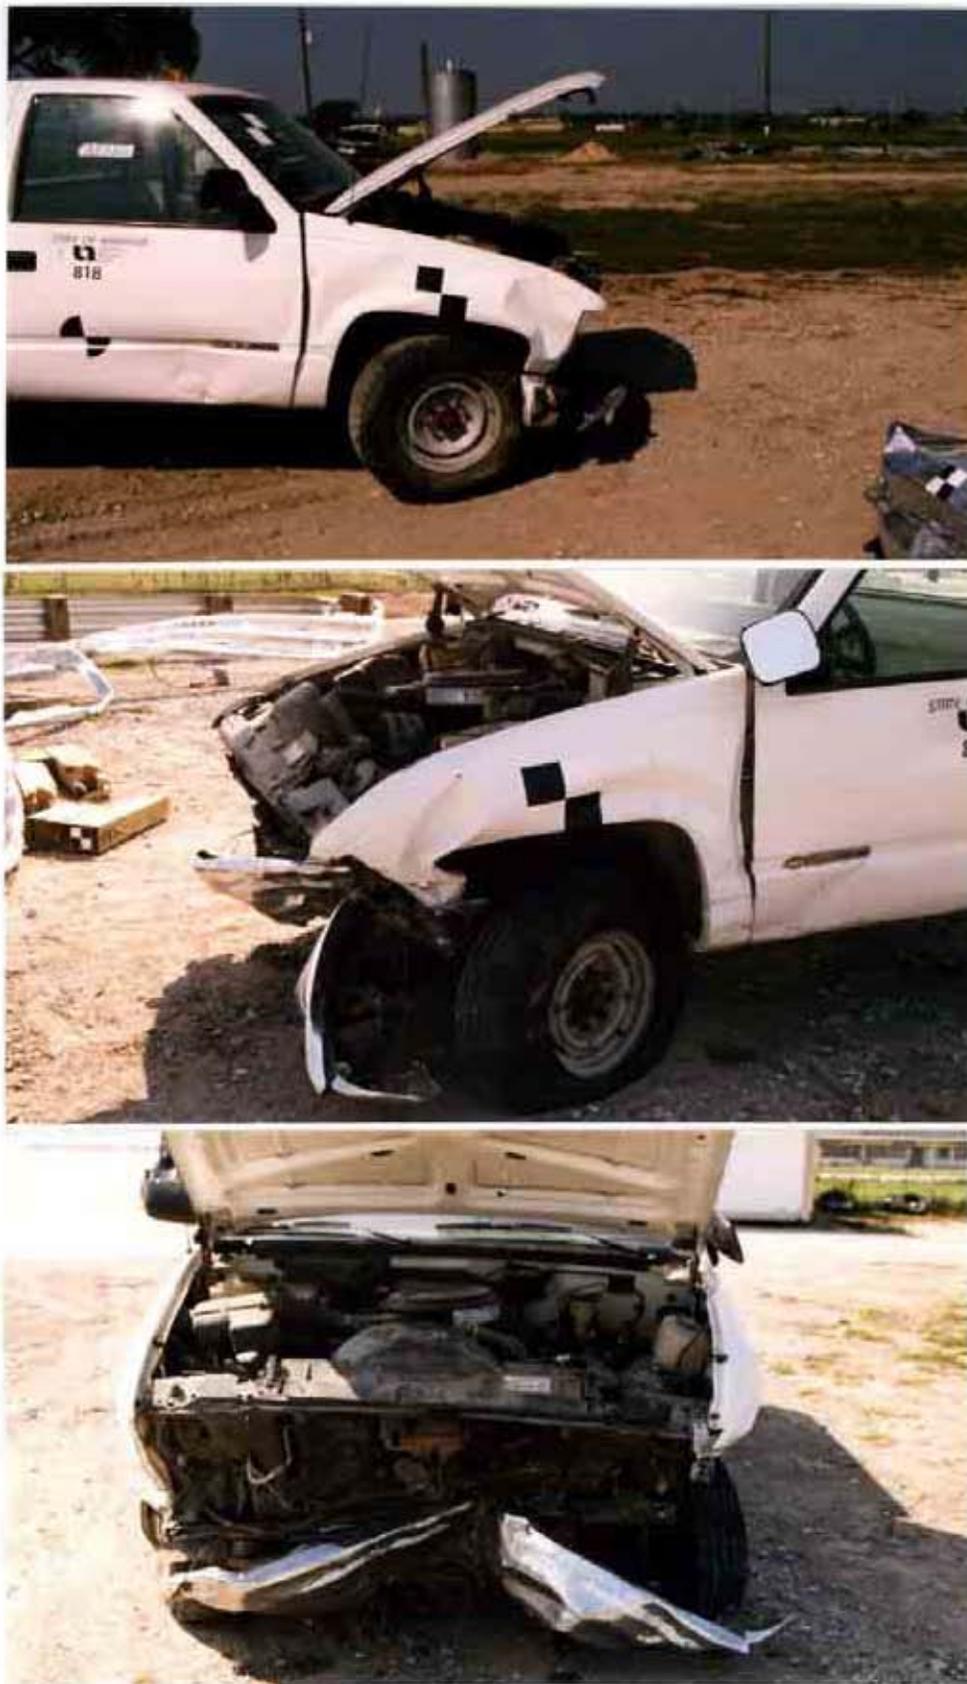
Figure 33. Vehicle Damage, Test MBN-5

Vehicle damage was moderate, as shown in Figure 33. The front bumper and the front of the pickup truck were crushed inward across the entire front width of the vehicle. The bumper crushed inward at the center and was folded around the supports at the end of the frame rails. The radiator of the truck was flattened. There was very little engine movement which occurred during the impact. The left-front fender of the pickup truck was bent down and forward. The lower section of the left door was dented and scratched and was slightly ajar. The left-front tire was cut and deflated. There was no significant rim damage. The front tire on the right side was not damaged and remained inflated. The right-front fender was crushed down and forward due to the barrier impact. A small amount of buckling and gouging occurred at the lower rear of the fender and the lower front of the right-side door. A quarter sized hole and scrape were made on the right side of the pickup truck box slightly in front of and above the wheel well. There was no crushing of the pickup truck's interior

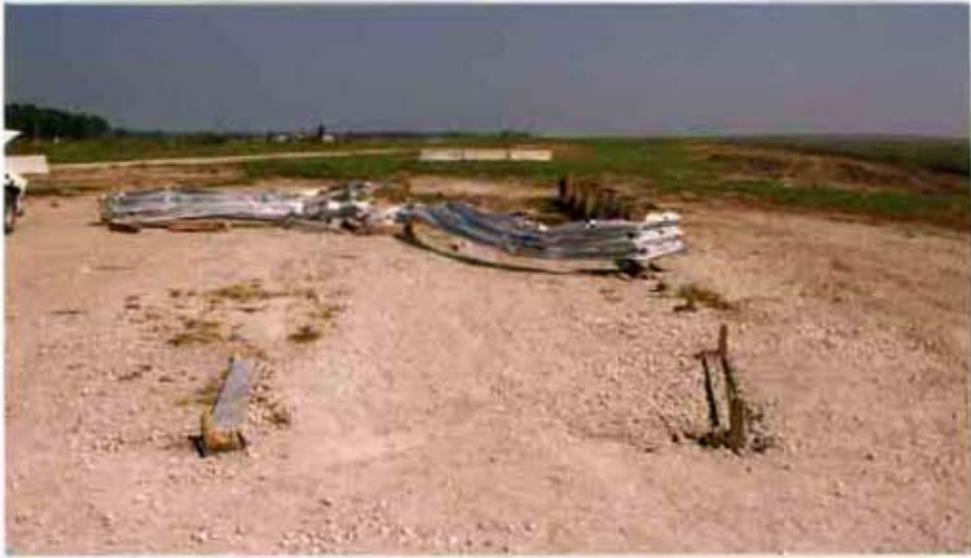
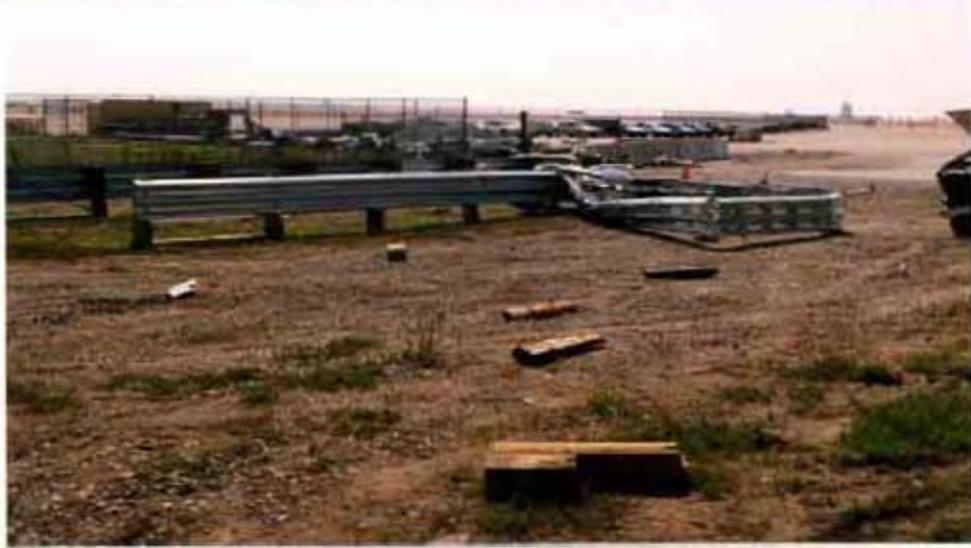
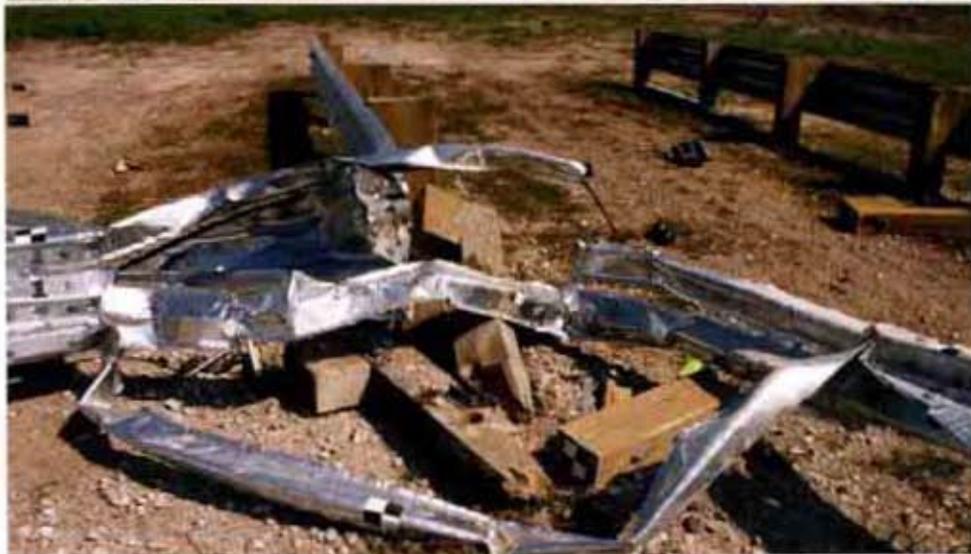
Figure 34. Barrier Damage, Test MBN-5

Barrier damage was extensive, as shown in Figures 34 through 36. Most of the post damage occurred on the left side of the system. A total of ten posts in the system were fractured. Six of the BCT posts fractured at the hole near the base of the post. Post nos. 1 through 3 on both sides of the barrier were broken in this manner. On the left side of the barrier, CRT post no. 4 was broken at the top hole while post no. 5 was broken at the bottom hole. Posts nos. 6 and 7 on the left side were also broken at ground level.

The damage to the three beam guardrail in the system consisted of buckling and tearing of the guardrail. Major buckles in the rail were formed around post nos. 4 and 7 on the left side of the barrier. Minor tearing of the rail occurred around post nos. 1 and 2 on both sides of the barrier. Additional tearing was observed 508-mm upstream of post no. 2 on the left side of the system. Major tearing was also observed in the nose section of the system. The top hump of the rail was ripped through the entire hump in the nose section beginning 330-mm right of the centerline of the nose, while the bottom hump of the rail in the nose was completely disengaged from the main piece of guardrail. No damage of the cables or the cable plates was found. The maximum longitudinal permanent set deflection of the rail was 11.3-m downstream of the nose of the barrier.

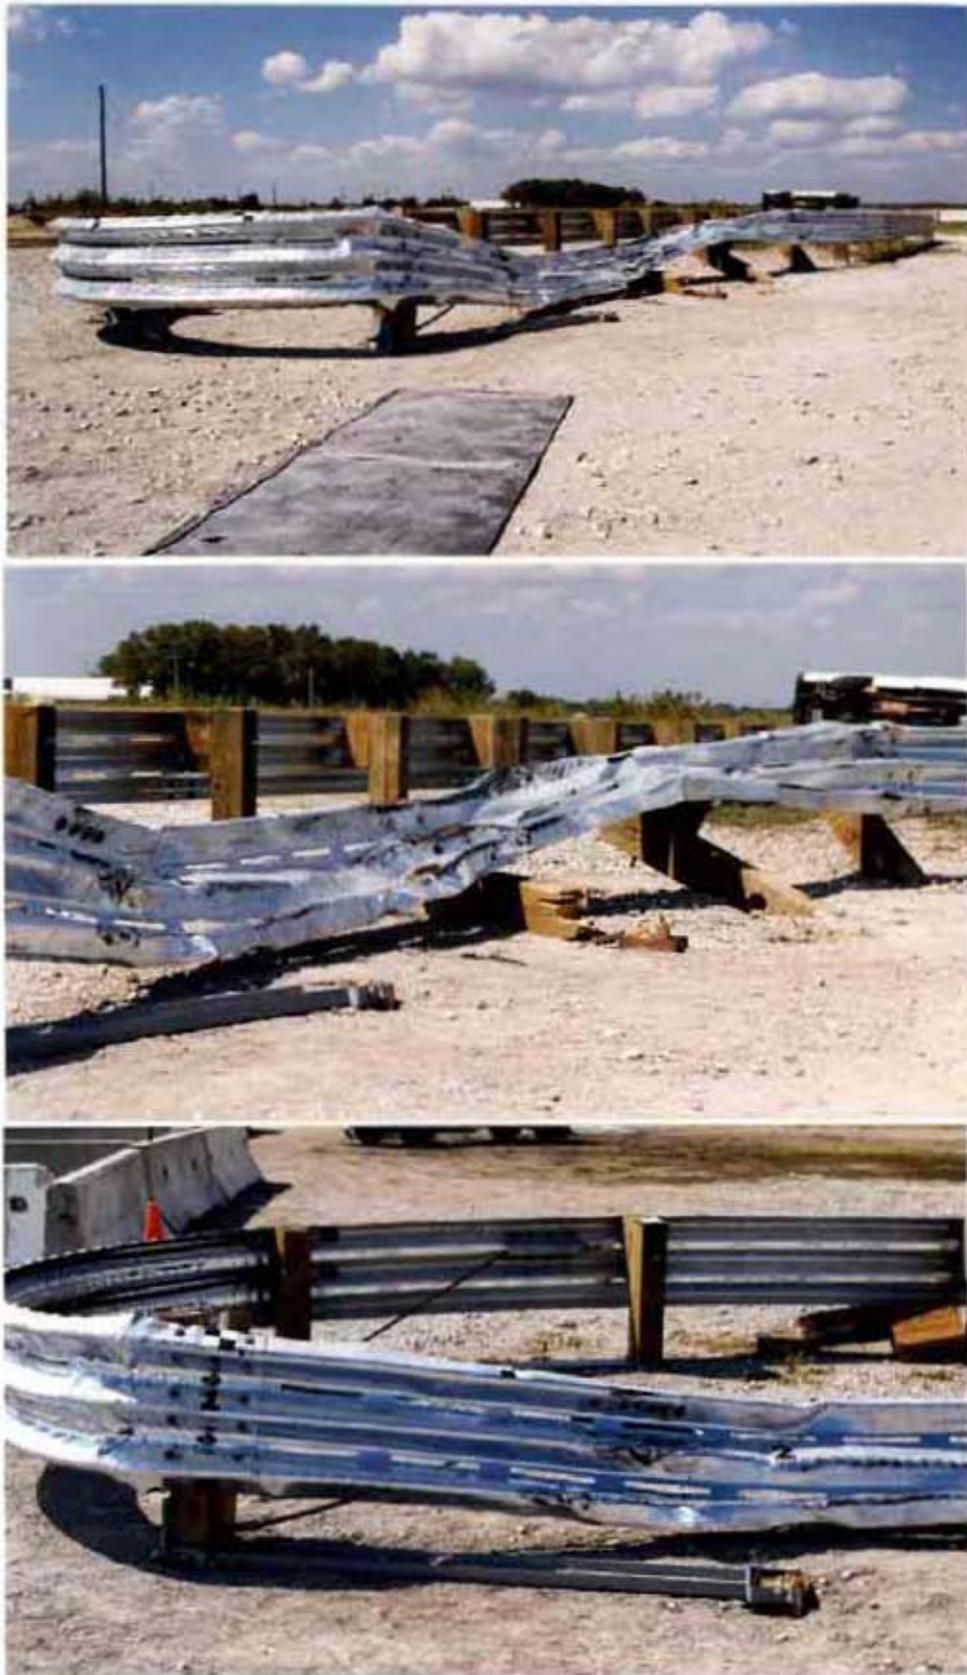
Figure 45. Barrier Damage, Test MBN-6

The failure of test MBN-6 to meet all of the safety performance criteria was directly attributed to the vaulting of the pickup truck. The pickup truck rode up the guardrail between post nos. 2 through 4 on the right side of the system. Two factors were believed to have attributed to the vehicle climbing and vaulting over the system. The first contributing factor which led to the failure of the system was a lack of sufficient guardrail tension developed upstream of the impact point. A second factor was that little lateral resistance was provided by the posts as post nos. 3 and 4 fractured on the right side. As these posts rotated and fractured, they remained bolted to the guardrail and pulled it down towards the ground.¹ The lack of tension and lateral resistance allowed the pickup truck to penetrate into the guardrail with increased rail deflection and rotation and without the vehicle being captured or redirected. This combination turned the guardrail into an effective ramp for the impacting pickup truck to climb up and vault over.

As a result of the failed test, design changes were necessary to allow the successful containment or redirection of the pickup truck. This meant that the three beam rail would need to remain upright and functional long enough in order to capture the front of the impacting vehicle, thus preventing vehicle climbing, vaulting, and rollover. These changes required that the rail tension and lateral stiffness be increased without adversely affecting the head-on impact performance of either the pickup truck or small car impacts.

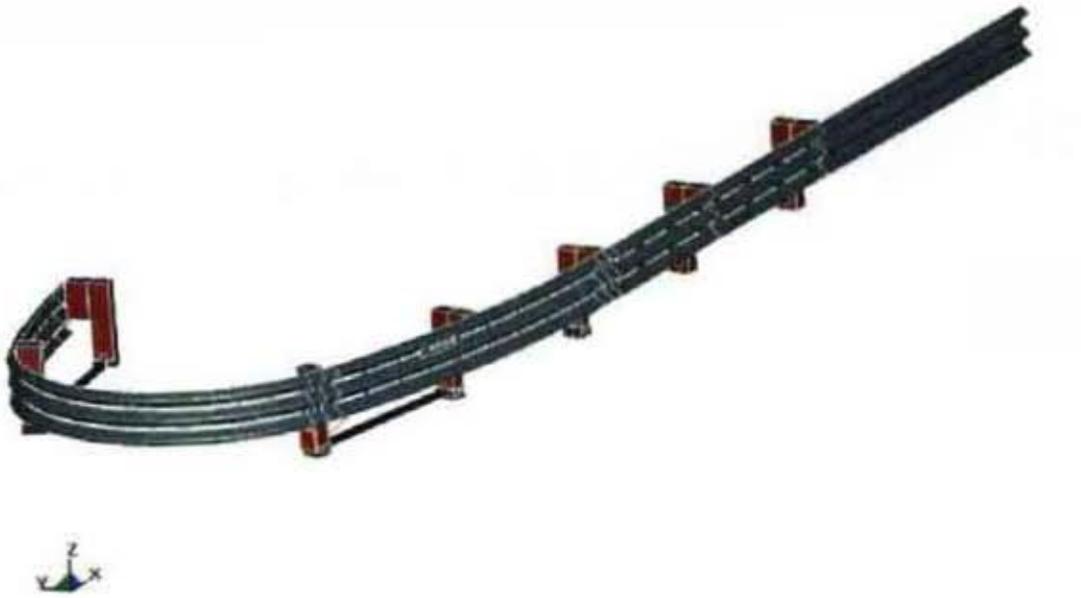
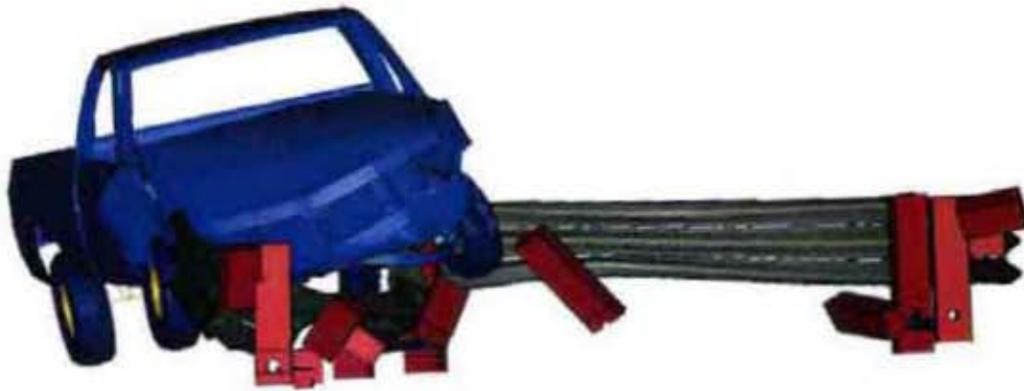
Figure 60. MBN-6 Simulation

MBN-6 was the CIP impact with a 2000-kg truck at 100 km/h and at 20 degrees. During the test, the rail began to roll over, forming a ramp which caused the truck to ride up and over the system. Simulating this event was the first step in the analysis. The CIP model and MBN-6 simulation of the event is shown in Figure 60. From the front-end view, it can be seen that the rail has rolled over, and the truck begins to climb up the rail.

By careful inspection of the simulation results, it was determined that the tire/suspension

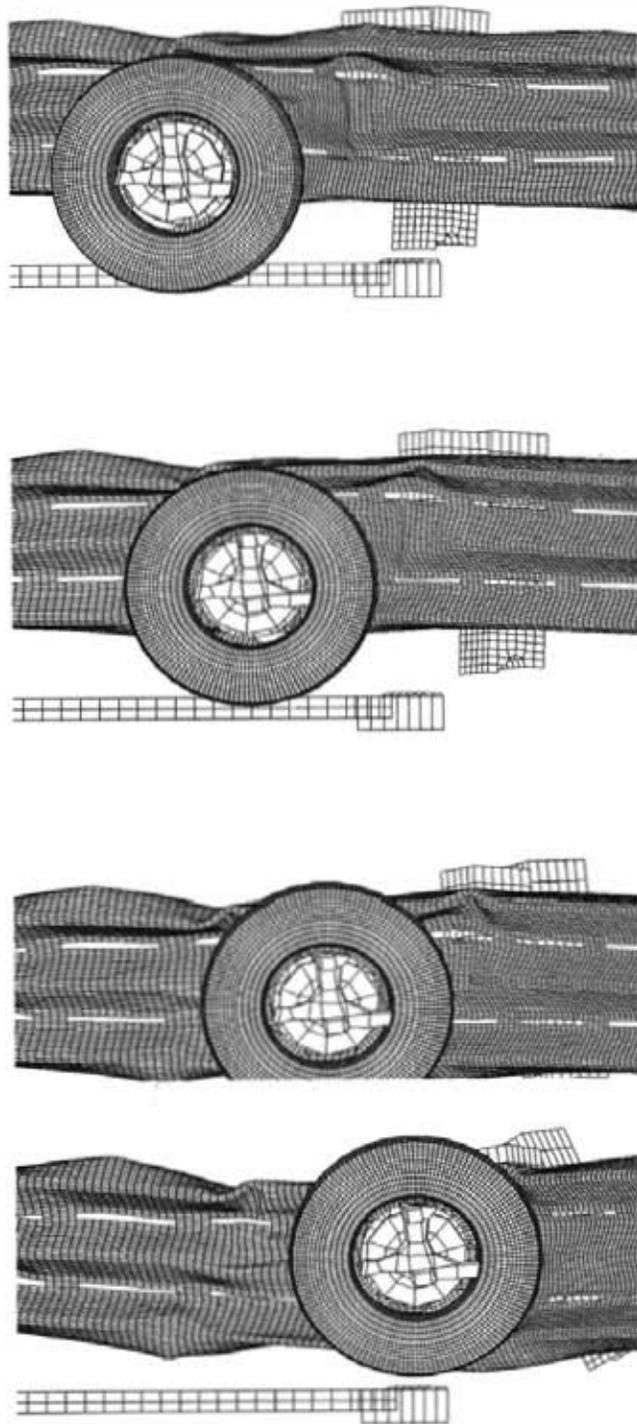
Figure 61. Ground Strut Influences Tire Behavior

system influenced the truck ride up the rail due to the tire impacting the ground line strut. A cut away view of this behavior is shown in Figure 61. Examination and comparison of overhead views of both the MBN-6 simulation and full-scale testing showed that when the vehicle reaches post no. 3 the rail rollover becomes evident, as shown in Figure 62. When the baseline model is modified by removing the ground line strut and replacing post nos. 1 and 2 with longer posts, the tire-strut interaction is eliminated. Simulation results of this modified model shows noticeable improvement in the rail behavior, as shown in Figure 63.
