PHASE II DEVELOPMENT OF A BULLNOSE GUARDRAIL SYSTEM FOR MEDIAN APPLICATIONS

MIDWEST ROADSIDE SAFETY FACILITY

MwRSF Research Report No. TRP-03-78-98

December 18, 1998

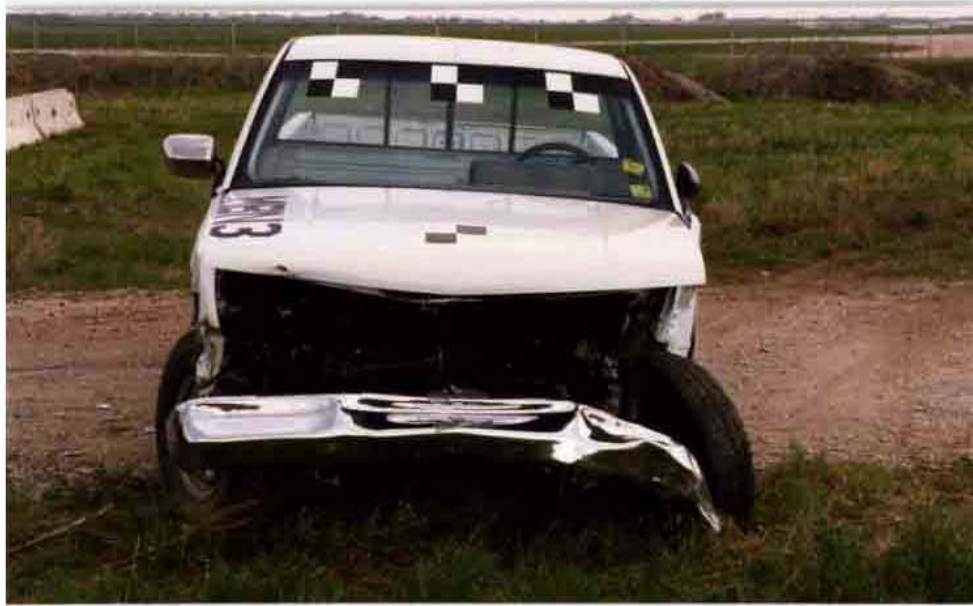
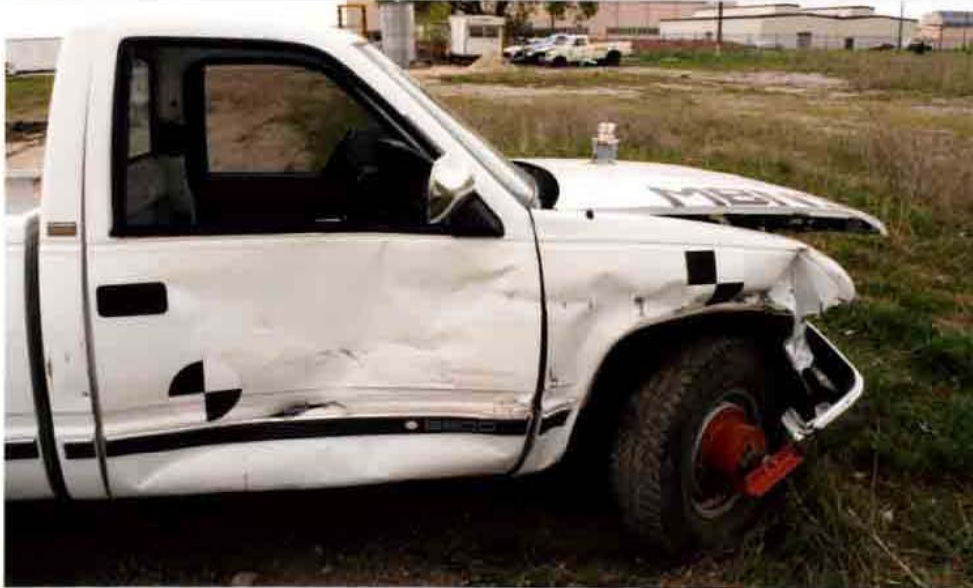
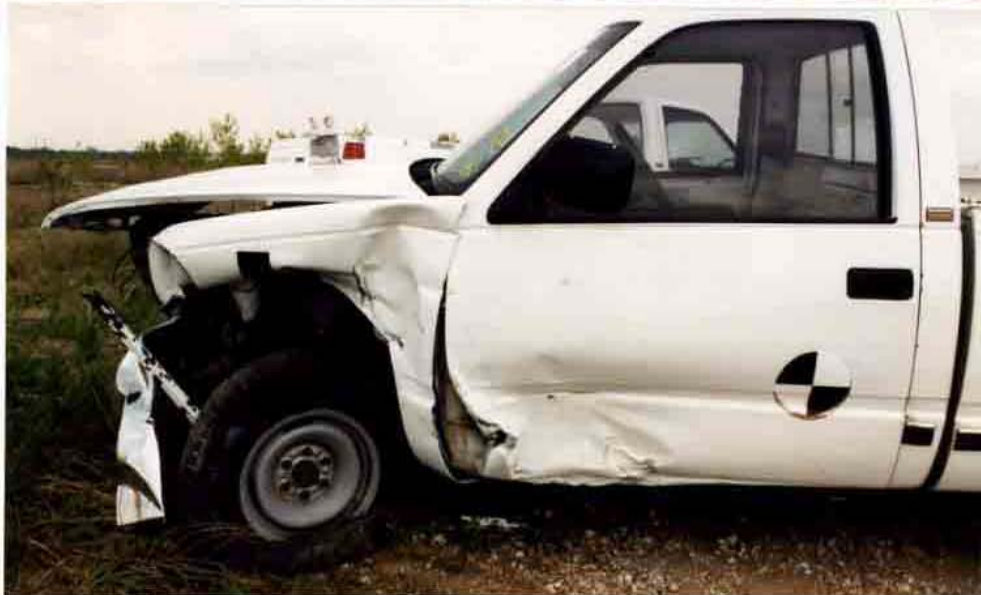
Figure 24. Vehicle Damage, Test MBN-3

Vehicle damage was moderate, as shown in Figure 24. The front bumper and front end of the truck were crushed inward uniformly. The bumper was bent and flattened across the length of the pickup. The left-front fender of the pickup truck was crushed inward due to the barrier impact. The lower-front section of the left door was also crushed inward, and some of the sheet metal on the door was ripped and scratched. The left-front and left-rear tires were cut and deflated. There was no significant rim damage. The tires on the right side were not damaged and remained inflated. The right-front fender was crushed back toward the right door due to the barrier impact. The right door was crushed inward and a 152.8-mm cut was made near the center of the door. The window on the right door was also shattered. There was no crushing of the pickup truck's occupant compartment.

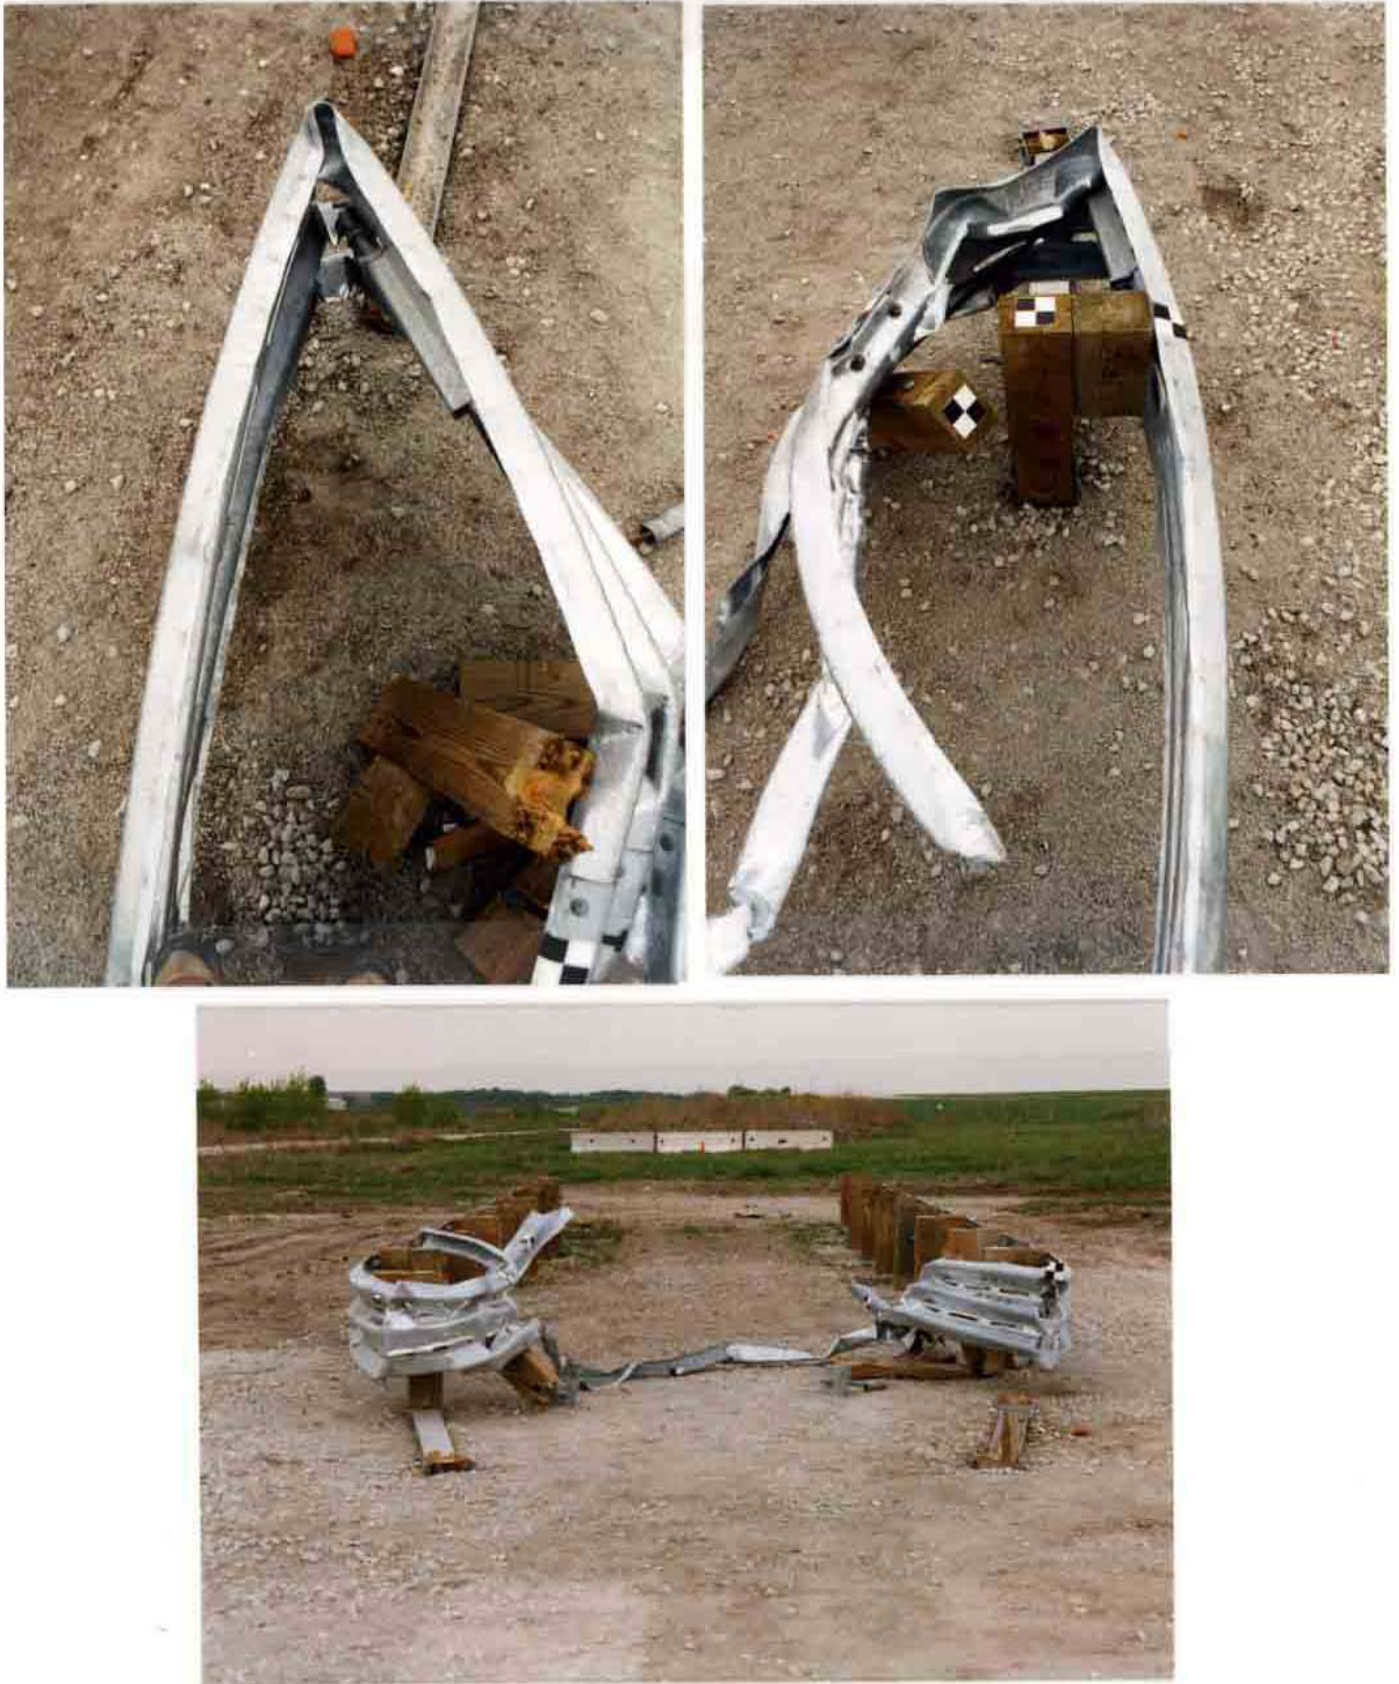
Figure 25. Barrier Damage, Test MBN-3

Barrier damage was extensive, as is shown in Figures 25 through 27. Three of the BCT posts fractured at the hole near the base of the post. Post no. 1 on both sides of the barrier was broken along with post no. 2 on the left side of the barrier. Post no. 11 on the left side of the barrier was contacted and broken as the truck exited through the middle of the barrier. The thrie beam buckled and bent around the cable box 813-mm upstream of post no. 2 on the left side of the barrier. The thrie beam also buckled at two locations on the right side of the barrier. The first buckle occurred at the start of the first set of slots downstream of the first rail splice, while the second buckle occurred around post no. 2.

The thrie beam tore in two places during the pickup truck impact. The first tear occurred 381-mm downstream and to the right of the nose of the barrier in the middle hump of the thrie beam. The second tear occurred 343-mm downstream and to the left of the nose of the barrier in the top hump of the beam. The lowest hump in the rail did not tear completely but did have partial rupture 381-mm downstream and to the right of the nose of the barrier. There were also some cuts in the rail on the right side of the barrier during impact. Major rips in the rail were found at 279-mm and at 178-mm upstream of post no. 1.

The failure of the system to meet all of the safety performance criteria was directly attributed to the fracture of the thrie beam. The fracture of the thrie beam in test MBN-3 occurred more rapidly than during test MBN-1. This behavior was believed to be attributed to the direct alignment of the Chevrolet pickup truck's front bumper with the middle hump of the thrie beam in test MBN-3. It is believed that this impact condition caused high stresses and strains to be generated immediately in the middle hump of the thrie beam nose section, thus leading to rapid rupture of the middle hump. For test MBN-1, the Ford's front bumper was aligned to contact both the top and middle humps of the thrie beam. This impact condition resulted in a more gradual increase and distribution of stresses and strains in the middle and top humps. However, it was noted that rail rupture still occurred. It became obvious to the researchers that the middle and top thrie corrugations were inadequate to contain the impacting head-on pickup truck in the present configuration. The top mounting heights for the Ford and Chevrolet bumpers were 737-mm (test MBN-1) and 622-mm (test MBN-3), respectively. A comparison of the bumper heights is shown in Figure 28.

Design changes were therefore necessary to contain the pickup truck by preventing rail fracture or contain the pickup even if rail fracture occurred. However, these design modifications, intended to adequately contain the pickup truck impact, were to be incorporated without adversely affecting the small car's impact performance.

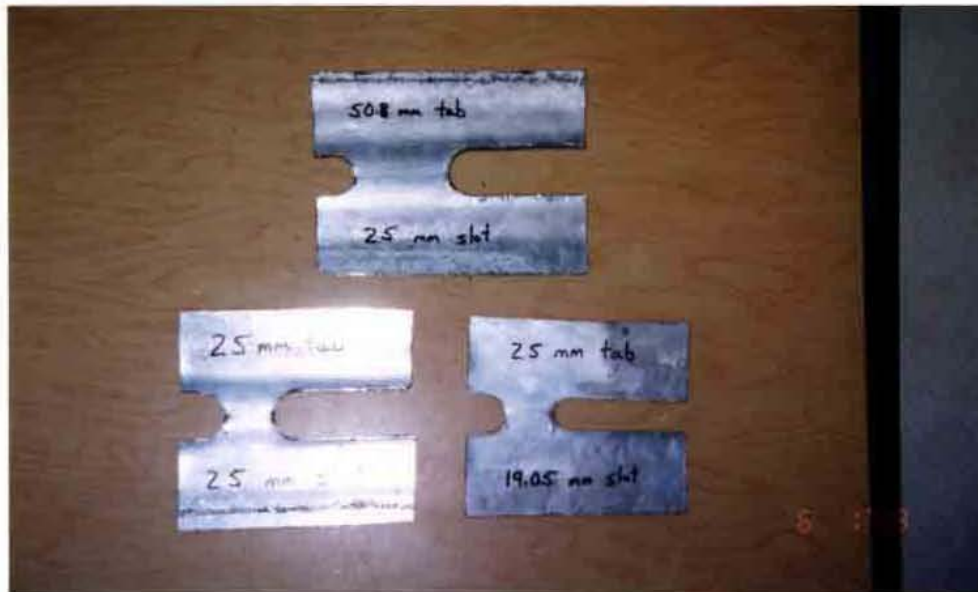
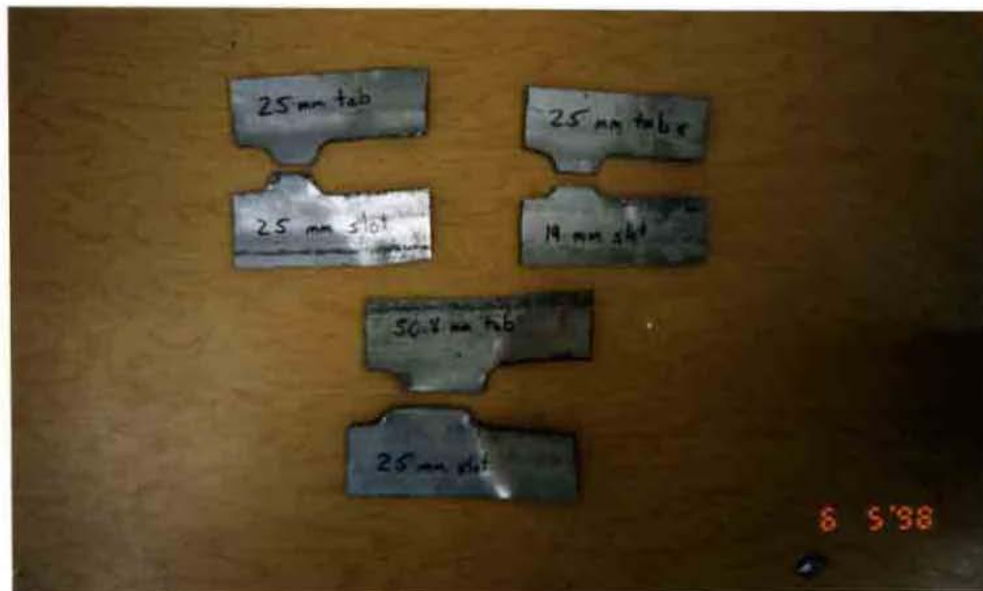
Figure 29. Physical Testing of Slot Tabs

During component testing, the 25-mm length tab tore at an average maximum force of 23.7 kN, while the 50-mm tab tore at an average of 27.2 kN, resulting in approximately a 15 percent increase in strength. Computer simulation of the component testing, using an effective plastic strain

failure of 0.2, failed the tabs at 24.7 kN for the 25-mm tab and 27.1 kN for the 50-mm tab. Simulation results compared very well with component testing results, and thus, the material properties from the component simulation could be used with confidence. One item of note was the required mesh density. In order to get reasonable tearing, the mesh density had to be relatively fine compared to the initial bullnose guardrail mesh. Thus, the bullnose guardrail mesh was refined by a factor of four to obtain the correct failure behavior.

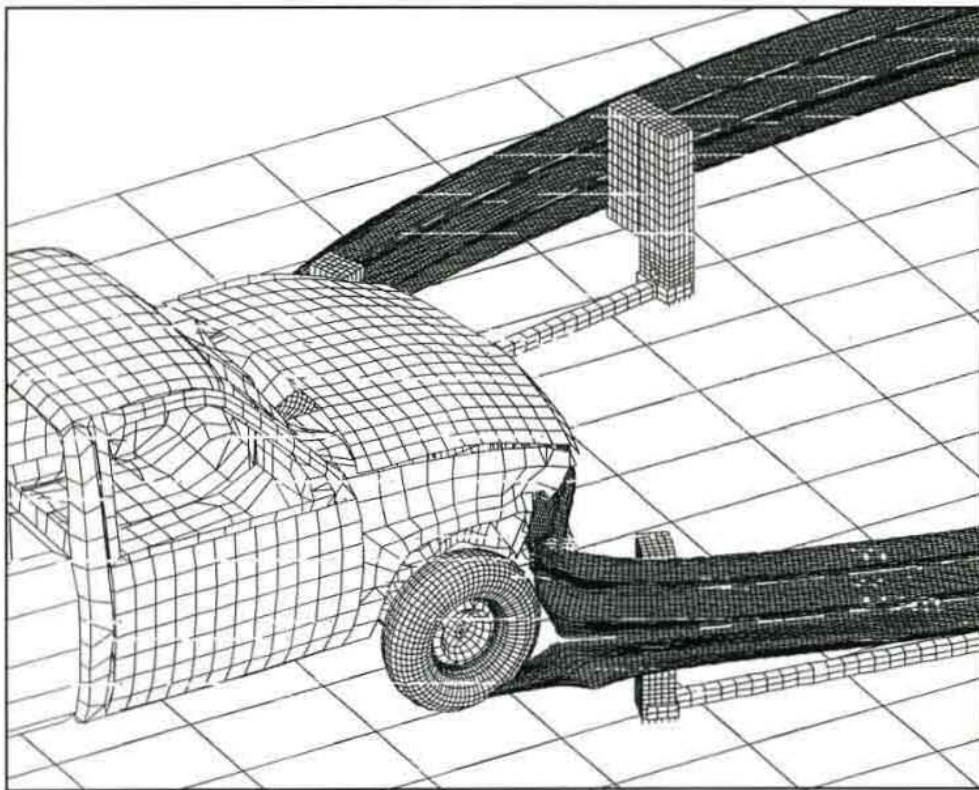
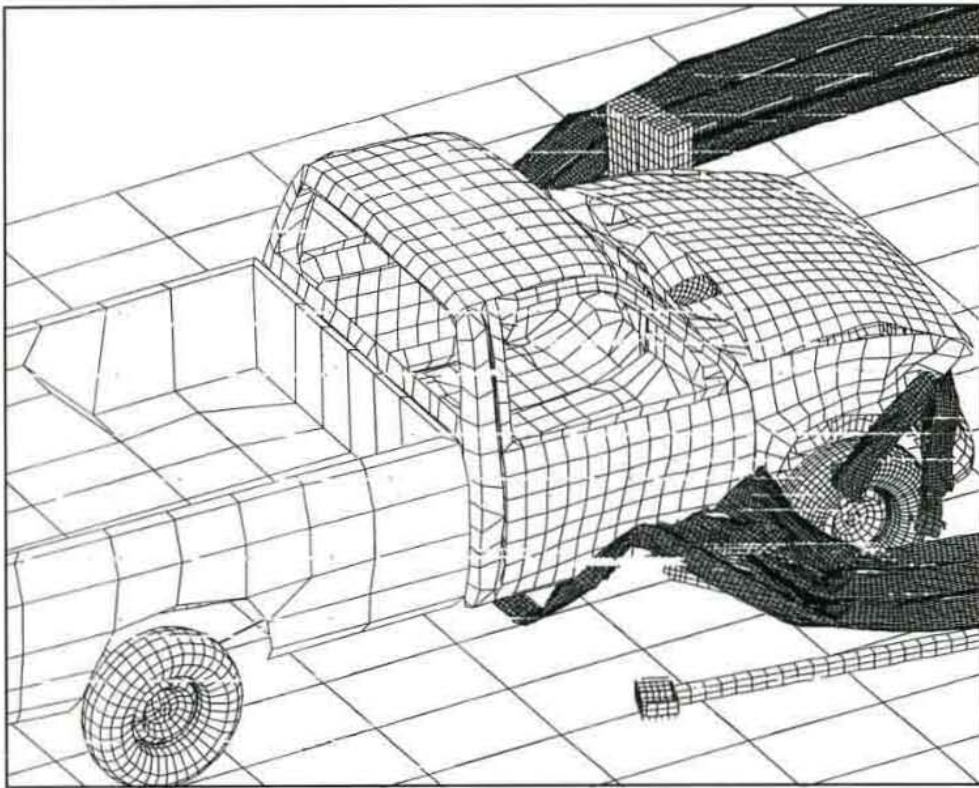
Figure 32. MBN-3 Simulation - Truck Tears Through Guardrail

With material failure and rotating tires defined, simulation of test MBN3 was repeated. This time the results were very encouraging, as shown in Figures 32 and 33. As the truck impacted the rail, the three peaks separated, wrapping themselves around the front of the truck. The lower peak contacted the tires and was pushed down and driven over by the front tires. As the rail wrapped around post no. 1, the upper two peaks of the rail tore just before the first splice in the rail. The vehicle then proceeded to penetrate behind the bullnose system. The velocity comparison between test and simulation is shown in Figure 33. After 200 ms, the vehicle was essentially rolling unconstrained and thus, not of concern.

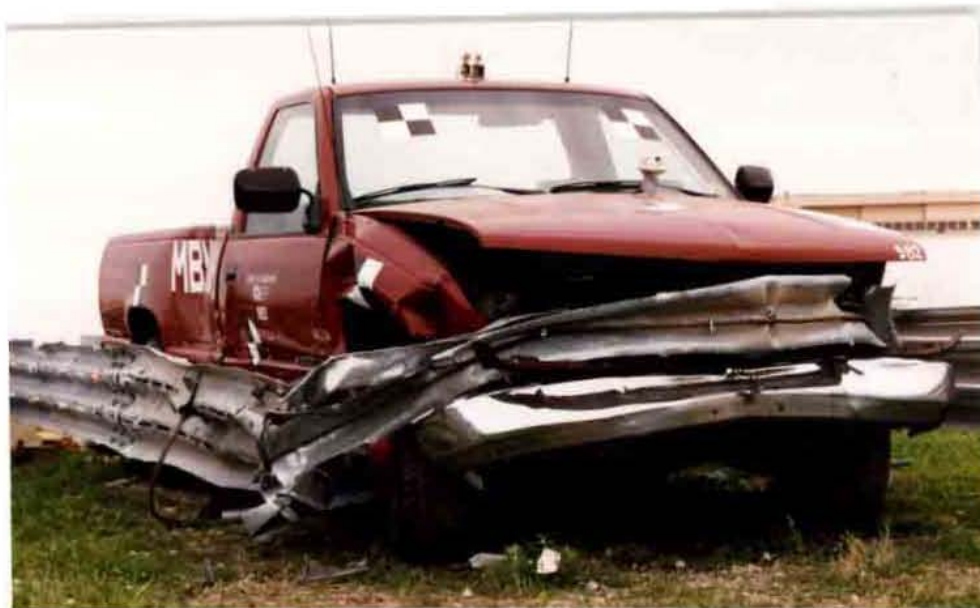
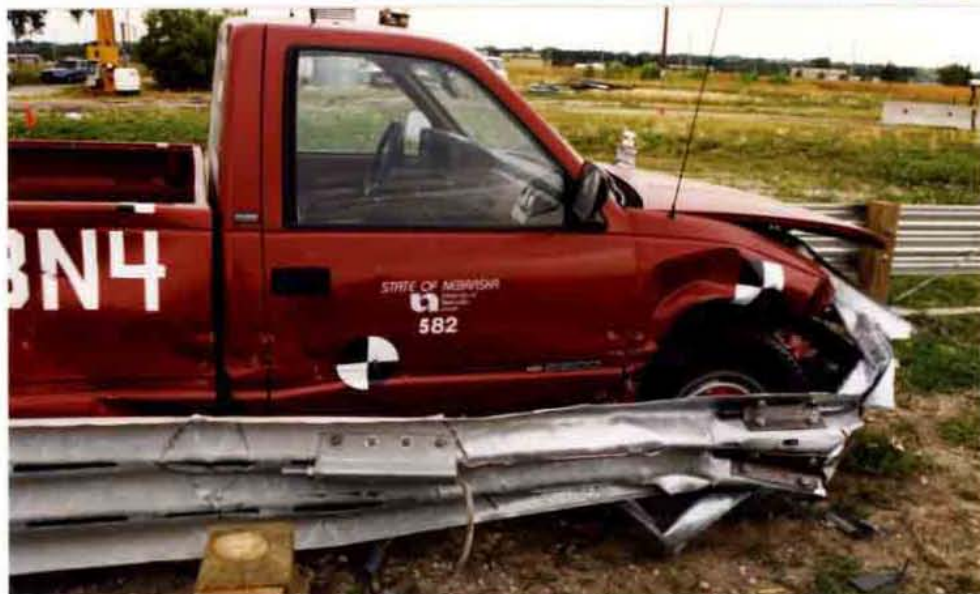
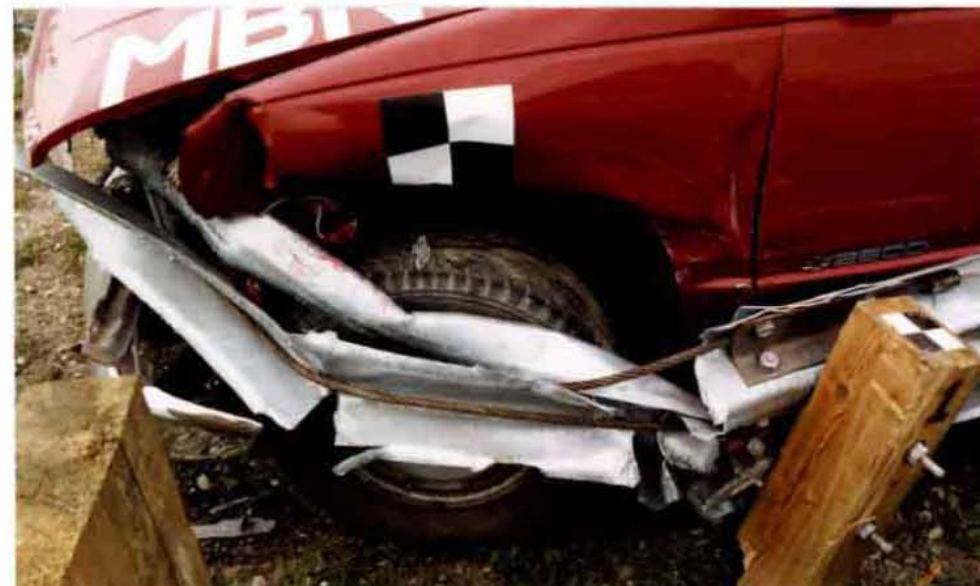
Figure 45. Vehicle Damage, Test MBN-4

Vehicle damage was moderate, as shown in Figure 45. The front end of the pickup truck was crushed, including the bumper, engine compartment, and front quarter panels. The front bumper of the pickup was crushed inward and flattened along the top half. All of the front sheet metal on the truck was crushed uniformly inward as well. The engine, hood, and several engine components such as the alternator, belts, and pulleys were undamaged. A small dent occurred to the ride side of the truck box due to contact with the kinked thrie beam. The right-side front fender was crushed downward and inward while the right-side door showed signs of contact with the rail. The left side of the vehicle was damaged similarly to the right side, except that no dent was found on the truck box. No damage occurred to the vehicle tires or the rims. There was no crushing of the pickup truck's occupant compartment.
