CONCEPT DEVELOPMENT OF A BULLNOSE GUARDRAIL SYSTEM FOR MEDIAN APPLICATIONS

MIDWEST ROADSIDE SAFETY FACILITY

MwRSF Research Report No. TRP-03-73-98

May 22, 1998

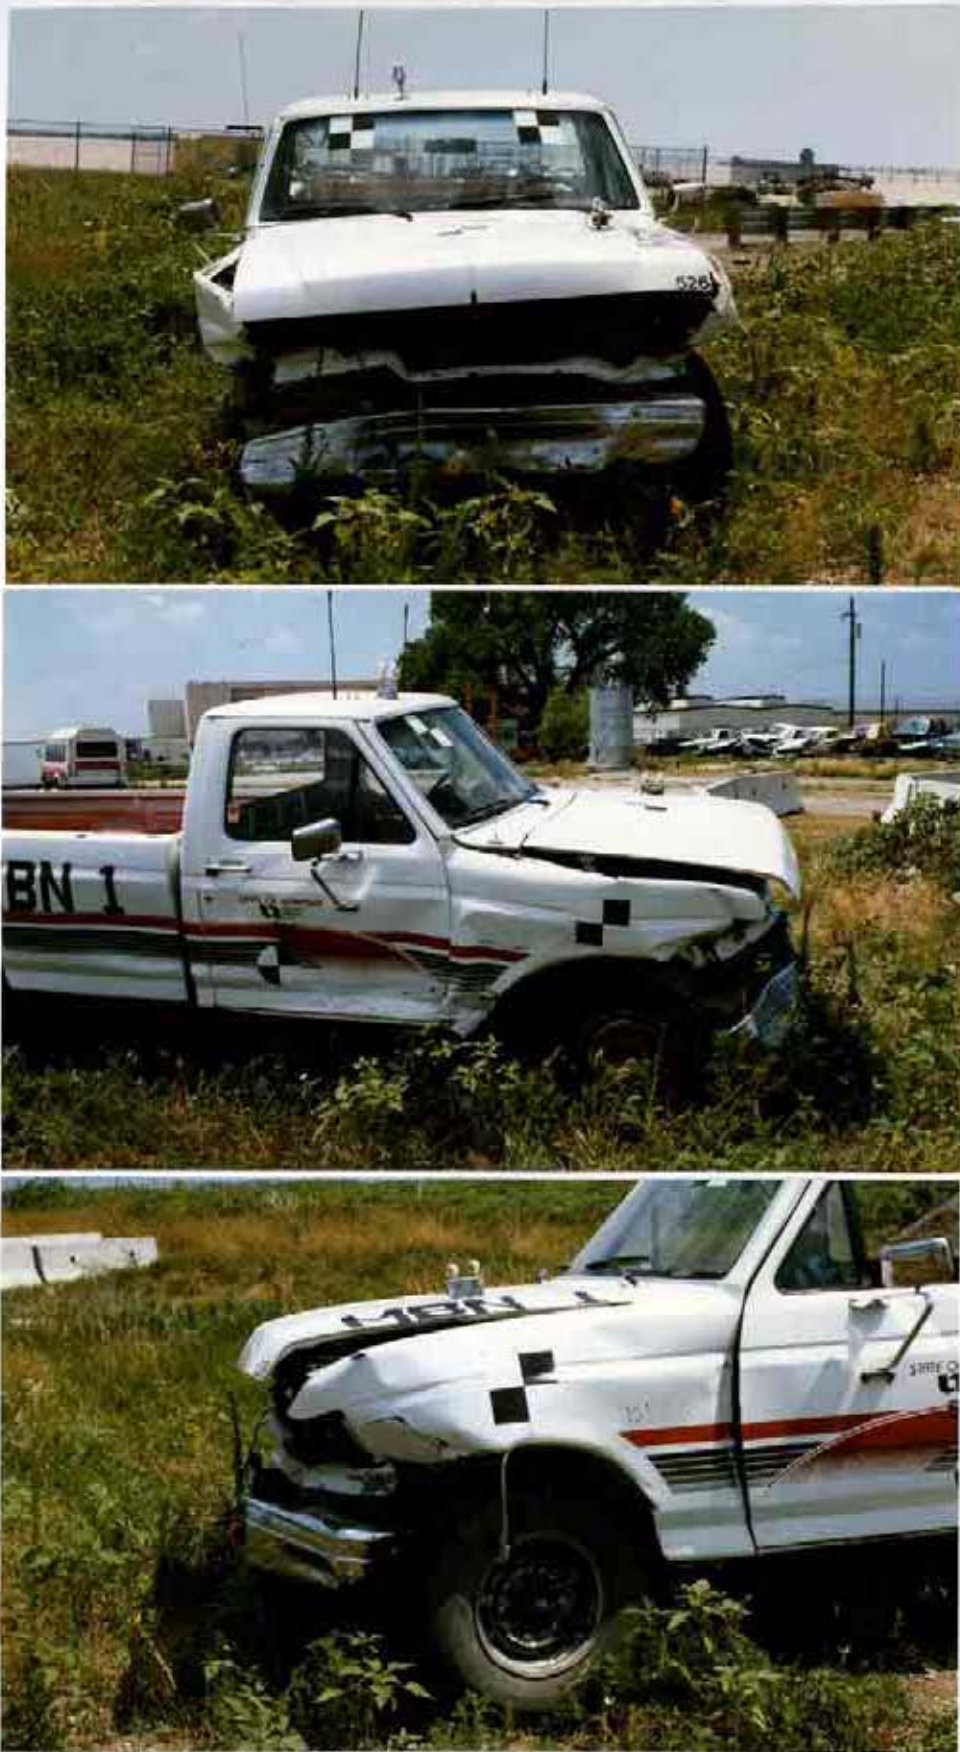
Figure 25. Vehicle Damage, Test MBN-1

Vehicle damage was moderate, as shown in Figure 25. The front bumper and front end of the truck were crushed inward. The right-front fender of the pickup truck was crushed outward due to the barrier impact. The lower section of the right door was slightly crushed inward. The left-front

fender of the truck showed some damage but there was no damage to the left-side door. There was no crushing of the pickup truck's occupant compartment. The front tire on the right side was detached from the rim during impact. Finally, the bolt mounts on the transmission were sheared off.

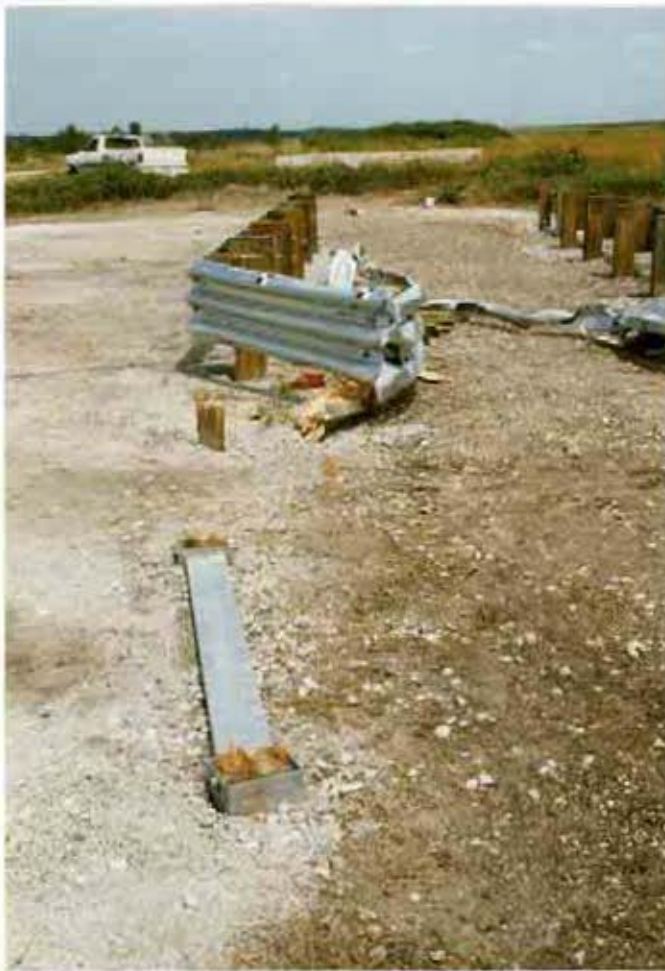
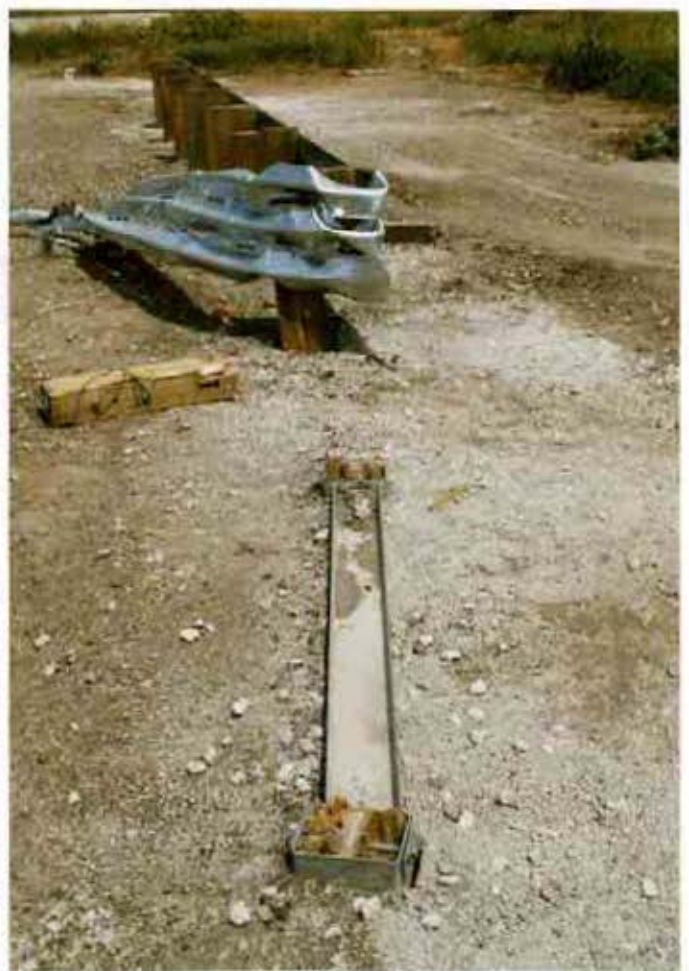
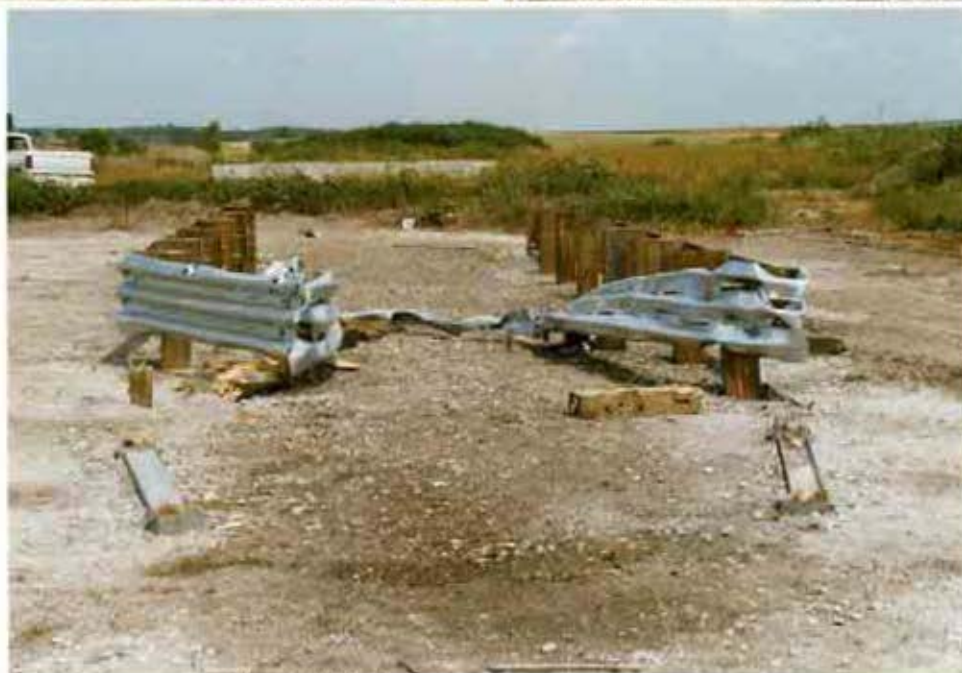
Figure 26. Barrier Damage, Test MBN-1

Barrier damage was extensive, as is shown in Figures 26 through 27. All four of the BCT posts used in the barrier fractured at the hole near the base of the post. Post no. 3 on both sides of the barrier was also broken. Post no. 11 on the left side of the barrier was contacted and broken as the truck exited through the middle of the barrier. The thrie beam buckled and bent at post no. 3 on both sides of the barrier. The thrie beam also buckled at post no. 4 on the left side of the barrier.

The failure of the system to meet all of the safety performance criteria was directly attributed to the fracture of the thrie beam. The causes of the thrie beam fracture were investigated for correction in future designs. The thrie beam fracture occurred when the rail wrapped around post no. 3 on the right side of the barrier. When the post did not fracture, the thrie beam was pulled tight while bending, thus creating large stresses in the thrie beam at high strain rates ultimately causing the thrie beam to fracture. The use of weaker posts at post nos. 3 and 4 would allow the beam to continue to deform without snagging on the posts, preventing the large stresses and ensuing beam failure that occurred in test MBN-1.

the slotted thrie beam rail prevented the pickup truck from overriding the nose section of the system. Therefore, the researchers believed that the system could be significantly improved by weakening the buckling and bending strength of the thrie beam rail after post no. 3 as well as replacing post nos. 3 and 4 with posts that would fracture more easily. Following the failure of test MBN-1, modifications were made to the guardrail system. These modifications to the bullnose guardrail system consisted of changing of post nos. 3 and 4 to breakaway posts and incorporating slots in another section of the thrie beam rail. A schematic of the modified design is shown in Figure 28, and photographs are provided in Figures 29 through 30.

For the first modification, post no. 3 on each side of the system was replaced by a 140-mm by 190.5-mm BCT post set in a foundation tube without a bearing plate, while post no. 4 on each side was replaced by a CRT post. These post changes were made to accelerate the fracture of the posts in those areas, prevent high loads being imparted into the thrie beam rail, and reduce the high rail stresses from occurring at concentrated locations. These changes would also allow for a more gradual dissipation of the vehicle's kinetic energy.

The slot pattern for rail section no. 2 on both sides of the bullnose barrier terminal was also modified slightly from the original design. The new slot pattern for rail no. 2 is shown in Figure 32. The slot pattern was changed to form eighteen 290-mm long slots, 9 in each valley. Each of the slots is separated by a 100-mm gap. The slot width remained 25 mm. The final major modification to the bullnose system was the addition of slots to rail section no. 3 on both sides of the system. The slot pattern of rail section no. 3 is shown in Figure 33. Twelve 300-mm slots were cut out of the valleys, six in each valley, with 250-mm spaces between them. The modification of the slots in section no. 2 and the addition of slots to section no. 3 serve to reduce the strength of the beam. Reducing the

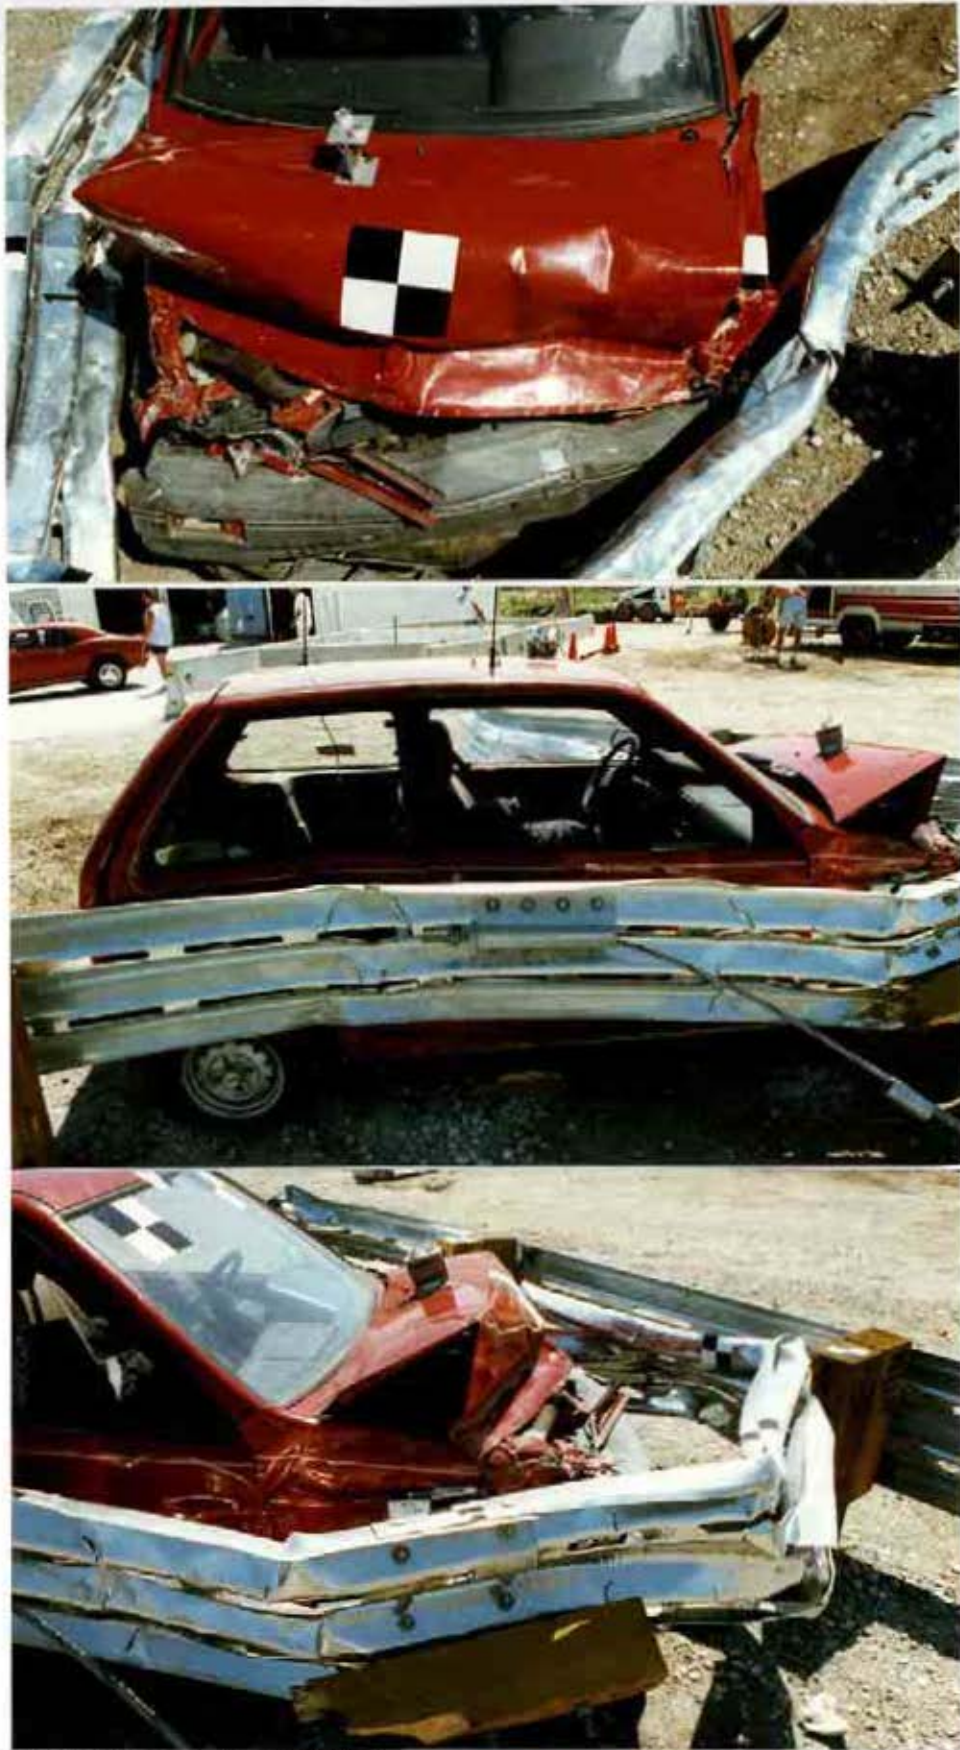
Figure 40. Vehicle Damage, Test MBN-2

Vehicle damage was extensive, as shown in Figure 40. The front end of the small car was crushed, including the bumper, engine compartment, hood, and front quarter panels. The front windshield was also fractured during the impact. The right-side sheet metal behind the door was

deformed inward approximately 12.7 cm due to "knees" forming in the thrie beam rail and impacting the side of the vehicle. The right-side door was damaged along its entire length, and the right-side window glass was shattered. The left-side door was deformed and wedged shut at the front hinge. Only minor floorboard deformation was found in the occupant compartment.

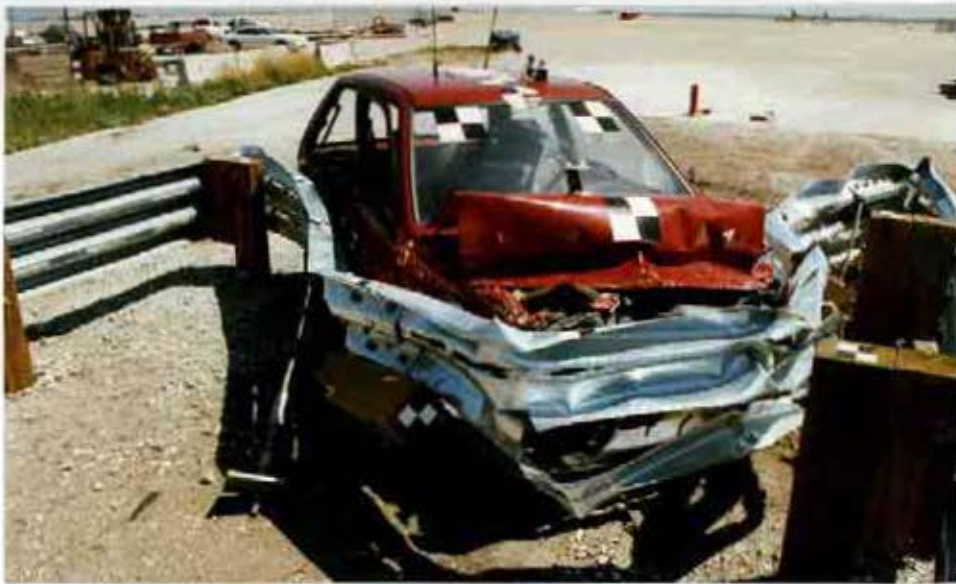
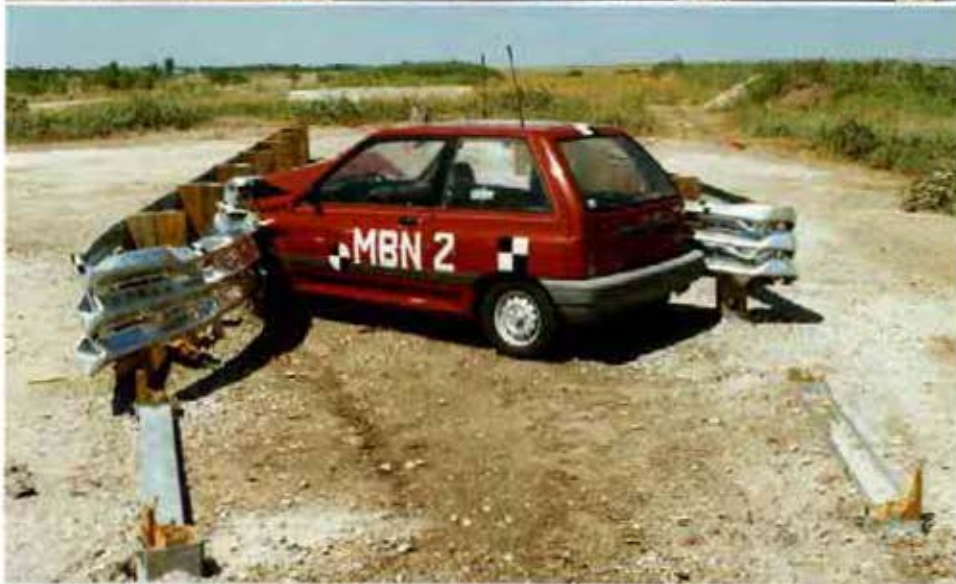
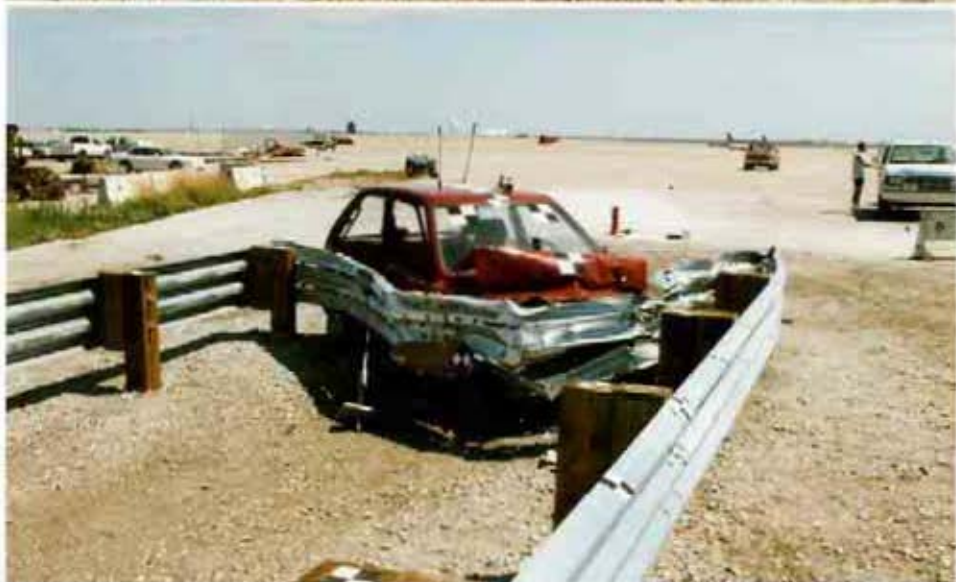
Figure 41. Barrier Damage, Test MBN-2

Barrier damage was extensive, as shown in Figure 41 through Figure 42. Post nos. 1 and 2 on each side of the system were completely fractured. The rail buckled during impact at post no. 2 on the left side of the system and slightly upstream of post no. 3 on the right side of the system. Significant tearing of the thrie beam occurred where the rail wrapped around the front end of the small car. Tearing of the horizontal slots in the thrie beam occurred at several posts and where the rail buckled near the posts nos. 2 and 3. In addition, tearing of the slots occurred at some midspan locations. Deformations to the thrie beam occurred to the nose piece as well as rail section no. 2 on both sides of the system. The deformed shape and deflection of the barrier is shown in Figure 43. The maximum permanent rail deflection was 7.11 m.
