CRASH TESTING OF MICHIGAN'S TYPE B (W-BEAM) GUARDRAIL SYSTEM – PHASE II

MwRSF Research Report No. TRP-03-104-00

December 13, 2000

Michigan Department of Transportation's Type B (W-beam) longitudinal barrier system was constructed and crash tested. The barrier design was constructed with a 2.66-mm (12-gauge) thick W-beam rail totaling 53.34 m in length. The W-beam rail was supported by twenty-five W152x13.4 steel posts, each measuring 1,830-mm long, and four standard BCT posts, each measuring 1,080-mm long. Each of the steel posts had a 152x203 by 360-mm long standard wood offset blockout. Post spacings were 1,905-mm on center.

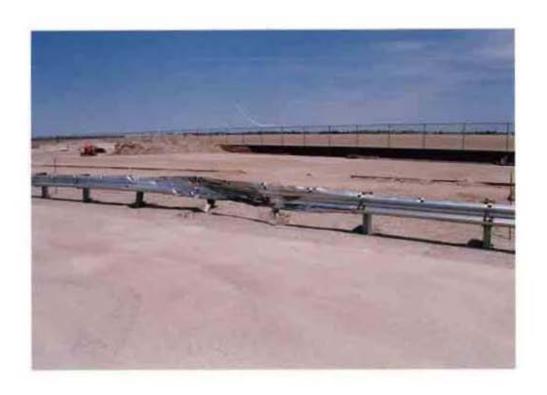
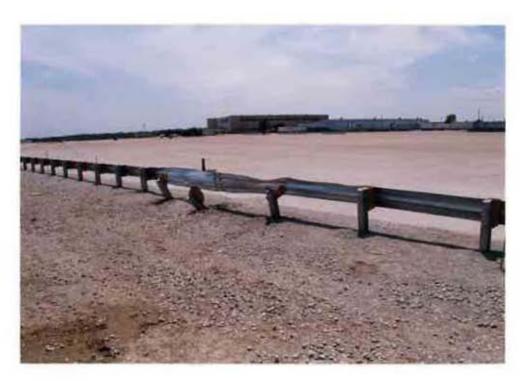
Figure 17. Type B Longitudinal Barrier Damage, Test MIW-2

Damage to the barrier was moderate, as shown in Figures 17 through 25. Barrier damage consisted mostly of deformed W-beam, contact marks on a guardrail section, and deformed guardrail posts. The W-beam damage consisted of major deformation and flattening of the impacted section between post nos. 13 and 15. Contact marks were found on the guardrail between post nos. 13 and 17. The top of the W-beam rail, downstream of post no. 21, was damage from the truck riding along the rail. A 559-mm long cut was found on the bottom peak starting 76-mm upstream of post no. 14.

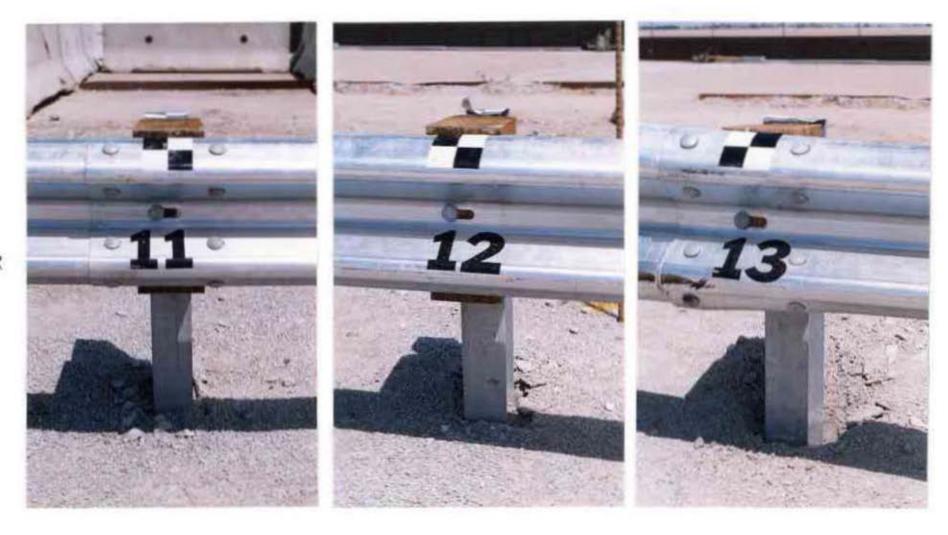
Figure 19. Type B Longitudinal Barrier Rail and Post Damage, Test MIW-2

Steel post nos. 3 through 13 and 17 through 19 moved backward slightly. Three steel posts, post nos. 14 through 16, rotated in the soil and bent toward the ground. A 406-mm long tire contact mark was found along the front face of post no. 14. The top of post no. 15 was also slightly

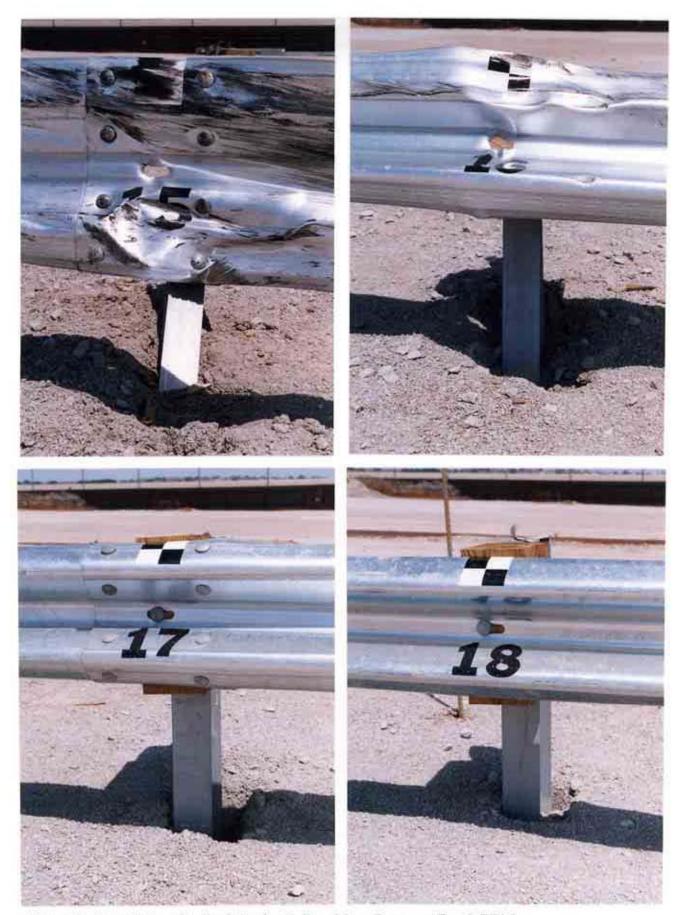
Figure 21. Type B Longitudinal Barrier Rail and Post Damage, Test MIW-2

damaged. The tops of steel post nos. 20 through 27 were contacted and damaged extensively by the vehicle. The wooden blockout at post no. 14 split down the middle but was still attached. Contact marks were found on the wooden blockout at post no. 15. A piece of the wooden blockout at post no. 16 was removed. Both the upstream and downstream anchorage systems move slightly, but the posts were not damaged, except for post no. 28 which was split along its length.

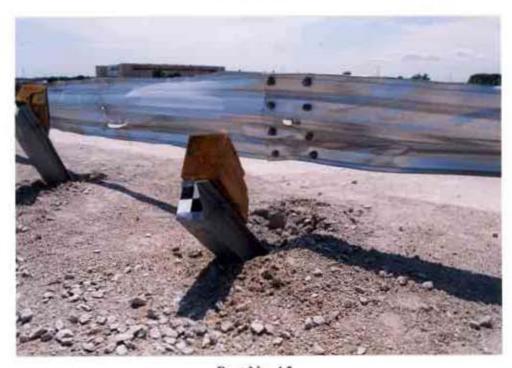
Post No. 15

The cause of this unacceptable behavior is attributed to the failure of the W-beam to release quickly from the guardrail posts. The splice in the W-beam rail element remained attached to post no. 15 until the right-front tire contacted the post. During this time, the post rotated downward approximately 250 mm. Although the blockout reduced the magnitude of the downward motion, this post attachment caused the W-beam to be pulled down during a period when it is normally lifted up to retain the impacting vehicle's front tire. As a result, the tire was forced out from under the guardrail when it struck post no. 15, and the wheel began to climb the barrier as the test vehicle progressed. This wheel climb lead to vehicle vaulting and the failure of the system to successfully redirect the test vehicle.

Careful inspection of the damaged guardrail system and photos of the barrier prior to impact revealed that the post bolts were installed near the downstream end of the slot in the rail element. Testing of the post bolt pullout strengths has shown that bolts installed near the end of the slot generate higher forces before being pulled through the rail. This installation detail may have helped prevent the post bolt from becoming detached from the rail element.

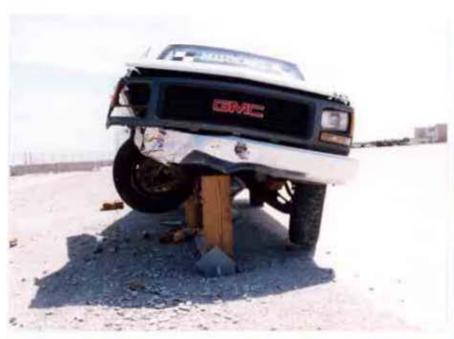
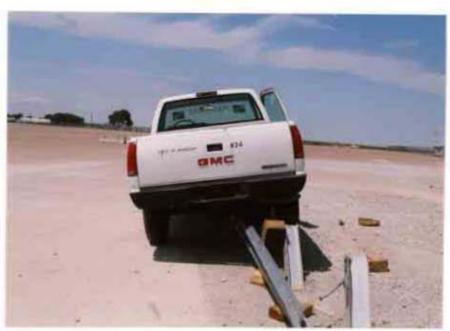
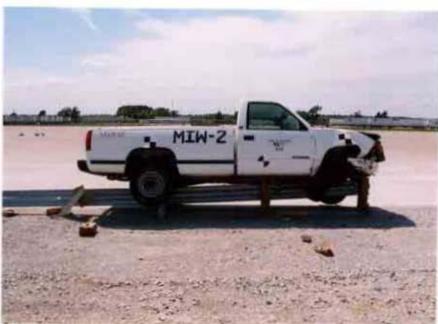
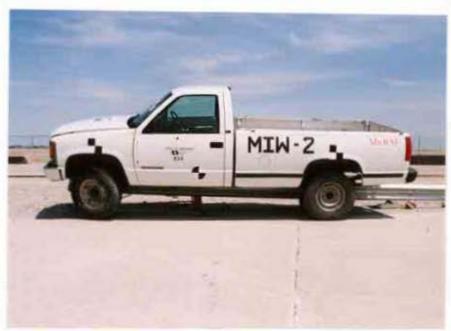
Figure 26. Vehicle Damage, Test MIW-2

Exterior vehicle damage was moderate, as shown in Figures 26 and 27. Interior occupant compartment deformations were determined to be negligible. The majority of the vehicle damage occurred to the vehicle's right side. The right-front fender was crushed inward and downward, and the right side of the front bumper was also bent toward the engine compartment. The right-front wheel assembly was deformed to approximately a 90 degree bend and pushed toward the firewall. Major damage was found on the inside of the right-front tire rim as well as tie-rod disengagement. The lower ball joint connection and the sway bar connection to the A-frame were deformed. The right side of the vehicle's frame was deformed extensively from the rear fender to the rear bumper. In addition, contact marks were observed on the inside of the right-rear wheel well. The outer side wall of the right-rear tire and the inner side wall of the right-front tire were slashed. Wood pieces were embedded into the A-frame and the connection between the drive shaft and rear end. Small

contact marks were found on the outside surface of the right-front tire and the lower front corner of the right-side door. The headlight, parking light, and fog light on the right-side broke. Minimal damage was found on the right side of the grill. No other damage to the vehicle was observed.
