**Crash Testing of Standard South
Dakota Road Closure Gates**

**Study SD94-10
Final Report**

**Prepared by:
Midwest Roadside Safety Facility (MwRSF)
Center for Infrastructure Research
Civil Engineering Department
University of Nebraska-Lincoln
1901 Y Street, Building C
Lincoln, Nebraska 68588-0601
(402)472-6864**

January 1995

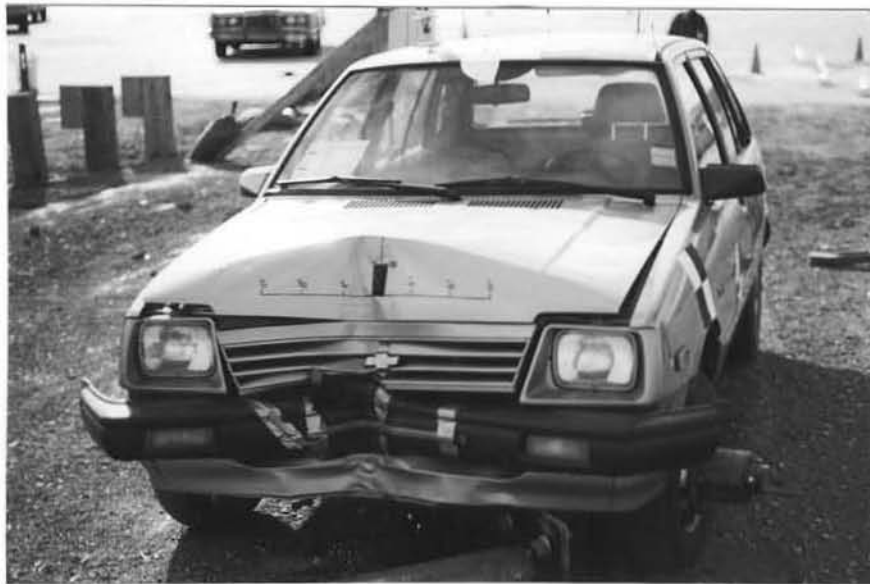
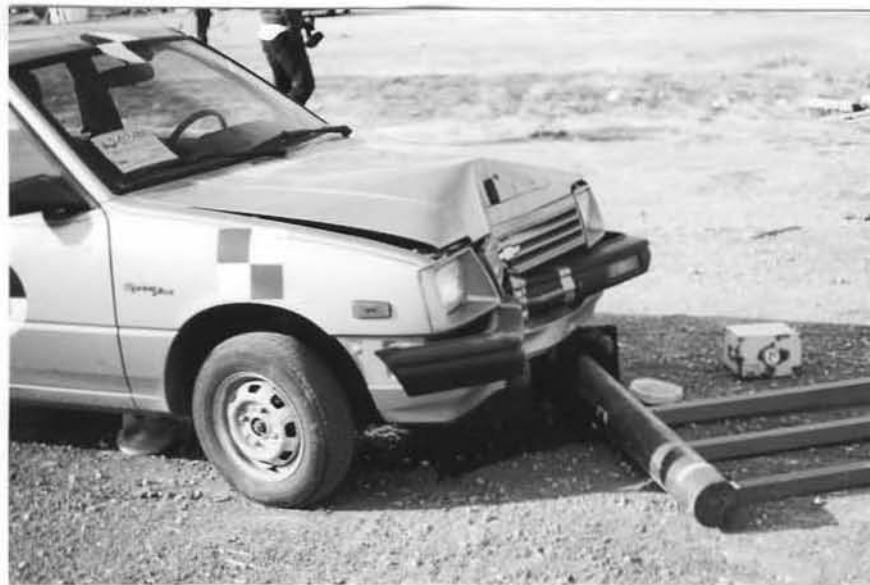
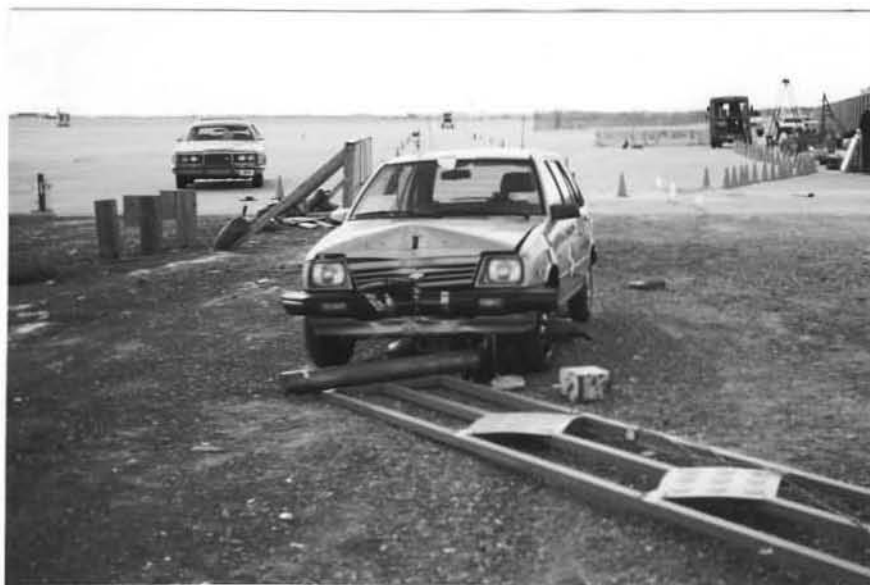
Figure 23. Vehicle Damage, SDG-1

Test vehicle damage consisted of only frontal crush to the bumper, hood, and grill. A maximum crush depth of 20.3 cm (8 in.) was measured on the front bumper of the test vehicle and approximately 27.9 cm (11 in.) of crush was measured on the hood of the test vehicle. There was no damage to the suspension or undercarriage of the test vehicle. The minimal damage to the test vehicle is shown in Figure 23.

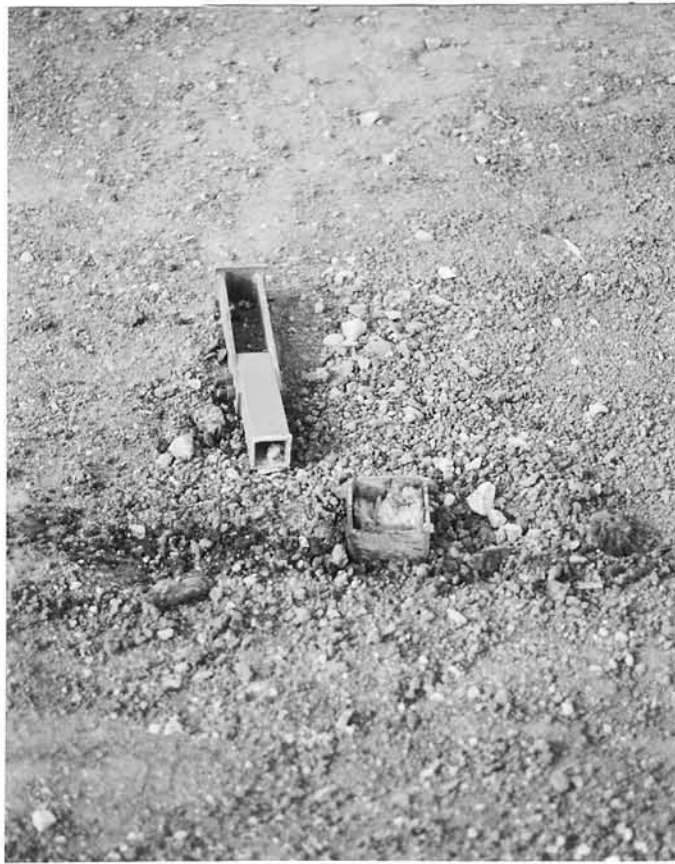
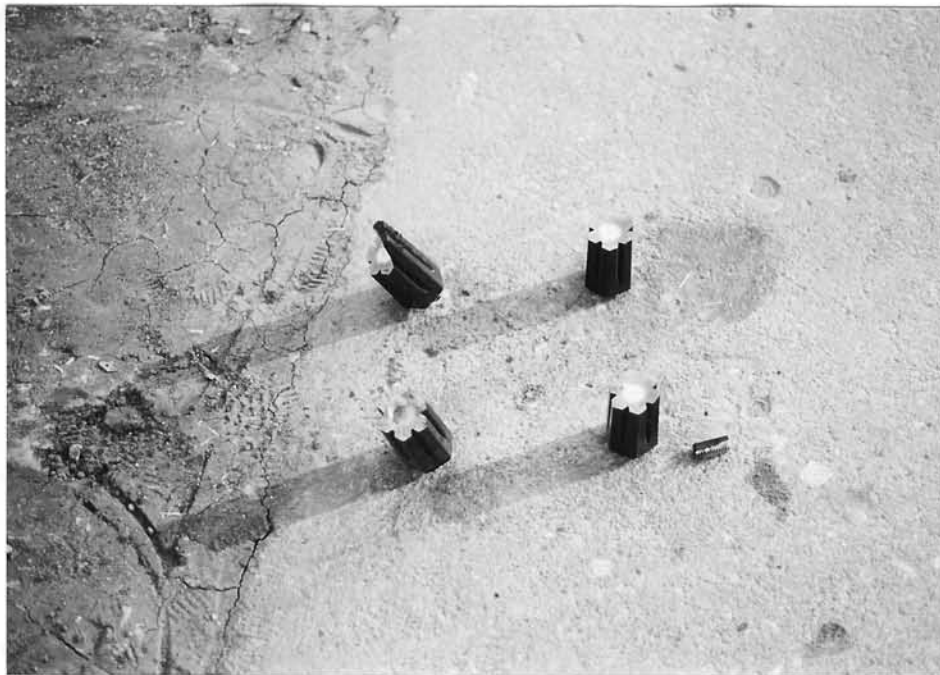
Figure 24. Component Damage, SDG-1

Damage to the road closure gate consisted only of fracture of the frangible couplers, hold back post, and gate stands, as shown in Figure 24. The frangible couplers were broken off flush with the top of the anchor rods, leaving a 7.6-cm (3-in.) stub height above the concrete surface. Two of the anchor bolts were bent forward. Damage to these components is shown in Figure 24. The gate post and gate were undamaged and remained connected. The final resting position of the gate was approximately 15.2-m (50-ft) downstream of impact, as shown in Figure 18.

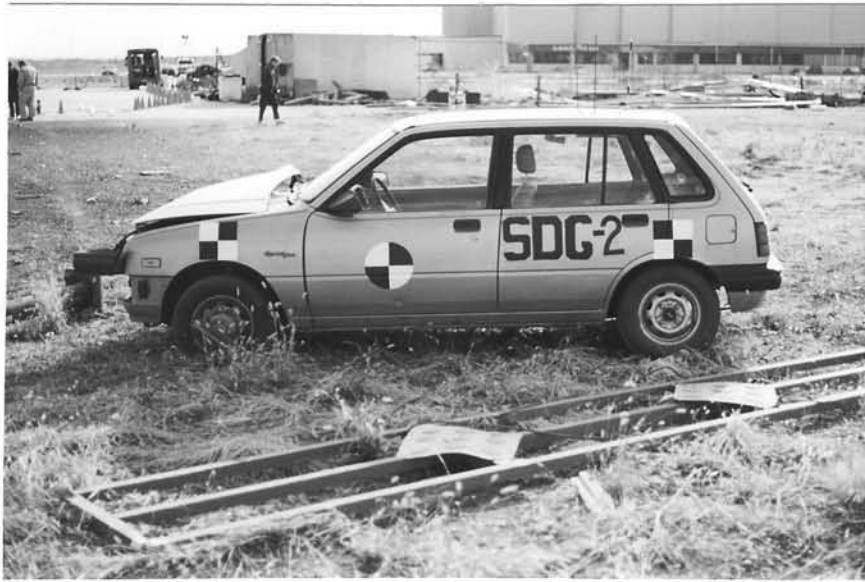
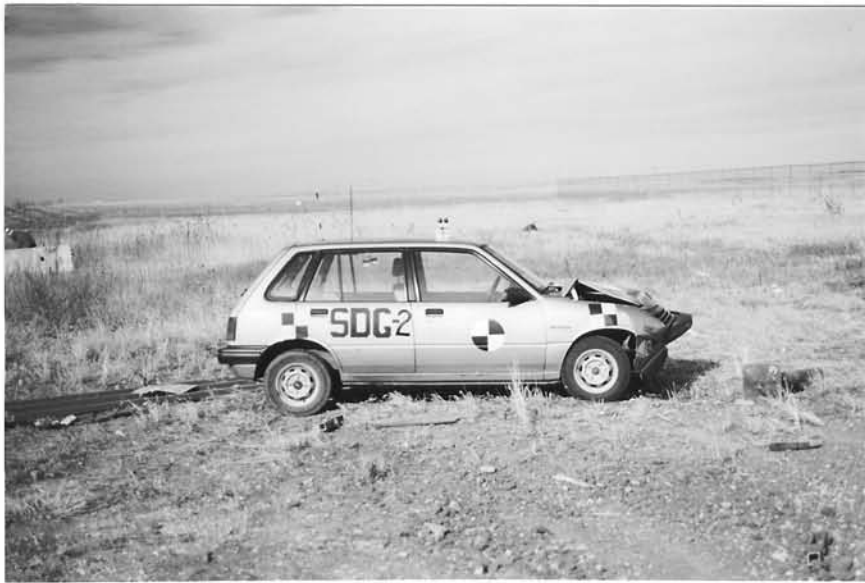
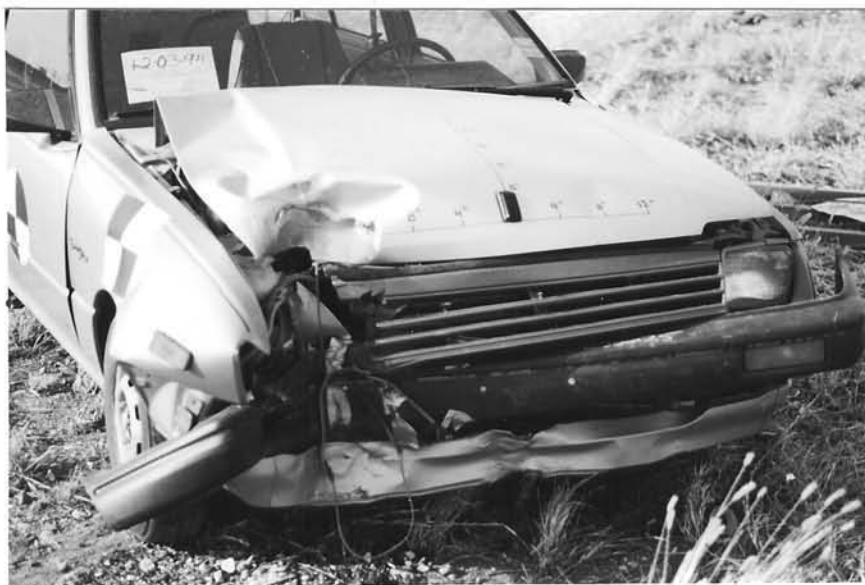
Figure 29. Vehicle Damage, SDG-2

Test vehicle damage consisted of frontal crush to the bumper, hood, and grill at the quarter point location. A maximum crush depth of approximately 30.5 cm (12 in.) was measured on the front bumper and hood. The right-front fender, wheel well, and hood were slightly buckled. There was no significant damage to the suspension or the undercarriage, since the vehicle did not run over any parts of the gate. There were no broken glass, flat tires, or occupant compartment damage. The damage to the test vehicle is shown in Figure 29.

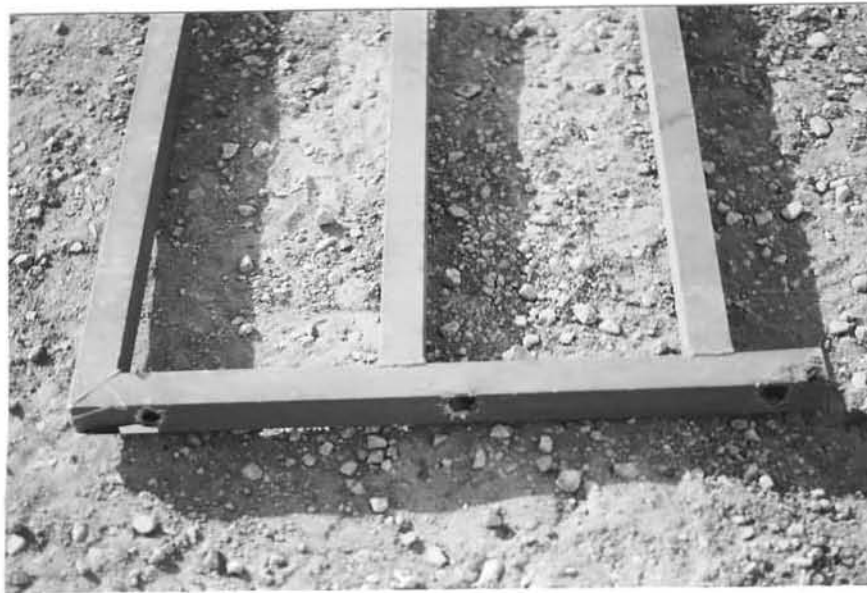
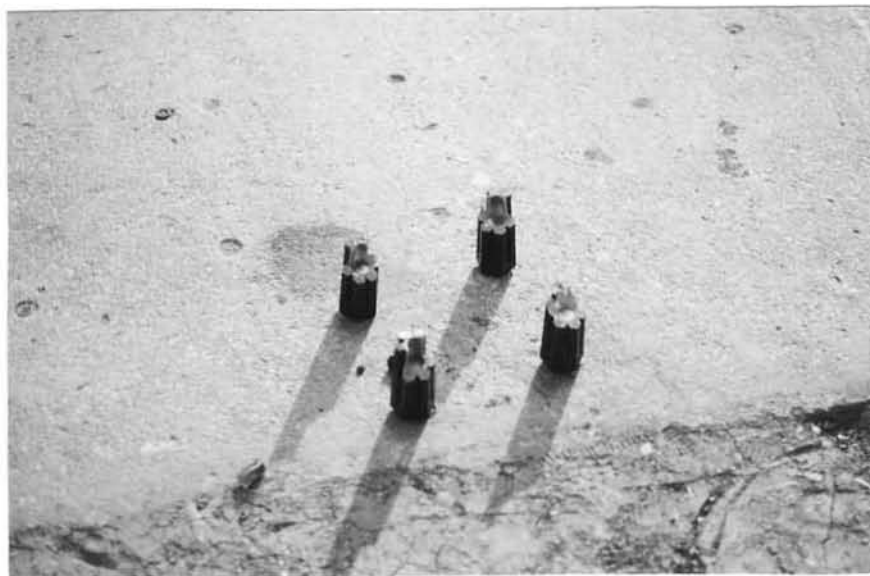
Figure 30. Component Damage, SDG-2

Damage to the road closure gate consisted of fracture of the couplers, hold back post, and gate stands, as shown in Figure 30. The frangible couplers were partially broken off with the top of the anchor rods on the upstream end of the couplers. The anchor rods were not bent, as shown in Figure 30. The gate post was undamaged, and the gate suffered minimal damage including the tear-out of the 1.9-cm (3/4-in.) bolts that connected the gate and gate post. The vertical aluminum tube on the upstream end of the gate was bent slightly. The final resting position of the gate was approximately 39.6 m (130 ft) downstream of impact, as shown in Figure 25.
