SAFETY PERFORMANCE EVALUATION OF MISSOURI'S GROUND-MOUNTED TEMPORARY SIGN STANDS – PHASE II

MIDWEST ROADSIDE SAFETY FACILITY

MISSOURI DEPARTMENT OF TRANSPORTATION

MwRSF Research Report No. TRP-03-158-05

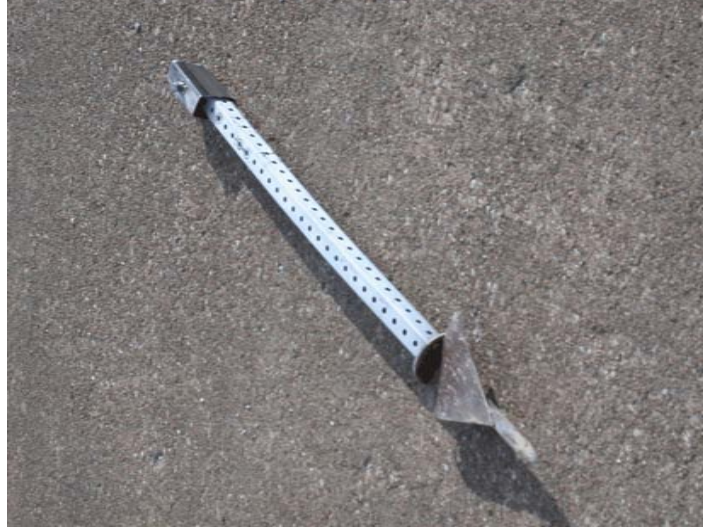
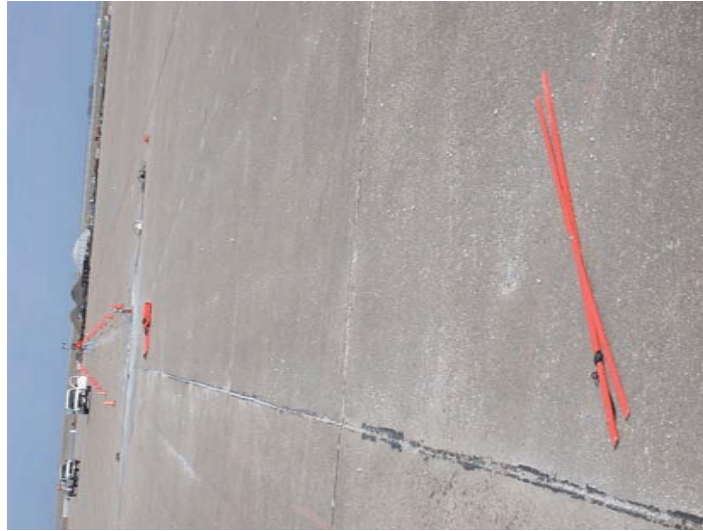
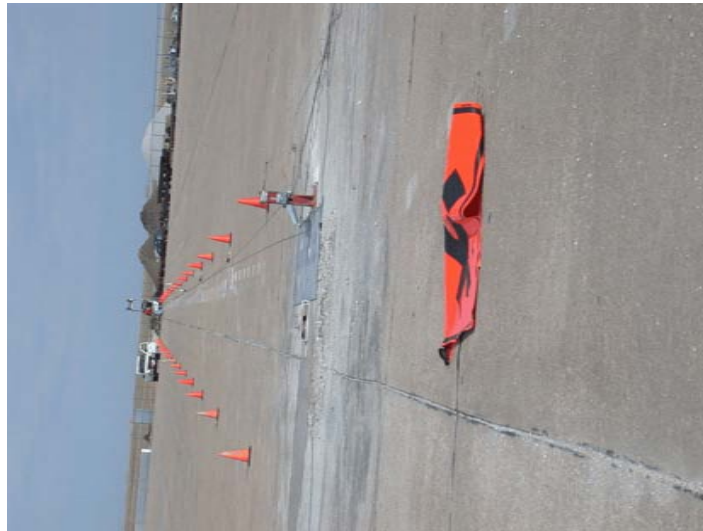
Figure 11. System No. 3 Damage, Test M-3

The moderate damage to System No. 3 is shown in Figure 11. The sign panel vinyl was removed from the horizontal and vertical crossbraces. The bottom crossbrace bracket was removed from the sign panel vinyl. Glass was embedded in the sign panel vinyl along the locations of the

vertical and horizontal crossbraces. The bottom of the vertical crossbrace was splintered. The sign panel bracket remained loosely attached to the sign post. The sign panel bracket was deformed on the bolt side. The soil plate on the sign post was deformed at the top. The sign post was pulled completely out of the ground.

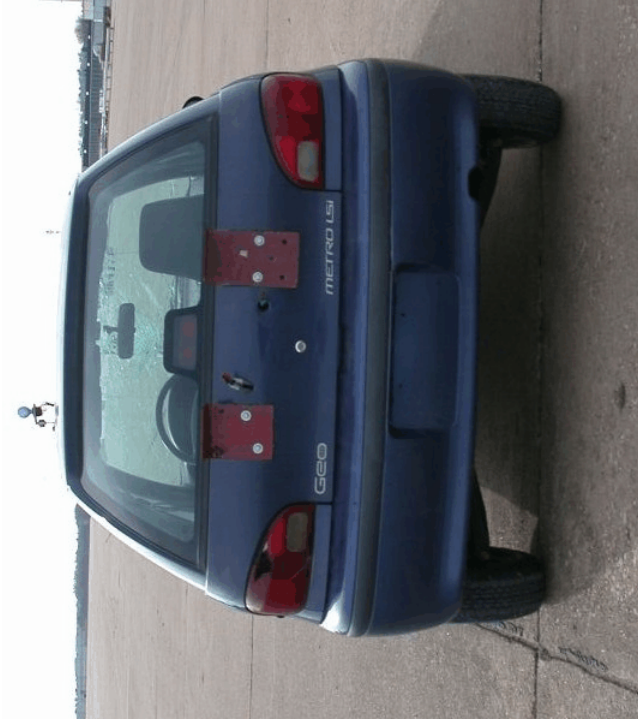
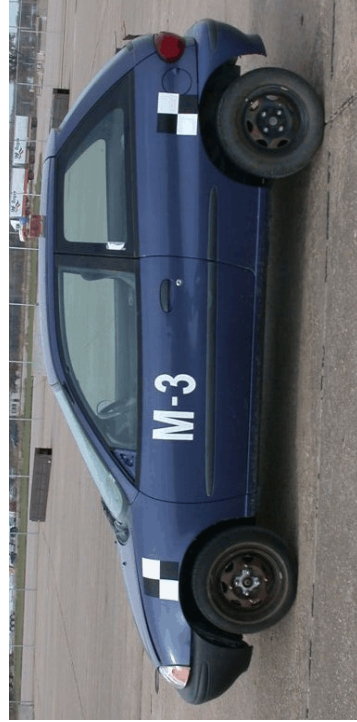
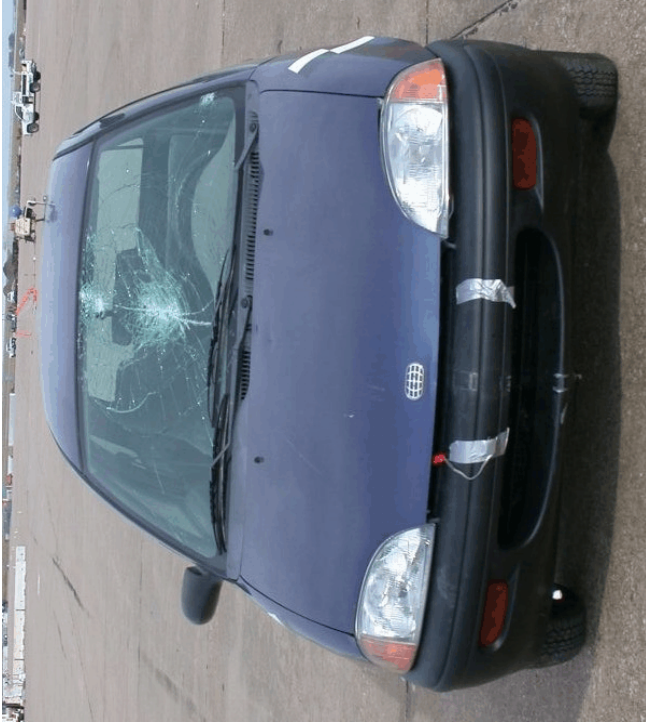
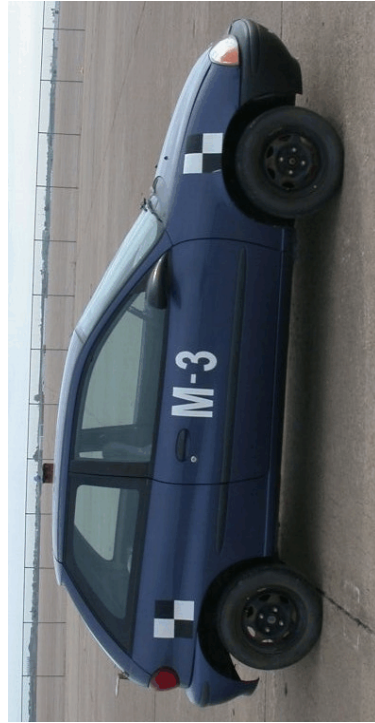
Figure 12. Vehicle Damage, Test M-3

Exterior vehicle damage is shown in Figures 12 through 14. The front bumper and lower plastic shield encountered light contact marks near the center. Contact and scrape marks were also found on the hood and roof. Two small dents were found near the top portion of the hood. The center of the windshield sustained extensive “spider web” cracking of both layers of the glass, causing weak spots. This region of the windshield was also deformed toward the interior of the vehicle with a concentrated indentation. A 32-mm (1 ¼-in) concentrated indentation occurred 89 mm (3 ½ in.) from the top of the windshield. Concentrated indentations were also found at both outer edges of the windshield. A significant amount of windshield glass had fractured off and was found in the interior of the vehicle. No damage was found to have occurred to the parking lights, headlights, and fog lights.

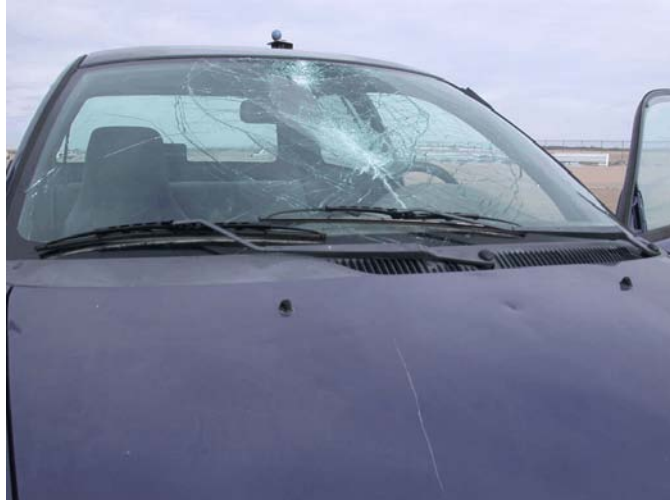
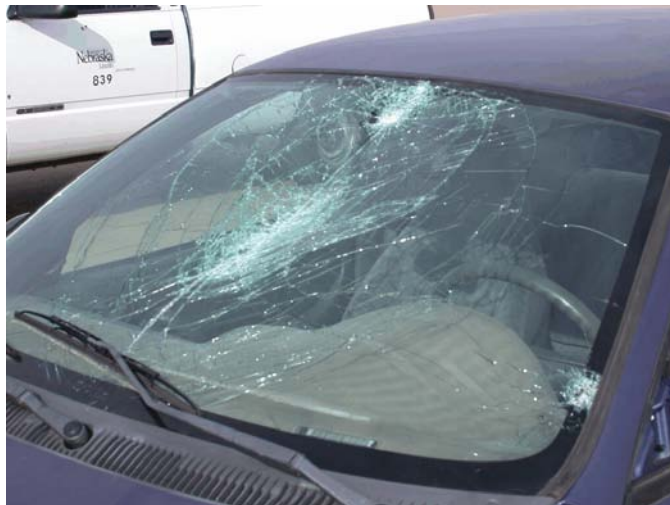
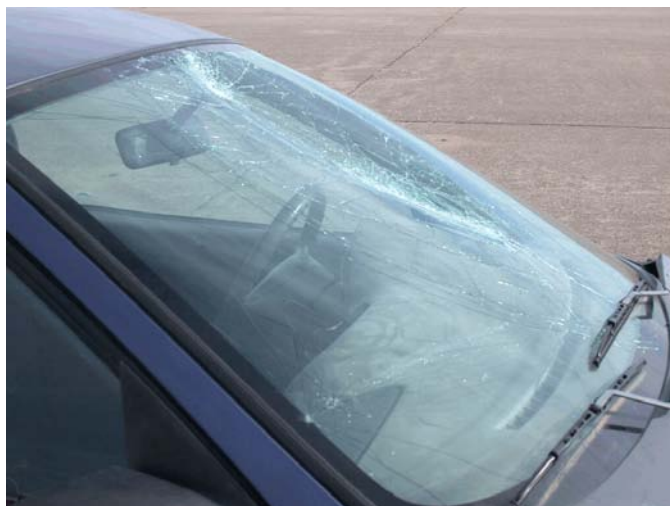
Figure 13. Windshield Damage, Test M-3

Following test M-3, a safety performance evaluation was conducted, and the work-zone traffic control device, System No. 3, was determined to be unacceptable according to the NCHRP Report No. 350 criteria. It was deemed unacceptable due to the extensive “spider web” cracking and indentation in the windshield which resulted in obstructed driver visibility and loss of structure of both glass layers. Detached elements and debris from System No. 3 did not penetrate, but showed potential of windshield penetration. Deformations of, or intrusion into, the occupant compartment did occur. The vehicle’s trajectory did not intrude into adjacent traffic lanes.

Following an analysis of the test results, the researchers determined that the quick release of the vertical crossbrace from the panel-to-post bracket led to the system failure. The sign panel had developed significant flex toward the vehicle prior to its release from the bracket. This downward panel movement toward the windshield, followed by the panel release, caused the concentrated impacts on the windshield.

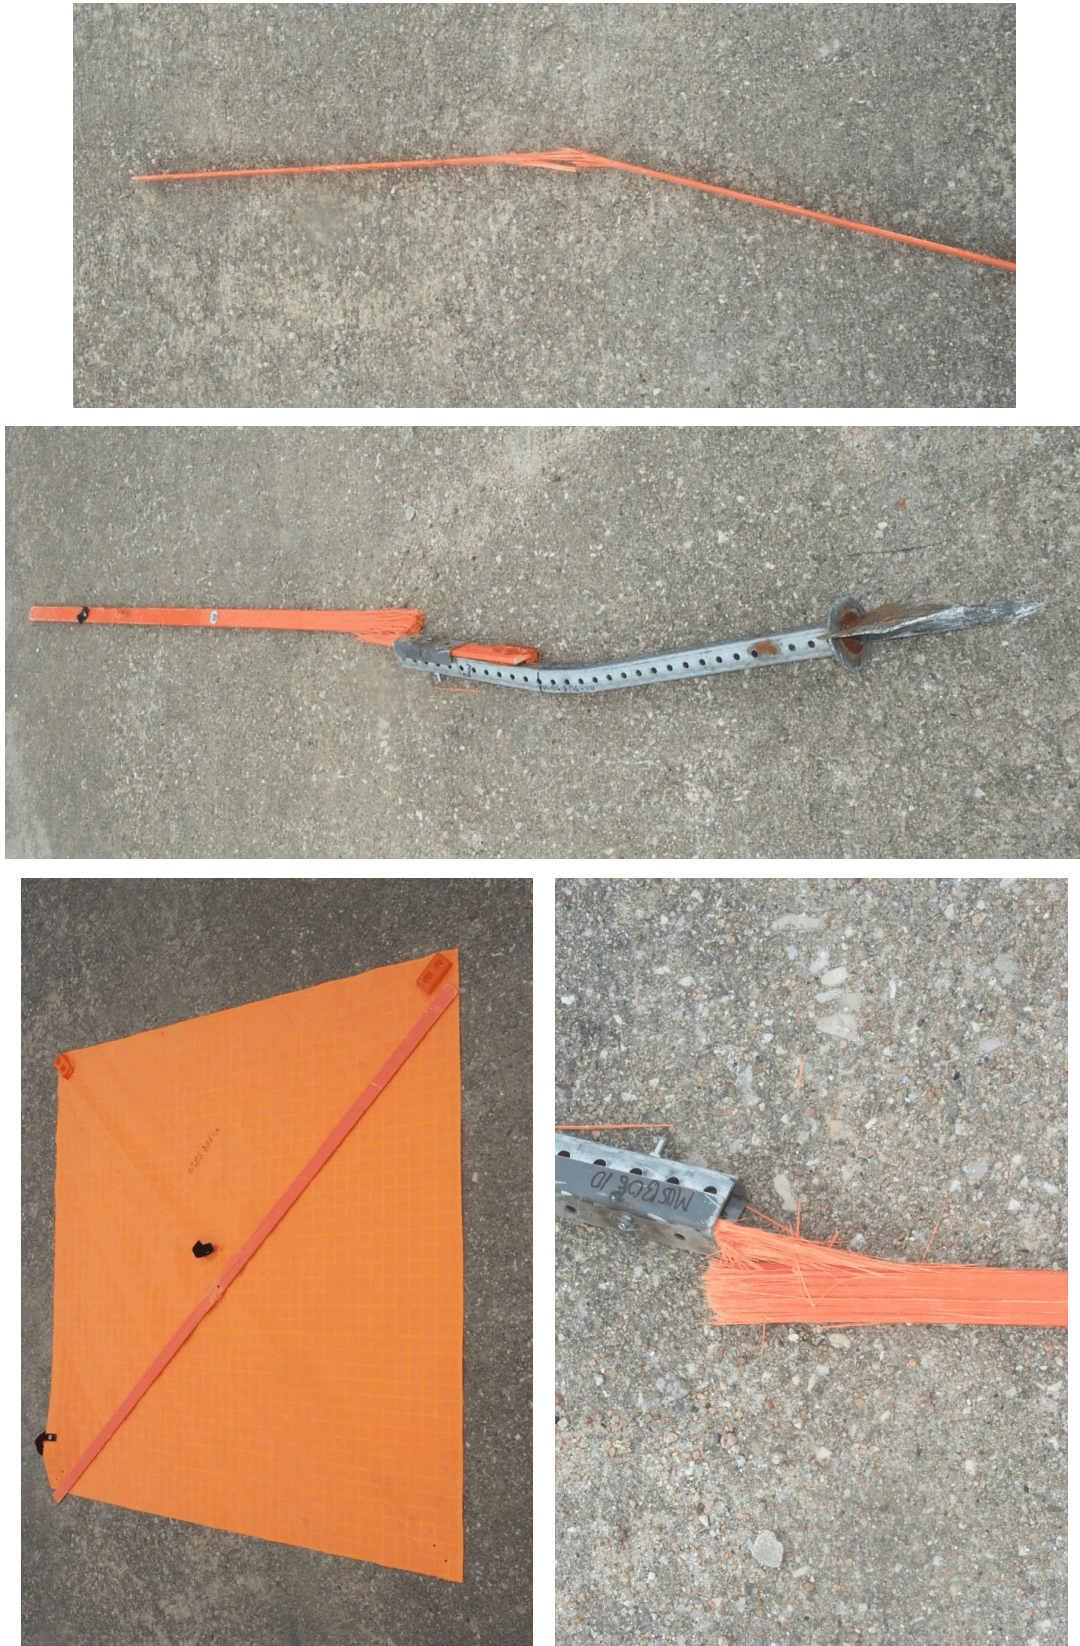
Figure 23. System Damage, Bogie Test MOSBOG-10

Damage to the modified system is shown in Figure 23. The system encountered moderate damage. The sign post deformed at the area of bumper impact. The sign panel vinyl was removed from the horizontal and vertical crossbraces. The vertical crossbrace remained attached to the sign post but encountered extensive splintering at the top of the sign post. The horizontal crossbrace disengaged from the vertical crossbrace, and the middle of the crossbrace encountered extensive fiberglass splintering. The soil plate on the sign post was deformed at the top. The sign post was pulled completely out of the ground. Both fiberglass crossbraces contacted the hood region, but no contact nor damage to the windshield area was observed. Furthermore, the system traveled along with the bogie. Subsequently, the bogie vehicle traversed over the deformed system in a stable manner.

Following the developmental bogie test MOSBOG-10, an evaluation was conducted, and the modified work-zone traffic control device performed acceptably in the bogie crash test. The modified system performed as expected, with the vertical crossbrace remaining attached to the sign post. If a small car would have been used in place of the bogie vehicle, the system would have deformed around the bumper at the front of the small car. Along with the deformation around the

front of the small car, the sign panel and crossbraces would have impacted the hood region of the vehicle. With this, it is believed that the system would not have become a potential hazard to the vehicle nor the occupant compartment. Therefore, the system's performance was acceptable in the 0 degree orientation.

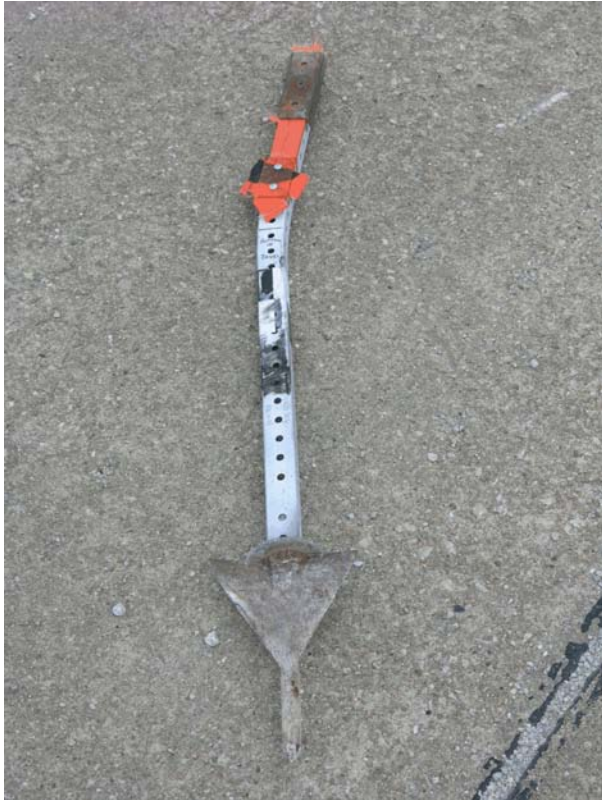
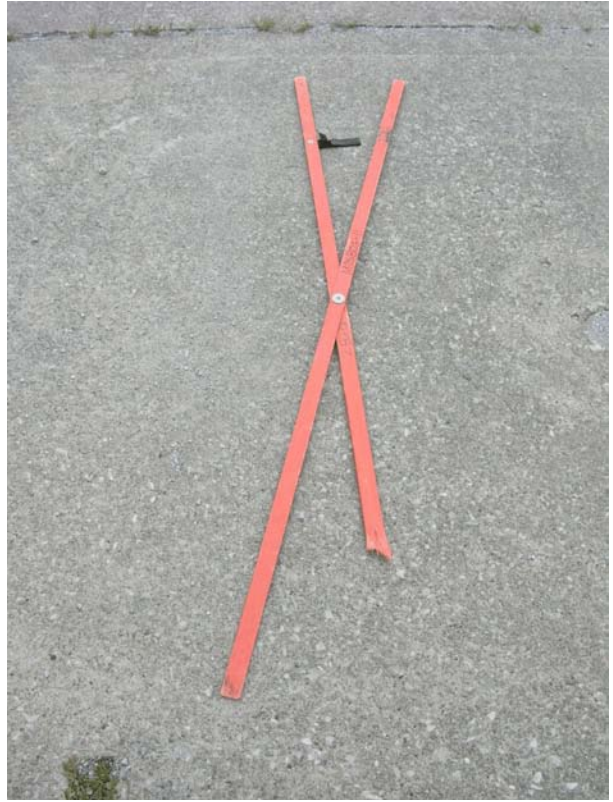
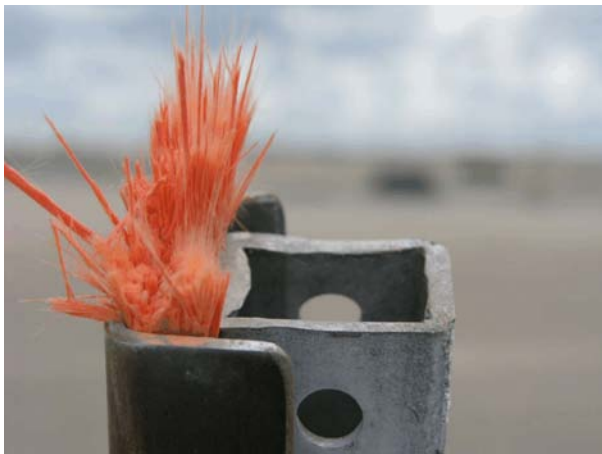
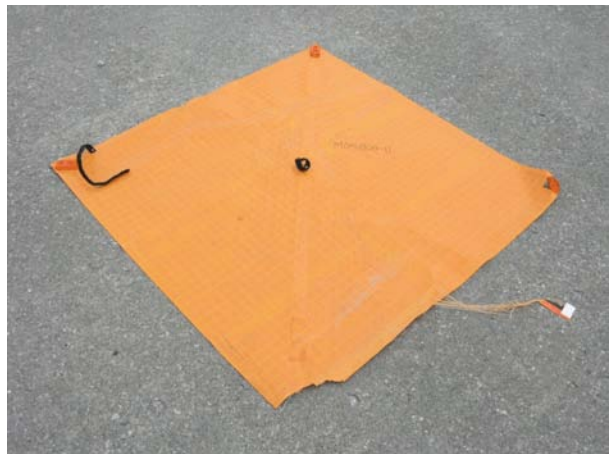
Figure 28. System Damage, Bogie Test MOSBOG-11 (90 degrees)

Damage to the modified system is shown in Figure 28. The system encountered moderate damage. The sign post deformed at the area of bumper impact. The sign panel vinyl was removed from the horizontal and vertical crossbraces. The vertical crossbrace fractured at the top of the sign post and encountered extensive fiberglass splintering at the fracture point. The bottom crossbrace bracket was removed from the sign panel vinyl and remained attached to the bottom of the vertical crossbrace. The soil plate on the sign post was slightly deformed. The sign post was pulled completely out of the ground. Both fiberglass crossbraces contacted the hood region, but no contact nor damage to the windshield area was observed. Furthermore, the system traveled along with the bogie. Subsequently, the bogie vehicle traversed over the deformed system in a stable manner.

Following the compliant bogie test MOSBOG-11, an evaluation was conducted, and the modified work-zone traffic control device performed acceptably in the bogie crash test. The modified system performed as expected, with the vertical crossbrace remaining attached to the sign post until the vehicle passed over the system. If a small car would have been used in place of the bogie vehicle, the system would have deformed around the bumper at the front of the small car. Along with the deformation around the front of the small car, the sign panel and crossbraces would

have impacted the hood region of the vehicle. With this, it is believed that the system would not have become a potential hazard to the vehicle nor the occupant compartment. Therefore, the system's performance was acceptable in the 90 degree orientation.

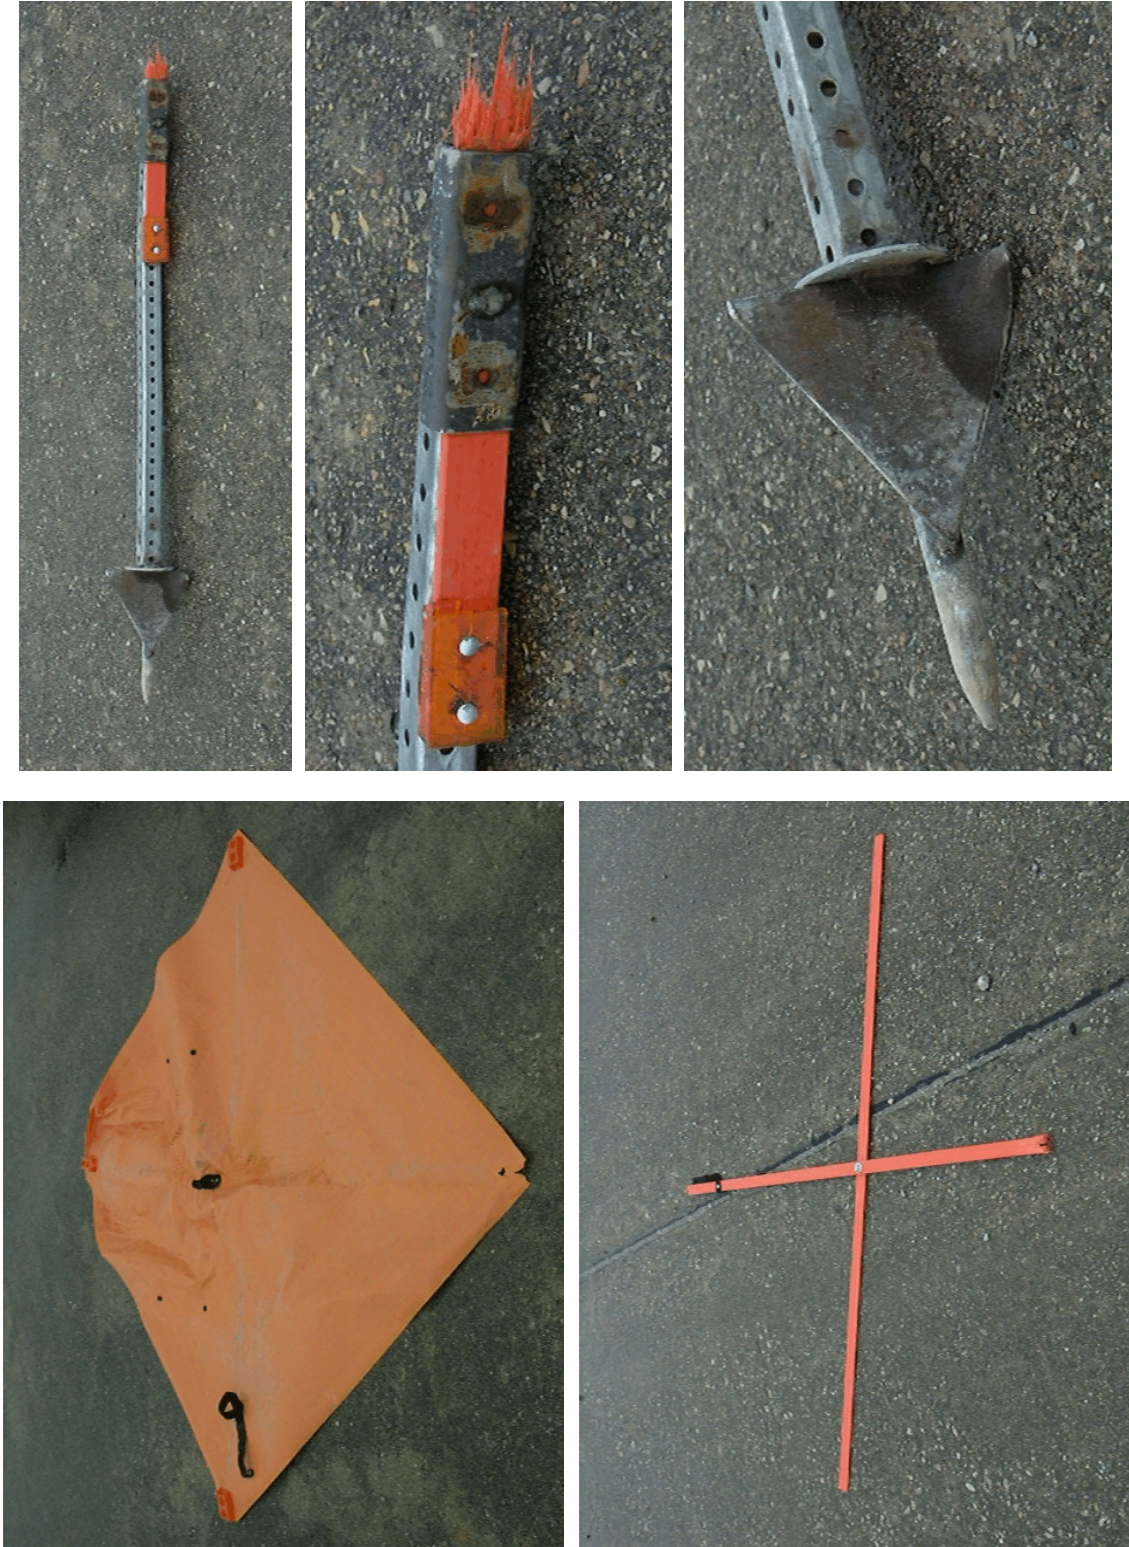
Figure 33. System Damage, Bogie Test MOSBOG-12 (0 degrees)

Damage to the modified system is shown in Figure 33. The system encountered moderate damage. The sign post deformed at the area of bumper impact. The sign panel vinyl was removed from the horizontal and vertical crossbraces. The vertical crossbrace fractured at the top of the sign post and encountered extensive fiberglass splintering at the fracture point. The bottom crossbrace bracket was removed from the sign panel vinyl and remained attached to the bottom of the vertical crossbrace. The soil plate on the sign post was deformed at the top. The sign post was pulled completely out of the ground. Both fiberglass crossbraces contacted the hood region, but no contact nor damage to the windshield area was observed. Furthermore, the system traveled along with the bogie. Subsequently, the bogie vehicle traversed over the deformed system in a stable manner.

region of the vehicle. Due to fracturing of the vertical crossbrace, the crossbraces traveled toward the vehicle after contact with the hood. However, it is believed that contact with the windshield never occurred. Therefore, the system's performance was acceptable in the 0 degree orientation.

It should be noted that there was an extra hole drilled in the vertical fiberglass crossbrace near the top of the sign post. It is believed that this caused a stress concentration point and caused the vertical crossbrace to fracture completely. When compared to the results of the developmental bogie test MOSBOG-10 on an identical system, without an extra hole in the crossbrace, the vertical crossbrace did not fracture completely. It is believed that the system's performance would be similar to that of bogie test MOSBOG-10 without the extra hole as it was designed. Thus, the system performed in an acceptable manner with and without a hole drilled in the vertical fiberglass crossbrace slightly above the top of the sign post.
