DEVELOPMENT OF A W-BEAM GUARDRAIL SYSTEM FOR USE ON A 2:1 SLOPE

MwRSF Research Report No. TRP-03-99-00

October 16, 2000

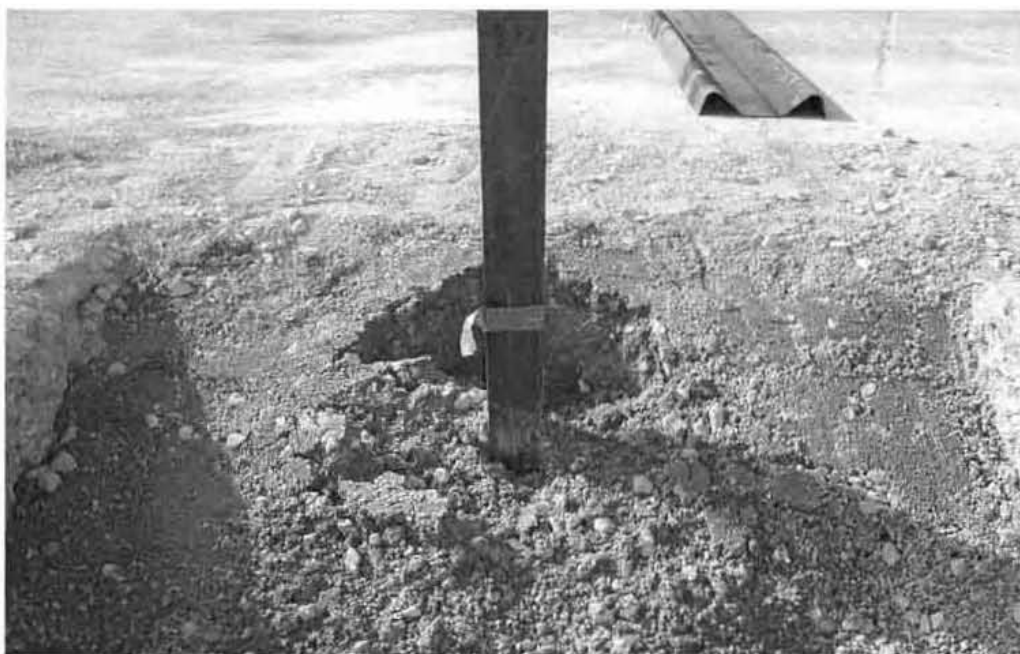
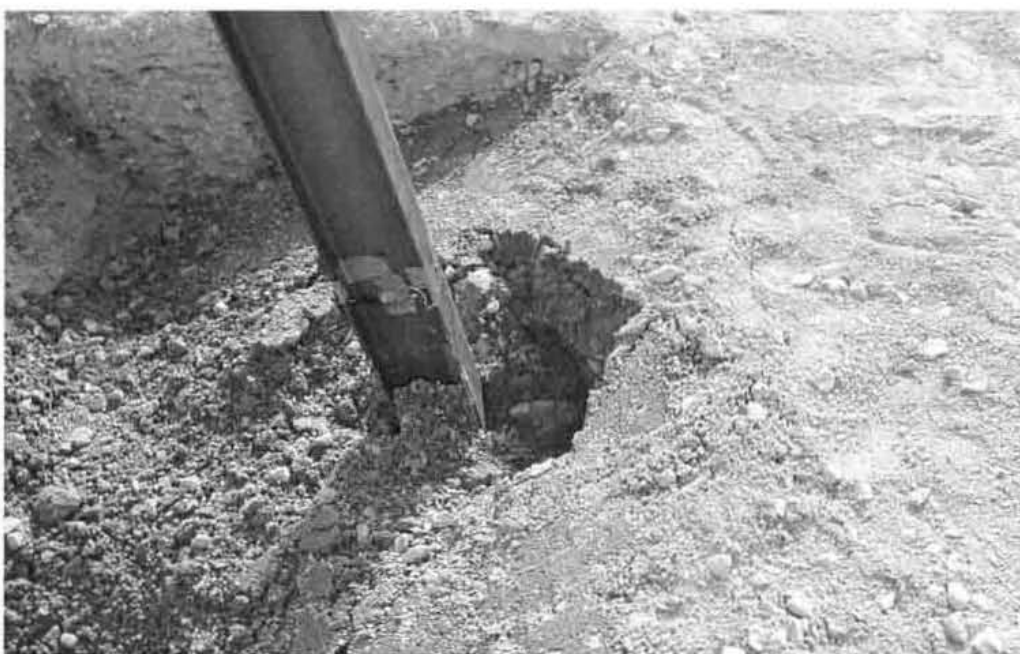
Figure 3. Post Damage and Soil Failure, Bogie Test MSB-1

Six bogie tests were performed and are summarized in Table 3. Force-deflection plots for each post test are shown graphically in Appendix A. Post damage and soil failure for each bogie test are shown in Figures 3 through 8. For all of the bogie impacts, it is noted that the primary mode of failure occurred in the soil rather than with post yielding.

Test No.	Speed (km/hr)	Peak Load (kN)	Deflection at Peak Load (mm)	Results
MSB-1	23.3	117.7	67.8	Small soil failure at front of post, post rotation
MSB-2	25.3	79.3	60.7	Large soil failure at front of post
MSB-3	23.2	64.6	63.5	457-mm radius soil failure at front of post
MSB-4	23.2	77.5	53.6	381-mm radius soil failure at front of post
MSB-5	21.7	41.3	72.9	305-mm radius soil failure at front of post
MSB-6	34.1	136.2	96.3	No soil failure at the front of the post, post slightly twisted during rotation, post bent 1.4 m from the top with maximum deflection of 121 mm

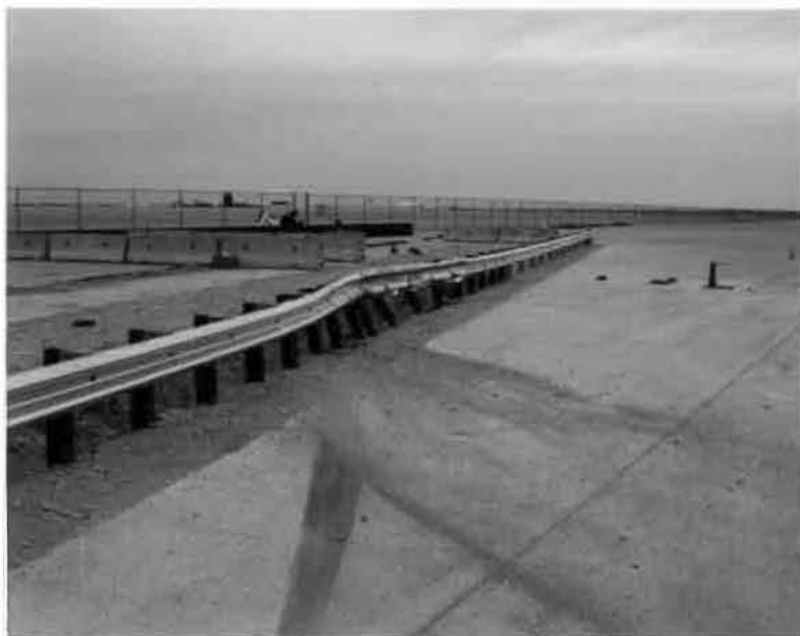
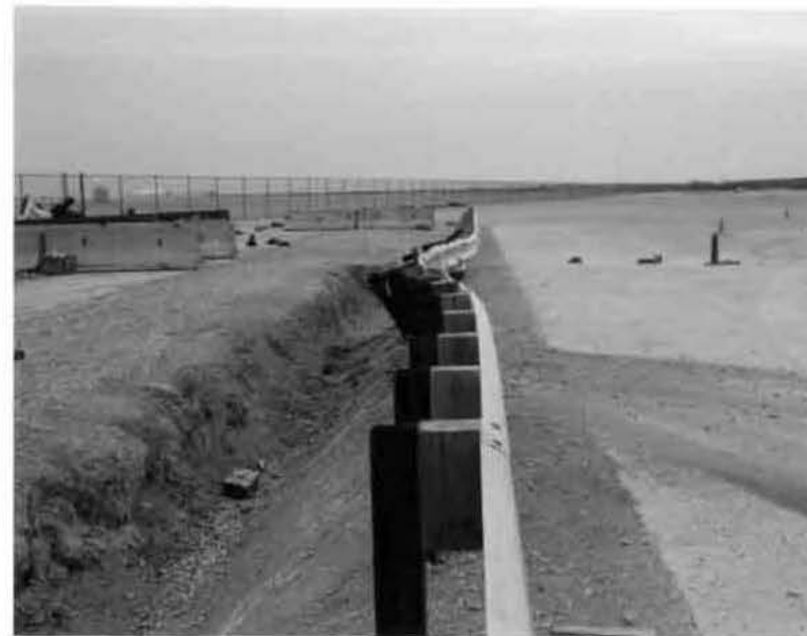
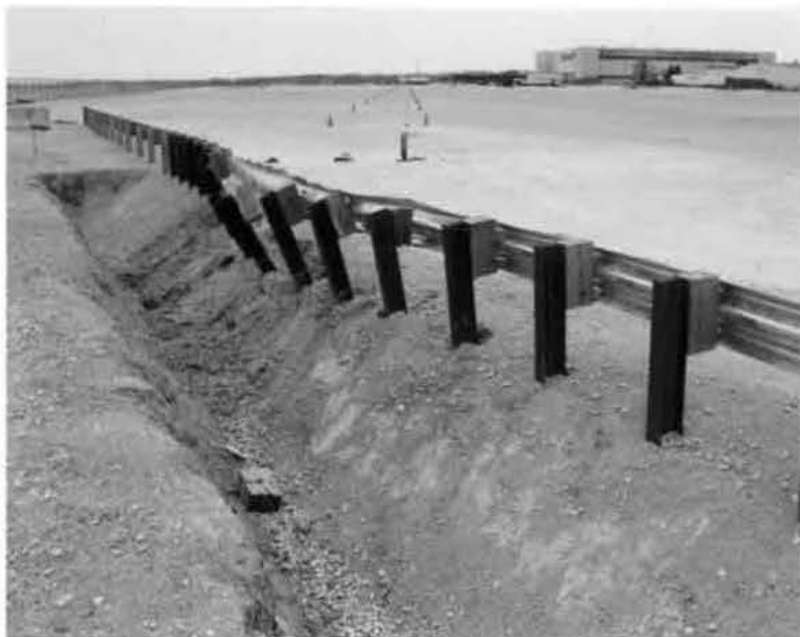
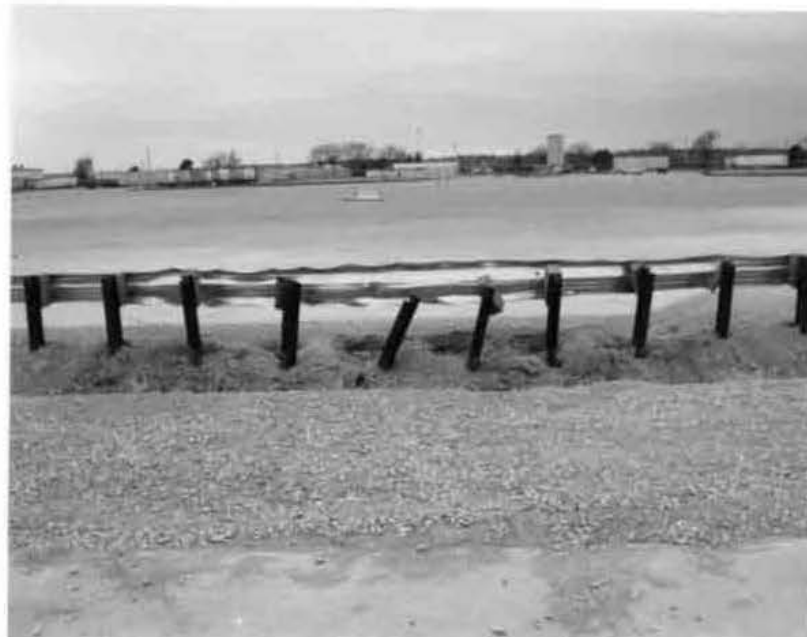
Figure 26. W-beam Guardrail System Damage, Test MOSW-1

Damage to the barrier was moderate, as shown in Figures 26 through 35. Barrier damage consisted mostly of deformed W-beam, contact marks on a guardrail section, and deformed guardrail posts. The W-beam damage consisted of moderate deformation and flattening of the lower portion of the impacted section between post nos. 17 and 25. Contact marks were found on the guardrail between post nos. 17 and 25. The W-beam rail was pulled off of post nos. 18 through 21.

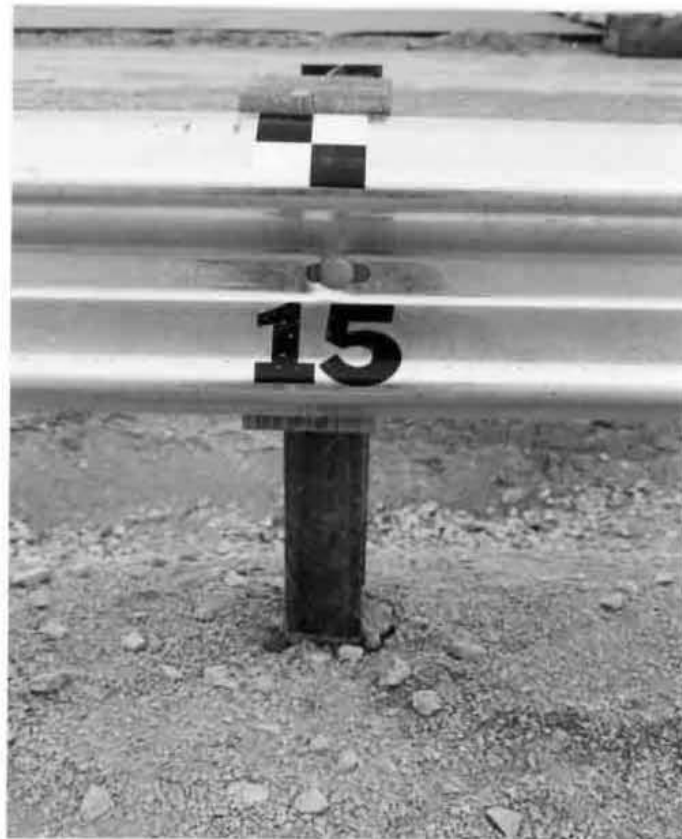
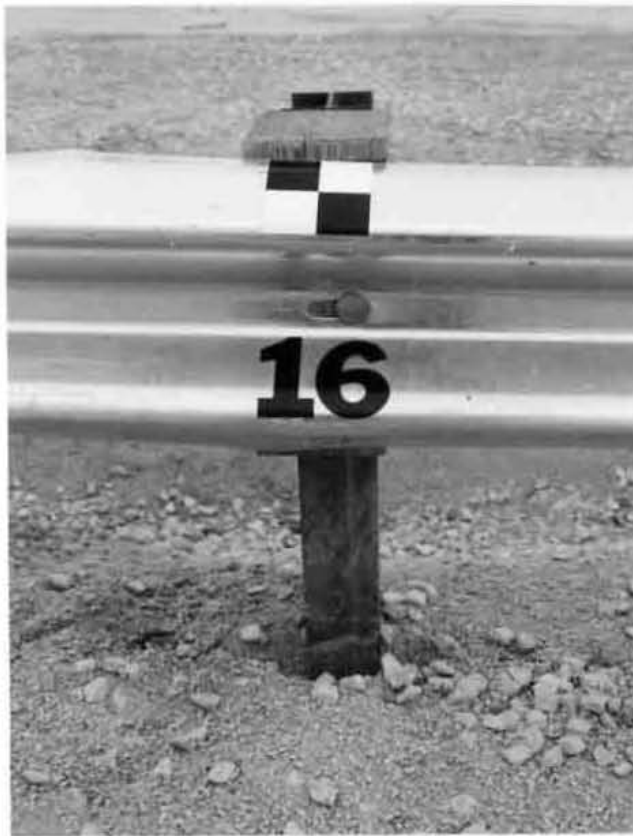
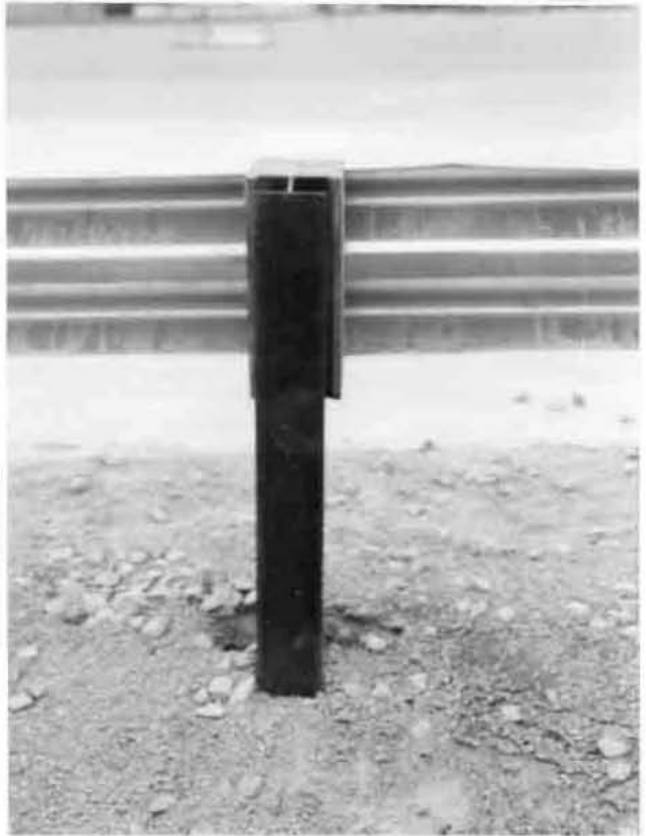
Figure 28. Post Nos. 15 and 16 Damage, Test MOSW-1

Steel post nos. 3 through 11 twisted in the CW direction when viewed from the traffic-side face of the rail. Steel post nos. 12 through 16 also twisted CW and were slightly rotated backward. Steel post nos. 17 and 18 twisted and rotated backward with major soil failure visible at the ground level. The front flanges on steel post nos. 19 and 20 encountered moderate plastic deformations due to the wheel contact with the posts. Post yielding damage was also found on post nos. 19 and 20, as shown in Figures 31 and 32. Steel post nos. 19 through 23 twisted CW, rotated, and were bent toward the ground. Steel post nos. 24 through 26 rotated backward. No significant post damage occurred to post nos. 27 through 36. Both the upstream and downstream anchorage systems were slightly moved longitudinally, but the posts were not damaged.

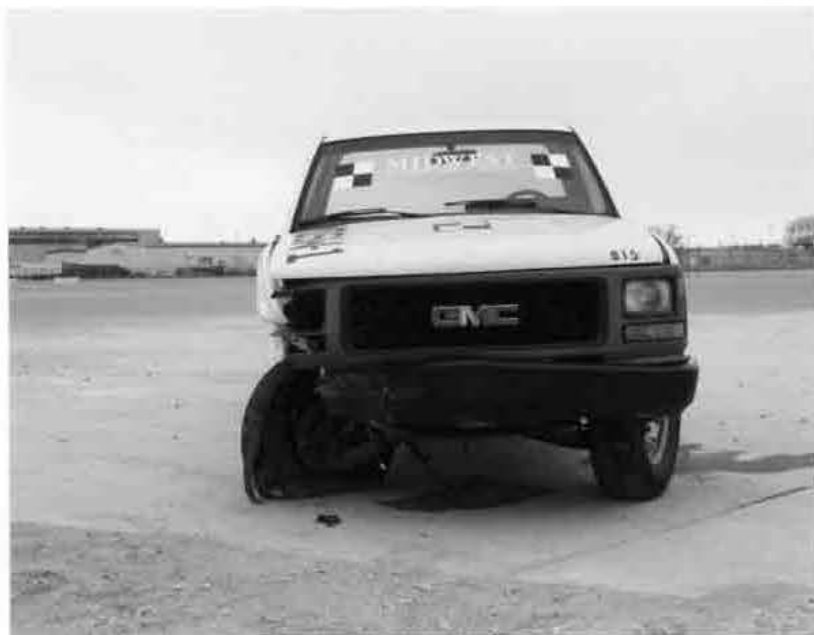
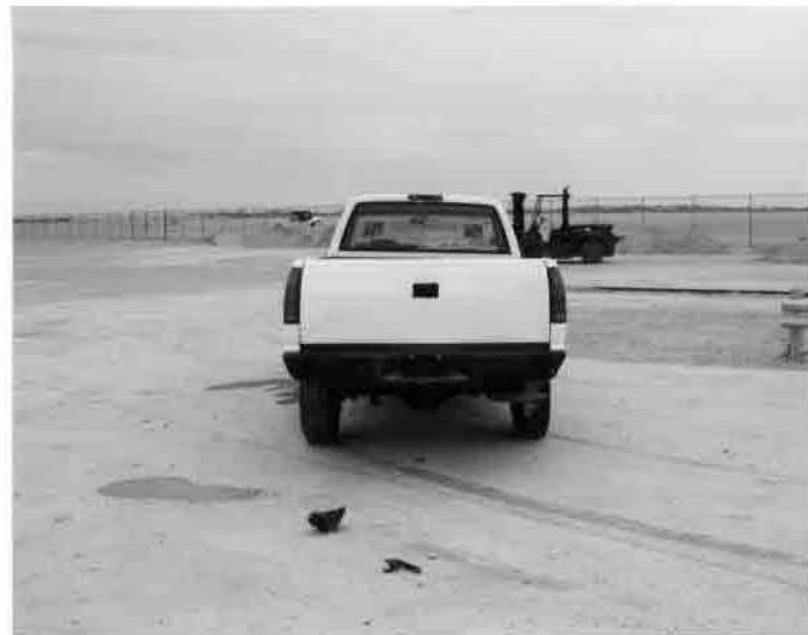
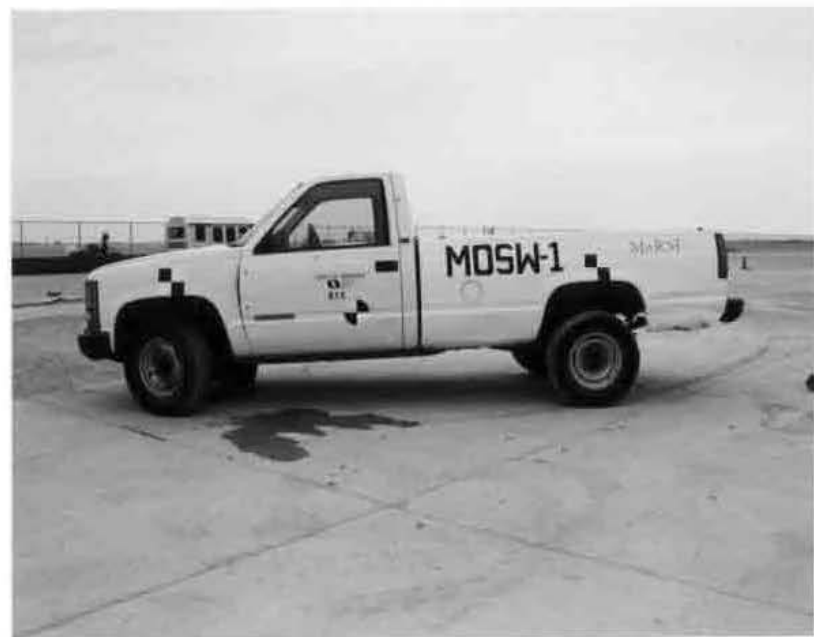
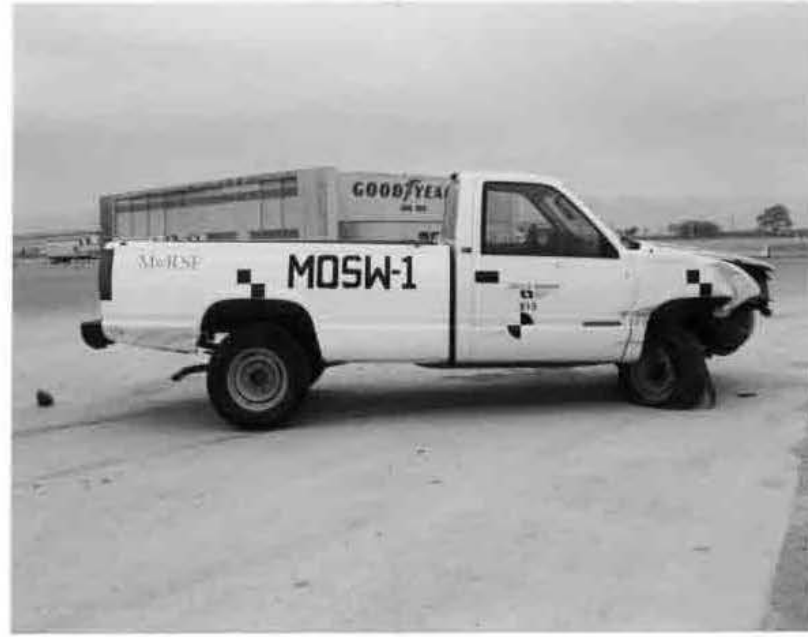
Figure 37. Vehicle Damage, Test MOSW-1

Exterior vehicle damage was minimal, as shown in Figures 37 and 38. Interior occupant compartment deformations were determined to be negligible. The right-front quarter panel was crushed inward and downward, and the right side of the front bumper was also bent back toward the engine compartment. The right-front wheel assembly was deformed slightly, including contact marks and slight deformations on the rim and disengagement of the tie-rod. The right-front tire was also deflated. Small contact marks were found on the lower-right side of the front fender and right-side door frame. The grill was only broken and deformed around the right-side headlight. No other damage to the vehicle was observed.
