DESIGN AND EVALUATION OF AN OPEN COMBINATION TRAFFIC/BICYCLE BRIDGE RAILING SYSTEM

MIDWEST ROADSIDE SAFETY FACILITY

MwRSF Research Report No. TRP-03-162-07

February 9, 2007

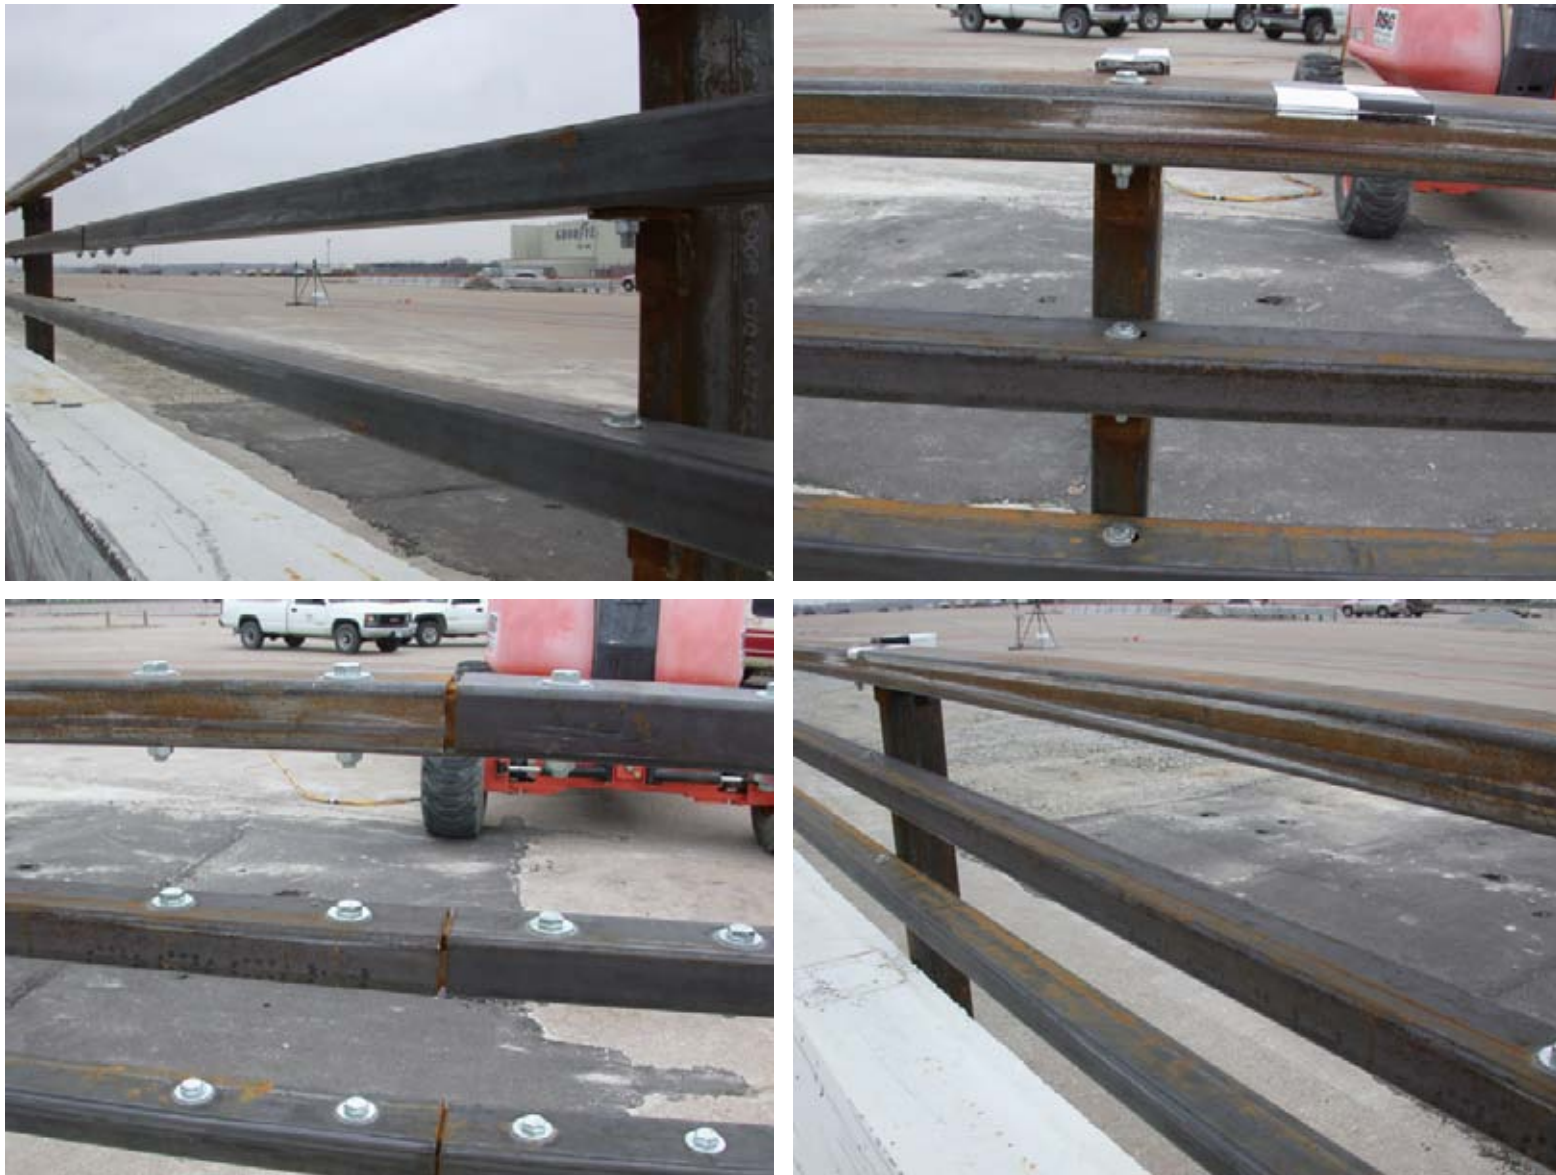
Figure 28. System Damage, Test MOBR-1

Damage to the combination traffic/bicycle bridge rail was minimal, as shown in Figures 27 through 28. Barrier damage consisted of contact and gouge marks on the concrete parapet, contact marks on the bicycle rail, and pull out of attachment bolts. The length of vehicle contact along the combination bridge rail was approximately 3 m (10 ft - 5 in.), which spanned from 533 mm (21 in.) upstream from post no. 3 through 460 mm (16 in.) upstream from the centerline of post no. 4.

Heavy scrapes from the wheel or bumper were located at 356 mm (14 in.) upstream from the centerline of post no. 3. A heavily-defined circular wheel mark was found on the front face of the concrete barrier at 610 mm (24 in.) downstream from the centerline of post no. 3. A 152-mm (6-in.) long gouge in the front face of the concrete barrier was found 152 mm (6 in.) upstream from post no. 3.

Contact marks were found on the upper rail of the bicycle rail beginning at the splice between post nos. 3 and 4 and ending 1,270 mm (50 in.) upstream from post no. 5. Contact marks were found on the front face of the lower and middle rails, starting at the splice between post nos. 3 and 4 to 914 mm (36 in.) downstream from the splice. Light contact marks were found on the bottom and top faces of all three rails. The top two bolts attaching post nos. 2 and 3 to the concrete barrier pulled 6 mm to 13 mm (1/4 in. to 1/2 in.) out of the concrete.

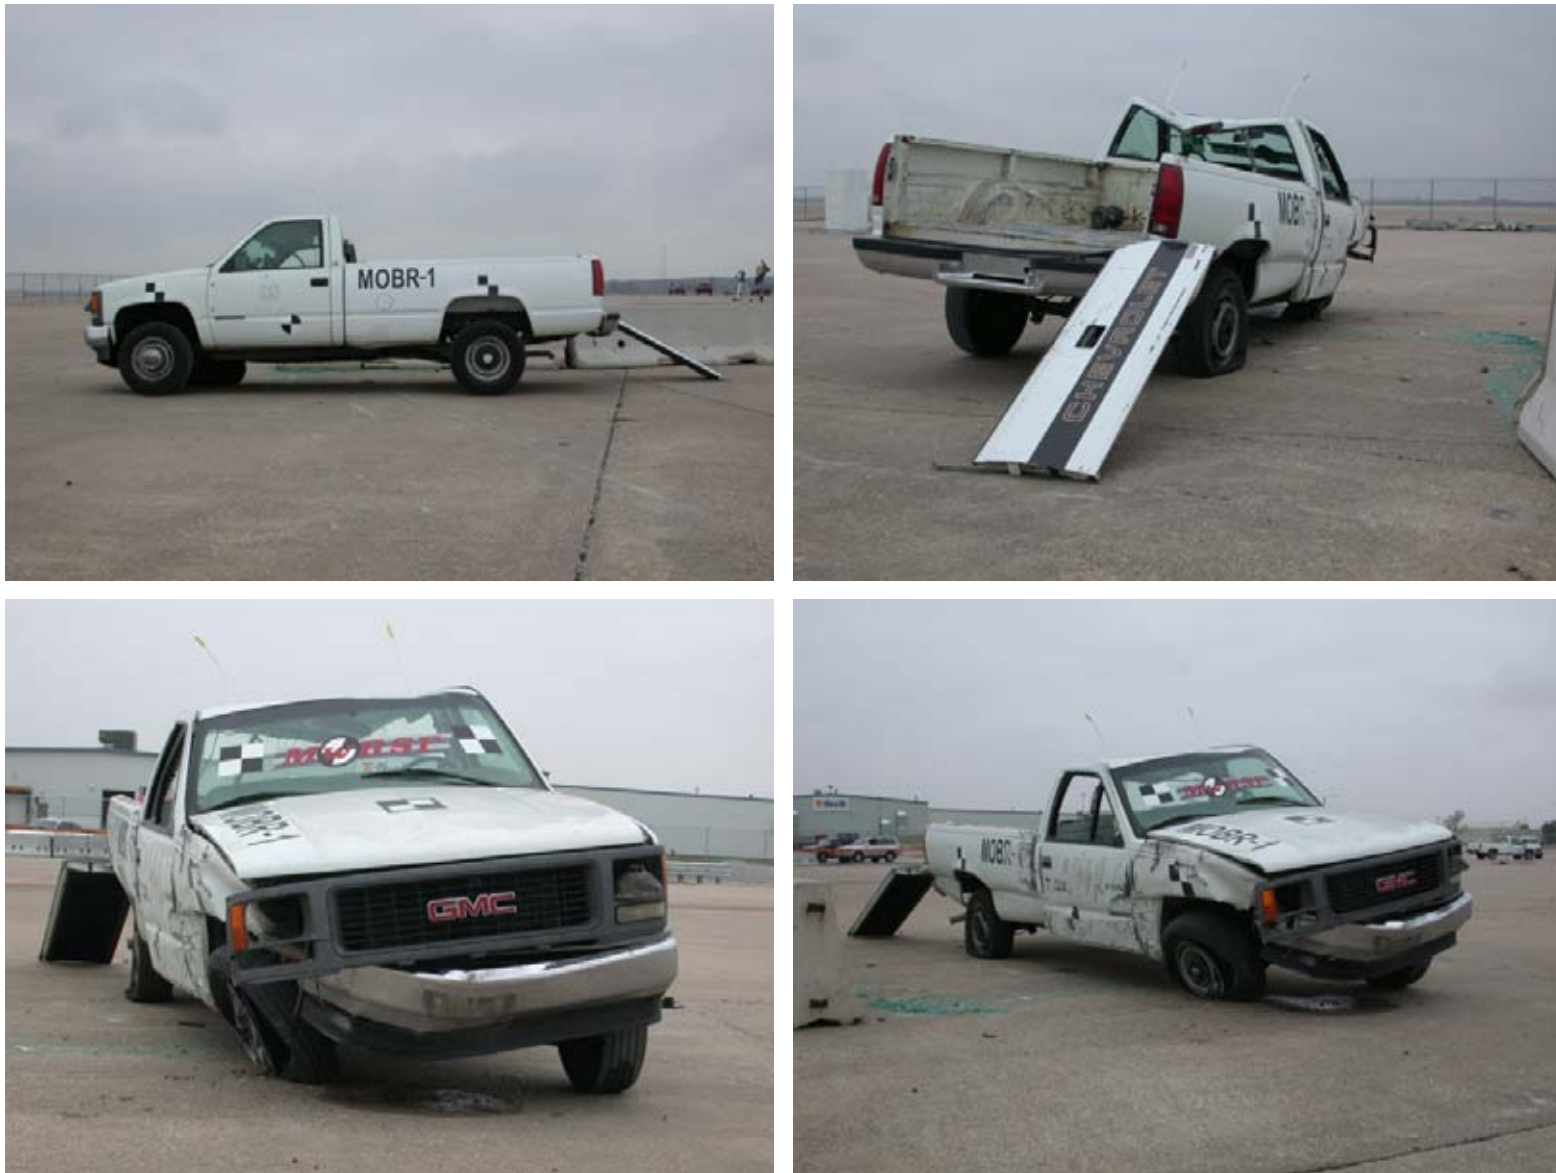
Figure 29. Vehicle Damage, Test MOBR-1

Exterior vehicle damage was extensive, as shown in Figures 29 through 33. Extensive occupant compartment deformations occurred due to vehicle rollover. Moderate deformations occurred near the center of the right-side floor pan. The majority of the vehicle damage was concentrated on the passenger side and front of the vehicle. The front bumper buckled at the centerline. The headlight assemblies were detached. The right side of the grill encountered significant damage and deformation. The right side of the front bumper was deformed and encountered white paint marks from the barrier. The right-front quarter panel was crushed inward and downward. The right-side wheel assembly was deformed severely backward into the frame. The right-side upper A-frame disengaged. The transmission housing and the starter housing were fractured. The frame encountered heavy tire marks due to rubbing from the deformed right-front wheel assembly. Heavy scraping and contact marks were found on the right-side door, front-right quarter panel, box, and right-front steel rim. The right-front wheel hub was ground down due to heavy scraping on the barrier. The seal between the right-front tire and rim was broken, and the tire was deflated. The left side of the roof was crushed extensively with the maximum crush occurring near the outside of the left side of the roof. The tailgate was disengaged from the vehicle. The right-side and rear windows were shattered. The windshield was heavily cracked on the left side.

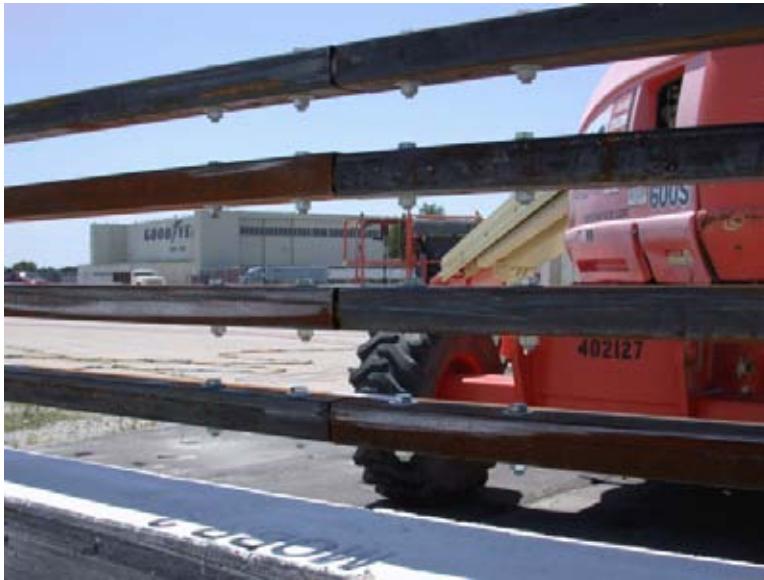
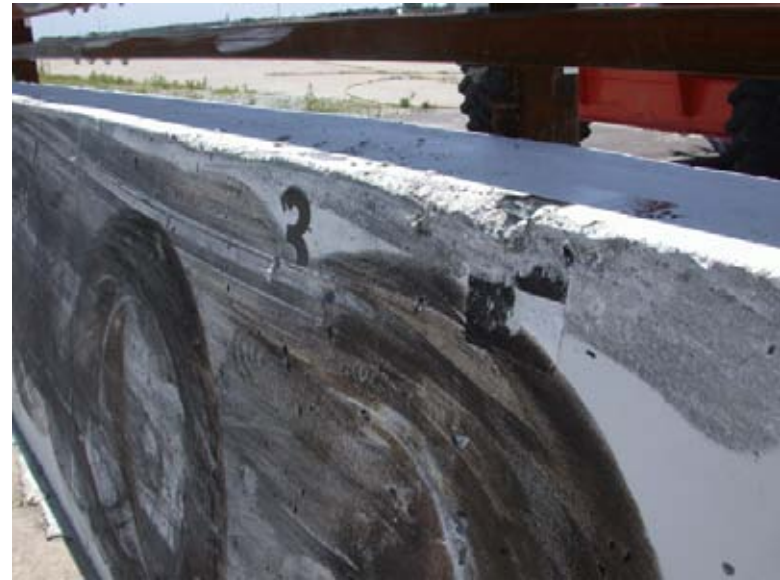
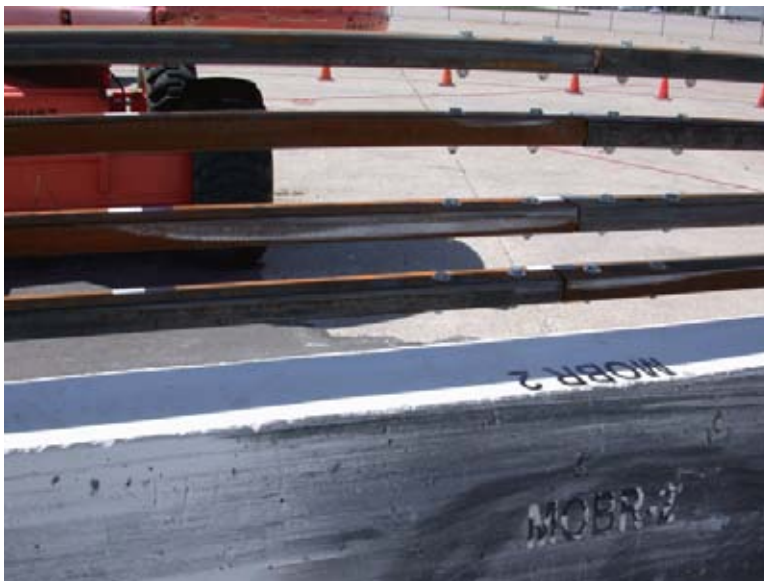
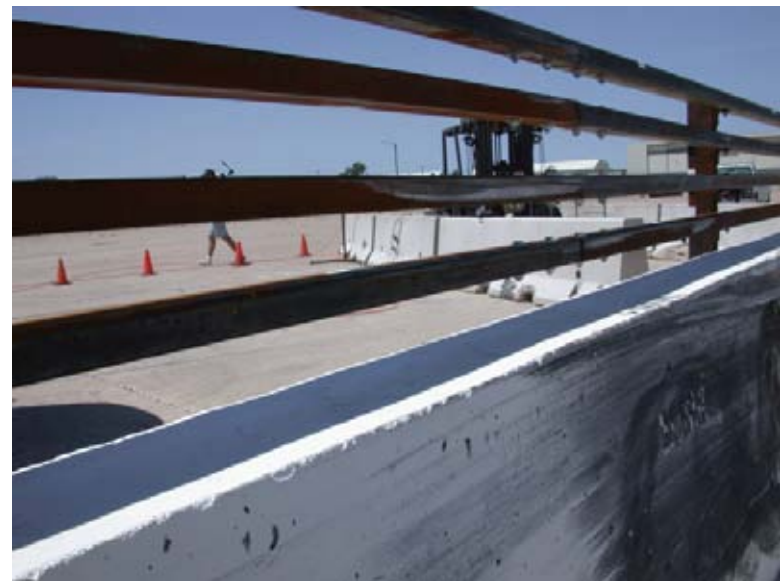
Figure 54. System Damage, Test MOBR-2

Damage to the combination traffic/bicycle bridge rail was minimal, as shown in Figures 53 and 54. Damage to the combination traffic/bicycle bridge rail consisted of contact marks and gouges on the concrete parapet and contact marks on the bicycle rail. Vehicle contact along the combination bridge rail was approximately 5.4 m (17 ft - 10 in.), which spanned 864 mm (34 in.) upstream from the centerline of post no. 3 through 1,524 mm (60 in.) downstream from the centerline of post no. 4. Tire marks began 559 mm (22 in.) upstream from the centerline of post no. 3, with a maximum

White paint marks were found on the front face of the bottom rail between 356 mm (14 in.) and 660 mm (26 in.) downstream from the centerline of post no. 3. Black rubber or plastic marks were also found on the bottom rail between 1,537 mm (60.5 in.) and 2,642 mm (104 in.) downstream from the centerline of post no. 3. Two distinct white paint marks were found on the front, bottom, and top faces of the lower-middle rail. The first mark began 330 mm (13 in.) downstream from the centerline of post no. 3 and continued for 2,007 mm (79 in.). A 6.4-mm (1/4-in.) wide by 1,384-mm (54.5-in.) long mark on the bottom face of the lower-middle rail, began 1,524 mm (60 in.) downstream from the centerline of post no. 3. The upper-middle rail encountered the most markings, with white paint on the front and bottom faces. The contact marks began 102 mm (4 in.) downstream from the centerline of post no. 3 and ended 3,327 mm (131 in.) downstream from the centerline of post no. 3. The width of these marks ranged from 6.4 mm (1/4 in.) to 51 mm (2 in.). The top rail also contained white paint and black tire marks on its front face. Six distinct marks, ranging in width from 6.4 mm (1/4 in.) to 38 mm (1 ½ in.), began 114 mm (4.5 in.) downstream from the centerline

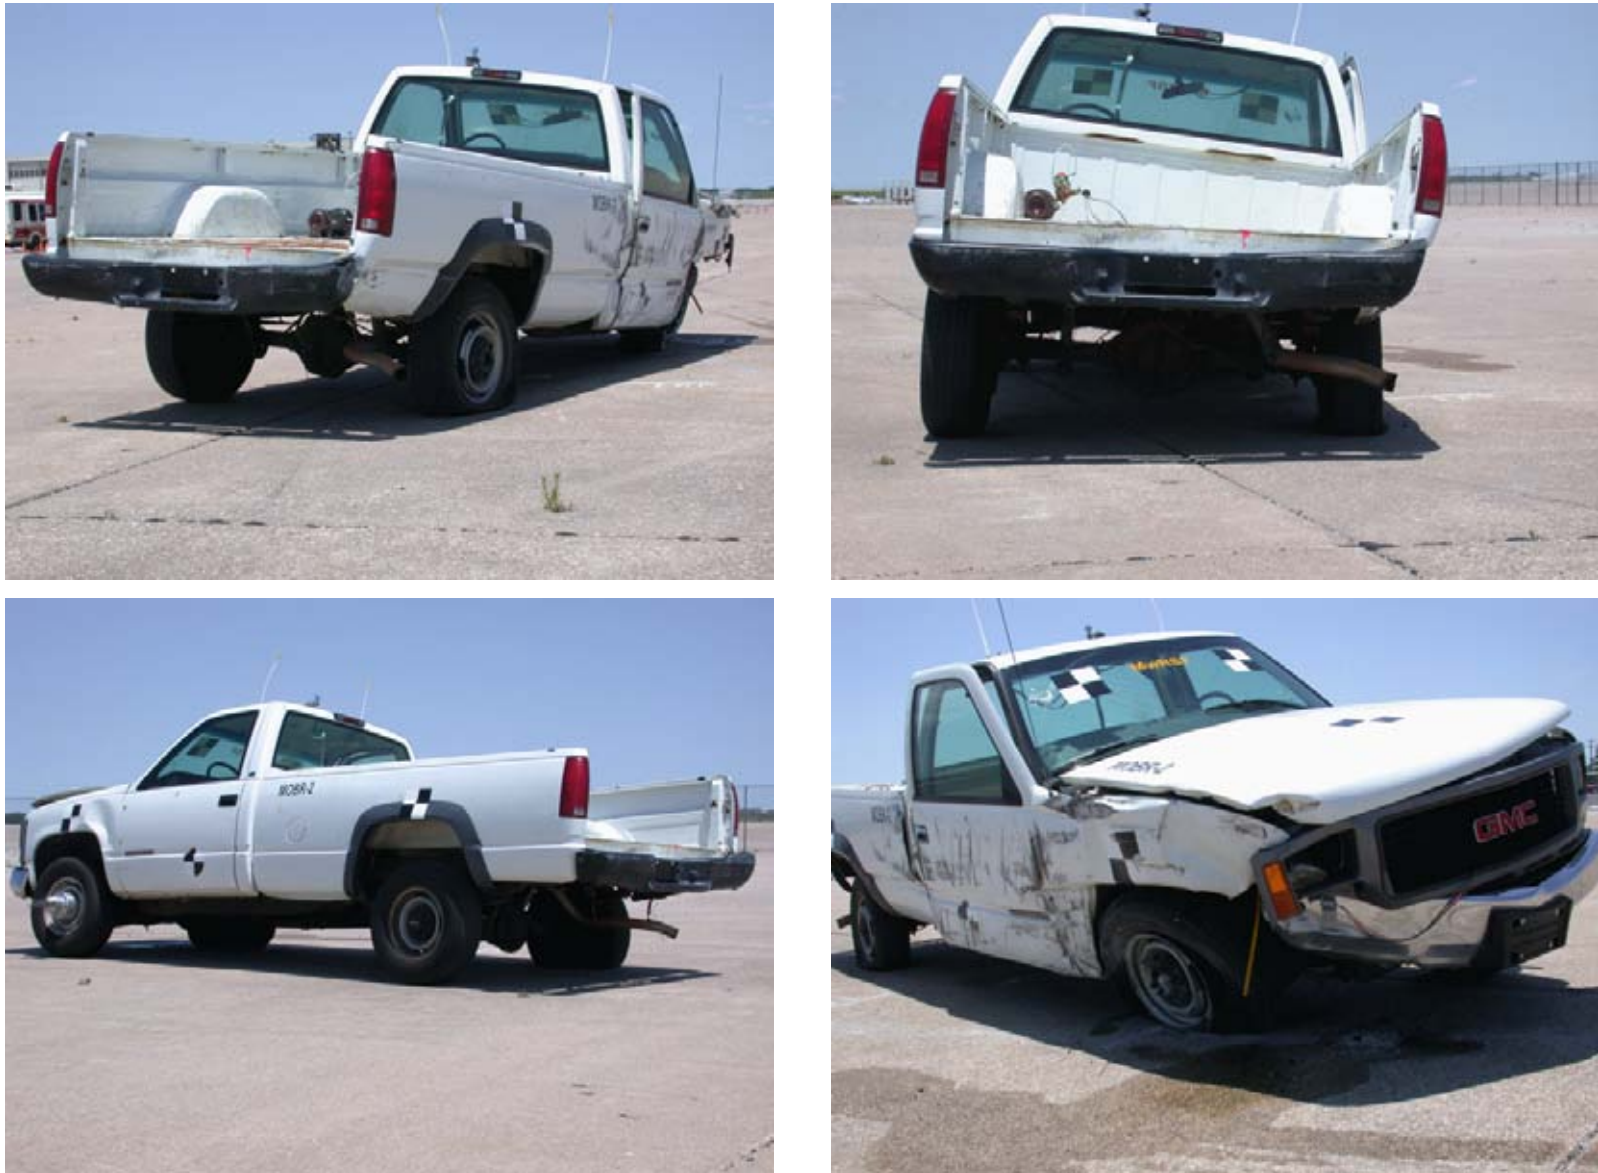
Figure 55. Vehicle Damage, Test MOBR-2

Exterior vehicle damage was moderate, as shown in Figures 55 through 59. Moderate deformation occurred near the center of the right-side floorboard, and the right side was shifted backward and inward. The majority of the vehicle damage was concentrated on the right side and the front of the vehicle. The front-right tire was pushed backward into the wheel well. The front-quarter panel was severely scratched at random locations, with concentrated scratches at the door hinge and hood joint. The right-front quarter panel was dented and buckled. The headlight housing was cracked, and the lights were pushed backward and downward into the wheel well. The front bumper was dented, scratched, and pushed back into the vehicle on the right side, and encountered a buckle point near the center.

The left side encountered only minor damage including a dent in the front quarter panel. The rear bumper was severely scratched and dented on the right side. The tailgate was detached from the vehicle. The roof suffered no damage.

The hood was latched but deformed upward on the left side and bent downward and backward on the right-front corner. The hood's hinges were severely deformed, but the hood could still be opened. The plastic grill and light housing assembly were cracked and pushed back into the wheel well. The air filter housing was cracked in half. The right-side door encountered random scratches with a high concentration at the handle height near the rear of the cab. The top of the right-side door was ajar, and the door could not be opened. The A-pillar had random scratches throughout its length and a severe dent at the bottom end. The box of the vehicle was severely scratched and dented, with minor scratches on the wheel well trim. The right-rear tire was scratched along the steel rim, and the hub cap was broken and collapsed. The right-rear tire was deflated, but the attachment and position of the wheel remained normal. The windshield showed cracks radiating outward from the bottom-center. All other glass remained undamaged.

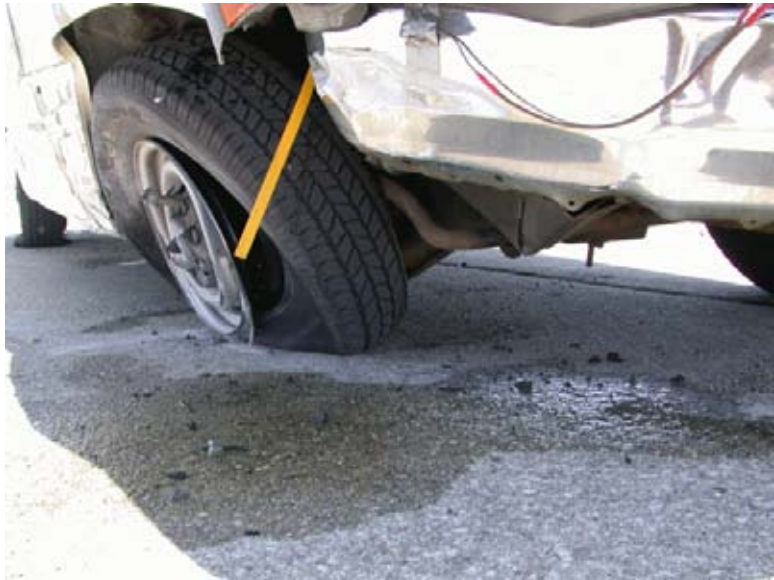
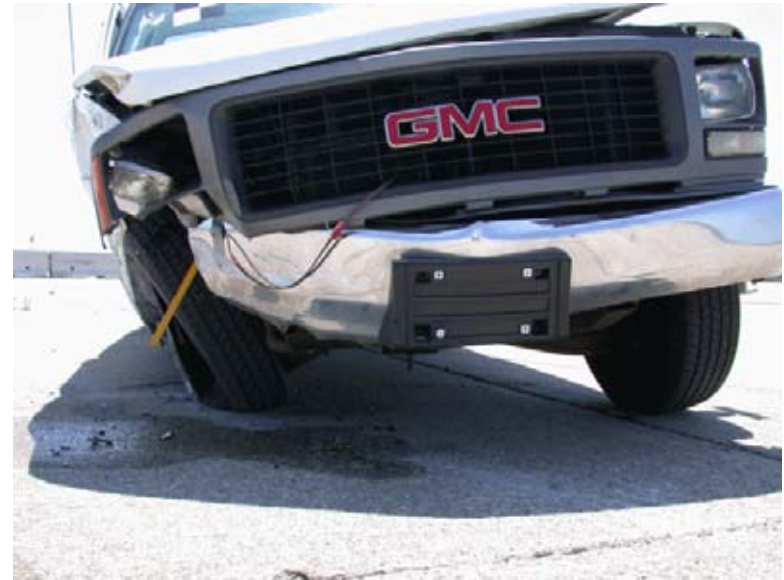
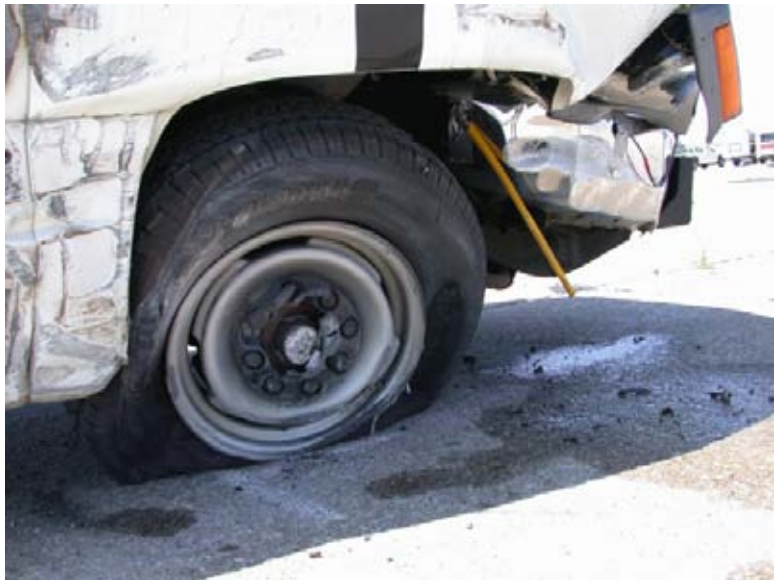
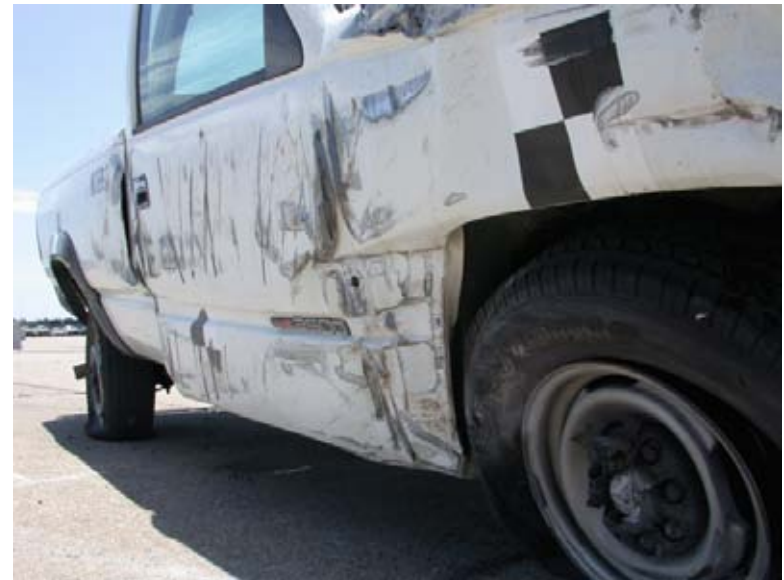
Figure 56. Vehicle Damage, Test MOBR-2

The outside steel rim of the right-front wheel was scratched, and the hub cap in the center was torn apart. The right-front tire's seal was broken, and the tire was deflated. The wheel bearing was severely scratched.

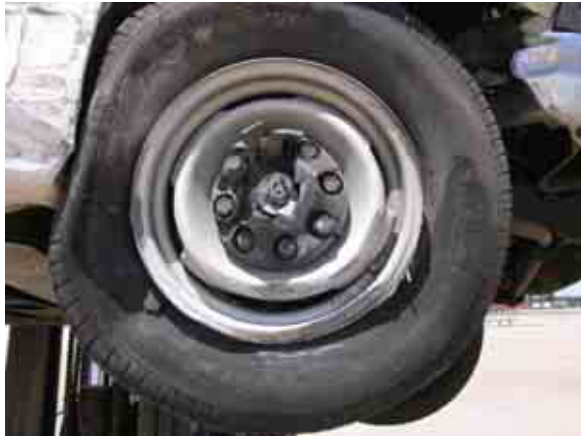
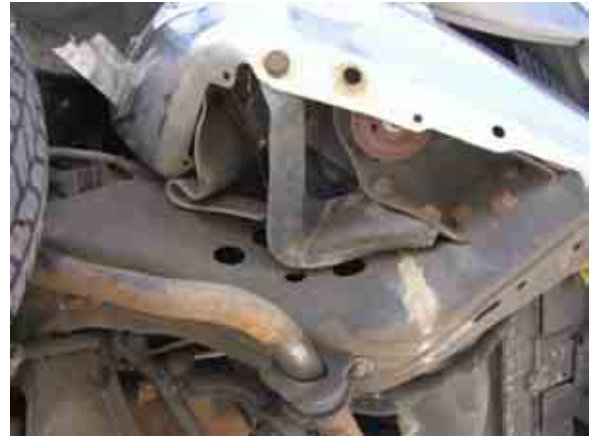
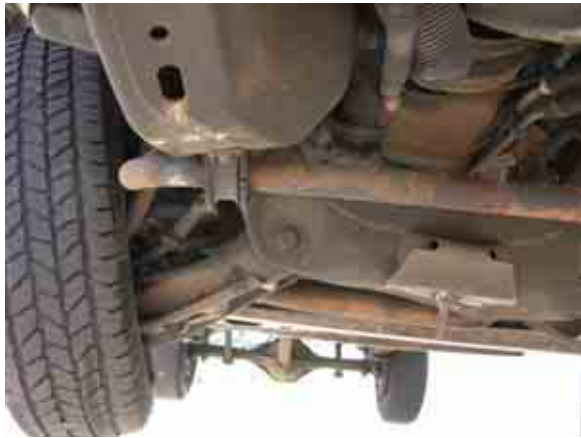
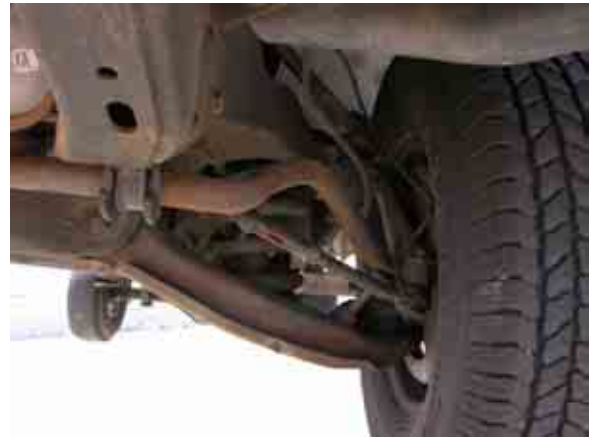
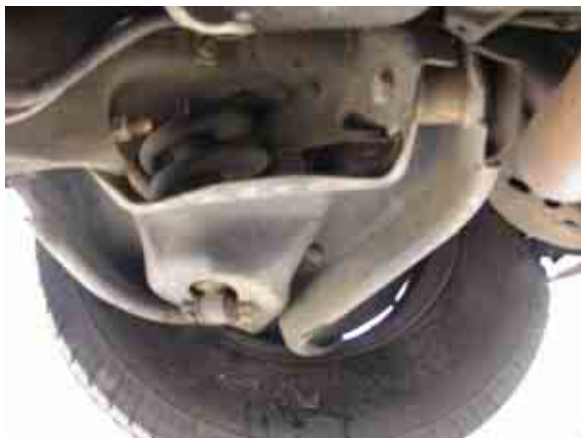
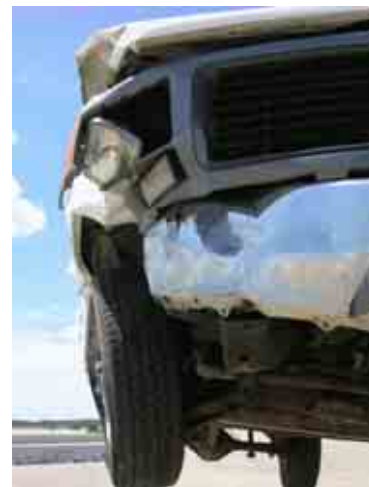
Figure 58. Vehicle Undercarriage Damage, Test MOBR-2

The right-side lower and upper A-arms were bent and buckled, with the lower arm more severely damaged than the upper. The right-side sway bar and tie rod were bent. The right-front end of the frame buckled at the front of the transmission mount and the cross frame buckled between the two front wheels. The right-side steering arm frame pivot was bent backward. The right-side bumper
