PERFORMANCE EVALUATION OF THE MIDWEST GUARDRAIL SYSTEM – UPDATE TO NCHRP 350 TEST NO. 3-10 (2214MG-3)

MwRSF Research Report No. TRP-03-172-06

October 11, 2006

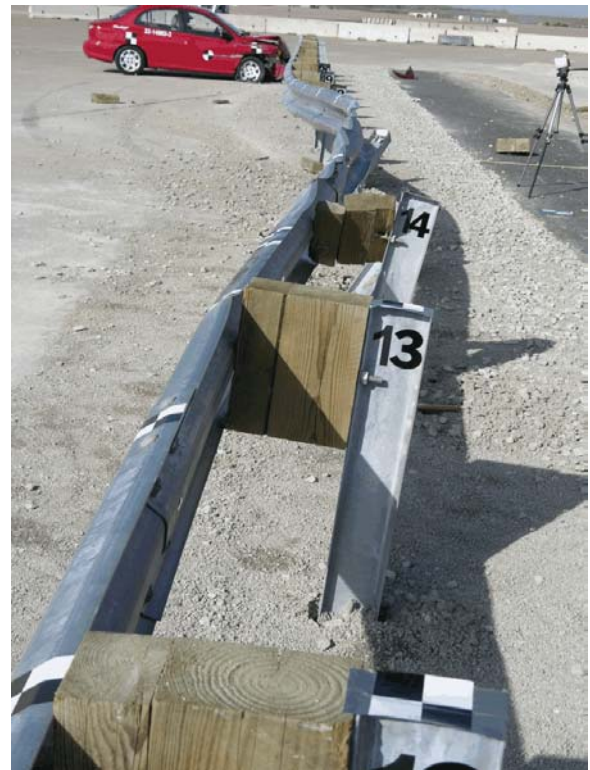
Figure 21. Midwest Guardrail System Damage, Test 2214MG-3

Damage to the barrier was moderate, as shown in Figures 21 through 25. Barrier damage consisted of deformed guardrail posts, disengaged wooden blockouts, contact marks on a guardrail section and posts, and deformed W-beam rail. The length of vehicle contact along the MGS system was approximately 8.3 m (27 ft), which spanned from 749 mm (29.5 in.) downstream from the centerline of post no. 13 through 1,822 mm (71.75 in.) downstream from the centerline of post no. 17.

Moderate deformation and flattening of the impacted section W-beam rail occurred between post nos. 13 and 18. Contact marks were found on the guardrail between post nos. 13 and 18. The guardrail buckled at 105 mm (4.125 in.) upstream of post no. 13 and 254 mm (10 in.) upstream of

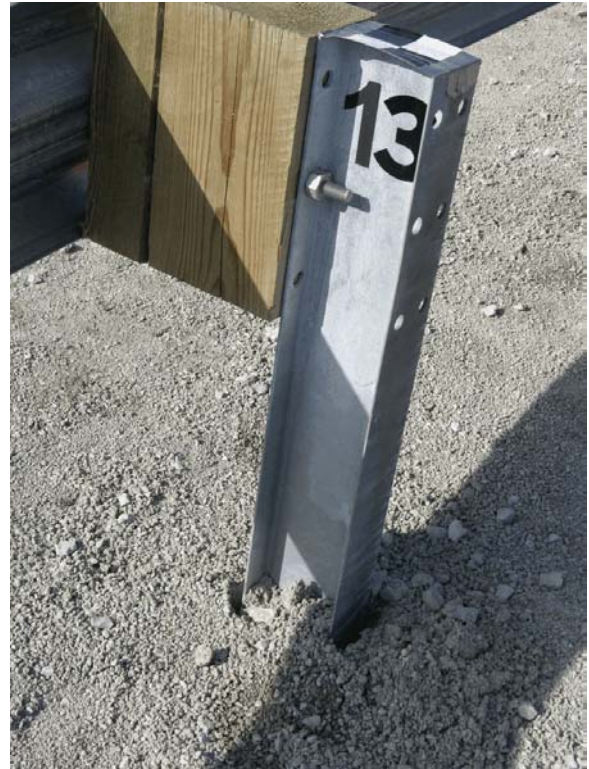
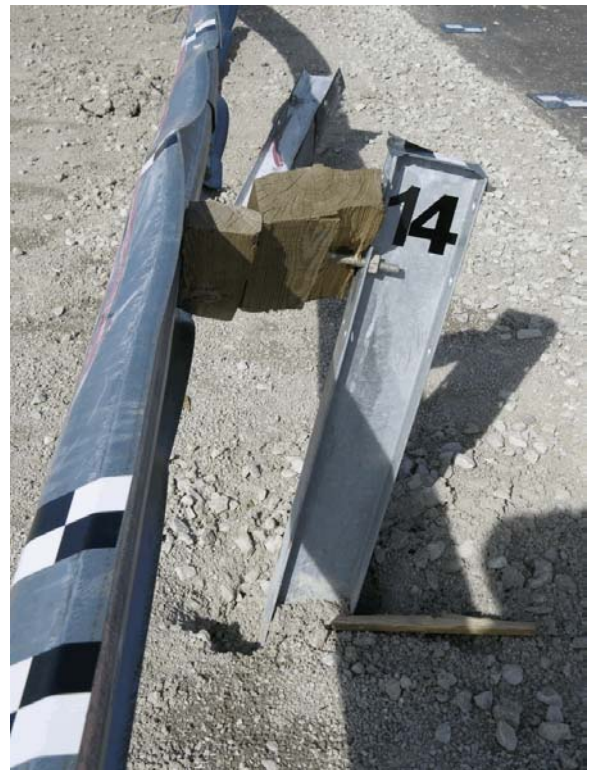
Figure 22. System Damage - Post Nos. 13 and 14, Test 2214MG-3

Steel post nos. 3 through 14 encountered minor twisting. Post no. 13 also rotated backward. Post no. 14 also rotated backward and downstream slightly. Post no. 15 rotated slightly backward and bent longitudinally downstream. Post no. 16 bent longitudinally downstream toward the ground and encountered major buckling and damage on the flanges. Post no. 17 rotated backward and bent longitudinally downstream. Post no. 18 also rotated backward slightly and bent slightly longitudinally downstream. Contact marks were found on the front and back flanges of post nos. 14 through 16. The post bolt at post no. 17 sheared off. The wooden blockouts at post nos. 14 through 17 were fractured and removed from the posts. The upstream and downstream anchorage systems moved longitudinally and the ground struts encountered plastic deformations on both ends. The upstream anchorage posts deflected downstream, while the downstream anchorage posts deflected upstream, but all four wood BCT posts remained undamaged.

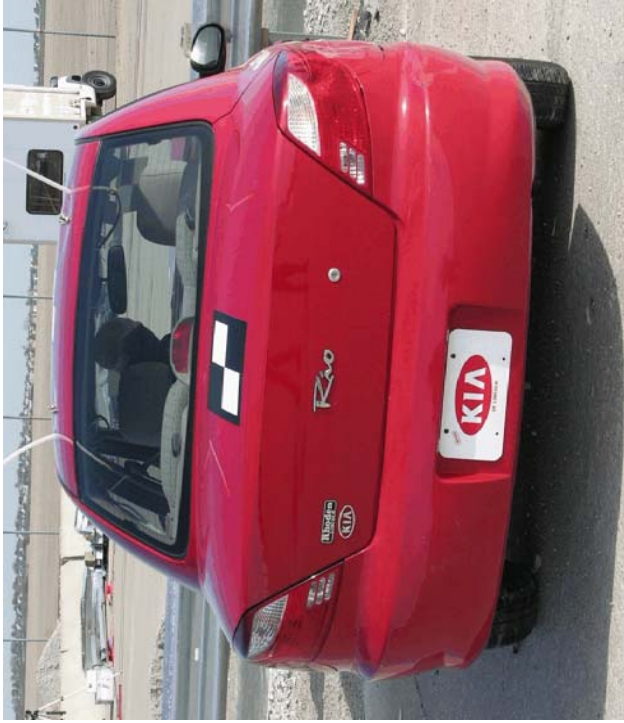
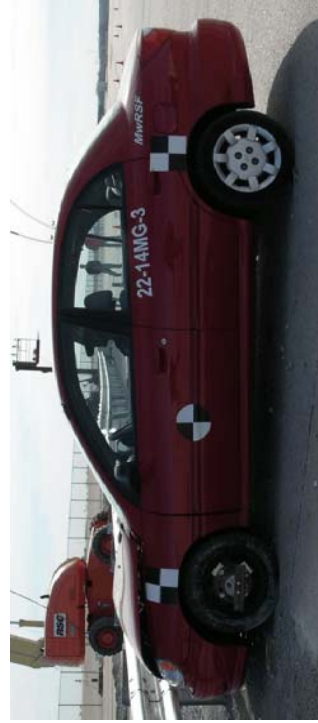
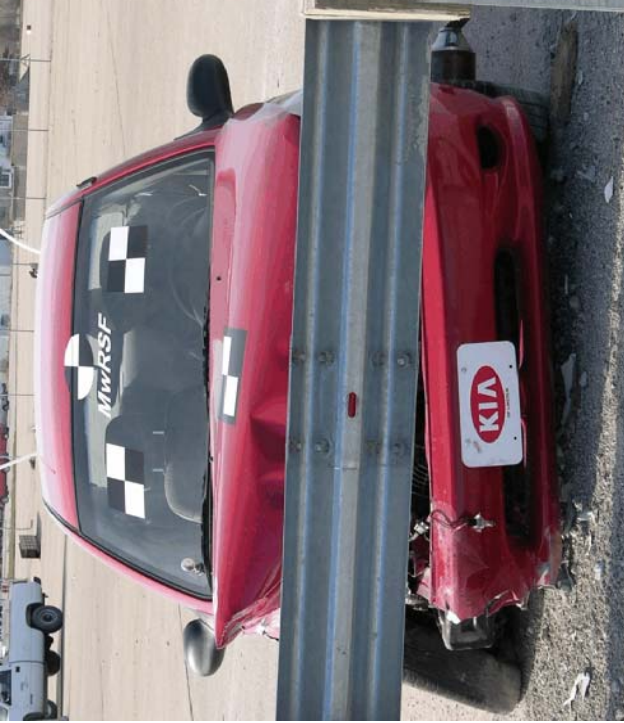
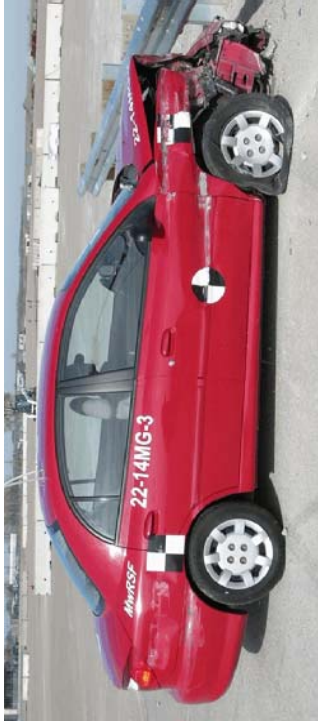
Figure 26. Vehicle Damage, Test 2214MG-3

Exterior vehicle damage was moderate, as shown in Figures 26 through 28. Occupant compartment deformations to the right side and center of the floorboard were judged insufficient to cause serious injury to the vehicle occupants. Maximum longitudinal deflections of 6 mm (0.25 in.) were located throughout the right-side floor pan. Maximum lateral deflections of 6 mm (0.25 in.) were located throughout the right-side floor pan. Maximum vertical deflections of 6 mm (0.25 in.) were located near the center of the right-side floor pan. Complete occupant compartment deformations and the corresponding locations are provided in Appendix C.

Damage was concentrated on the right-front corner of the vehicle. The right-front quarter panel was deformed inward and downward toward the engine compartment. The right side of the front bumper was flattened and crushed inward toward the frame. The front frame was bent about the centerline and the right side was bent backward and downward. The right-side frame with the connection to the wheel was bent backward also. The right-side of the hood buckled upward and crushed inward. The protective plastic molding in the right-front wheel well was fractured. The right-front wheel assembly deformed and crushed inward toward the engine compartment. The right-front steel rim was bent on both the interior and exterior sides. The right-front tire was pulled off the rim and deflated. The right-front door encountered dents and scratches and was ajar at the top. The right rear door also encountered contact marks from system interaction. The right-rear quarter panel sustained minor contact marks and denting. The right-rear bumper was scratched and dislodged slightly. The right-side headlight, park light, and brake light fractured and disengaged from the vehicle. The left-side headlight was dislodged out of its socket. All window glass remained
