# **PERFORMANCE EVALUATION OF THE MIDWEST GUARDRAIL SYSTEM – UPDATE TO NCHRP 350 TEST NO. 3-11 (2214MG-1)**

MwRSF Research Report No. TRP-03-170-06

October 10, 2006

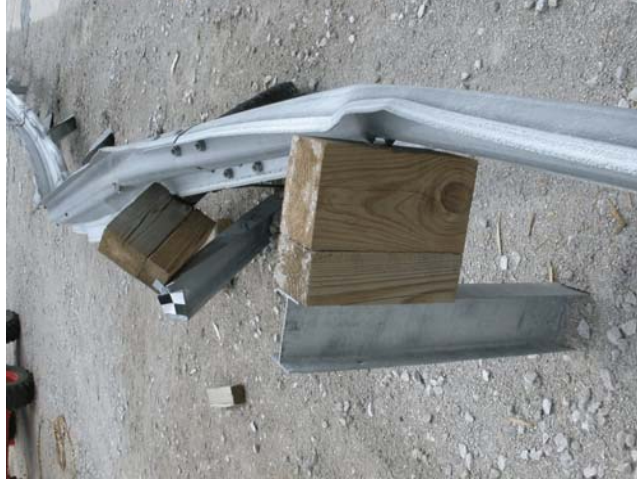
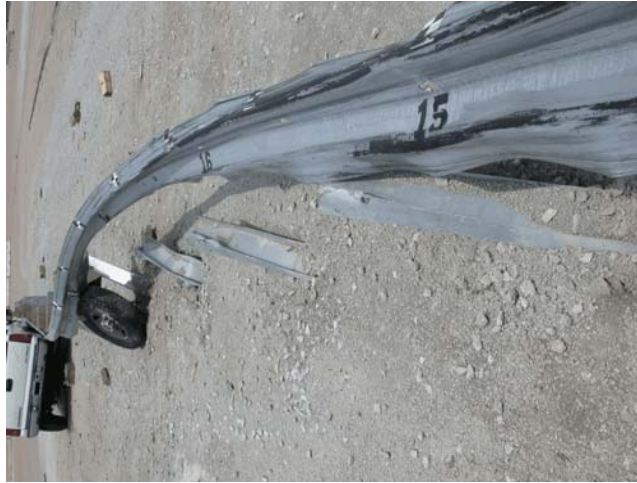
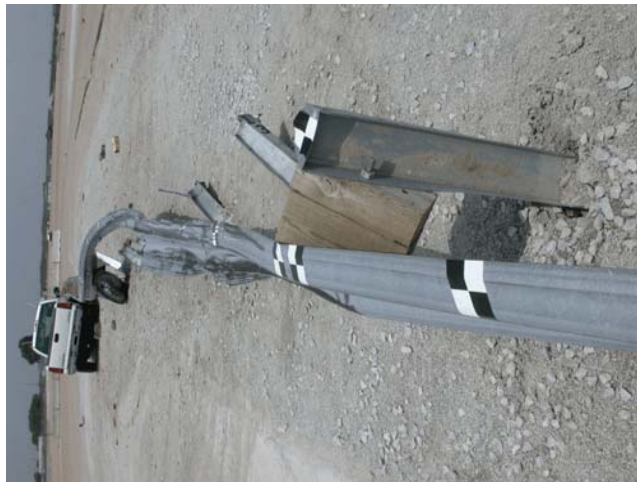
Figure 23. Midwest Guardrail System Barrier Damage, Test 2214MG-1

Damage to the barrier was moderate, as shown in Figures 23 through 28. Barrier damage consisted of deformed guardrail posts, disengaged wooden blockouts, contact marks on a guardrail section and posts, and deformed W-beam rail. The length of vehicle contact along the MGS system

The permanent set of the barrier system is shown in Figure 23. The maximum lateral permanent set rail and post deflections were 1,089 mm (42.875 in.) at the centerline of post no. 16 and 648 mm (25.5 in.) at post no. 13, as measured in the field. The maximum lateral dynamic rail and post deflections were 1,447 mm (57.0 in.) at the midspan between post nos. 14 and 15 and 764 mm (30.1 in.) at post no. 13, as determined from high-speed digital video analysis. The working width of the system was found to be 1,456 mm (57.3 in.).

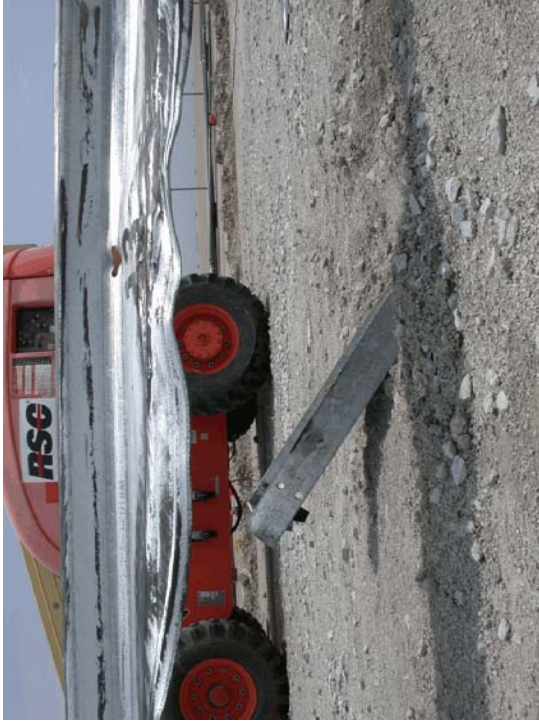
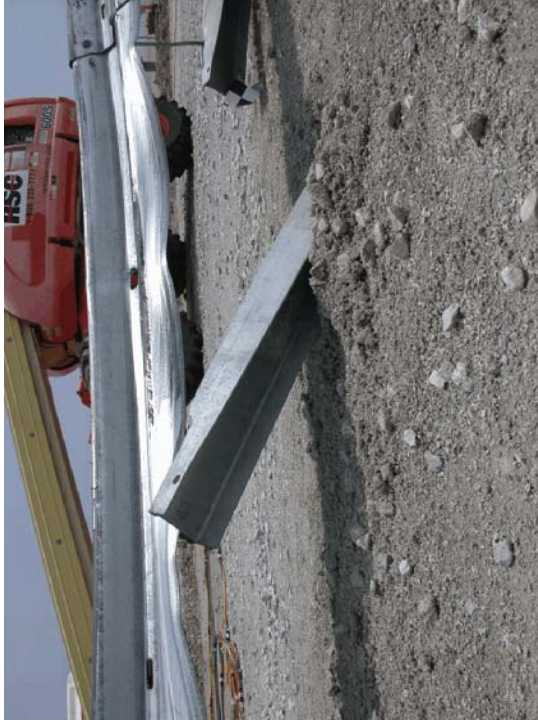
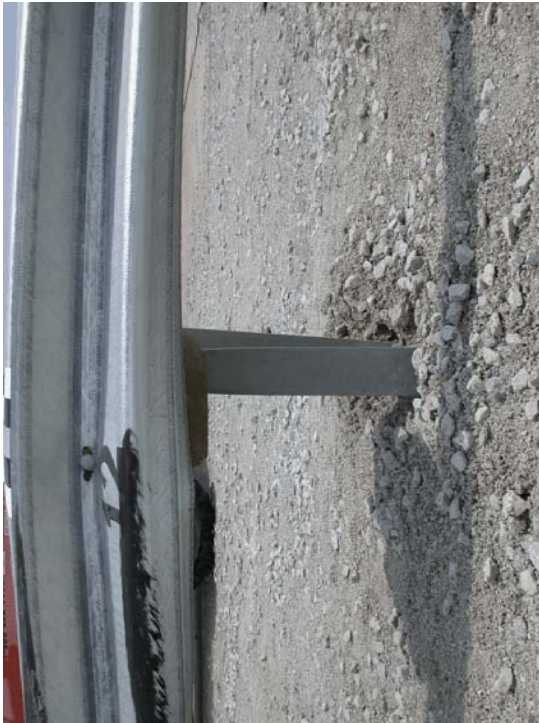
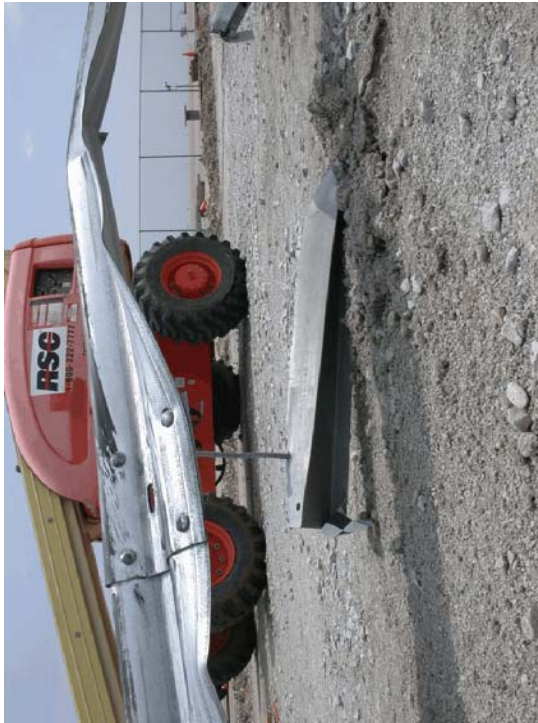
Figure 24. Midwest Guardrail System Post Nos. 12 through 15 Damage, Test 2214MG-1

slightly downstream. Post nos. 13 and 19 rotated backwards slightly, while post no. 19 also encountered minor buckling of the web. Post nos. 14 through 18 were bent longitudinally downstream toward the ground. Post no. 14 encountered significant buckling of the downstream front flange. Post no. 15 and 17 were severely buckled, while the bolt hole of post no. 17 was torn out. The right flange of post no. 16 and the web of post no. 18 buckled. Contact marks were found on the upstream edge of the back flange of post no. 16 and toward the top of the upstream edge of the back flange of post no. 17. Small gouges were found in the web of post no. 17 from the post bolt. The post bolts at post nos. 13 and 15 sheared off. The upstream and downstream anchorage systems moved longitudinally and the ground struts encountered plastic deformations on both ends. The upstream anchorage posts deflected downstream, while the downstream anchorage posts deflected upstream, but all four wood BCT posts remained undamaged.

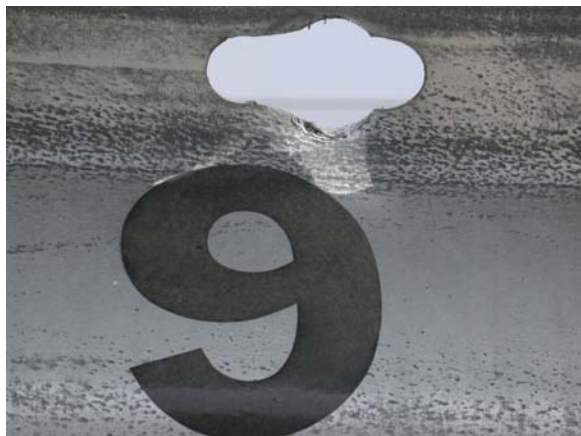
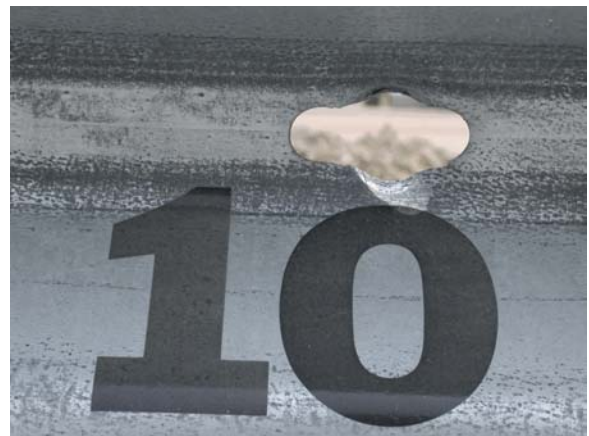
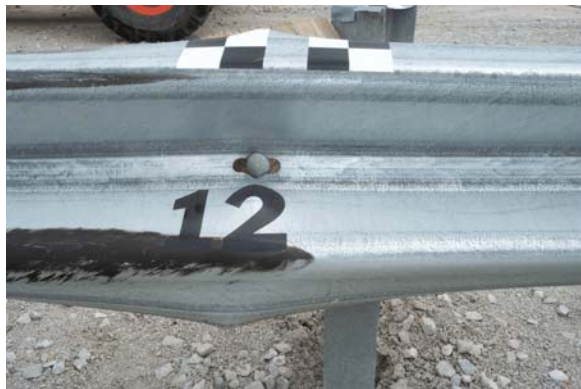
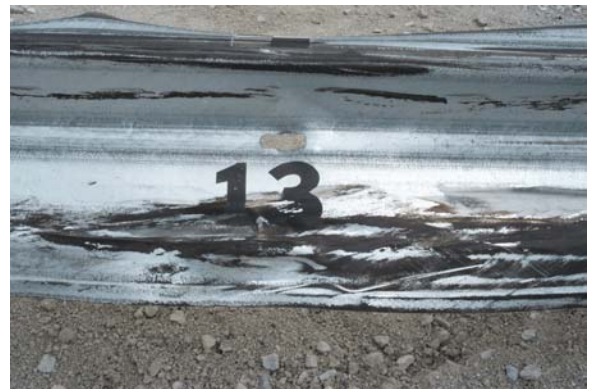
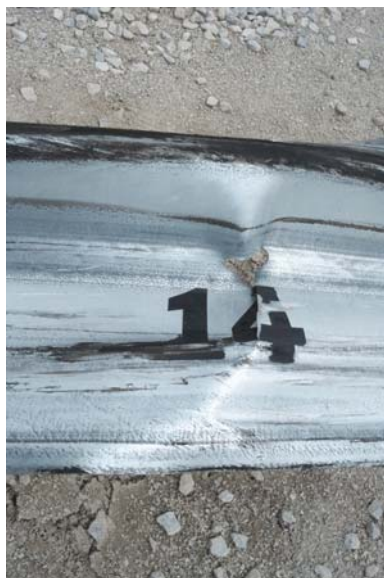
Figure 26. Post Nos. 9, 10, and 12 through 14 Guardrail Damage, Test 2214MG-1

Moderate deformation and flattening of the impacted section W-beam rail occurred between post nos. 13 and 18. Contact marks were found on the guardrail between post nos. 12 and 19. A small tear was found in the top corrugation 6 mm (0.25 in.) upstream of post no. 14. The guardrail buckled at 216 mm (8.5 in.) upstream of post no. 11, 64 mm (2.5 in.) downstream of the midspan between post nos. 11 and 12, and at post no. 12. The guardrail also buckled at the upstream side of splice between post nos. 12 and 13, at the post bolt hole of post no. 14, and 368 mm (14.5 in.) downstream from the midspan between post nos. 13 and 14. Other guardrail buckle points were found at 267 mm (10.5 in.) upstream of post no. 15 and 1,276 mm (50.25 in.) downstream of post no. 15. The guardrail encountered numerous buckle points at post no. 16. Major buckling of the guardrail occurred at 533 mm (21 in.) downstream of post no. 16. The guardrail also buckled at 51 mm (2 in.) upstream of post no. 18, 254 mm (10 in.) downstream of post no. 18, at post no. 19, and 279 mm (11 in.) downstream of post no. 19. The W-beam was pulled off post nos. 3 through 10 and 13 through 18. The W-beam rail sustained tearing and significant yielding around the post bolt slots at post nos. 14 through 19, while only minor yielding occurred around the post bolt slots at post nos. 11 through 13. No significant guardrail damage occurred downstream of post no. 20, except for slight rail deflection and minor contact marks between post nos. 22 and 25 due to secondary vehicle contact with the system before coming to rest.

The wooden blockouts at post nos. 5 through 7 and 10 rotated slightly while still attached to the post. The wooden blockout at post no. 11 encountered slight damage to the upstream front corners due to contact from the W-beam rail. The wooden blockout at post no. 12 rotated to approximately a 45 degree angle and remained attached to the post. The wooden blockouts at post nos. 14 through 17 were fractured and removed from the post.

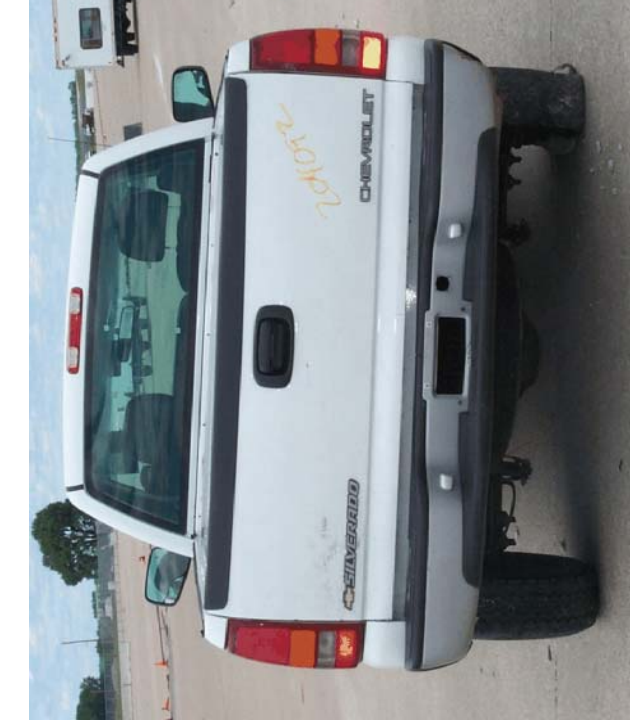
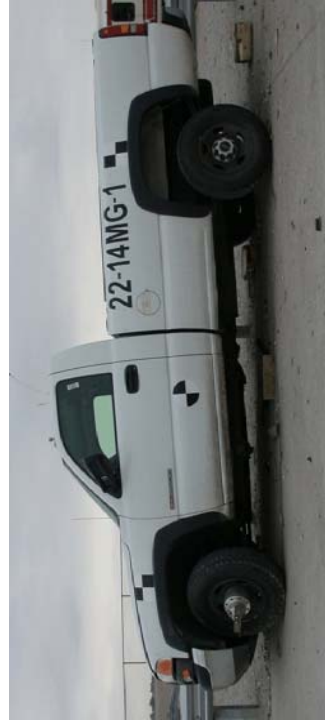
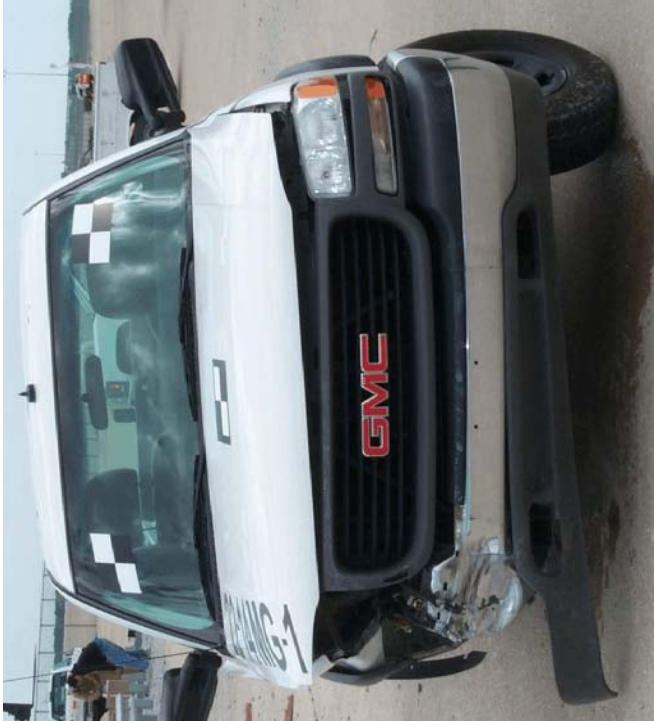
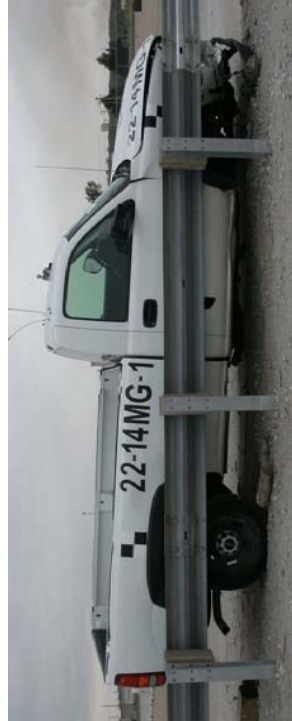
Figure 29. Vehicle Damage, Test 2214MG-1

Exterior vehicle damage was moderate, as shown in Figures 29 through 32. Occupant compartment deformations to the right side and center of the floorboard, as shown in Figure 32, were judged insufficient to cause serious injury to the vehicle occupants. Maximum longitudinal deflections of 13 mm (0.5 in.) were located near the center of the right-side floor pan. Maximum lateral deflections of 25 mm (1.0 in.) were located near the center of the right-side floor pan. Maximum vertical deflections of 13 mm (0.5 in.) were located near the firewall at the right-front corner and center of the right side. Complete occupant compartment deformations and the corresponding locations are provided in Appendix C.

Damage was concentrated on the right-front corner of the vehicle. The right-front quarter panel was deformed inward and downward toward the engine compartment. The right side of the front bumper was flattened and bent back toward the engine compartment and contacted the lower frame rail. The box was bent upward and inward behind the right-rear wheel. The right side of the hood was bent slightly. The right-front wheel assembly deformed and crushed inward toward the engine compartment. The right-side ball joints and steering linkage were fractured. The upper control arm was bent. The right-front tire disengaged from the rest of the wheel assembly. The right-rear tire deflated. The right-side headlight and park light fractured and disengaged from the vehicle. All window glass remained undamaged. The left side and rear of the vehicle remained undamaged.
