NCHRP 350 DEVELOPMENT AND TESTING OF A GUARDRAIL CONNECTION TO LOW-FILL CULVERTS

MwRSF Research Report No. TRP-03-114-02

November 1, 2002

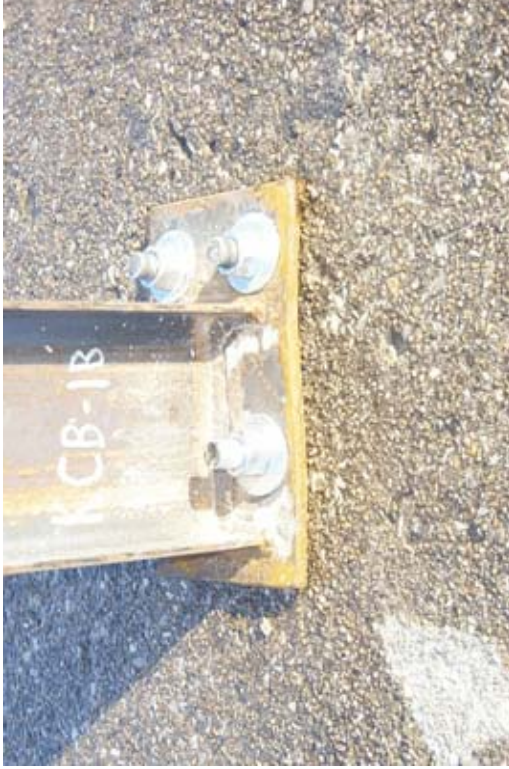
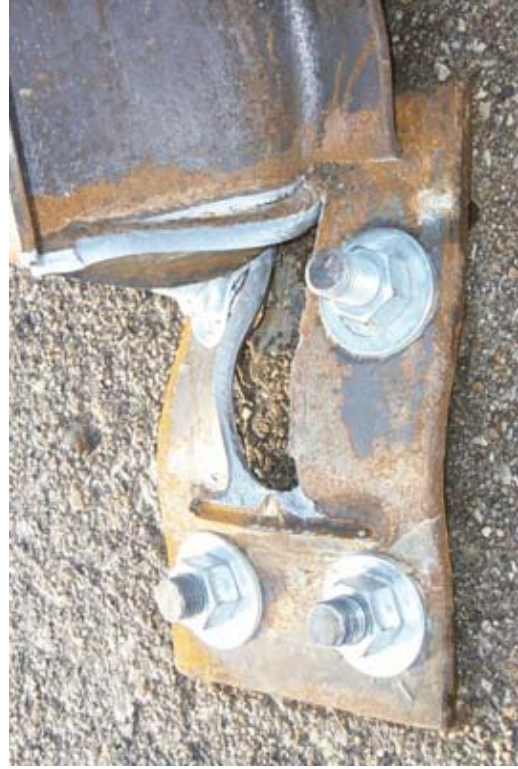
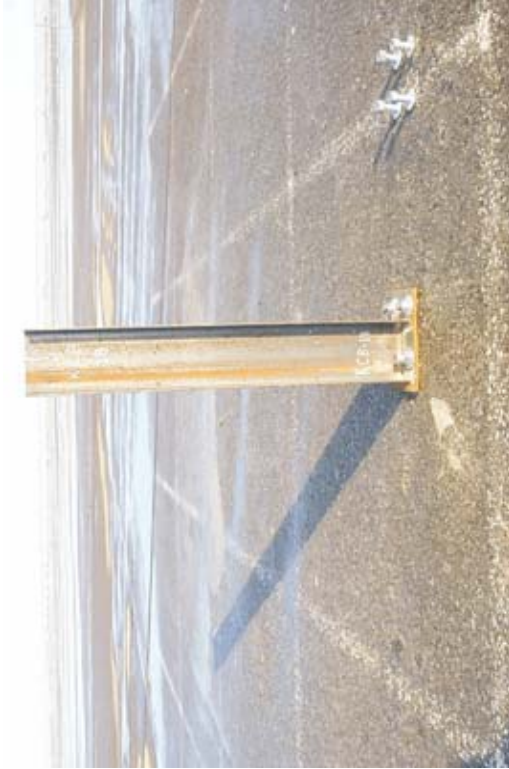
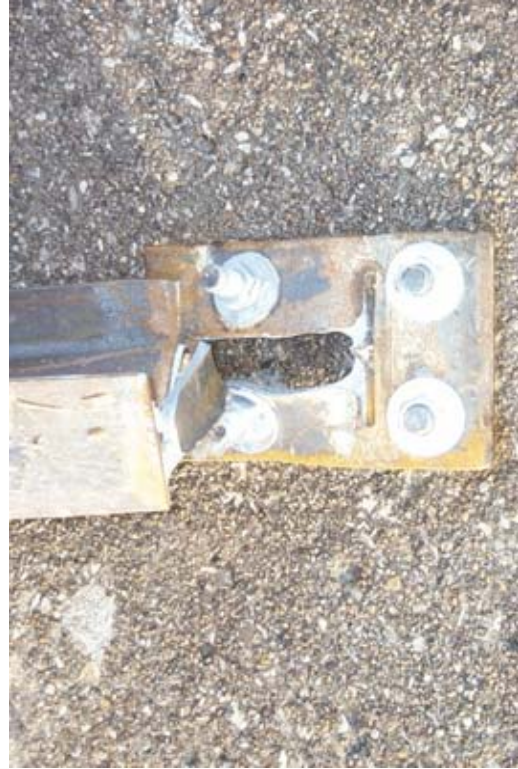
Figure 24. Post and Plate Damage, Bogie Test KCB-1b

Seven bogie tests were performed and are summarized in Table 4. For bogie tests KCB-1b through KCB-6, failure occurred in either the weld between the post and base plate or in the threaded rods used to anchor the plate to the concrete. For bogie test KCB-7, the post and plate yielded without any bolt damage or weld failure. Because this failure mechanism is more readily reproducible than weld failure, the post-to-culvert attachment configuration used in bogie test KCB-7 was recommended for further evaluation using computer simulation modeling. Post and plate damage for each bogie test are shown in Figures 24 through 30. Force-deflection plots for each post test are shown graphically in Appendix B.

Test No.	Speed (km/hr)	Peak Load (kN)	Deflection at Peak Load (mm)	Results
KCB-1b	16.4	49.7	86.6	Plate failure, fractured away with post
KCB-2	16.1	91.6	36.1	Weld failure
KCB-3	16.1	49.3	116.6	Bolts failed in tension, plate deformed
KCB-4	16.1	82.0	117.6	Weld failure
KCB-5	16.1	38.5	162.3	Plate buckled and weld failure
KCB-6	16.1	60.5	327.2	Plate buckled and weld failure
KCB-7	17.7	65.3	61.2	Post and plate yielded, no bolt damage or weld failure

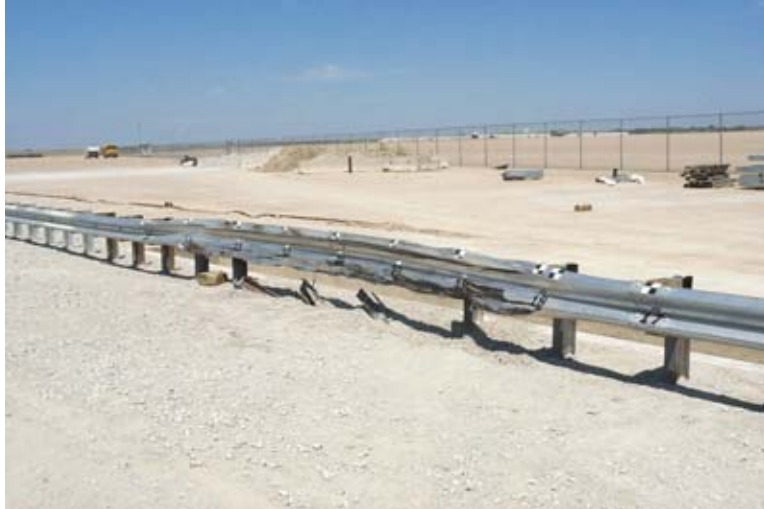
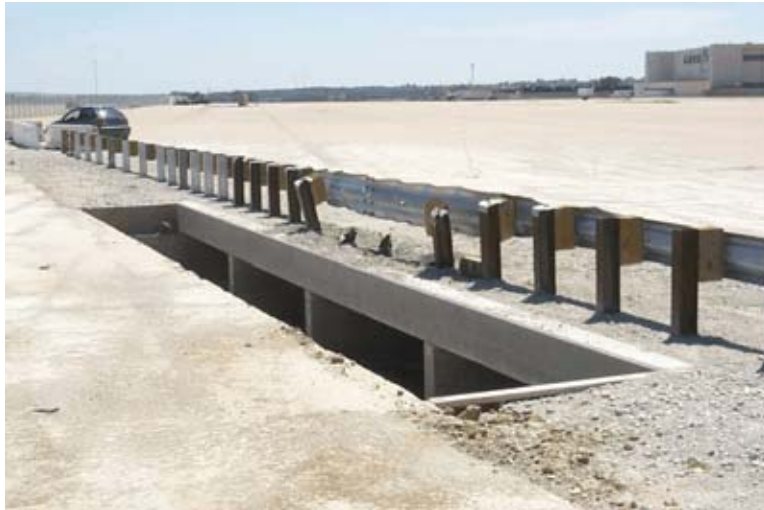
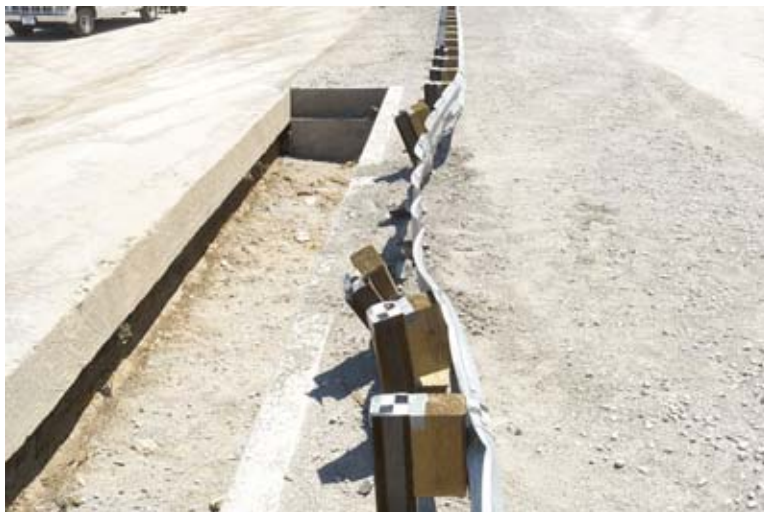
Figure 48. W-Beam Guardrail System Damage, Test KC-1

Damage to the barrier was moderate, as shown in Figures 48 through 62. Barrier damage consisted mostly of deformed W-beam, contact marks on a guardrail section, and deformed guardrail posts.

The guardrail damage consisted of moderate deformation and flattening of the impacted section of the W-beam rail between post nos. 18 and 24. Contact marks were found on the guardrail between post nos. 18 and 25. The guardrail was buckled at 305-mm downstream from the center of post no. 25. The W-beam was pulled off of post nos. 19 through 23. No significant guardrail damage occurred upstream of post no. 17 nor downstream of post no. 26.

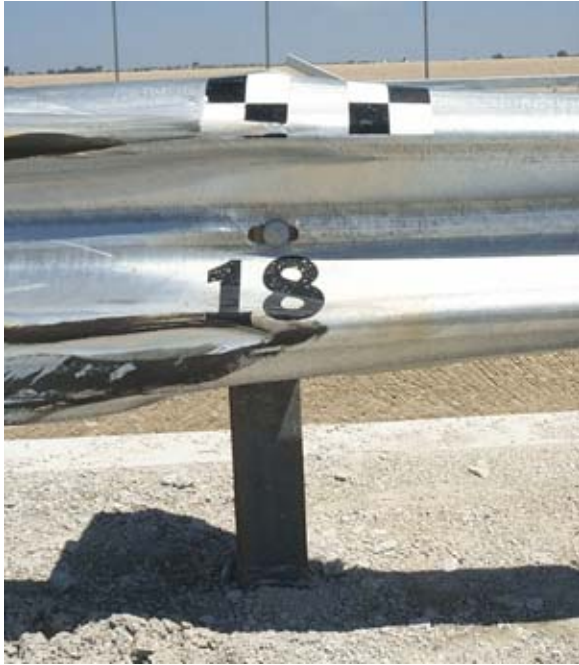
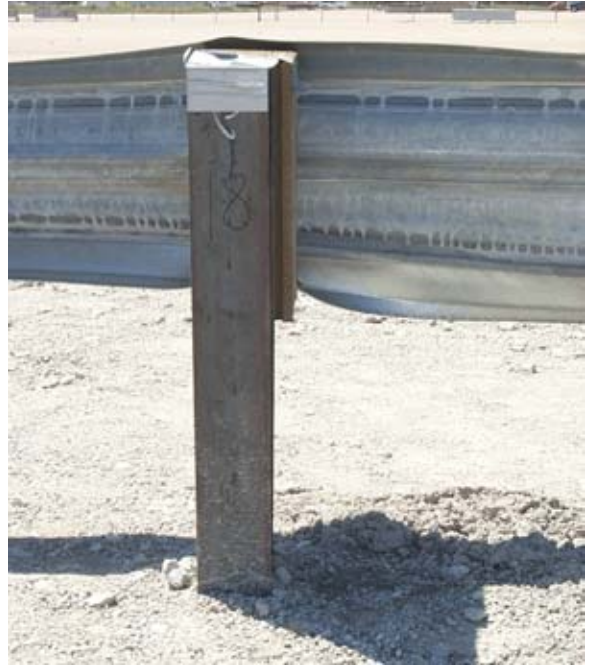
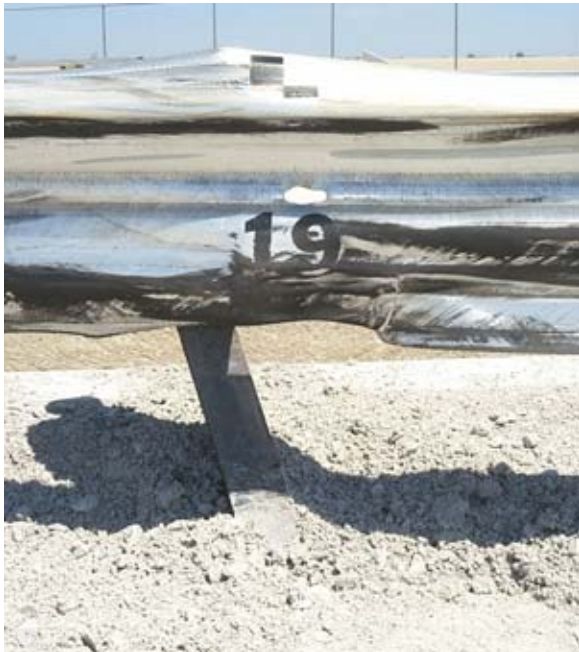
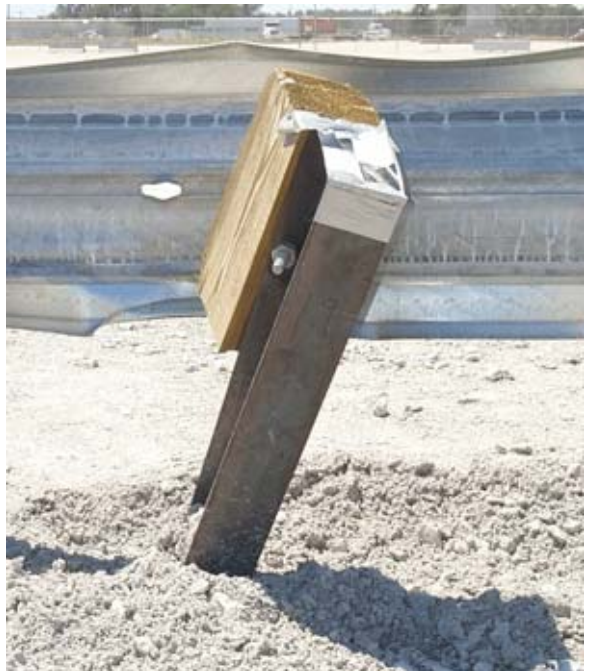
Figure 52. Post Nos. 18 and 19 Damage, Test KC-1

Steel post no. 18 rotated backward slightly while steel post no. 19 bent laterally backward and longitudinally downstream. Steel post nos. 20 through 22 were bent longitudinally toward the ground in the downstream direction. Steel post no. 23 was bent longitudinally downstream but not as extensively as post nos. 20 through 22. Steel post no. 24 was slightly twisted and bent longitudinally downstream. Contact marks were found on the front face of post nos. 18 through 24. No significant post damage occurred to post nos. 1 through 17 nor 25 through 41. The upstream anchorage system was slightly moved longitudinally, while the downstream anchorage system remained unmoved. The posts in both the upstream and downstream anchorage systems were not damaged.

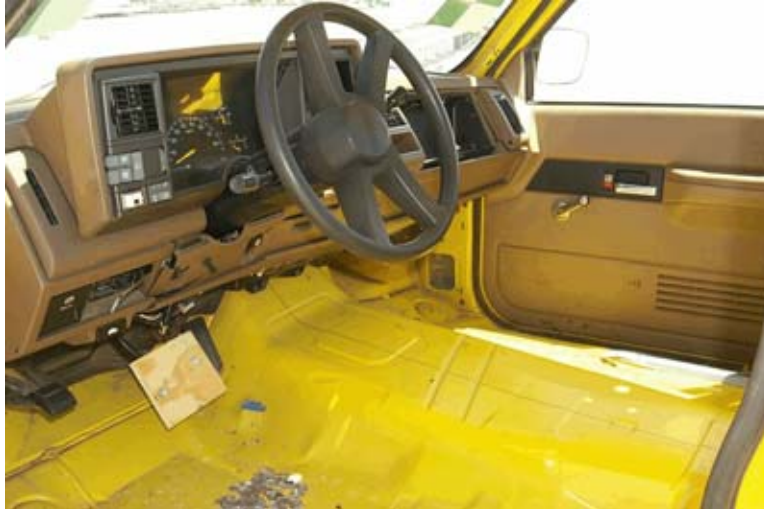
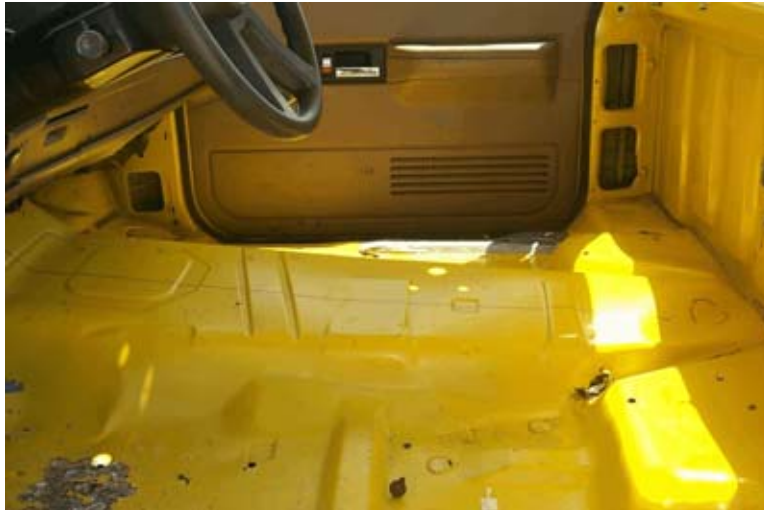
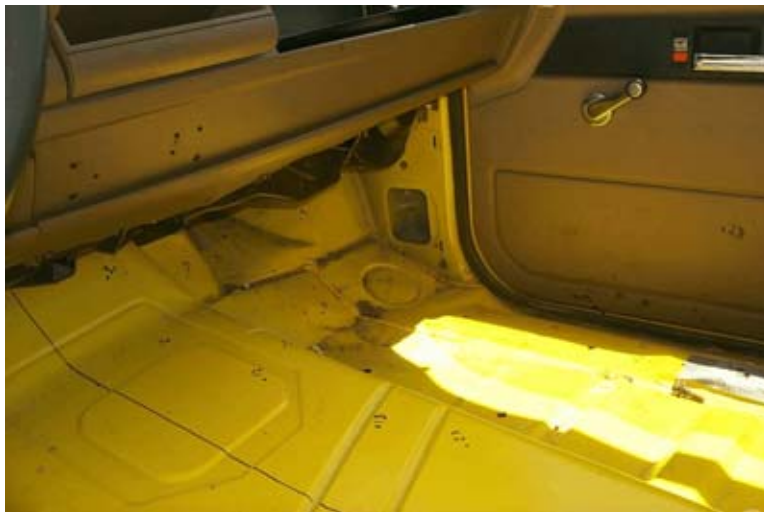
Figure 65. Occupant Compartment Deformations, Test KC-1

Exterior vehicle damage was moderate, as shown in Figures 63 through 65. Minimal occupant compartment deformations occurred with only slight deformations of the firewall. Occupant compartment deformations and the corresponding locations are provided in Appendix E. Contact marks were found along the lower portion of the entire right side of the vehicle. The right-front fender was deformed downward and inward toward the engine compartment. The right-front side of the bumper was deformed inward and contacted the upper A-frame control arm. A buckling point was found at the center of the front bumper. The right-front steel rim was deformed, and the tire was torn and deflated. Scuff marks were found on the right-rear tire side wall. The right-side headlight region was crushed inward toward the engine compartment, and the headlight broke. The

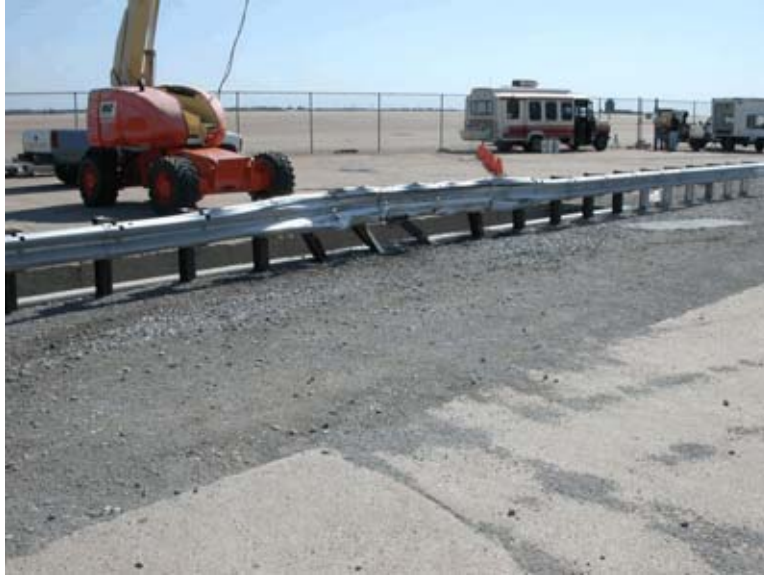
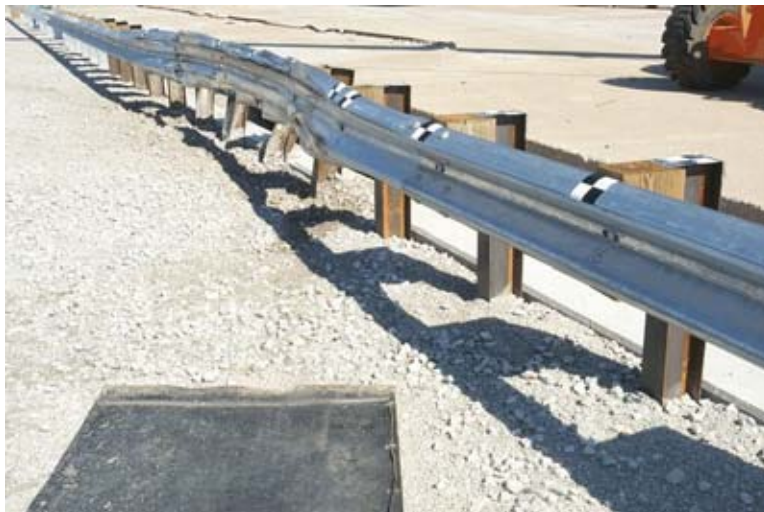
Figure 82. W-Beam Guardrail System Damage, Test KC-2

Damage to the barrier was moderate, as shown in Figures 82 through 89. Barrier damage consisted mostly of deformed W-beam, contact marks on a guardrail section, and deformed guardrail posts.

The guardrail damage consisted of moderate deformation and flattening of the lower portion of the impacted section of the W-beam rail between post nos. 17 and 23. Deformation and flattening of the upper portion of the impacted section of W-beam rail occurred between post nos. 17 and 24. Contact marks were found on the guardrail between post nos. 17 and 24. The bottom of the guardrail at post no. 19 deformed around the bottom of the wood blockout. The top of the guardrail was buckled at 152-mm downstream from the center of post no. 24. The W-beam was pulled off of post nos. 20 through 22. No significant guardrail damage occurred upstream of post no. 17 nor downstream of post no. 25.
