**PERFORMANCE EVALUATION OF THE  
PERMANENT NEW JERSEY SAFETY SHAPE  
BARRIER – UPDATE TO NCHRP 350  
TEST NO. 3-10 (2214NJ-1)**

**MIDWEST ROADSIDE SAFETY FACILITY**

MwRSF Research Report No. TRP-03-177-06

October 13, 2006

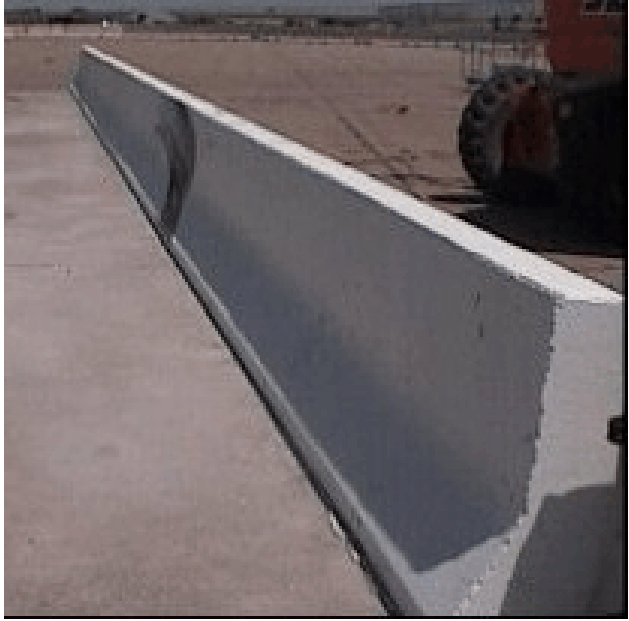
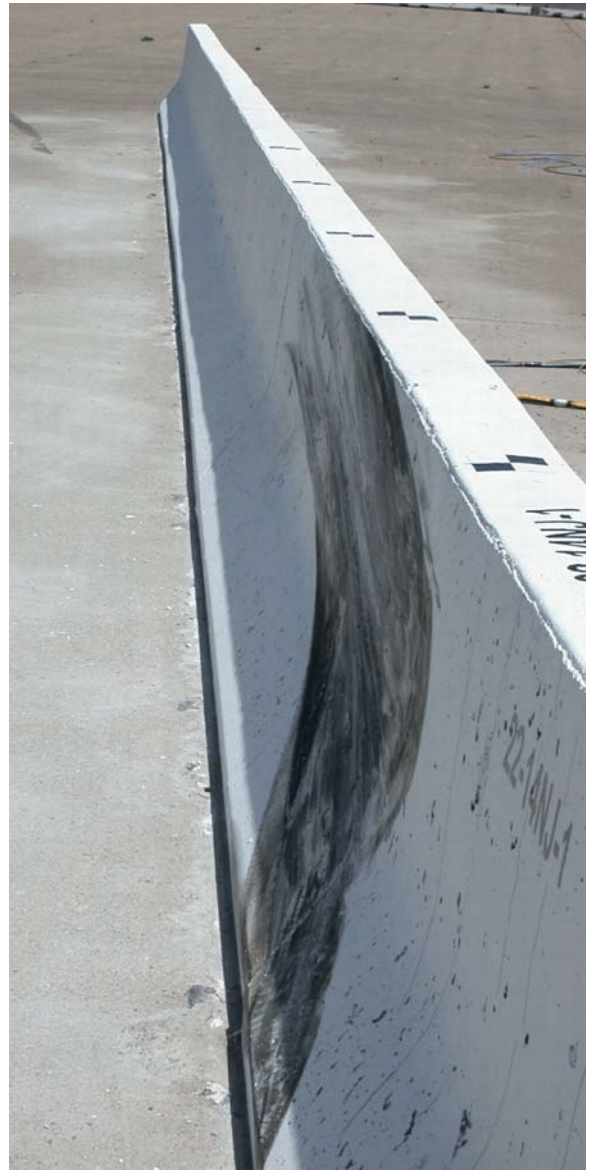
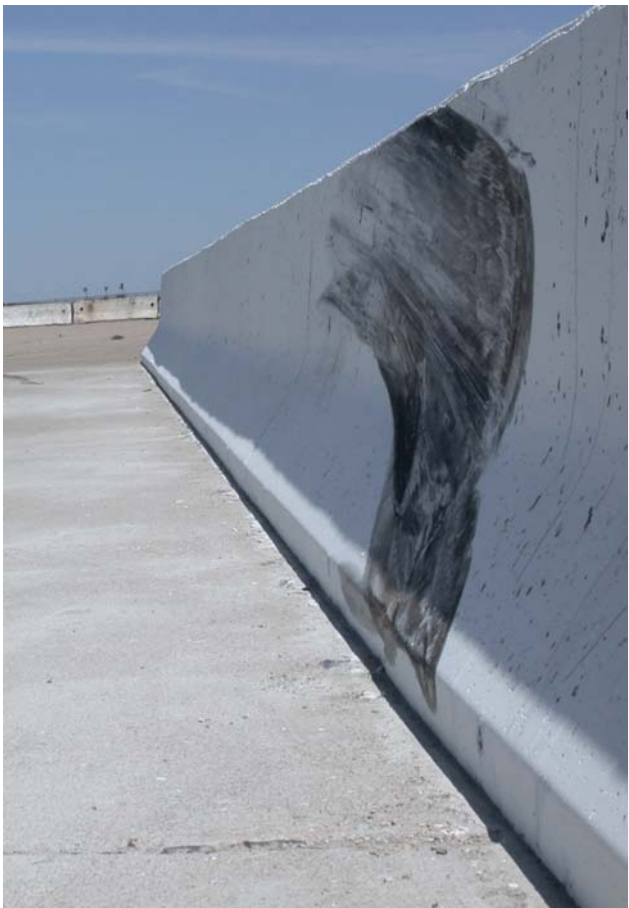
Figure 22. Permanent New Jersey Safety Shape Barrier Damage, Test 2214NJ-1

Damage to the barrier was minimal, as shown in Figure 22. Barrier damage consisted of contact and gouge marks. The length of vehicle contact along the concrete barrier system was approximately 3.35 m (11 ft), which spanned from 5,626 mm (221.5 in.) downstream from the upstream end of the barrier through 8,979 mm (353.5 in.) downstream from the upstream end of the barrier.

The permanent set of the barrier system was negligible. The working width of the system was found to be 485 mm (19 in.).

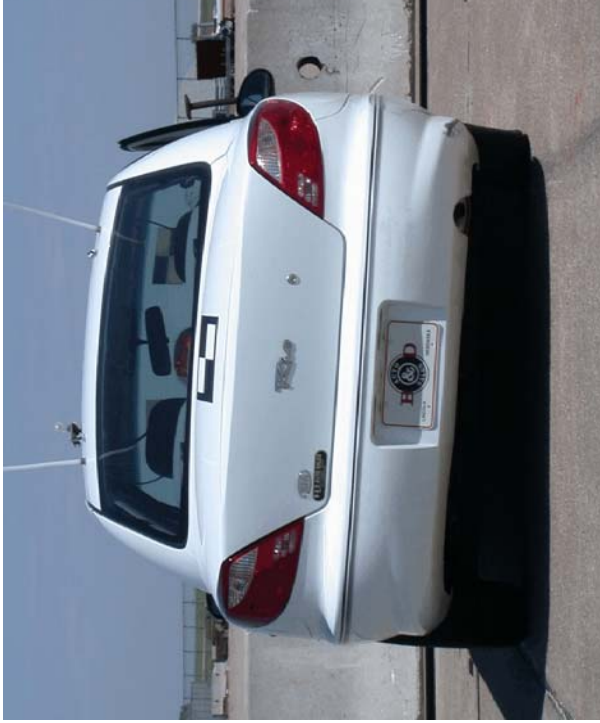
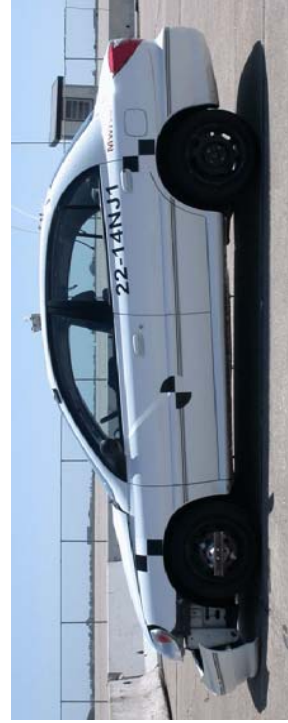
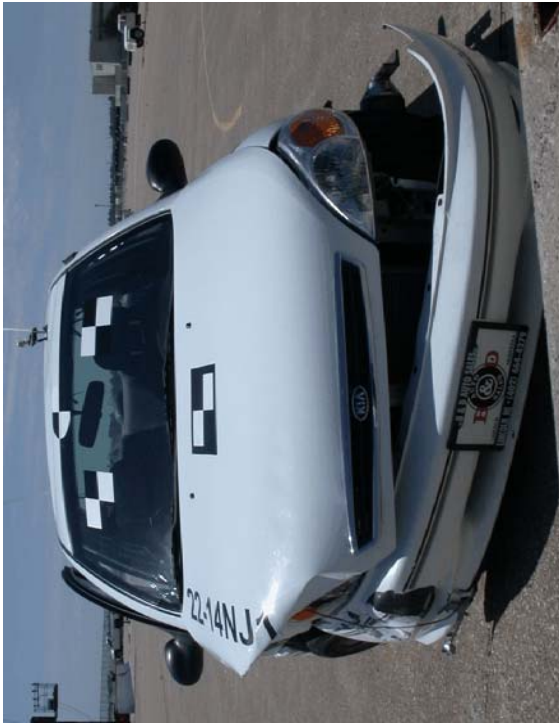
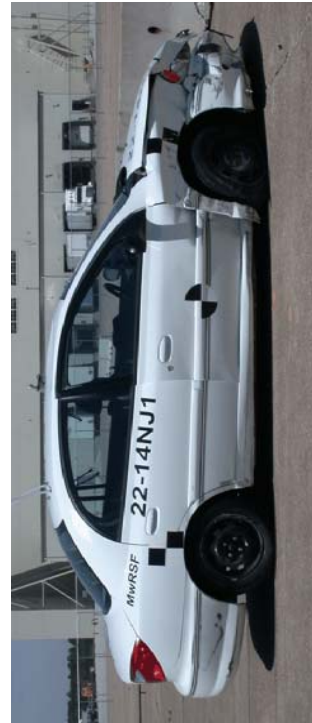
Figure 23. Vehicle Damage, Test 2214NJ-1

Exterior vehicle damage was moderate, as shown in Figures 23 through 25. Occupant compartment deformations to the right side and center of the floorboard were judged insufficient to cause serious injury to the vehicle occupants. Maximum longitudinal deflections of 57 mm (2.25 in.)

Damage was concentrated on the right side of the vehicle. The right-front quarter panel was deformed inward and downward toward the engine compartment. Contact marks were found on the right-rear quarter panel. The right side of the front bumper was flattened and bent back toward the engine compartment and also encountered scratches and cracks. The left side of the front bumper disengaged from the frame and buckled inward toward the engine compartment. The front bumper disengaged from the front mounting bolts. The right-rear door encountered a small dent directly in front of the rear tire. The top of the right-front door was ajar. The trim on the right-front door was bent and encountered a large abrasion. The molding behind the right-front tire was crushed inward. Scratches were found along the entire right side moldings at the bottom of the doors. The hood buckled and deformed backward on the right side. The right half of the roof buckled slightly. The right-side engine mount buckled severely. The radiator was bent and deformed. Contact marks were observed on the muffler. The right-front control arm connection to the frame was bent 51 mm (2 in.) away from the frame. Scratches were found on the skid plate, three of the lug nuts on the right-front tire, and two of the lug nuts on the right-rear tire. Contact marks were also found on the lower-right-rear control arm and on the inside of the right-rear wheel well. The right-front and right-rear steel rims were deformed and dented. The right-front tire pulled away from the bead and was deflated. The right-side headlight assembly was broken and pushed inward. The lower-right side of the

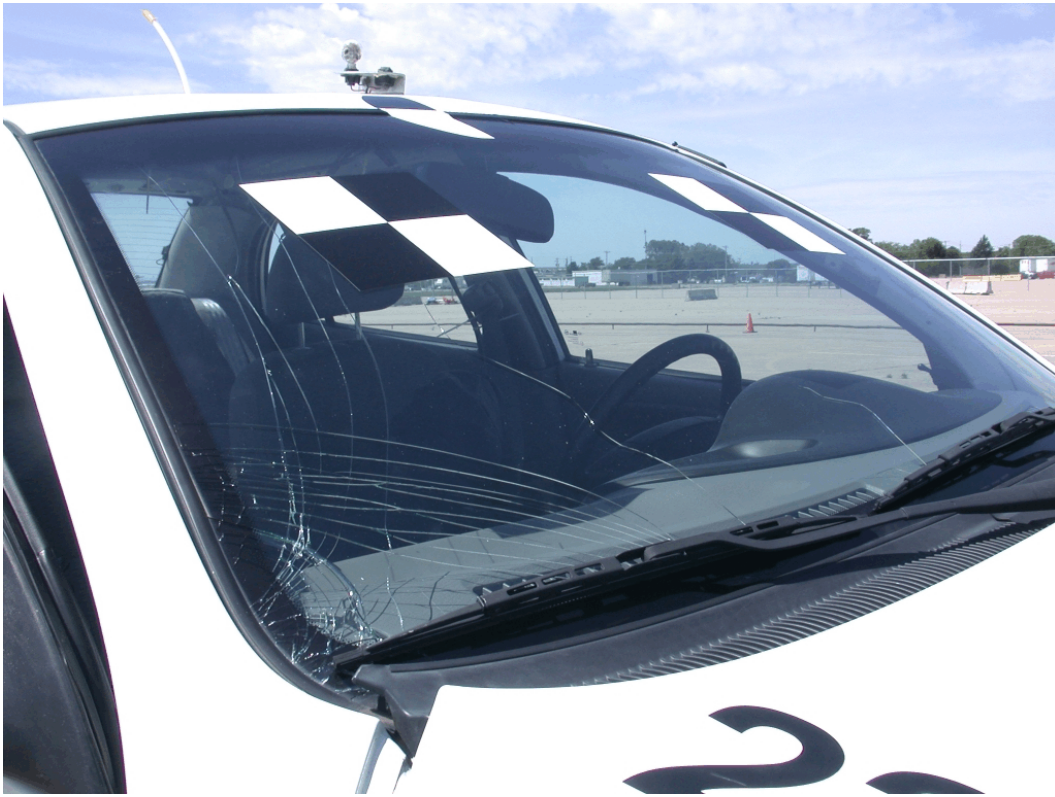
Figure 25. Windshield Damage, Test 2214NJ-1

windshield encountered minor cracking. All other window glass remained undamaged. The left-side and rear of the vehicle remained undamaged.
